## Inspection Photos

Location Name: TEP ROCKY MOUNTAIN LLC 33-1-795 Pit

Facility ID: 414557

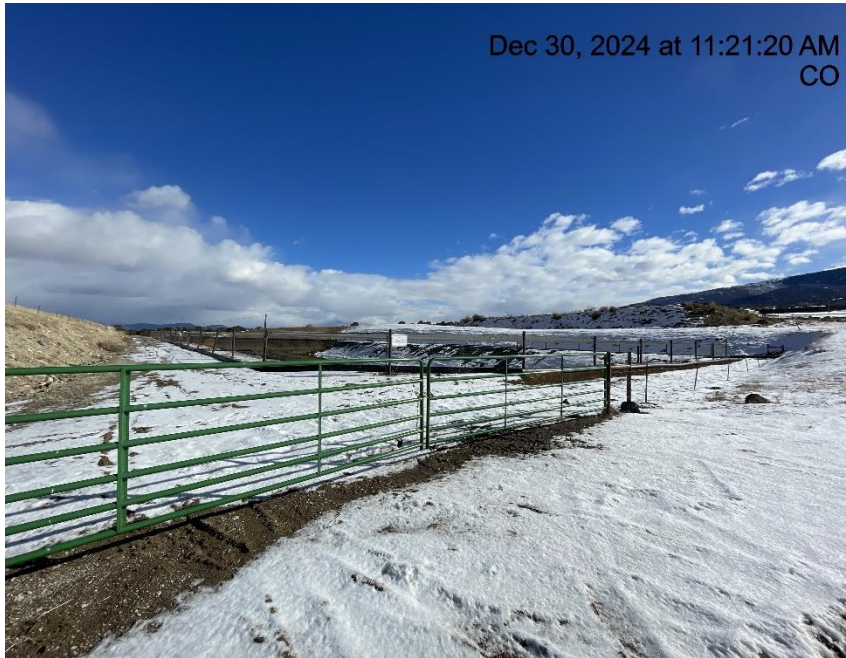
Photo # 5649 From entrance to location

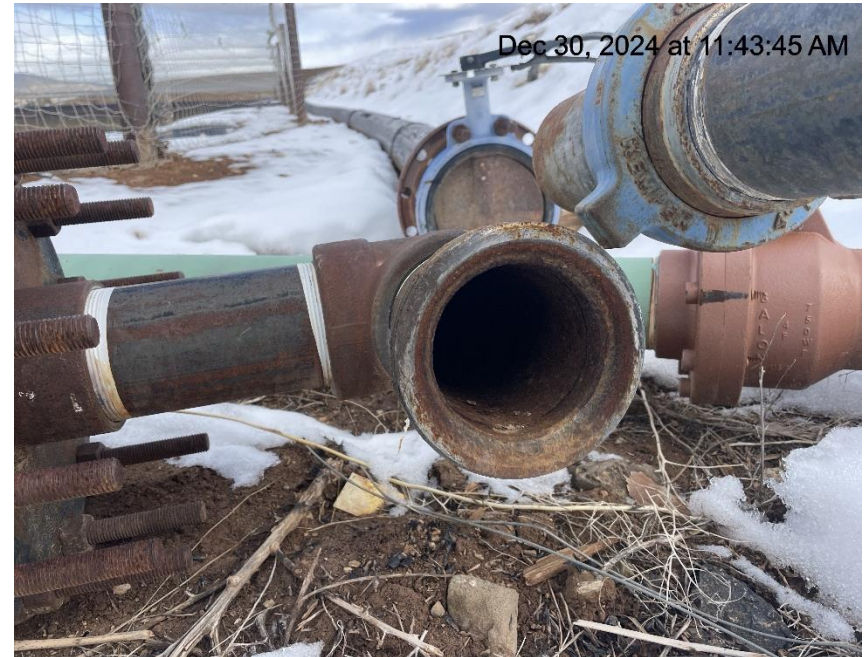
Photo # 5654 Open ended piping/wildlife hazard/available for entry by wildlife

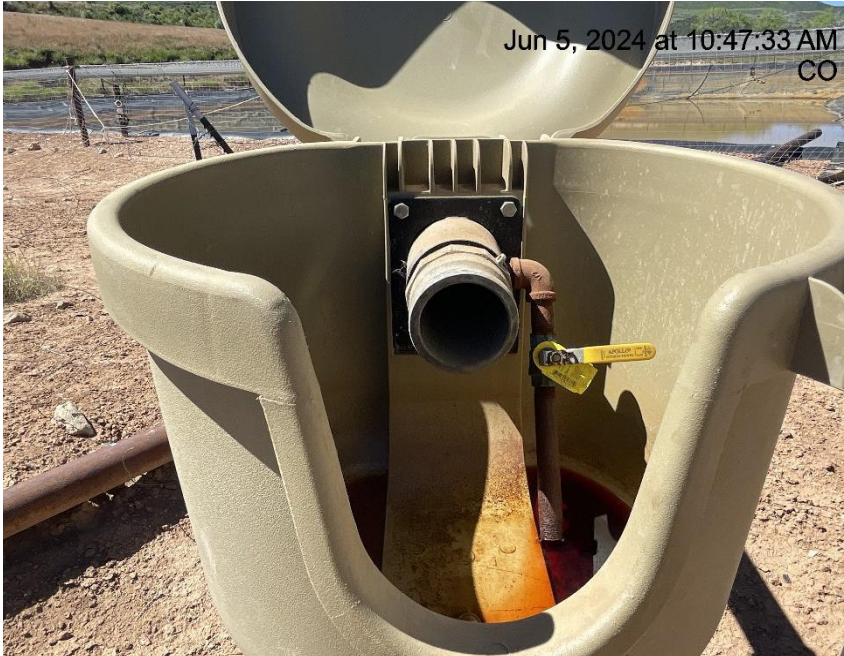
Photo # 9377 From inspection 708903976 conducted on 06/05/2024 Open ended load line

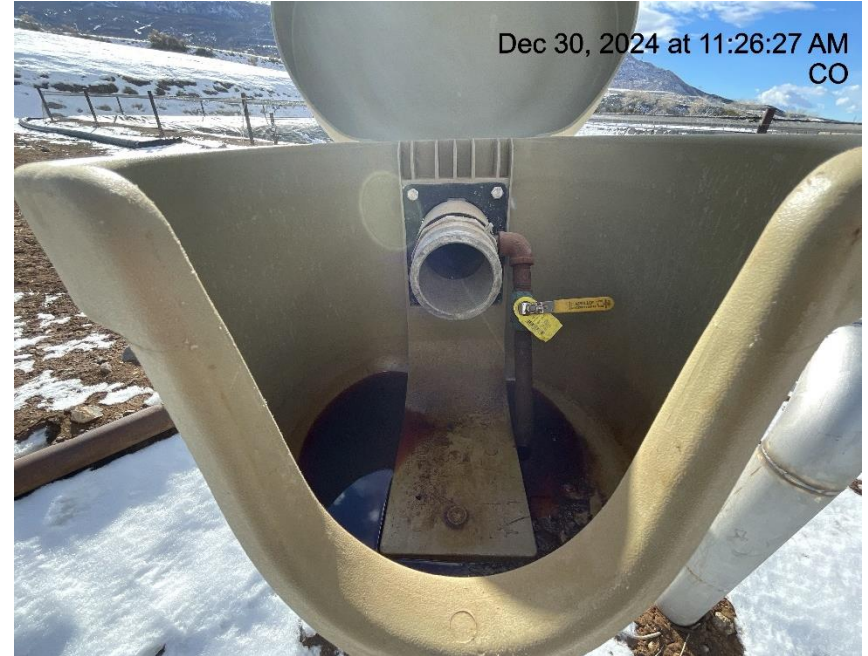
Photo # 5655 Open ended load line

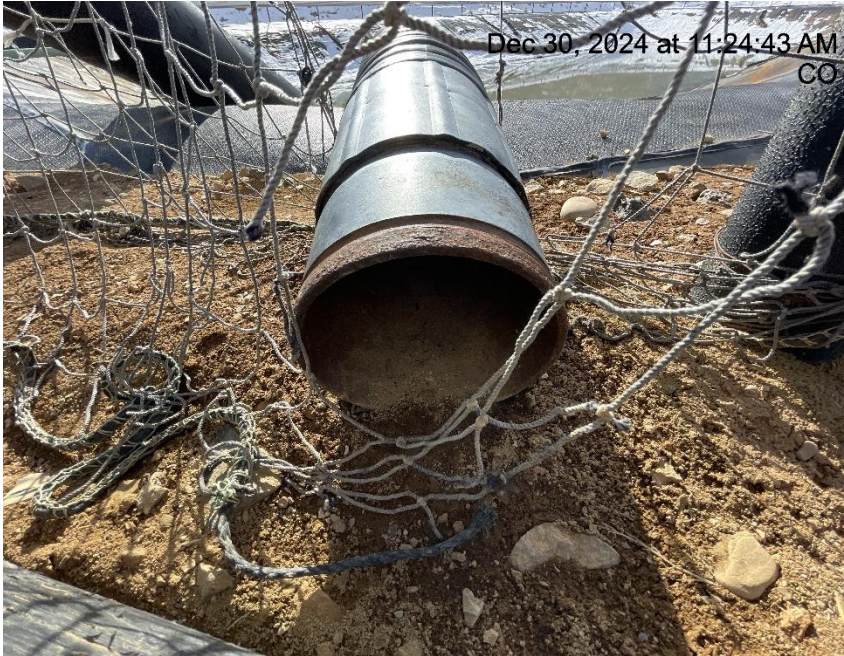
**Photo # 5656 Open ended piping & netting also needs maintenance/available for entry by wildlife/wildlife hazards**

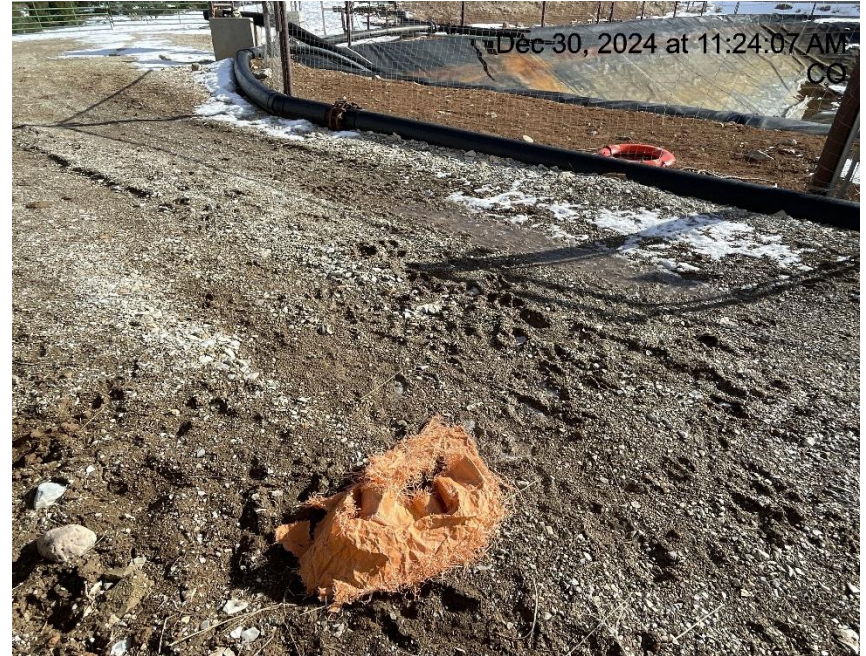
**Photo # 5657 Debris**

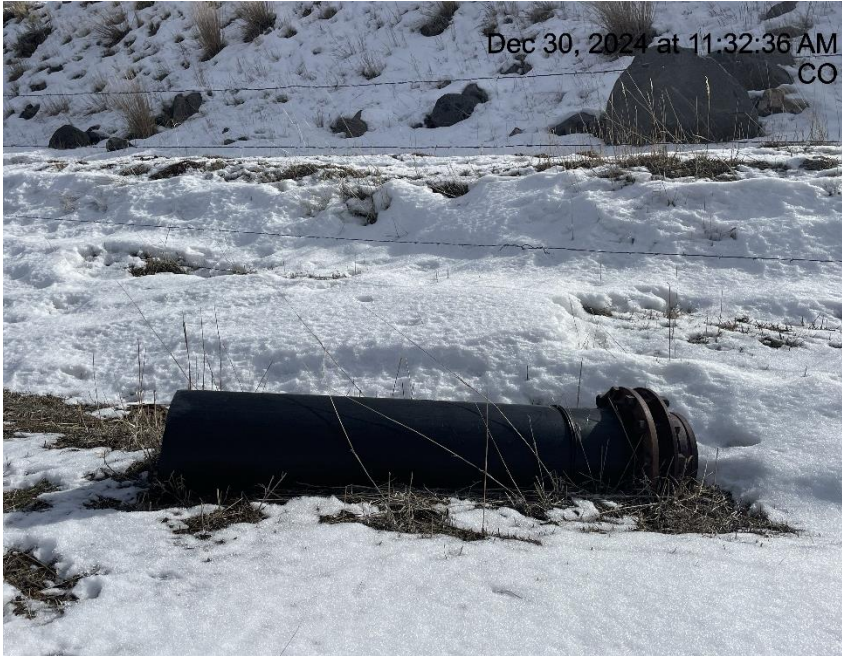
Photo # 5658 Debris
