Inspection Photos

Location: QB ENERGY KNOX-68S96W/11NWNW (OD11 Pad)

Location ID: 334064

Date: 12/30/2024

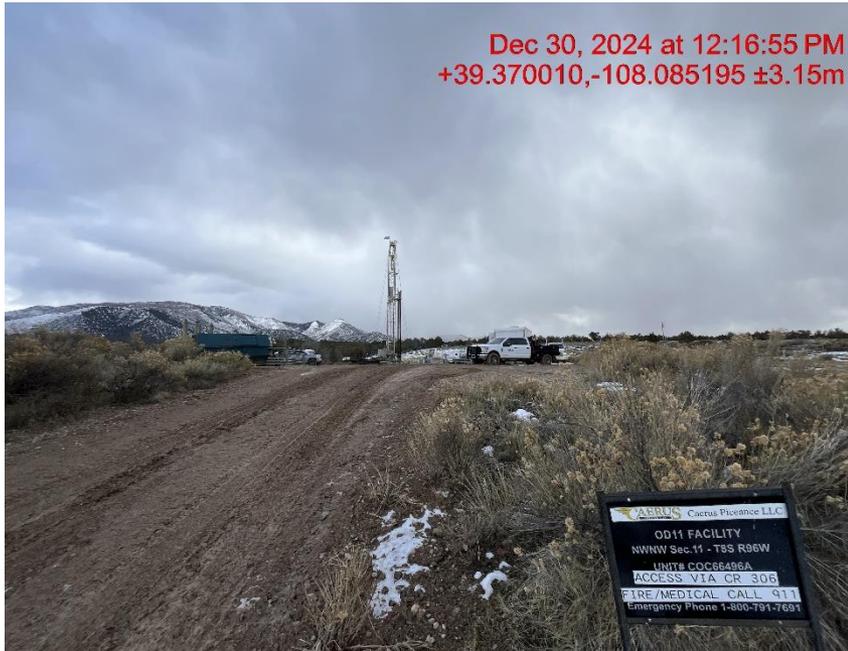
Photo # 1546 Entrance to location

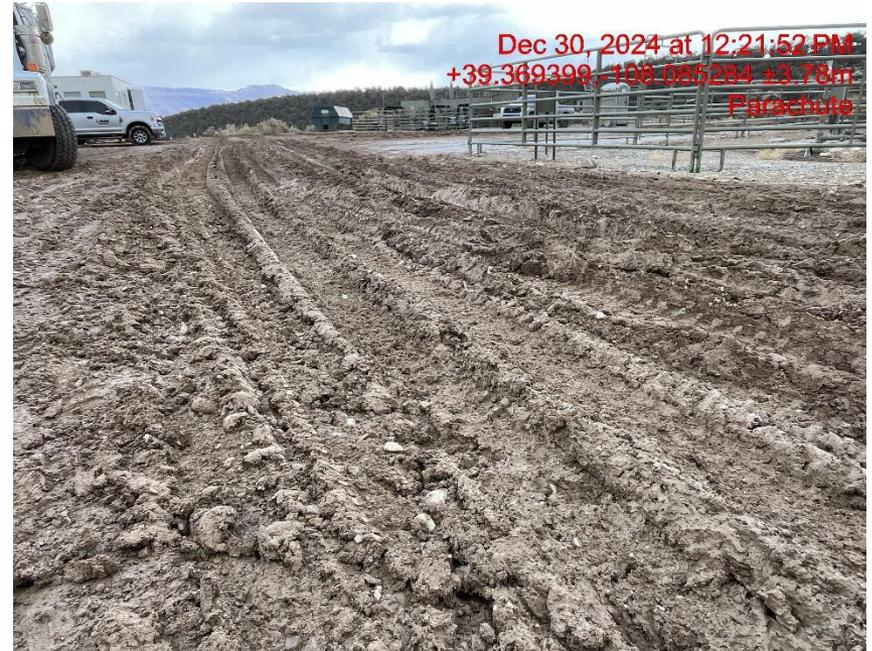
Photo # 1551 Lack of stabilization/compaction on location/insufficient BMP's

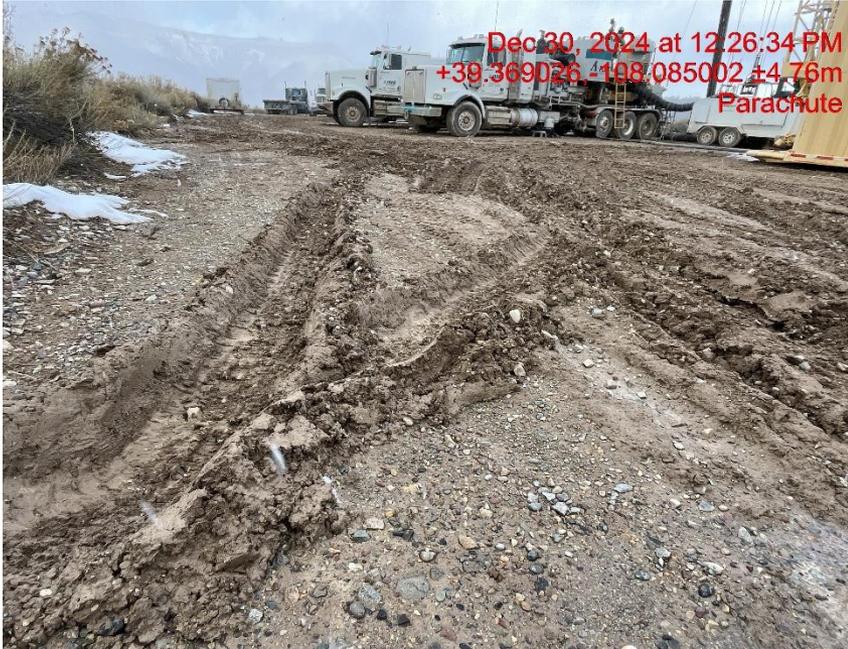
Photo # 1560 Lack of stabilization/compaction on location/insufficient BMP's

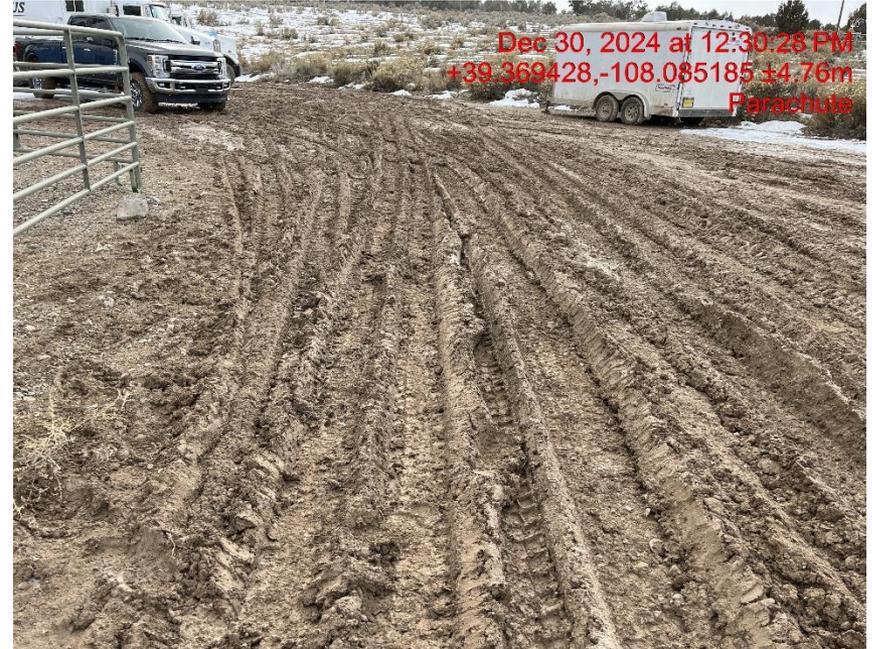
Photo # 1564 Lack of stabilization/compaction on location/insufficient BMP's

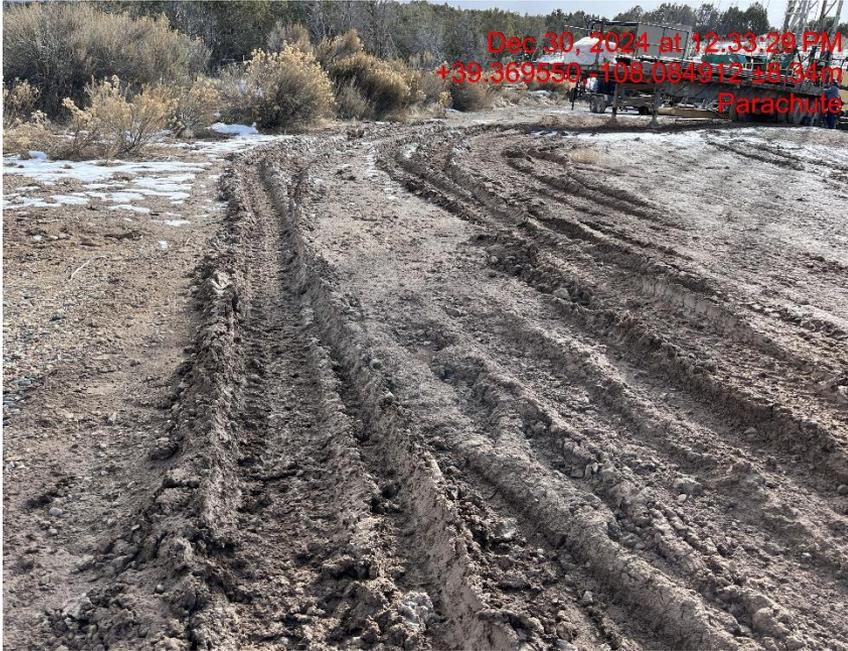
Photo # 1567 Lack of stabilization/compaction on location/insufficient BMP's

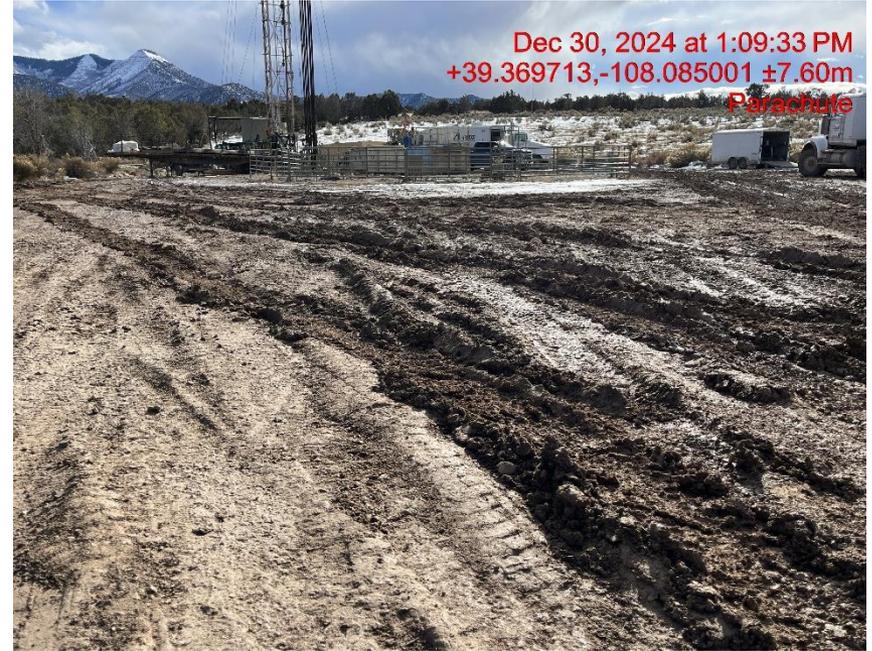
Photo # 1571 Lack of stabilization/compaction on location/insufficient BMP's

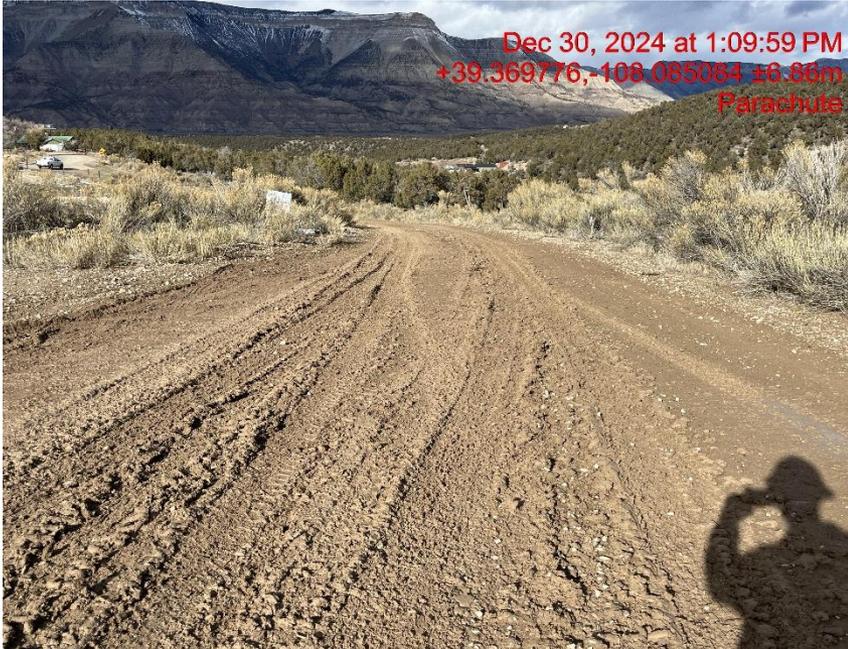
Photo # 1573 Lack of stabilization/Compaction/Insufficient tracking BMP's/Tracking from location onto lease road

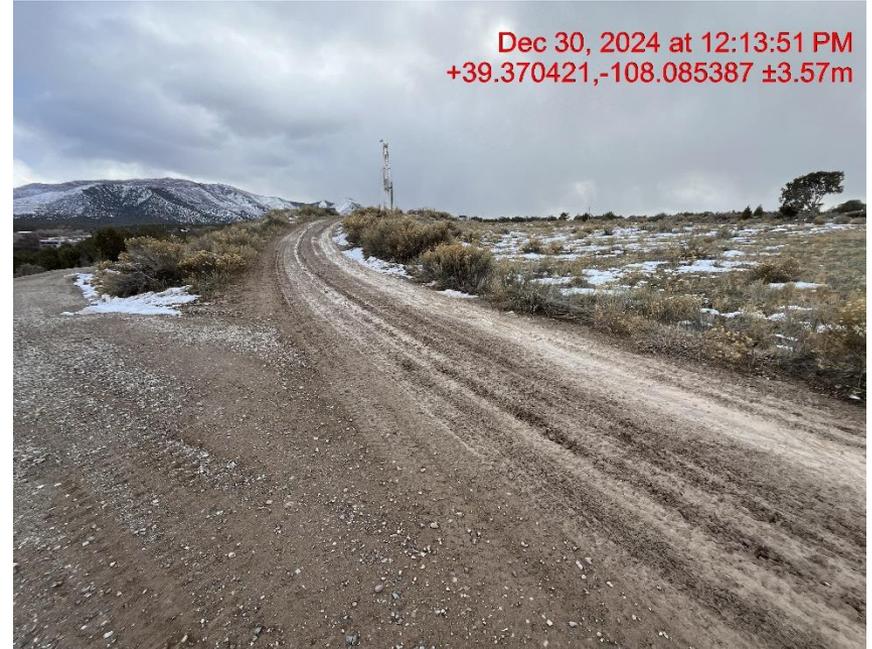
Photo # 1543 Tracking on lease road/Insufficient tracking BMP's

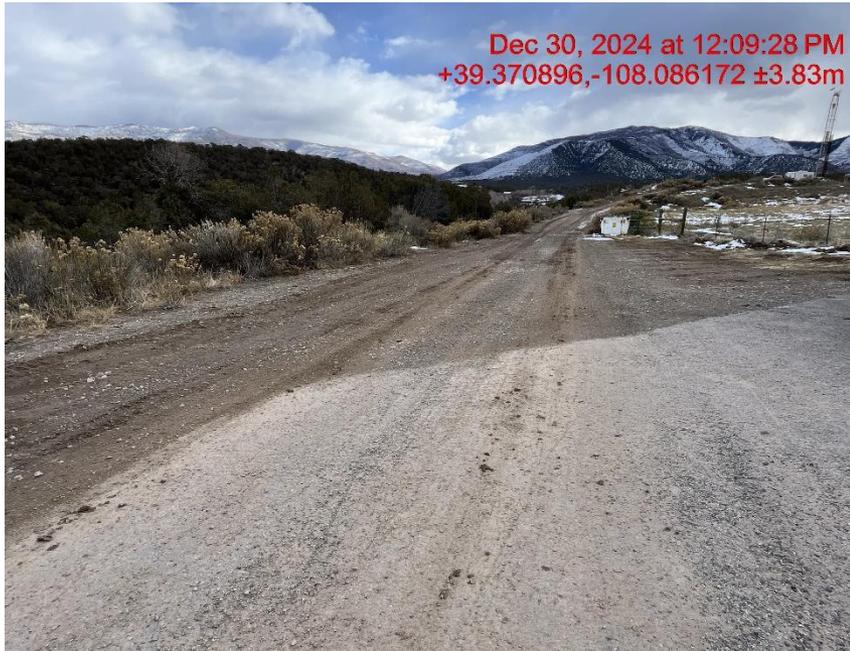
Photo # 1533 Tracking from lease road onto CR 306/Insufficient tracking BMP's

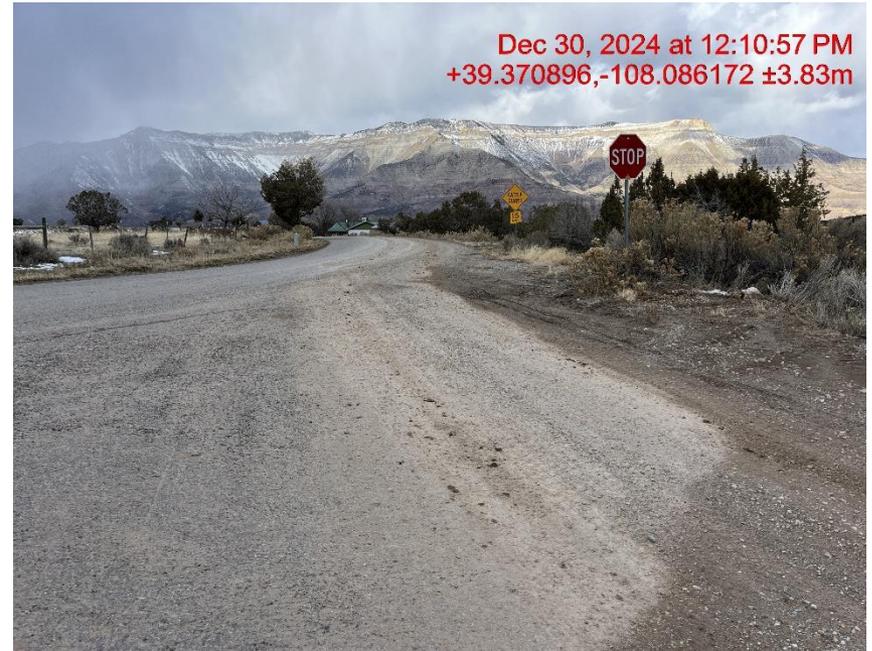
Photo # 1537 Tracking from lease road onto CR 306/Insufficient tracking BMP's

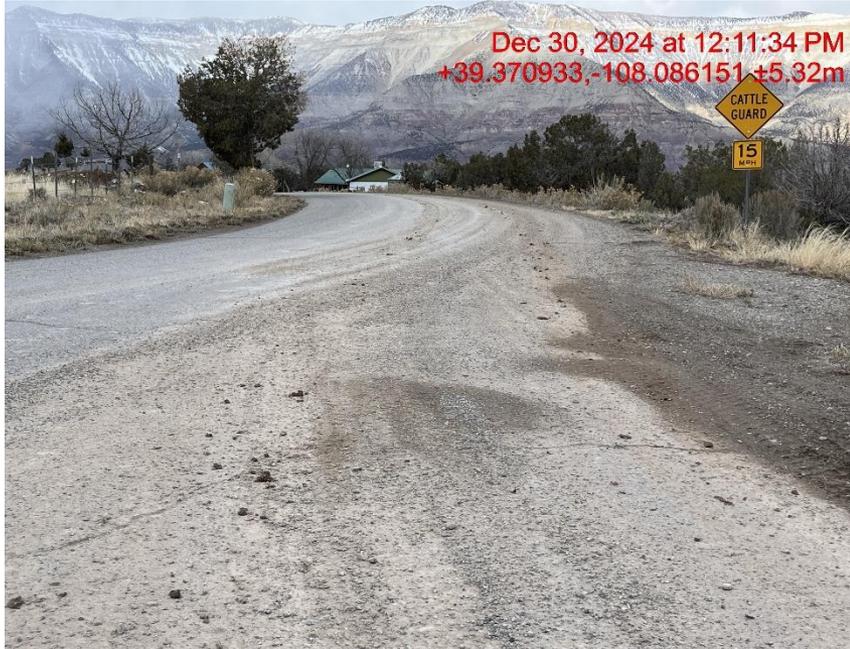
Photo # 1539 Tracking from lease road onto CR 306/Insufficient tracking BMP's

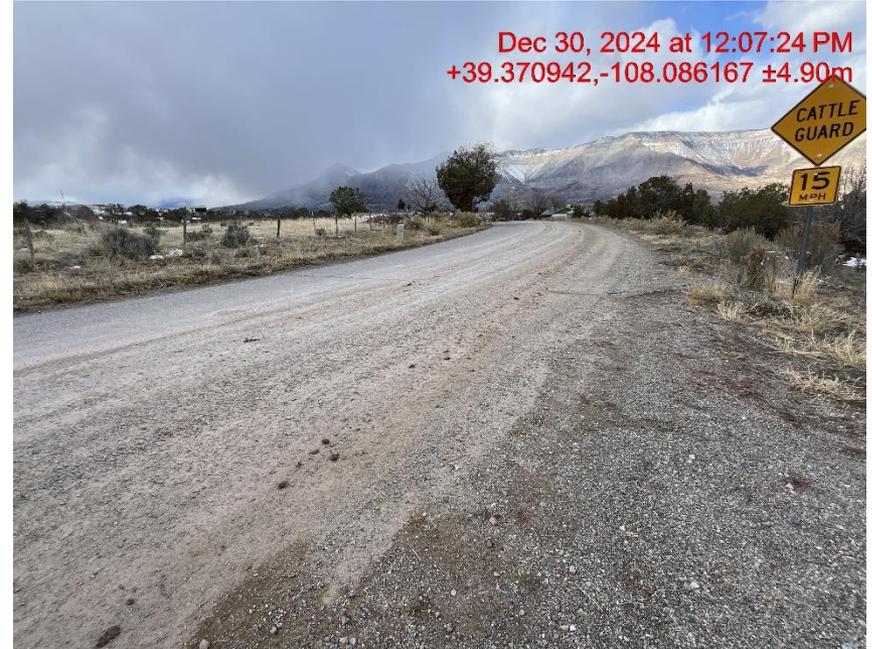
Photo # 1527 Tracking from lease road onto CR 306/Insufficient tracking BMP's
