Inspection Photos

Location: QB ENERGY HYRUP-68S96W/2NESW (Pad-2 K)

Location ID: 334342

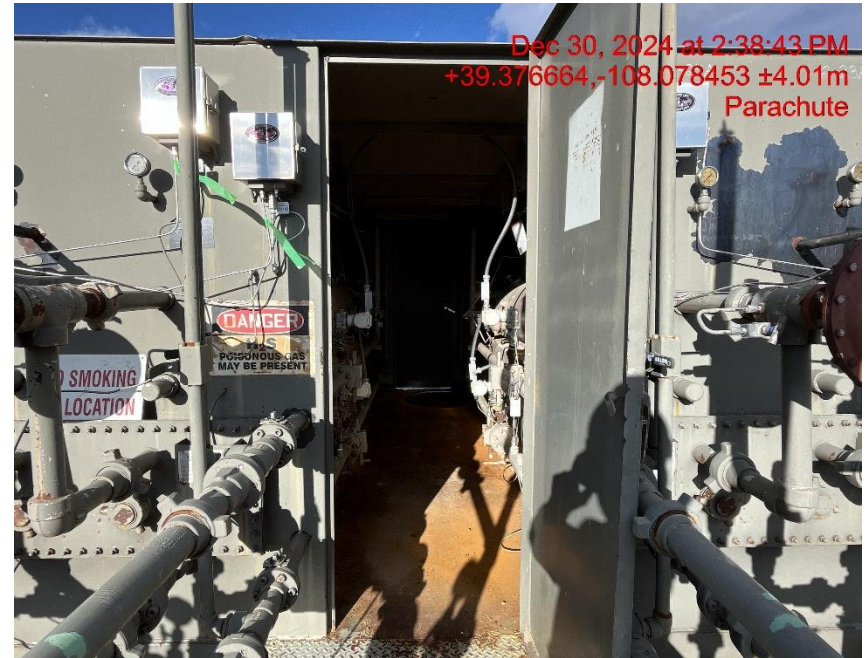
Photo # 1599 Wildlife hazard

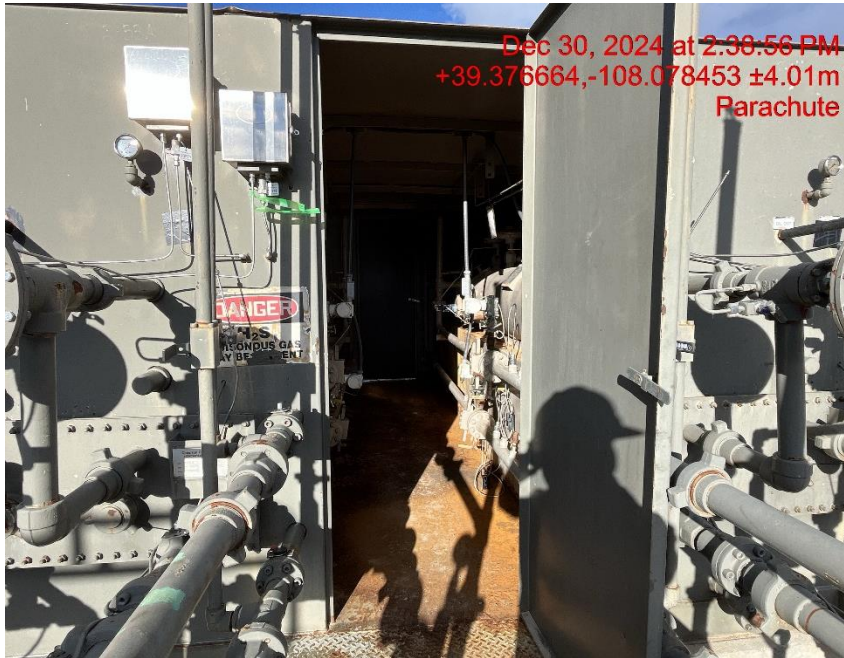
Photo # 1600 Wildlife hazard

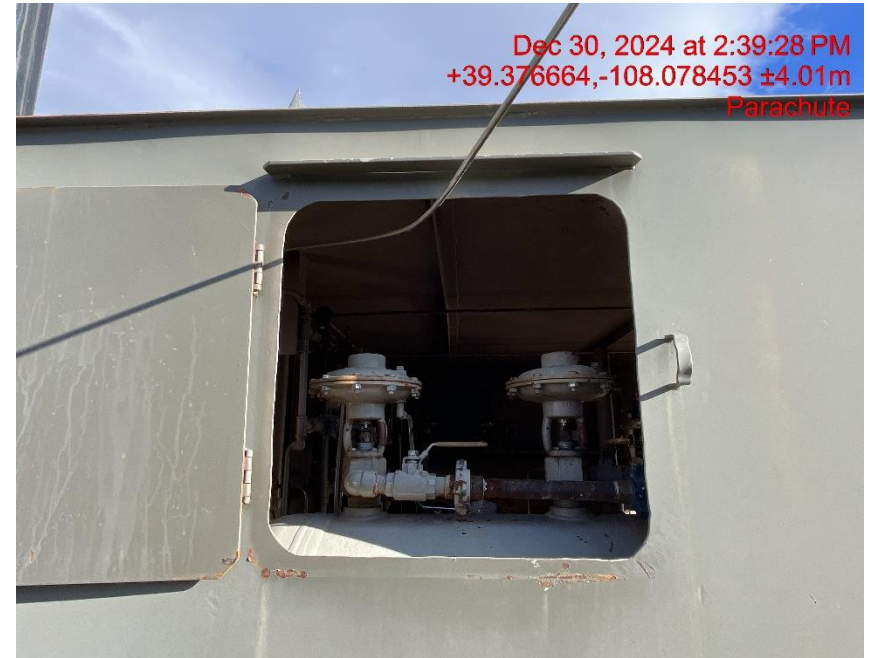
Photo # 1601 Wildlife hazard

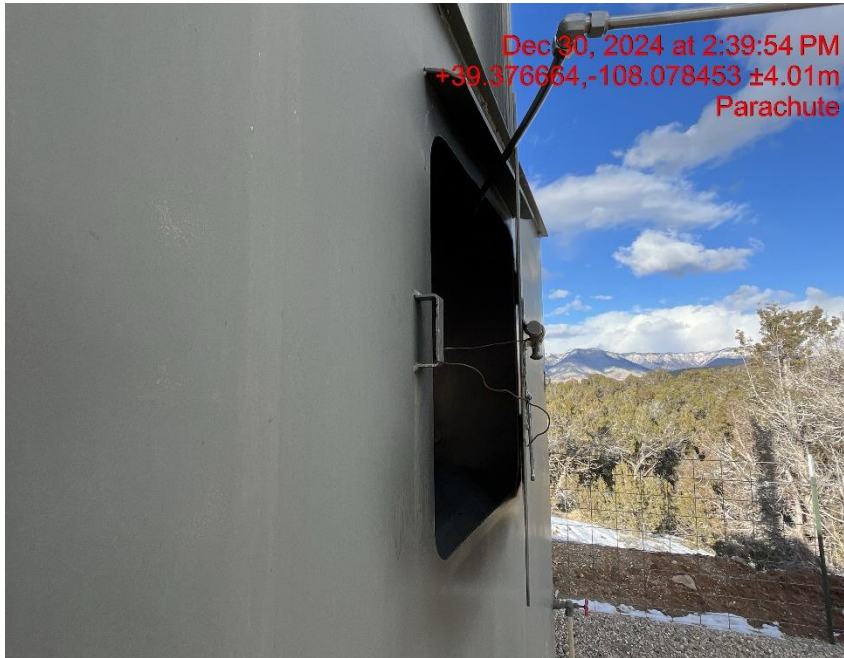
Photo # 1603 Wildlife hazard

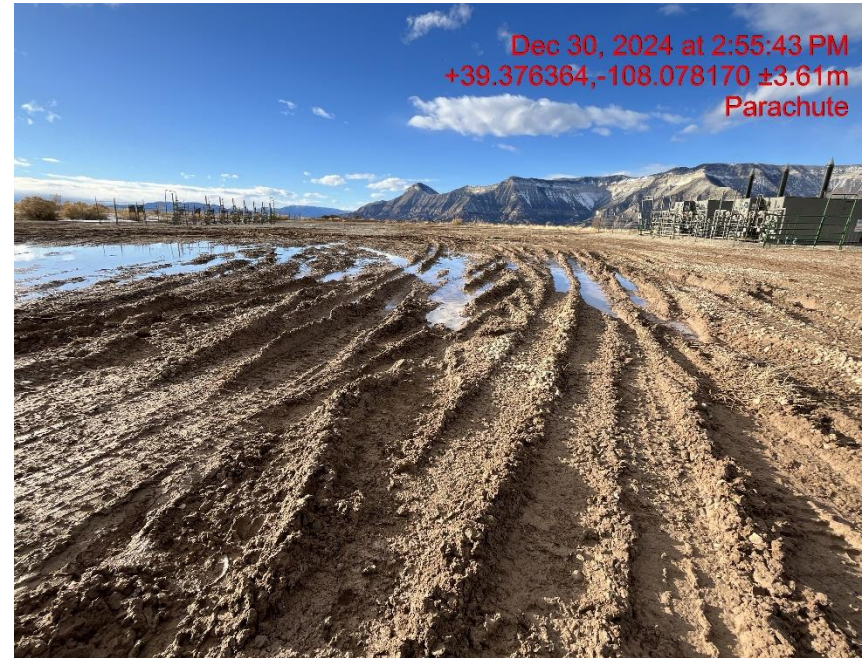
Photo # 1624 Lack of stabilization/compaction on location/insufficient BMP's

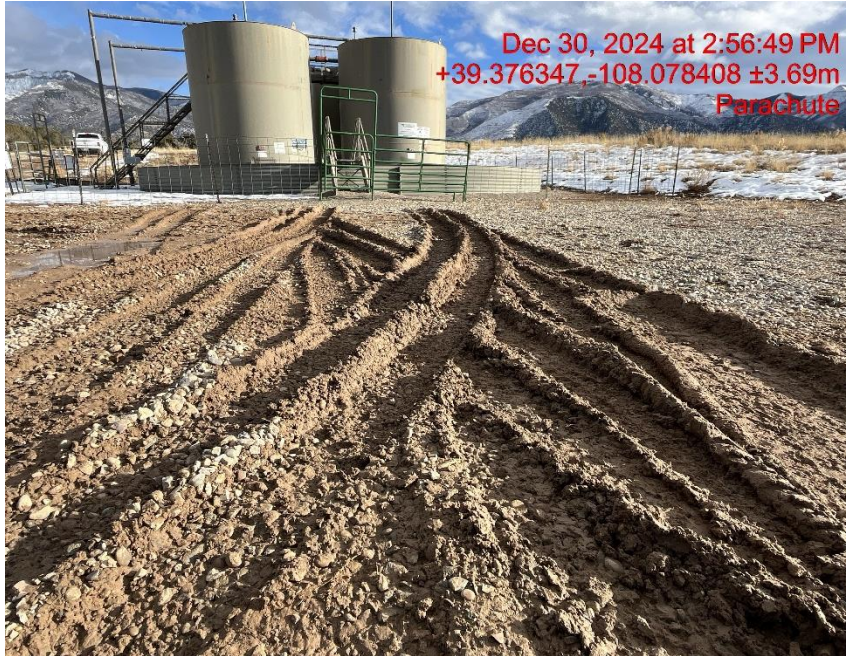
Photo # 1626 Lack of stabilization/compaction on location/insufficient BMP's

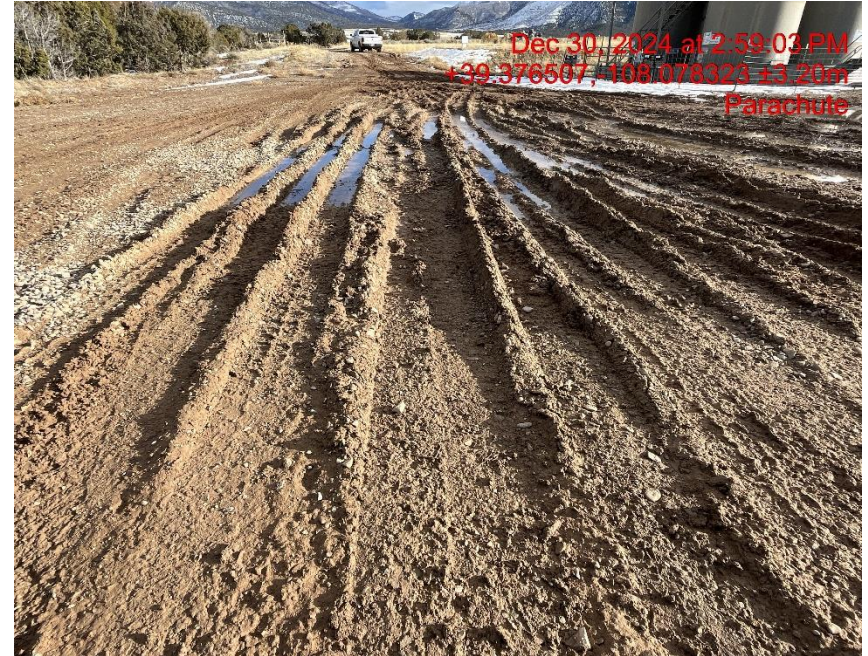
Photo # 1628 Lack of stabilization/compaction on location/insufficient BMP's

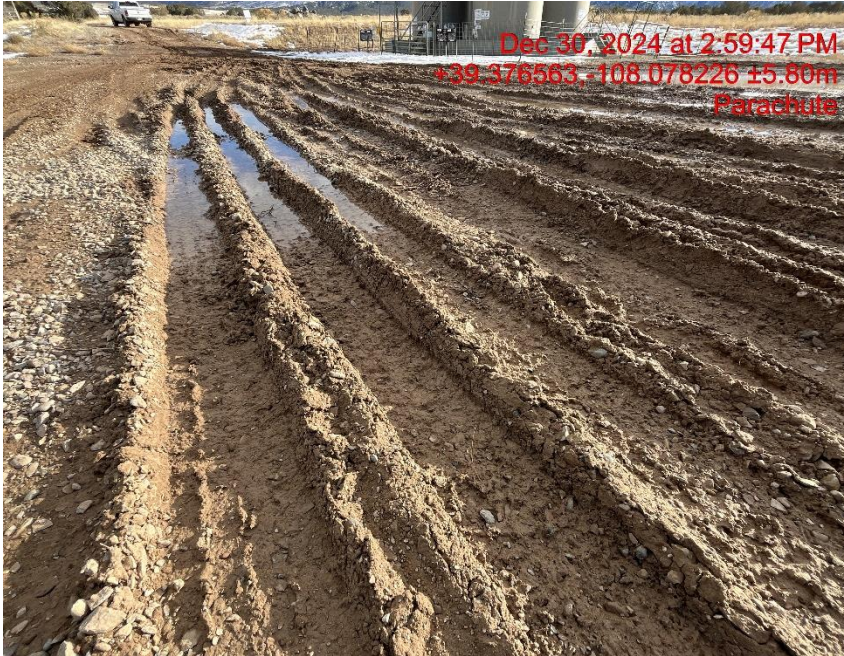
Photo # 1630 Lack of stabilization/compaction on location/insufficient BMP's

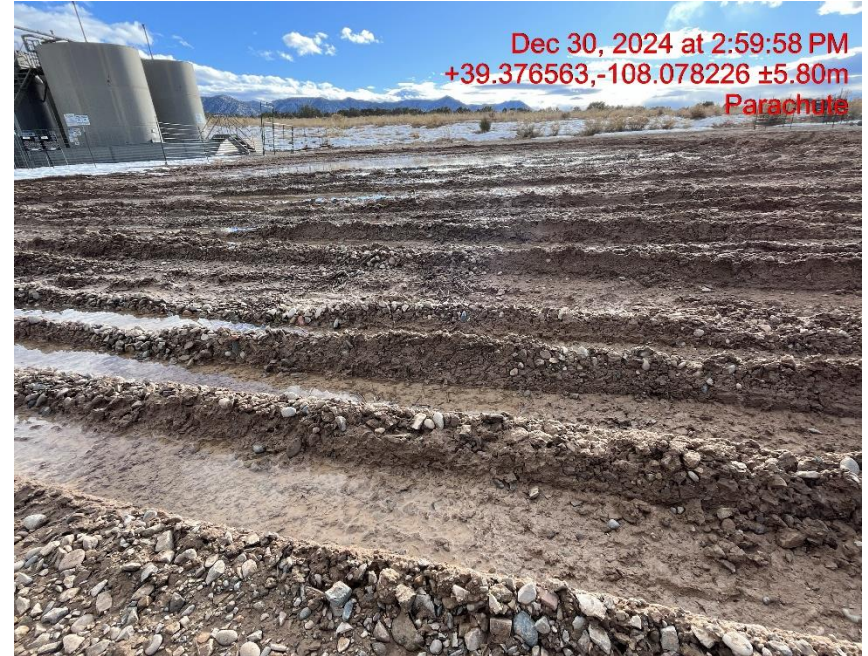
Photo # 1631 Lack of stabilization/compaction on location/insufficient BMP's
