Inspection Photos
Location Name: R.S. Vincent unit 1
Location ID: 318180

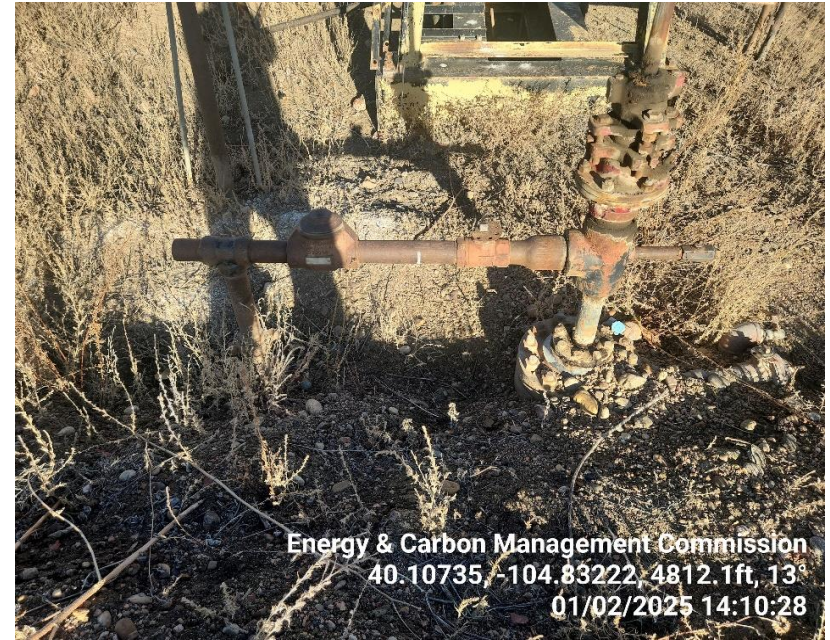
Photo 2 Wellhead.

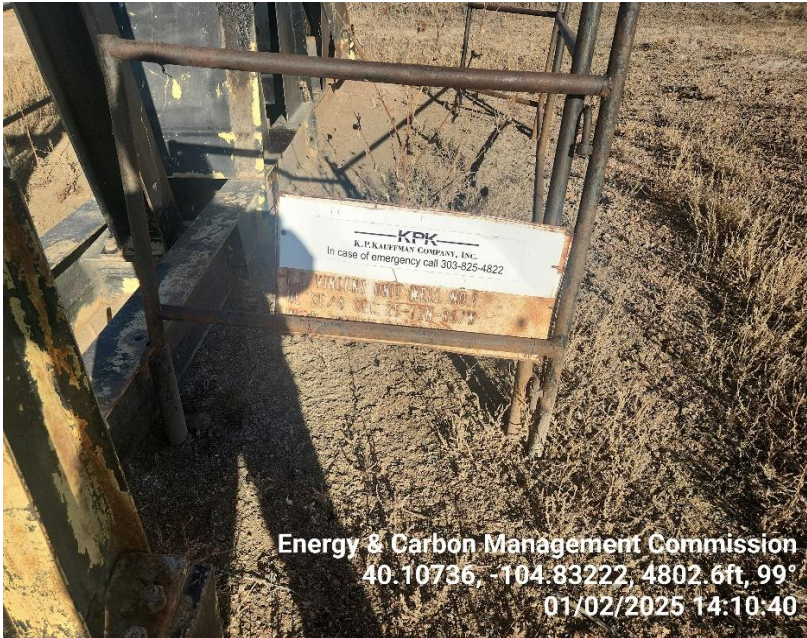
Photo 3 Wellhead sign.

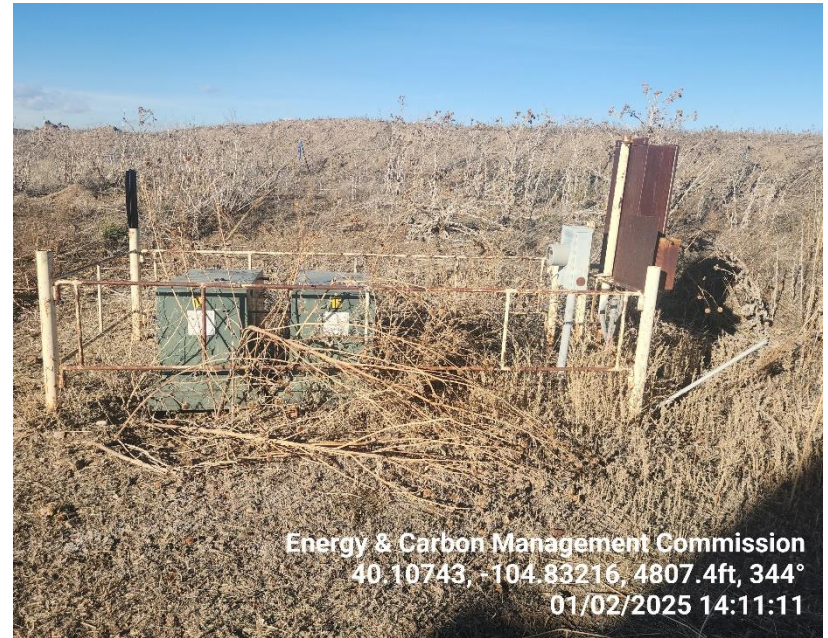
Photo 4 Ancillary equip.

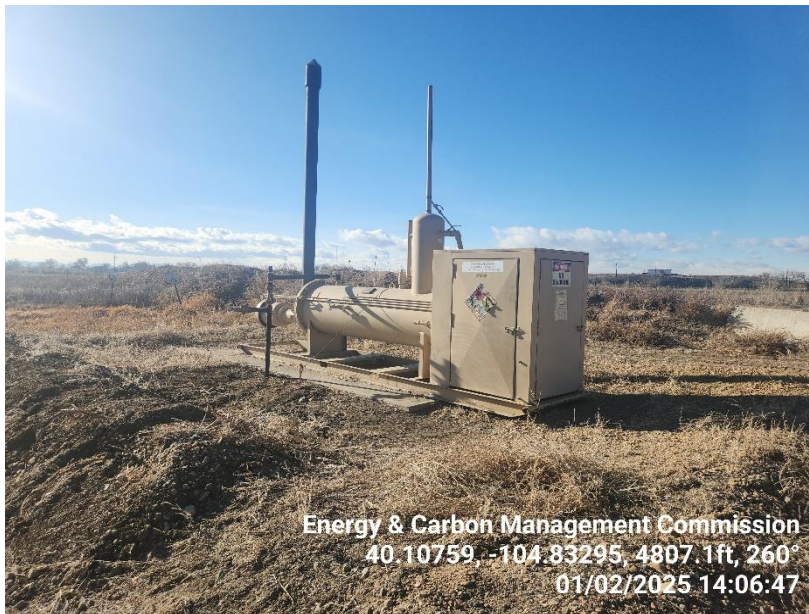
Photo 7 Horizontal Heated Separator.

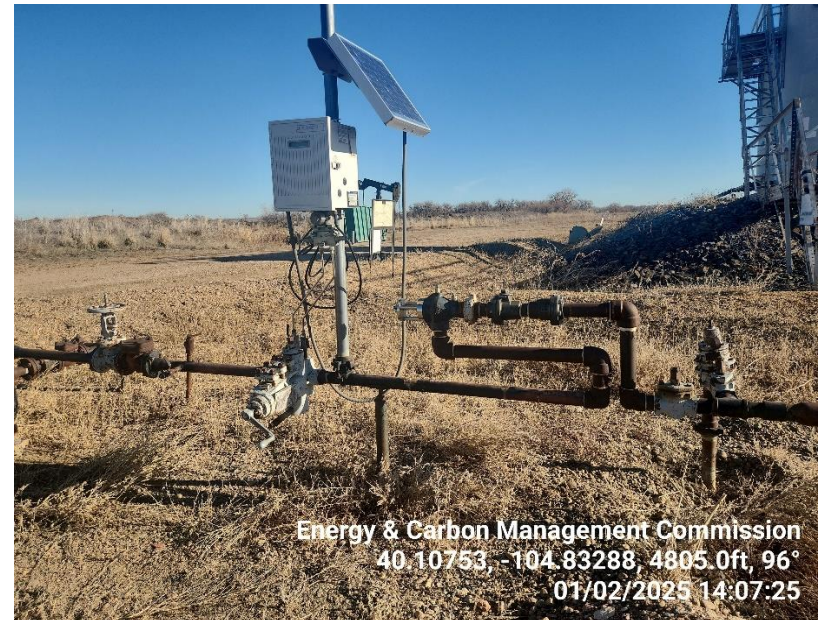
Photo 8 Gas meter run.

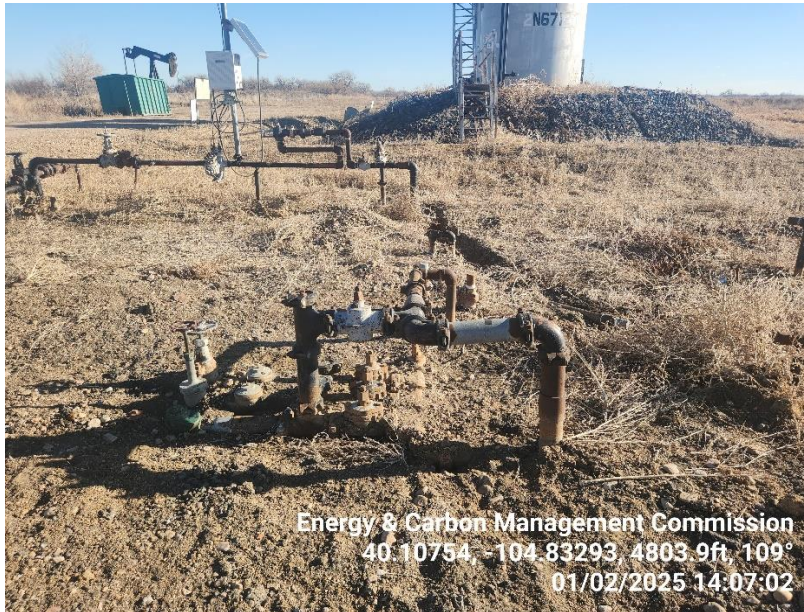
Photo 9 Flow line manifold.

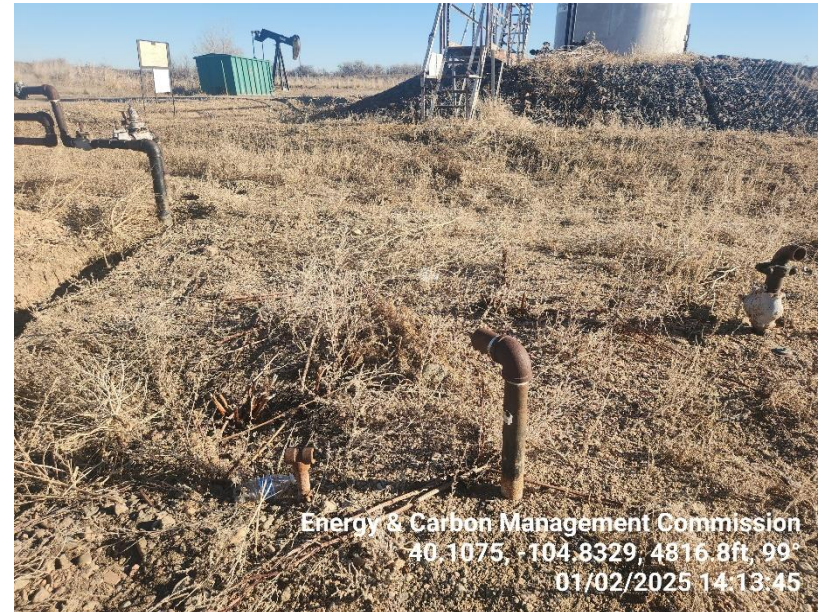
Photo 10 Unmarked flow lines.

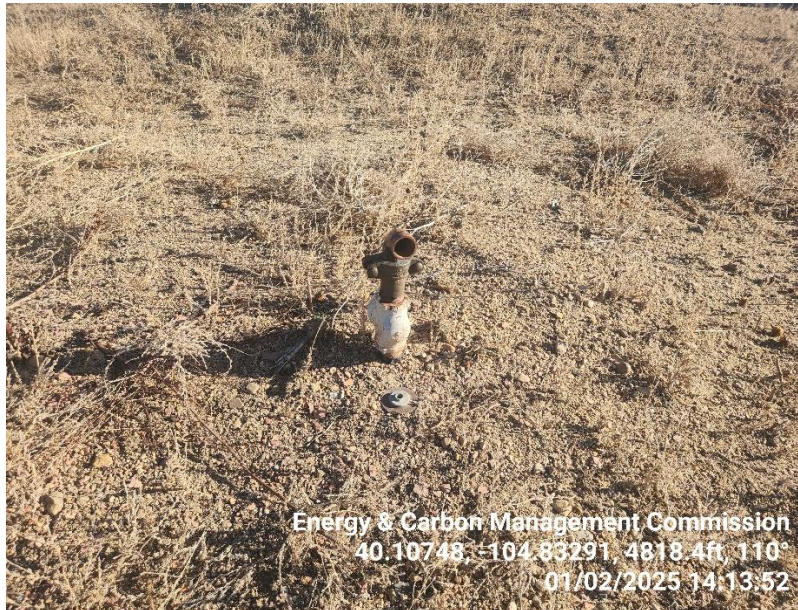
Photo 11 Flow line manifold.

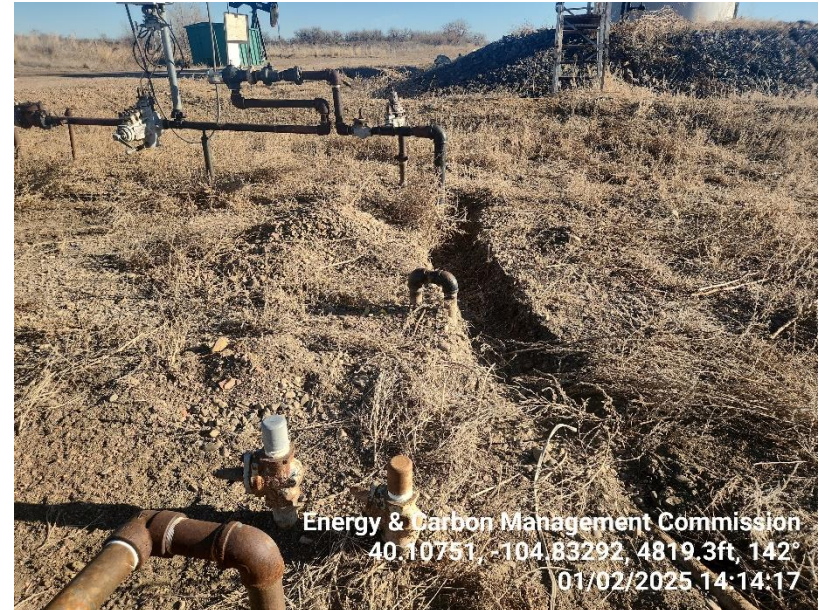
Photo 12 Unmarked flow lines.

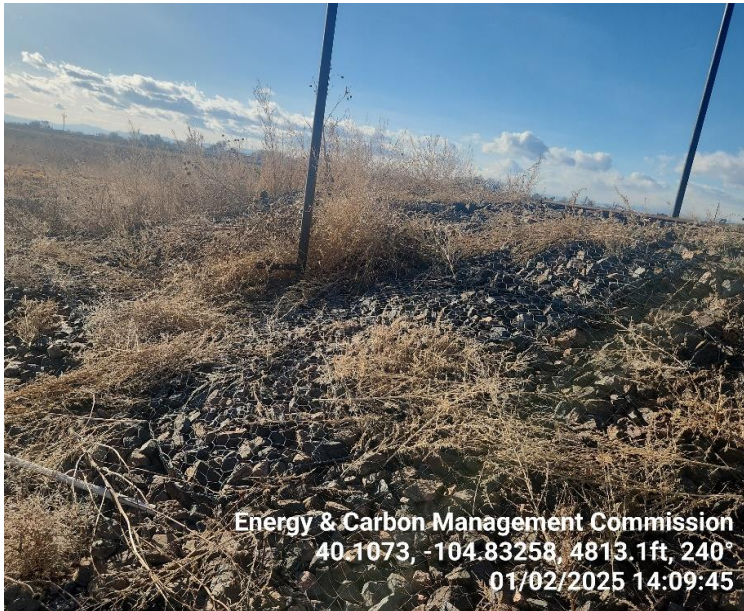
Photo 13 Dead vegetation around the tank battery.

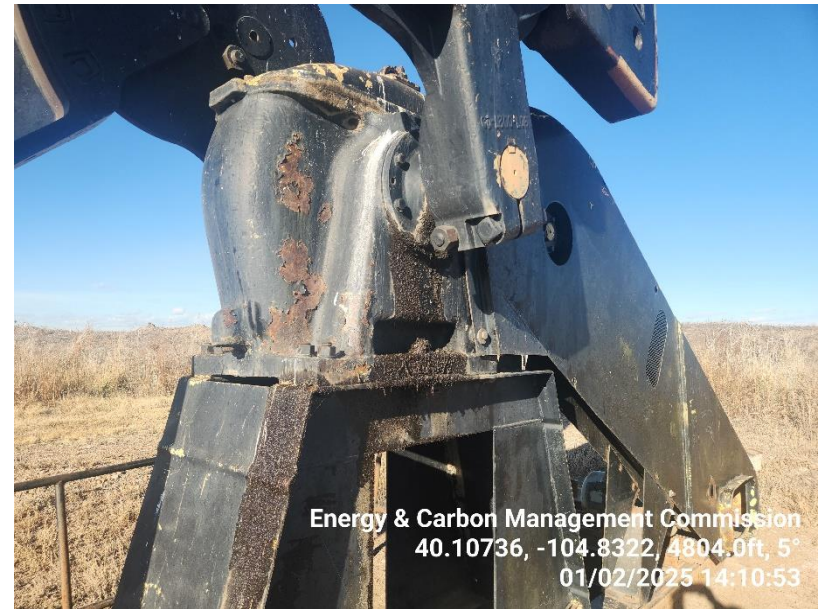
Photo 14 Leaking gear box.
