Inspection Photos

12/31/2024

Operator: ANSCHUTZ EXPLORATION CORP -
3104

Location ID: 484545

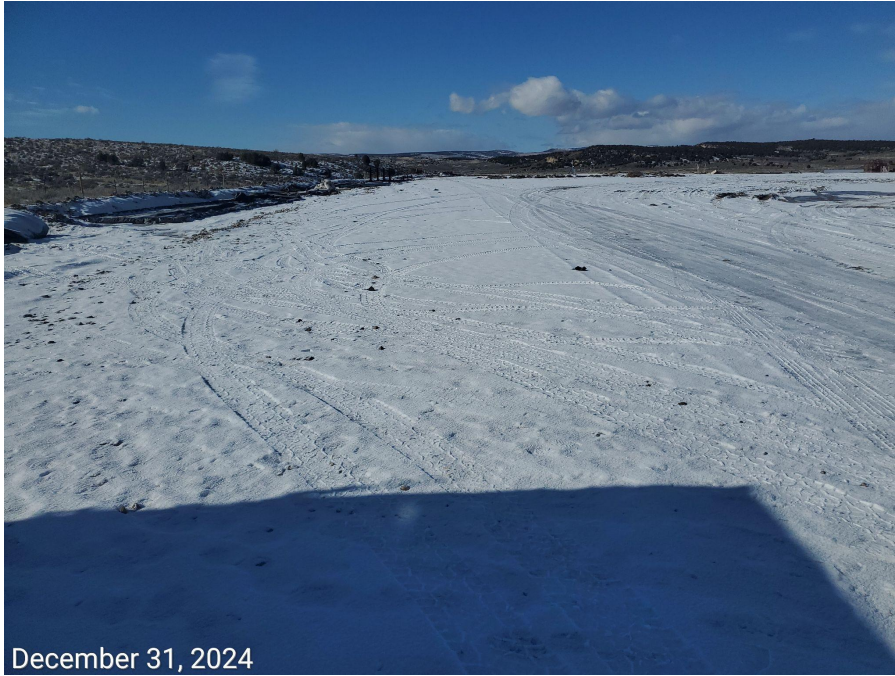
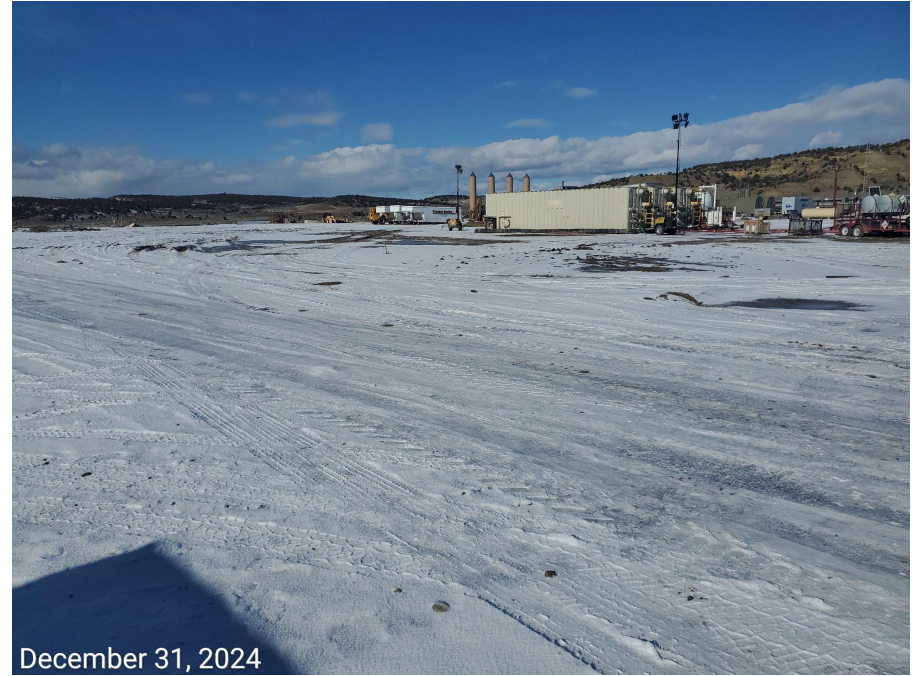
Photo 1: Photos 1-2 taken from the south end of the Location. Photos provide an overview from west, northwest, northeast to east.

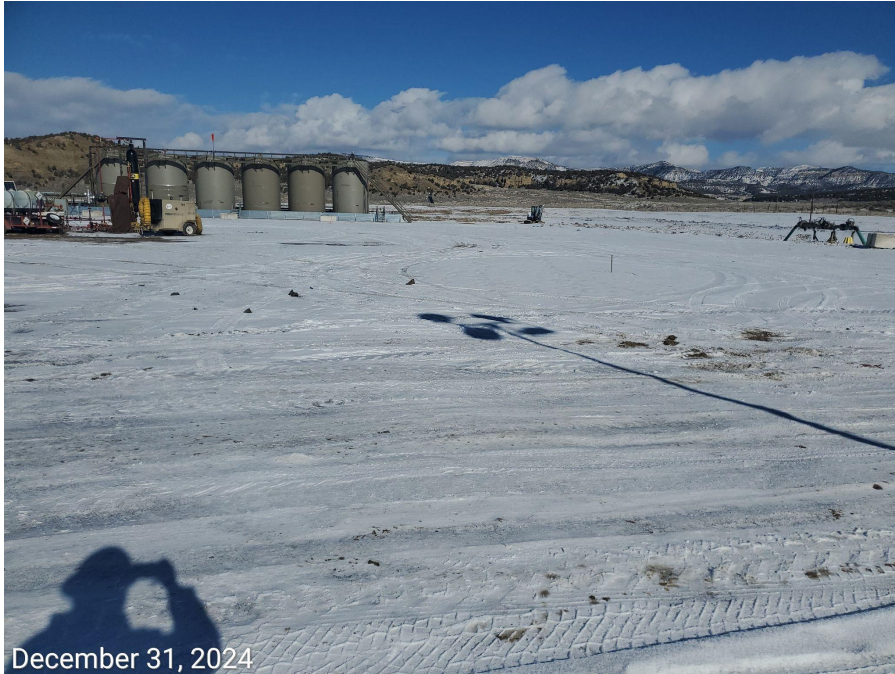
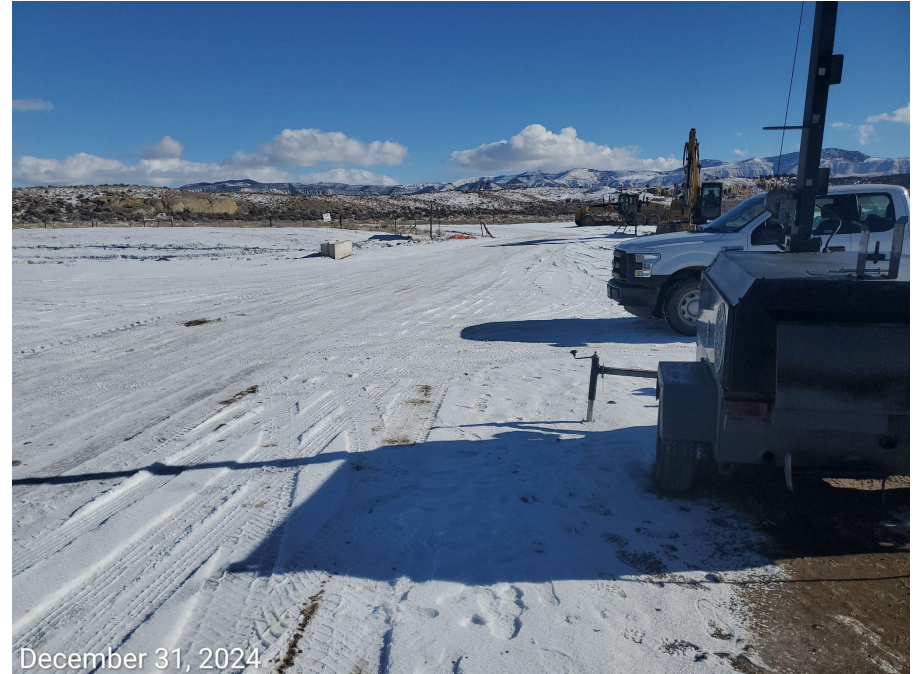
Photo 2: See comments under photo 1.

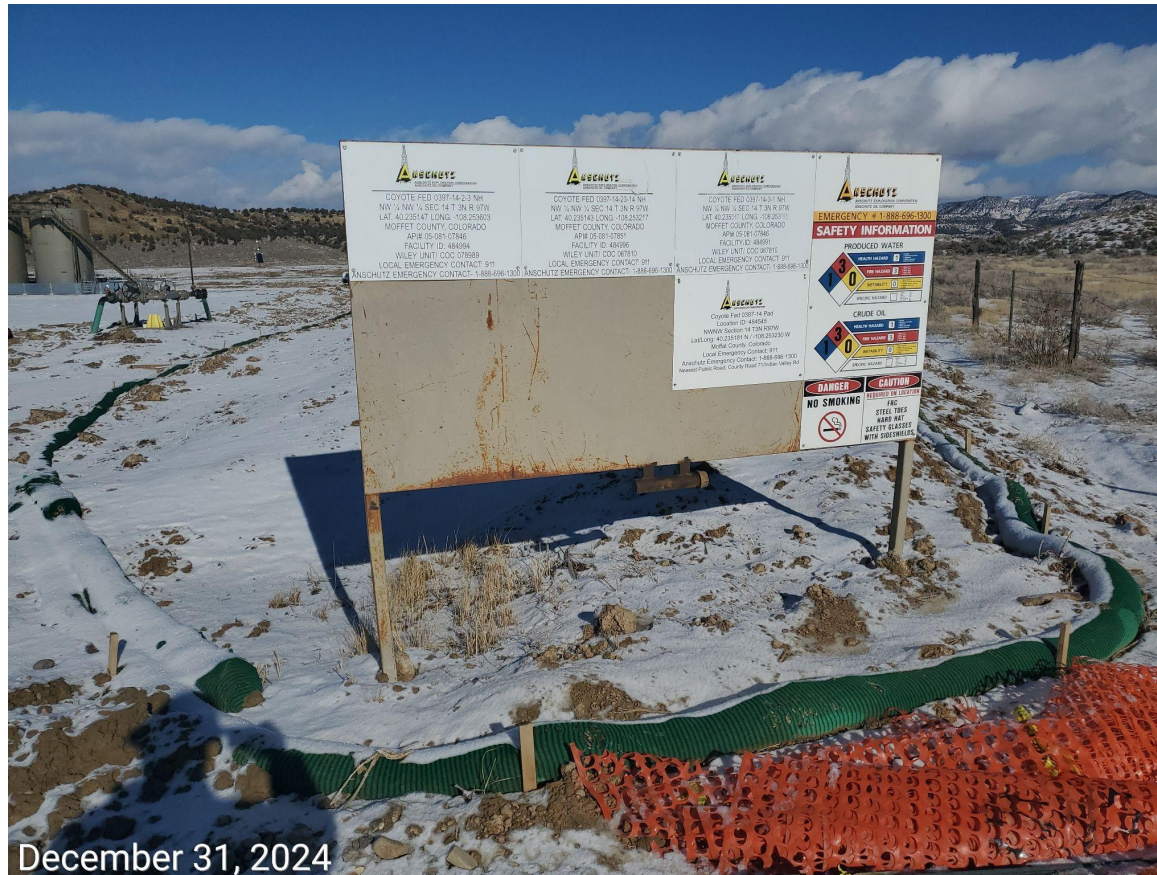
Photo 3: Signage at Location entrance.

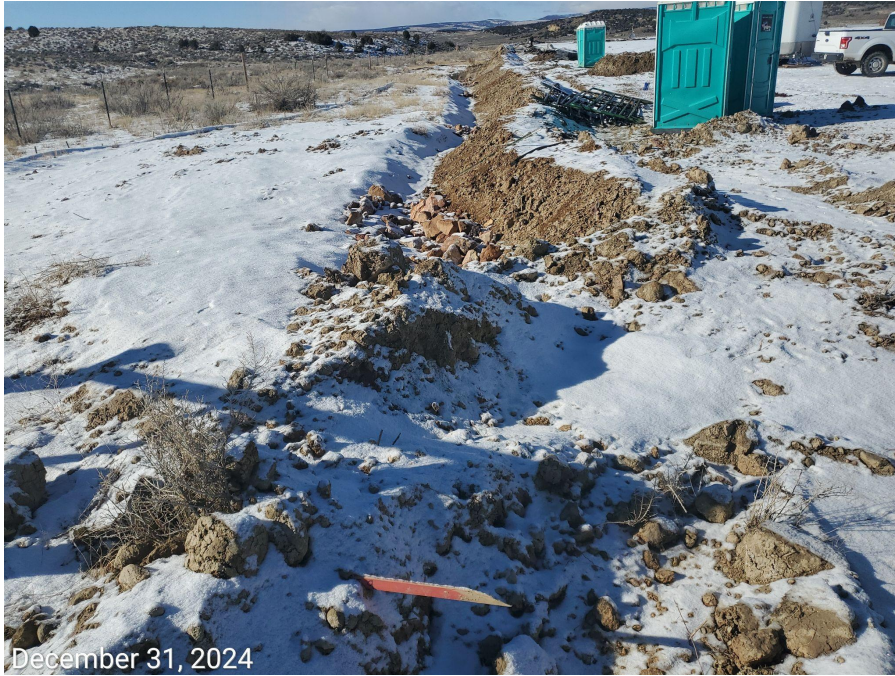
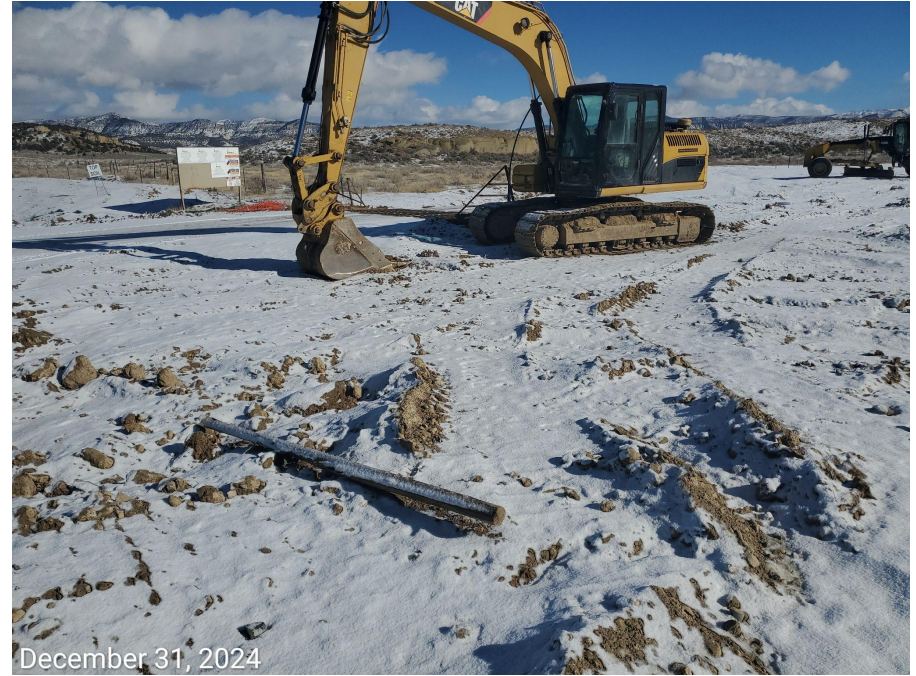
Photo 4: Photos taken from the stormwater diversion ditch on the southeast end of the Location. BMP has been filled and is no longer in proper functioning condition.

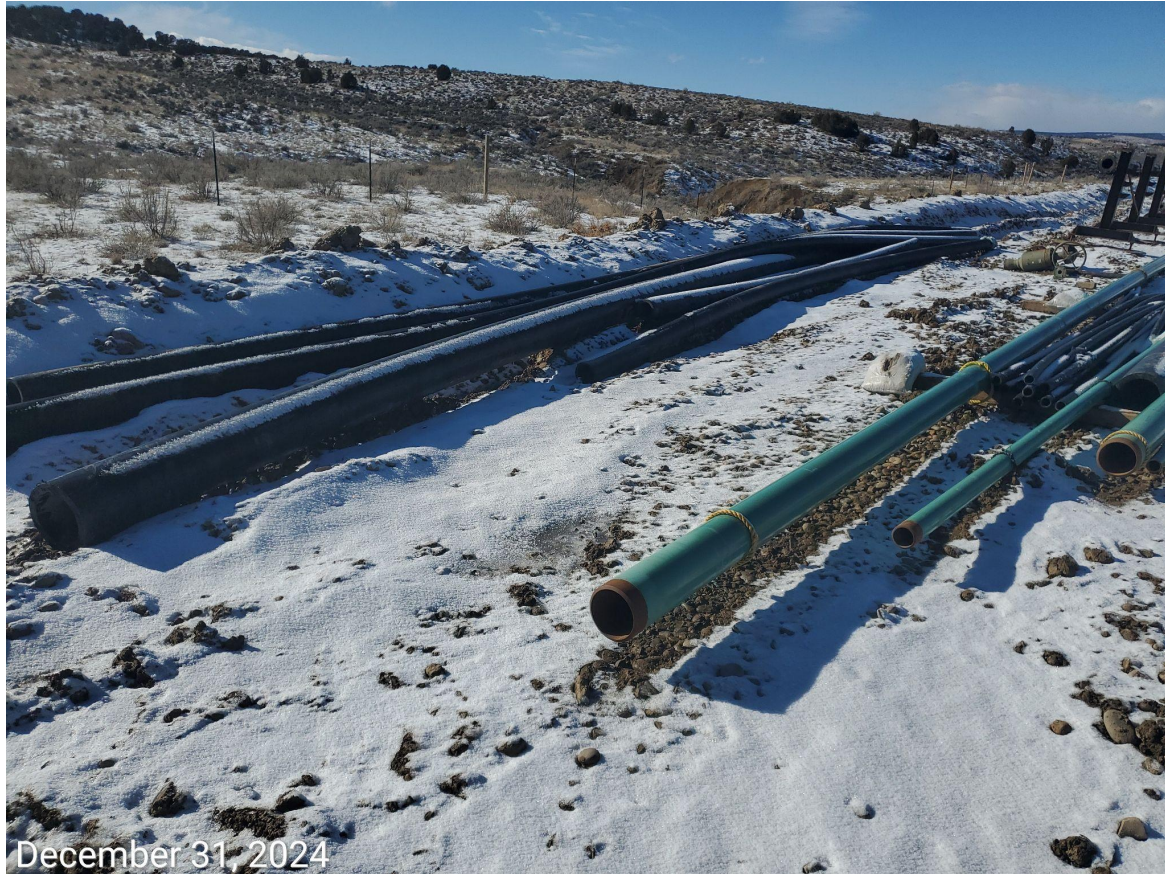
Photo 5: Photo shows equipment stored within the stormwater diversion ditch on the south end of the Location.

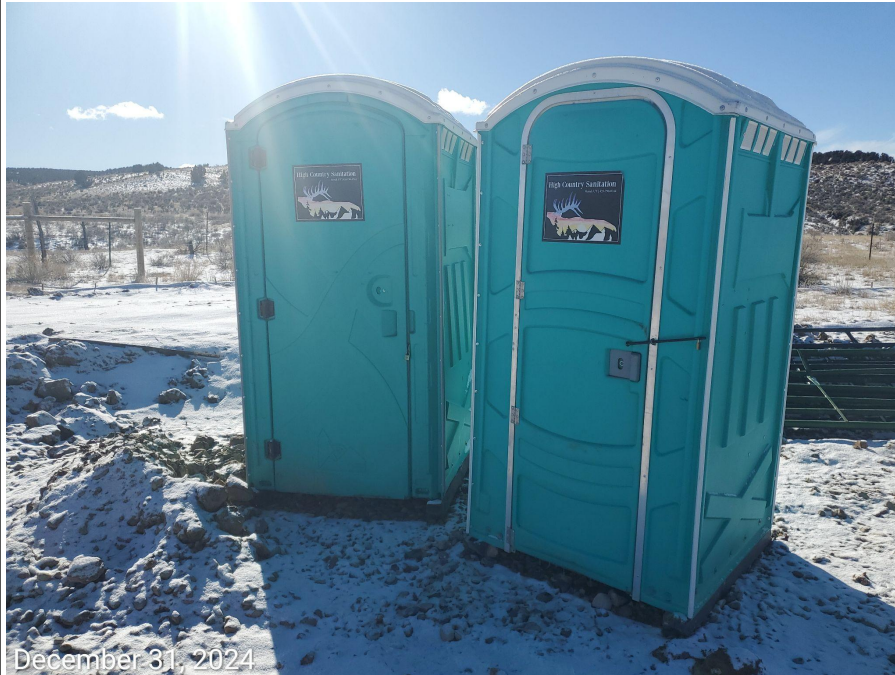
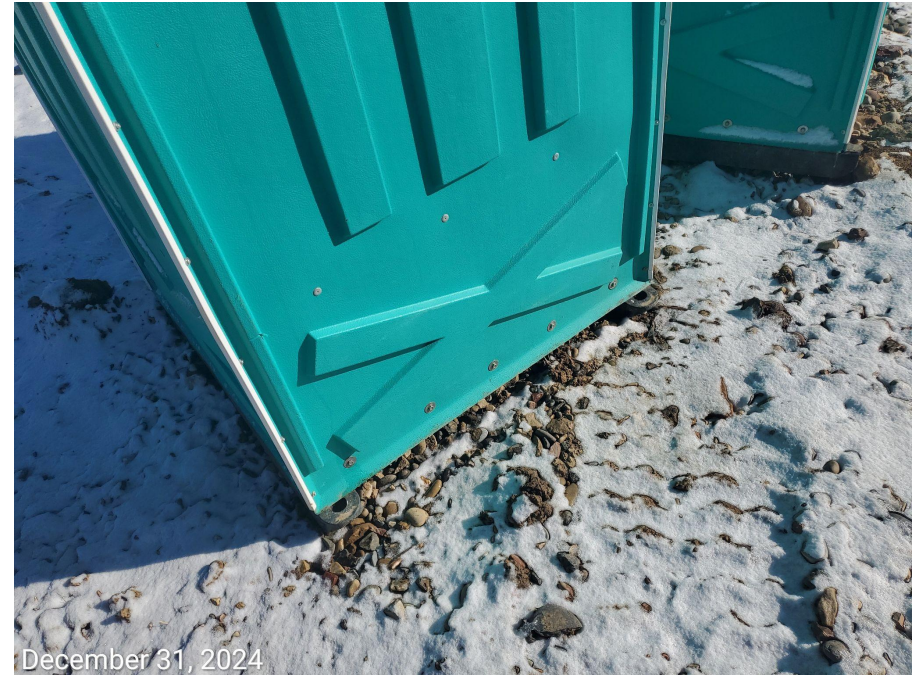
Photo 6: Photo taken from the south end of the Location. Photo shows sanitary facilities have not been physically secured. 4 facilities have been stored on the south end of the Location. These chemical containers have also been stored within 500 feet of an intermittent drainage.

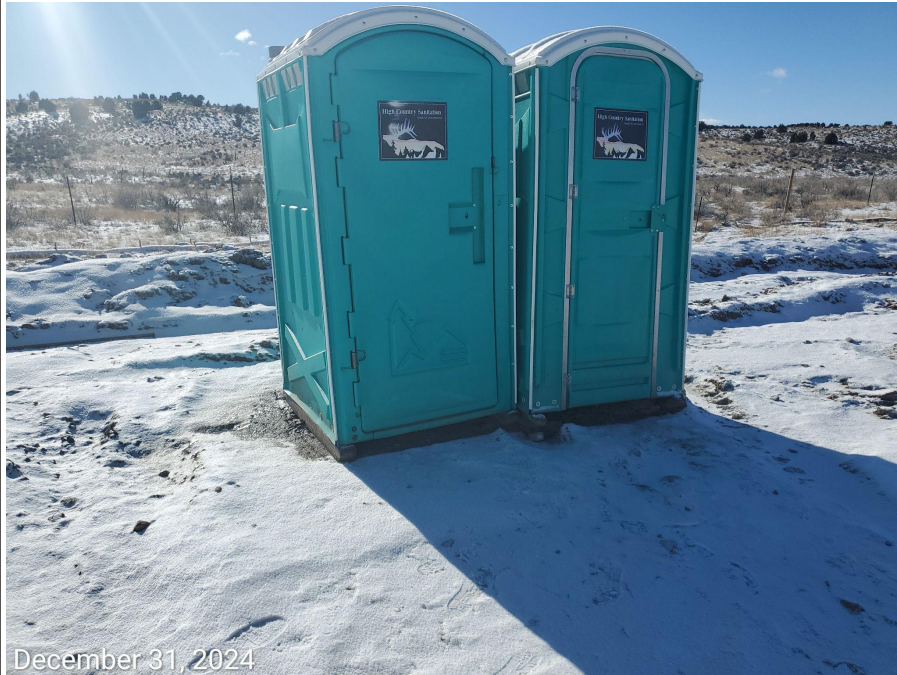
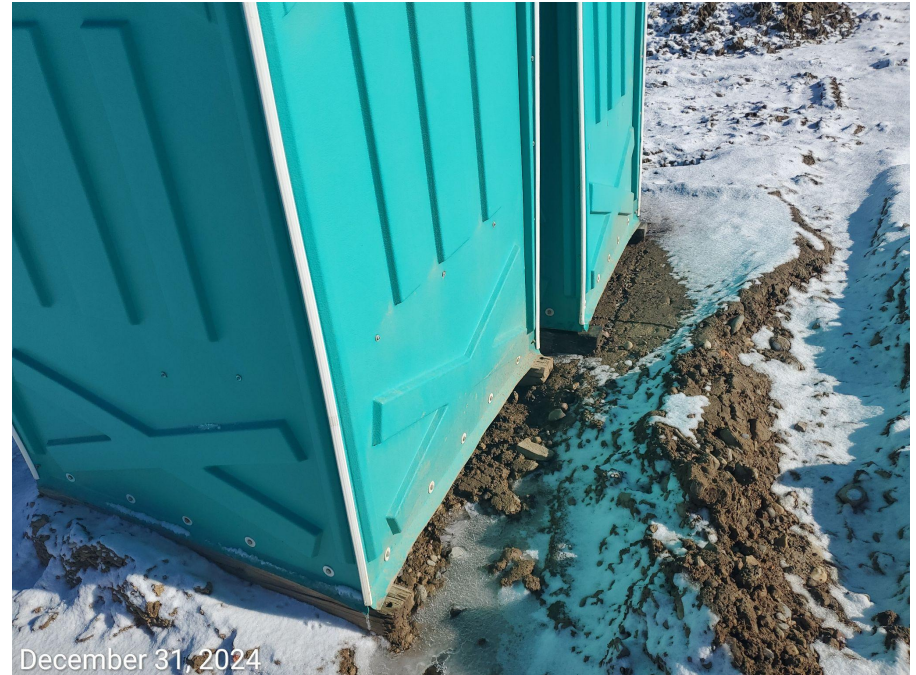
Photo 7: See comments under photo 6.

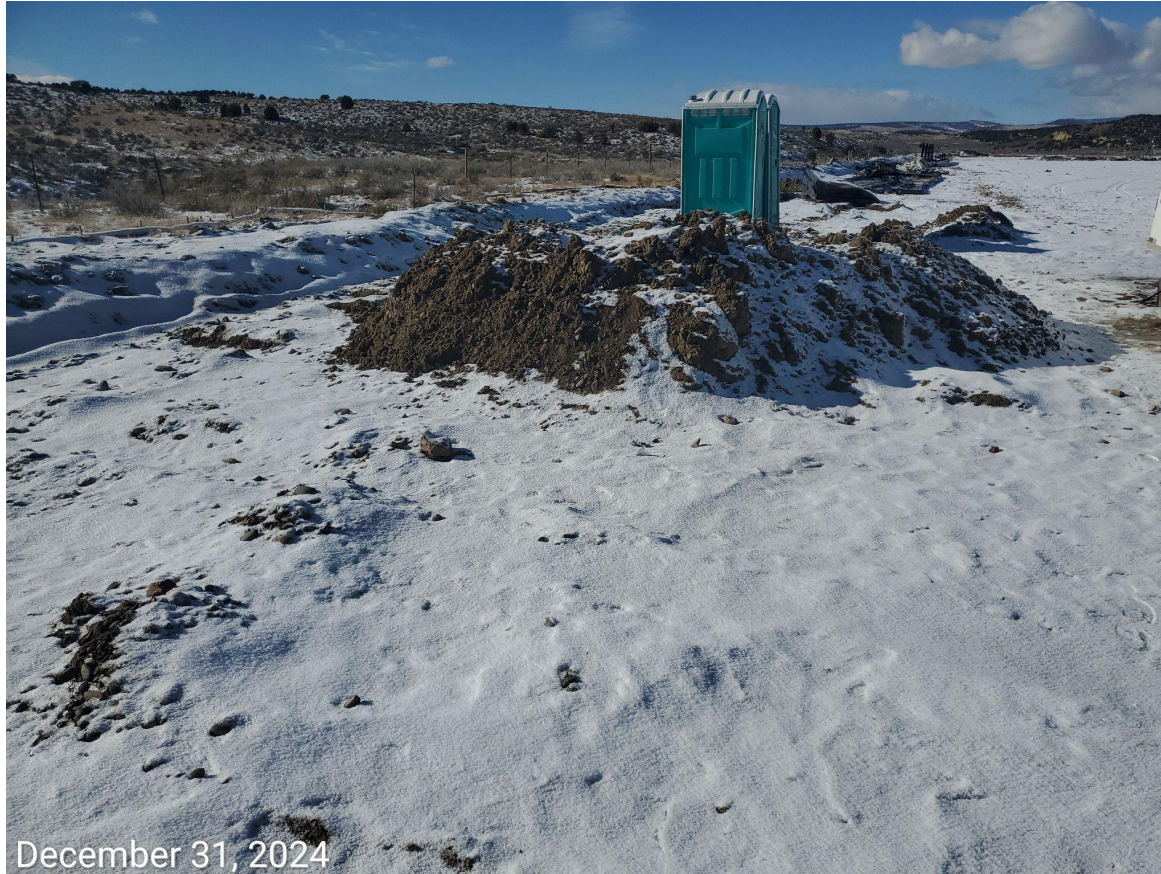
Photo 8: Photo taken from the south end of the Location. Photo shows stockpiled soils/materials missing BMPs to minimize erosion, degradation and sediment transport.

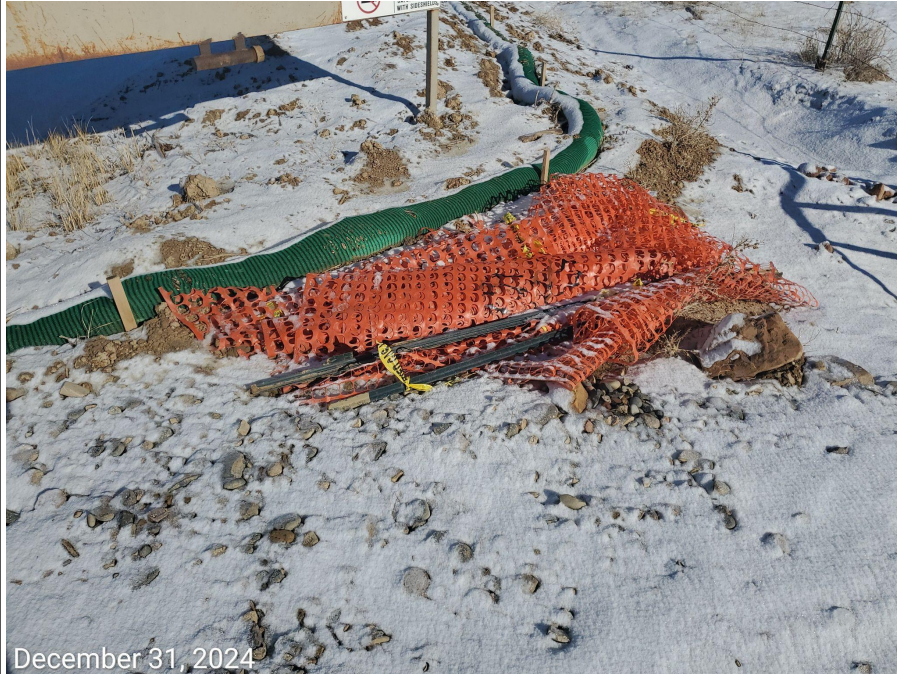
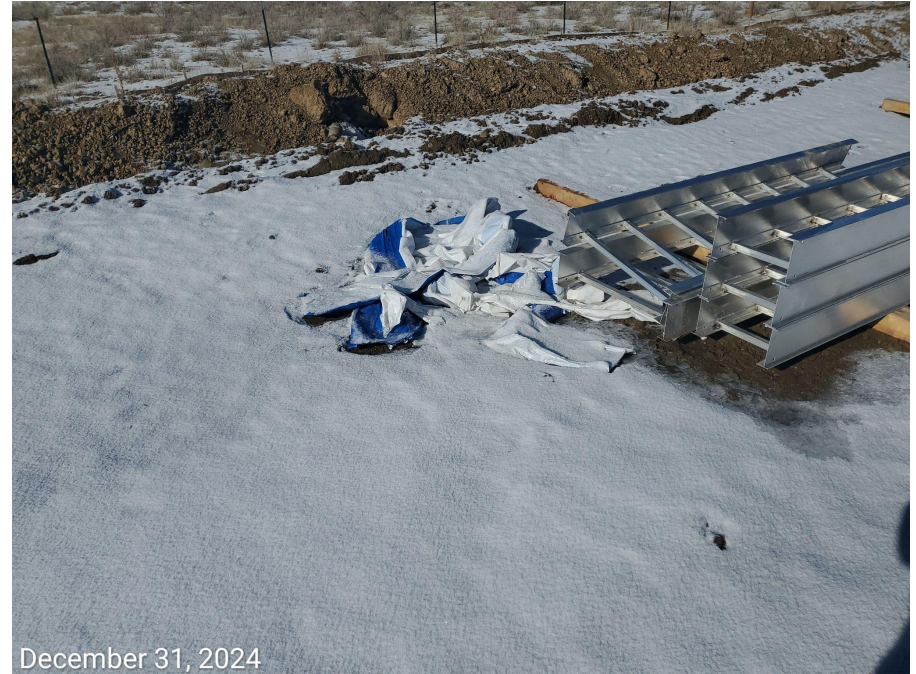
Photo 9: Photos 9-12 examples of trash/debris/rubbish observed improperly stored/placed on the Location.

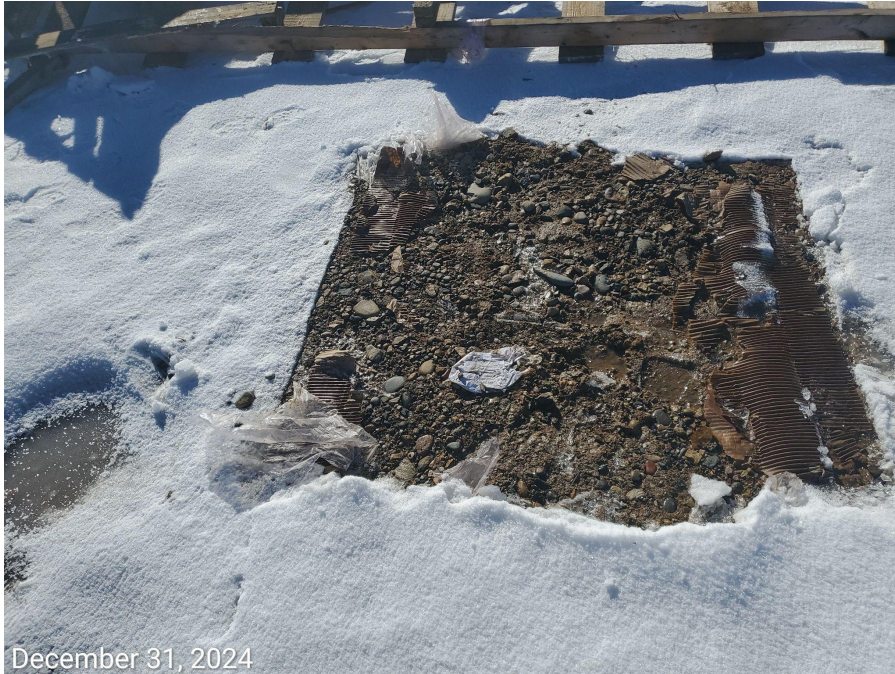
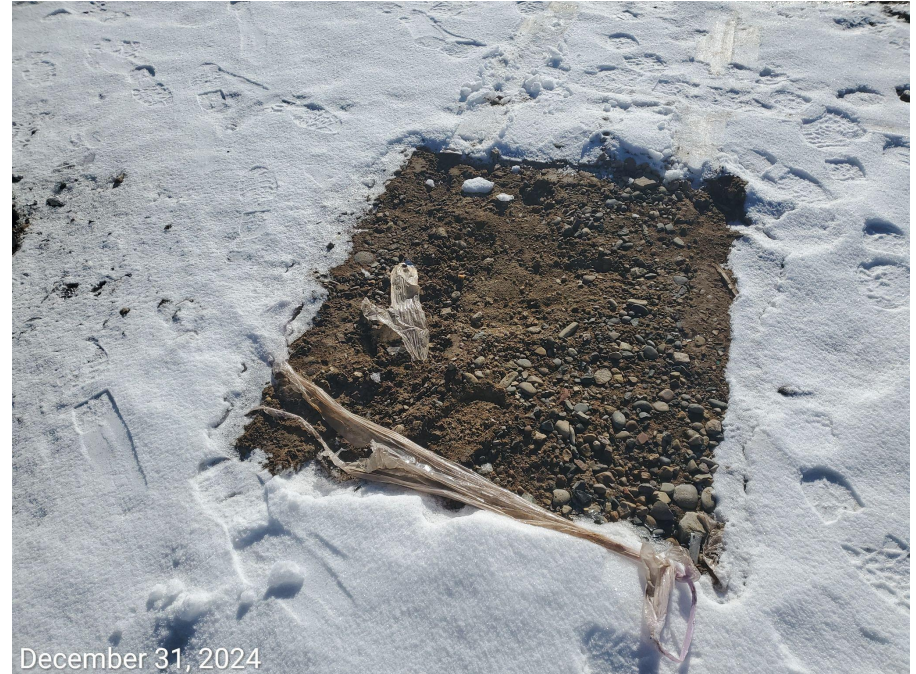
Photo 10: See comments under photo 9.

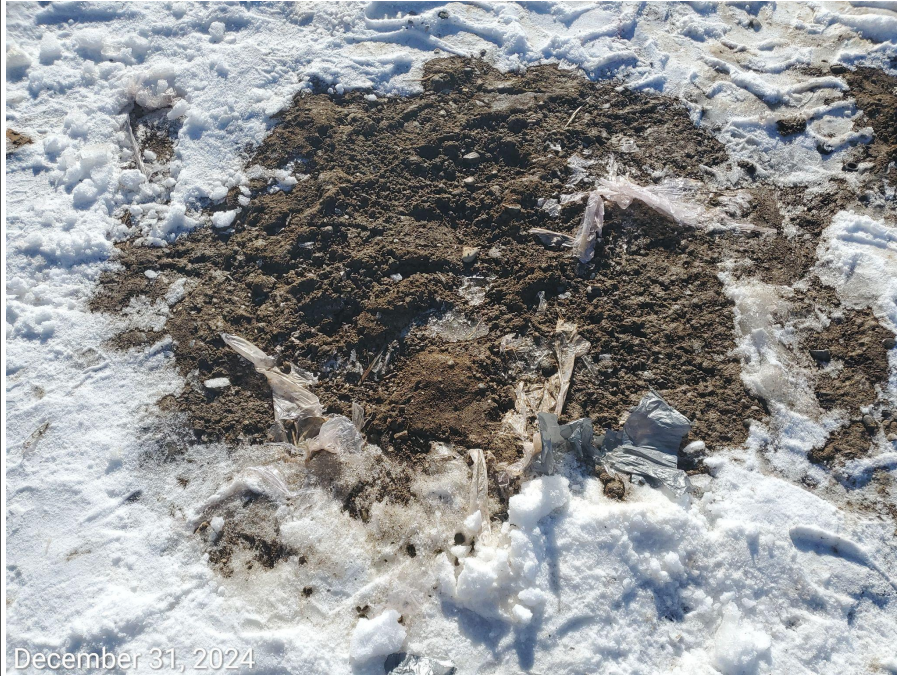
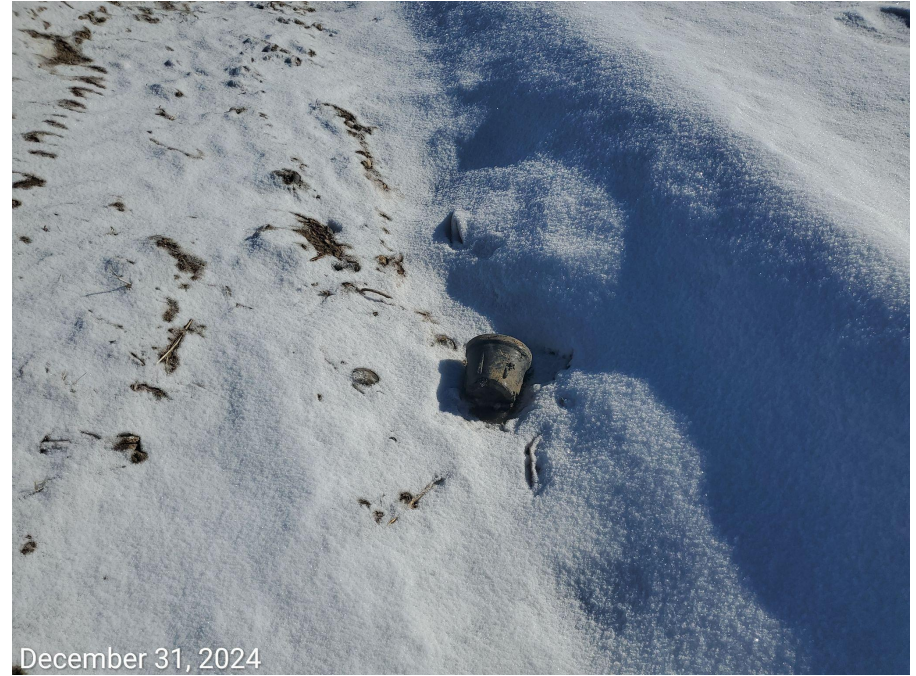
Photo 11: See comments under photo 9.

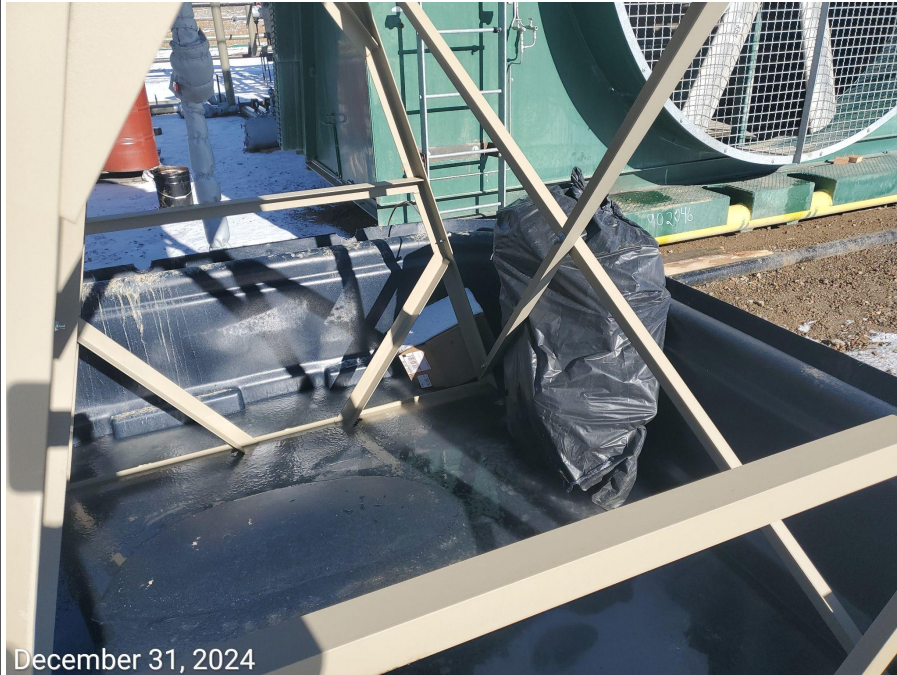
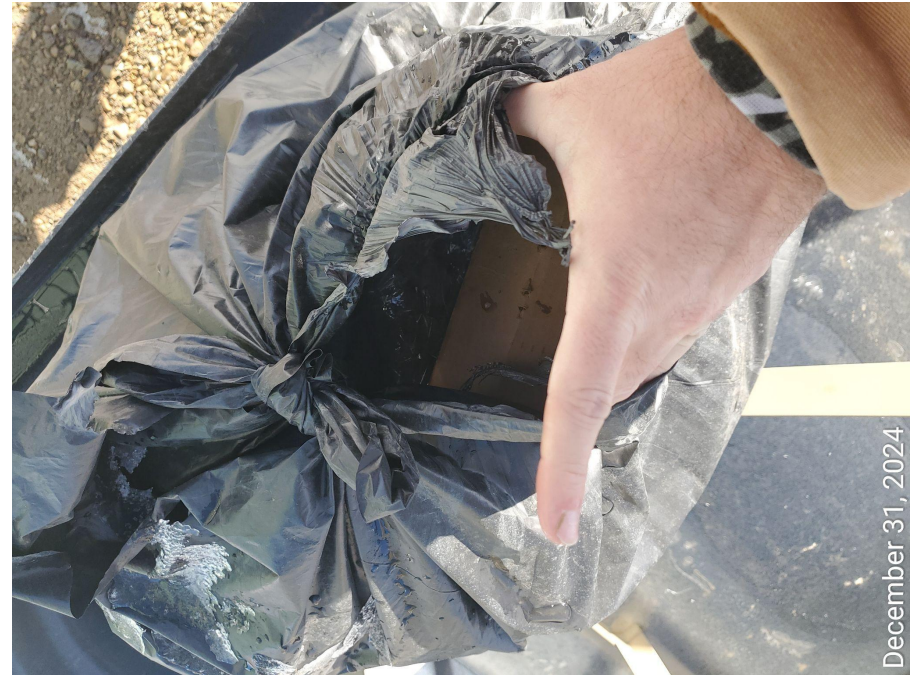
Photo 12: See comments under photo 9.

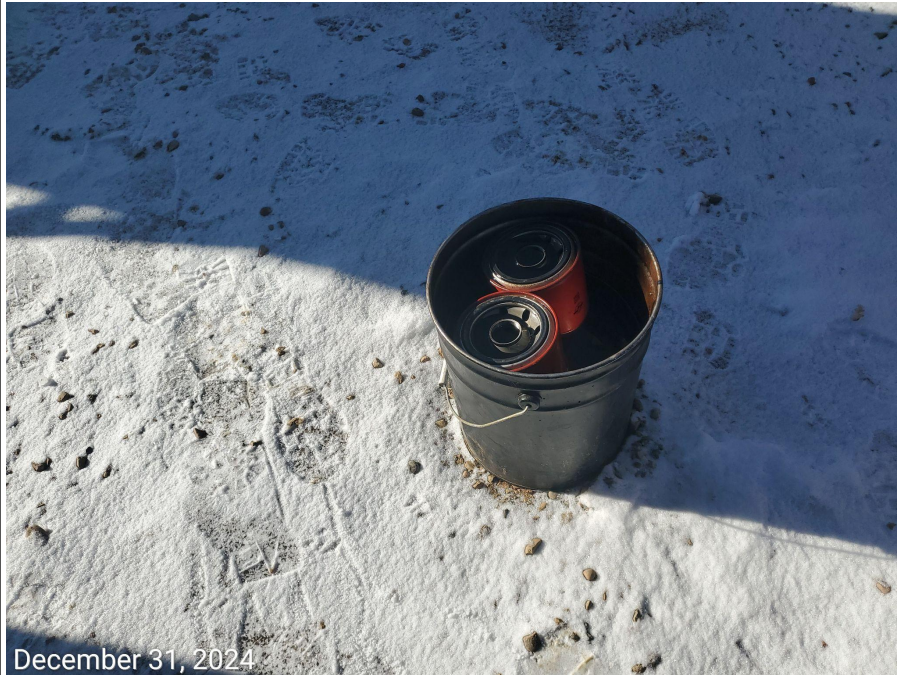
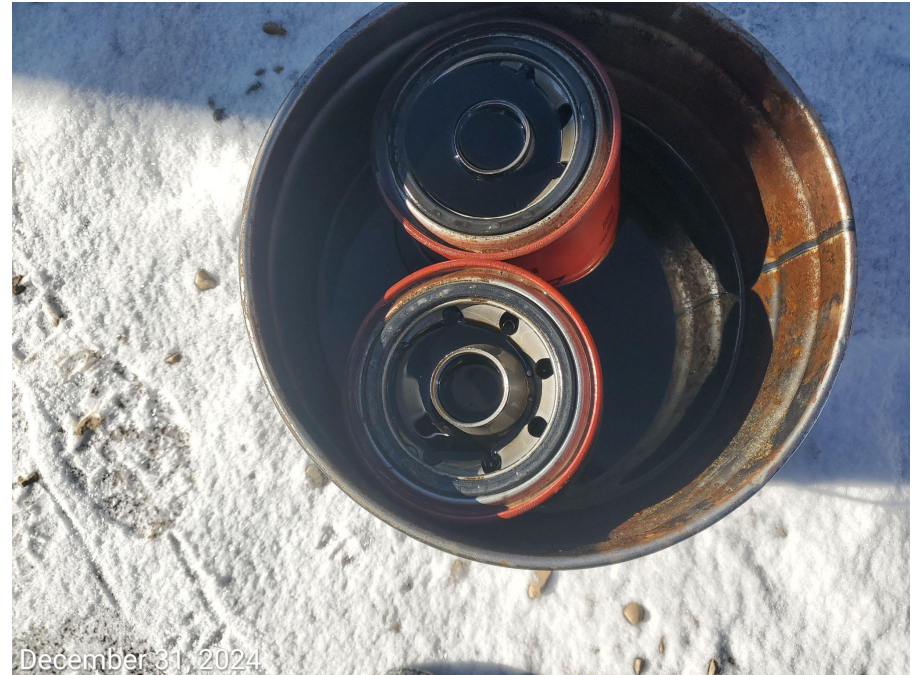
Photo 13: Photos 13-15 examples showing containers (barrels, jugs, buckets, etc...) improperly stored on the location without proper spill prevention and containment measures. Photo 13 also shows open bucket containing what appears to be used filters and oil. This is not proper storage of chemicals or trash.

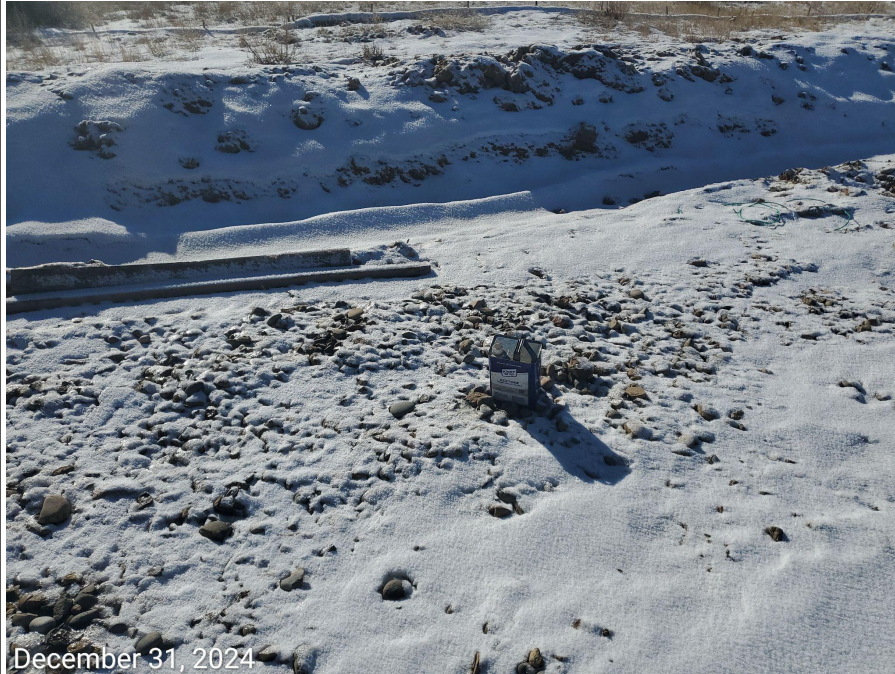
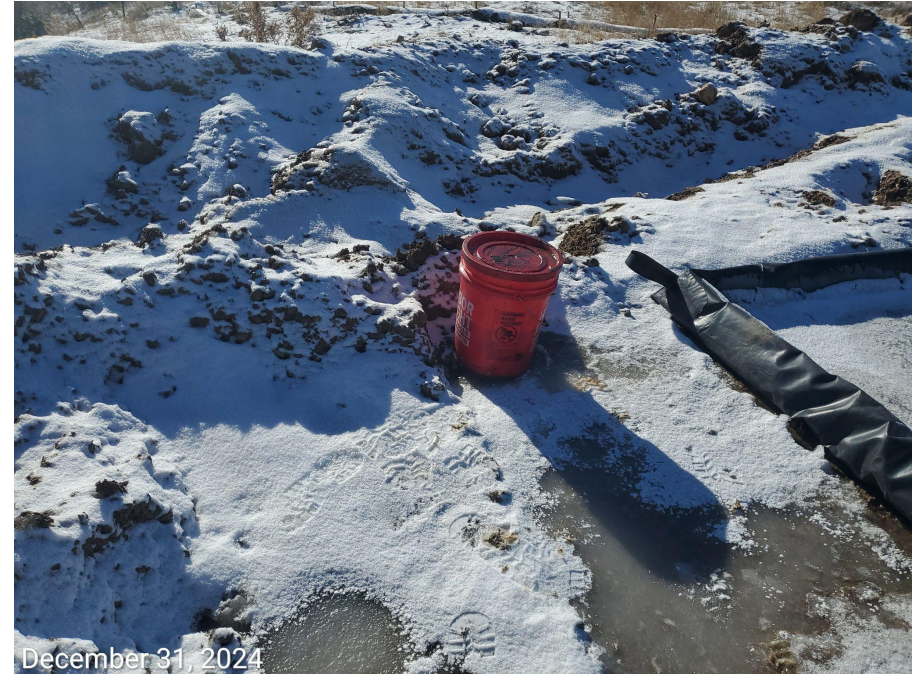
Photo 14: See comments under photo 13.

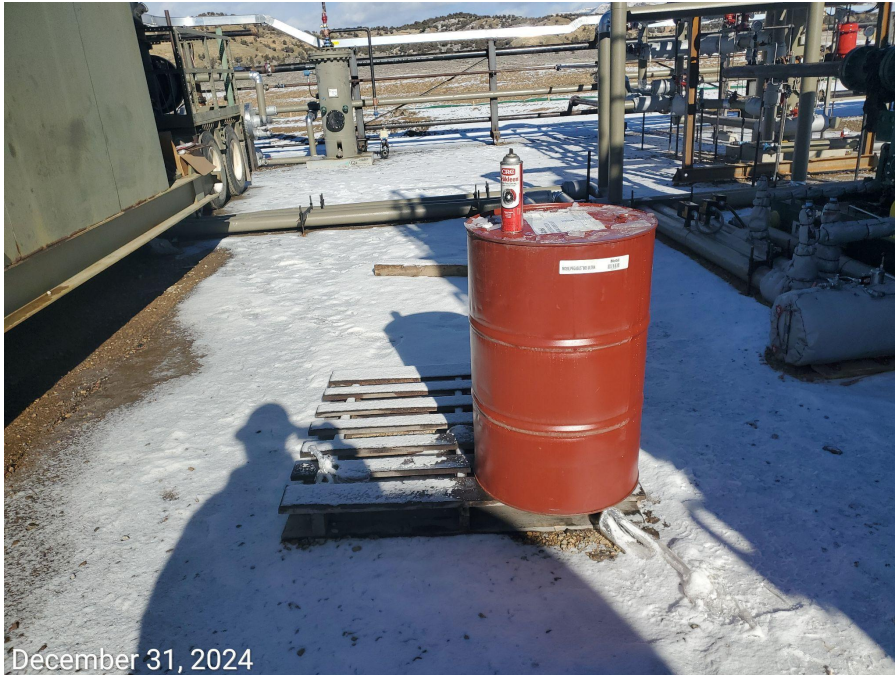
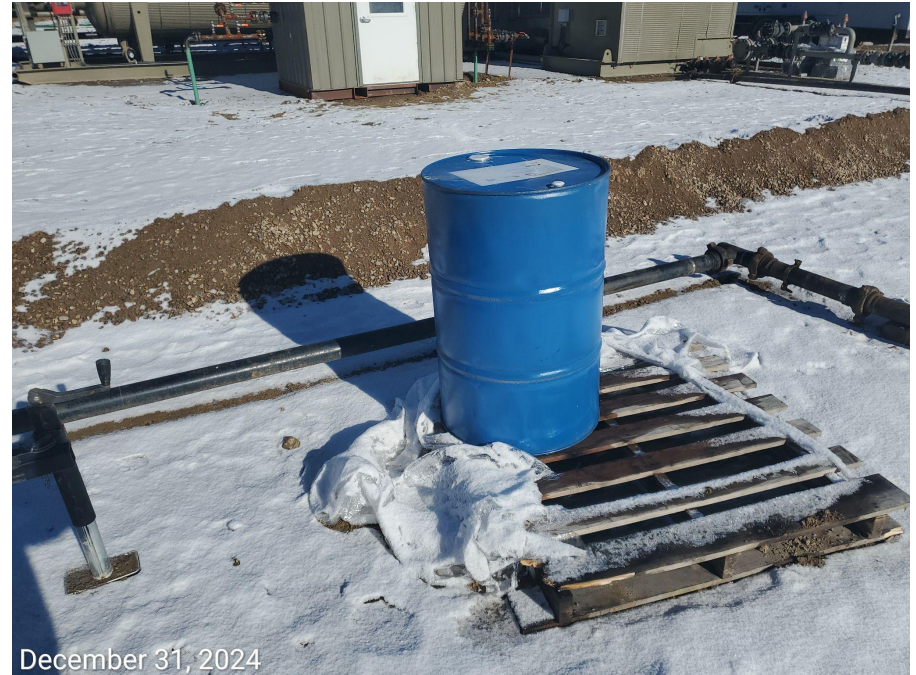
Photo 15: See comments under photo 13.

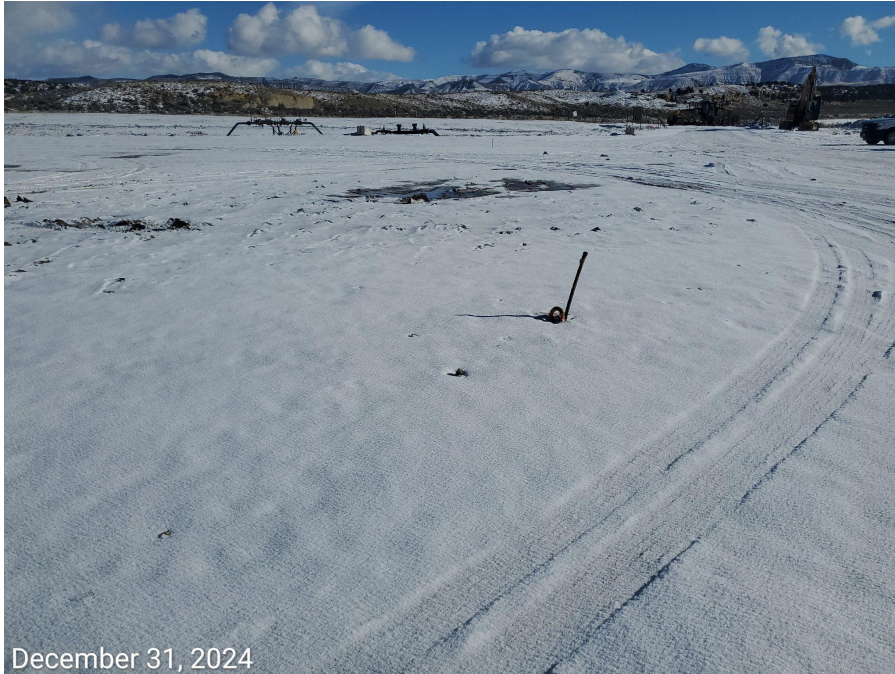
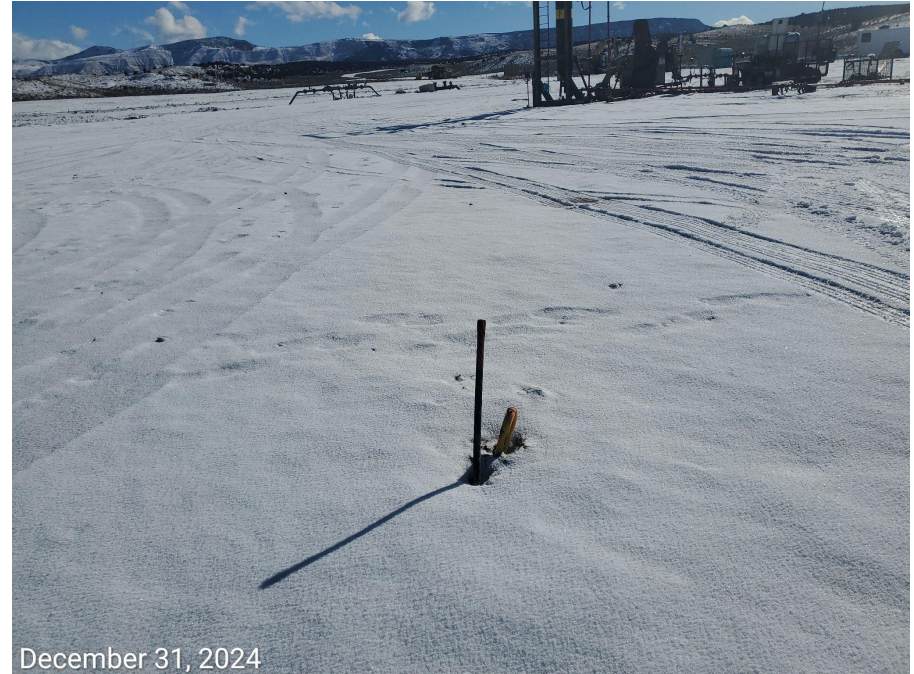
Photo 16: Photos examples showing anchors on the Location. If anchors will be left permanently for future use (post drilling operations), anchor markers will need to comply with 1003.a and 603.j requirements.

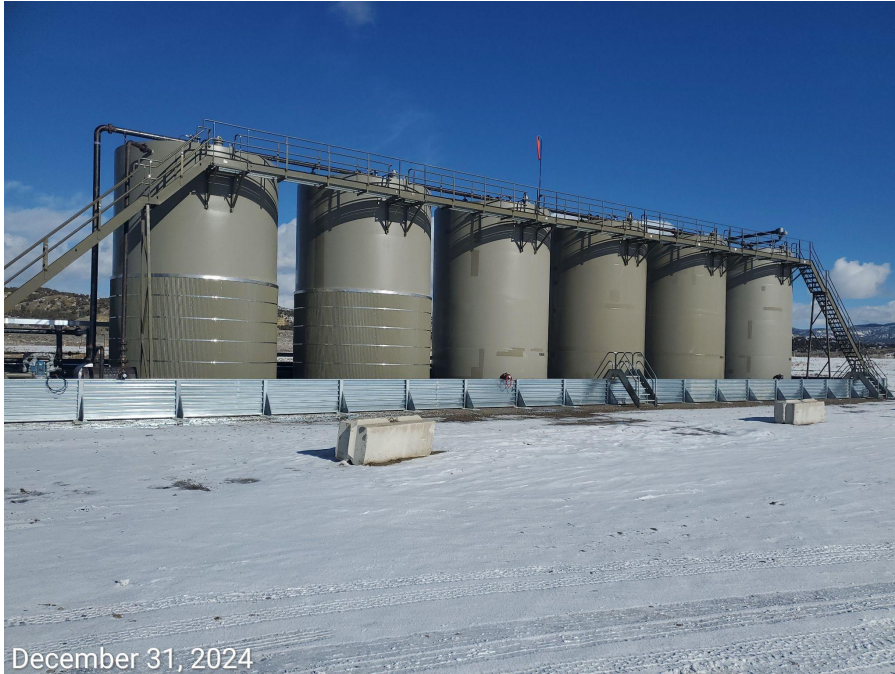
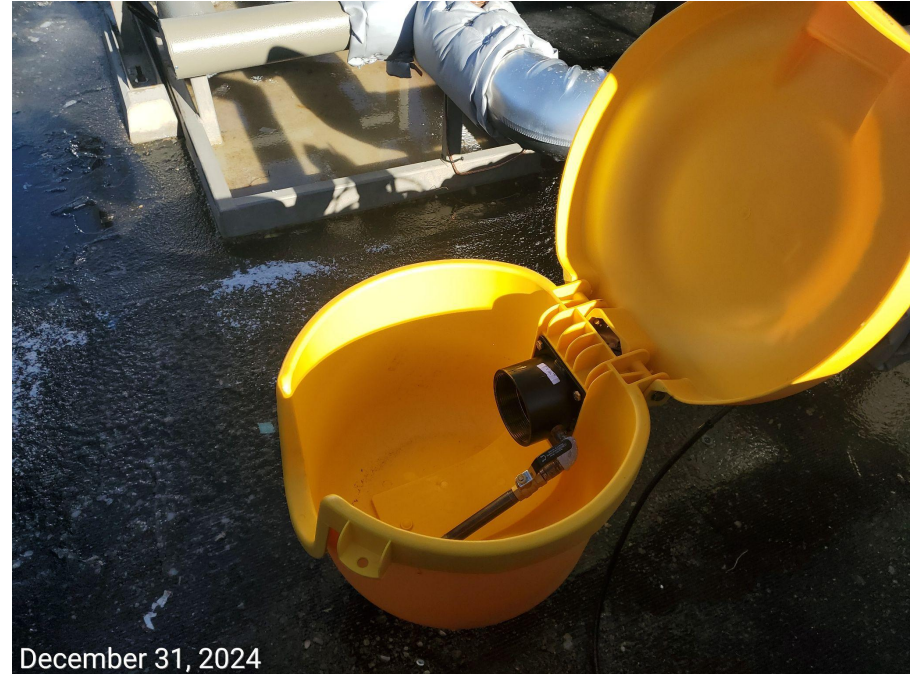
Photo 17: Photos show a tank battery facility has been installed on the northeast end of the Location. Tanks have not been properly labelled pursuant to Rule 605.h. Photo right shows lines at tank have not been capped/plugged.

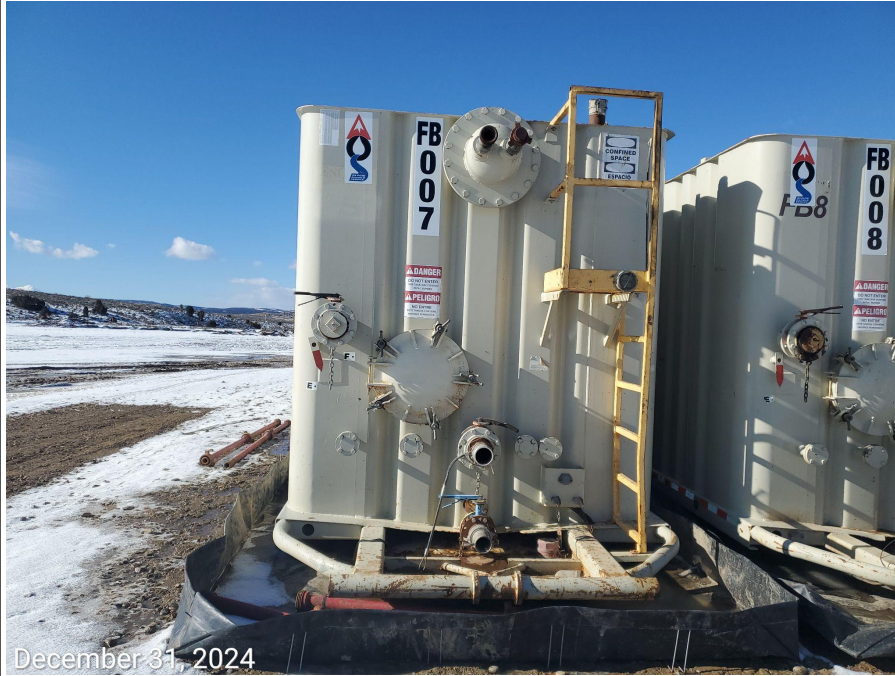
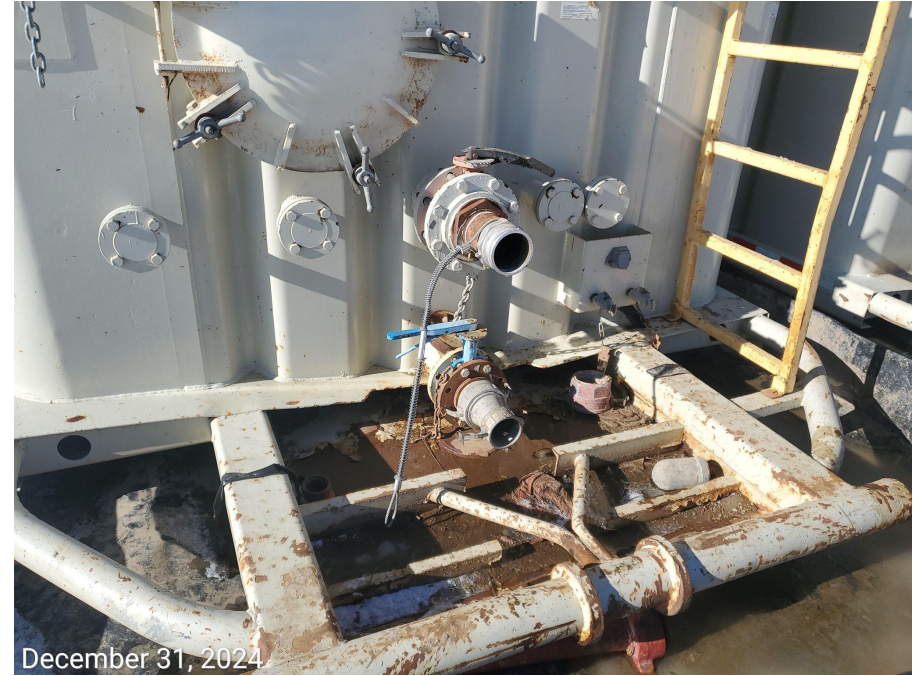
Photo 18: Photos show lines at tanks on Location are missing cap/plug. Photos also show tanks/containers have not been properly labelled pursuant to Rule 605.h

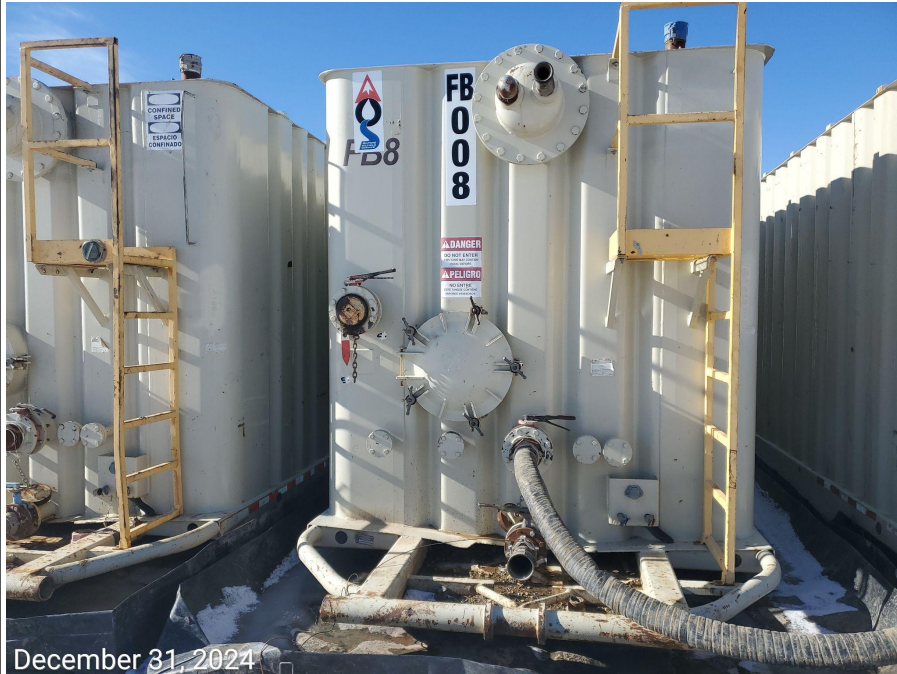
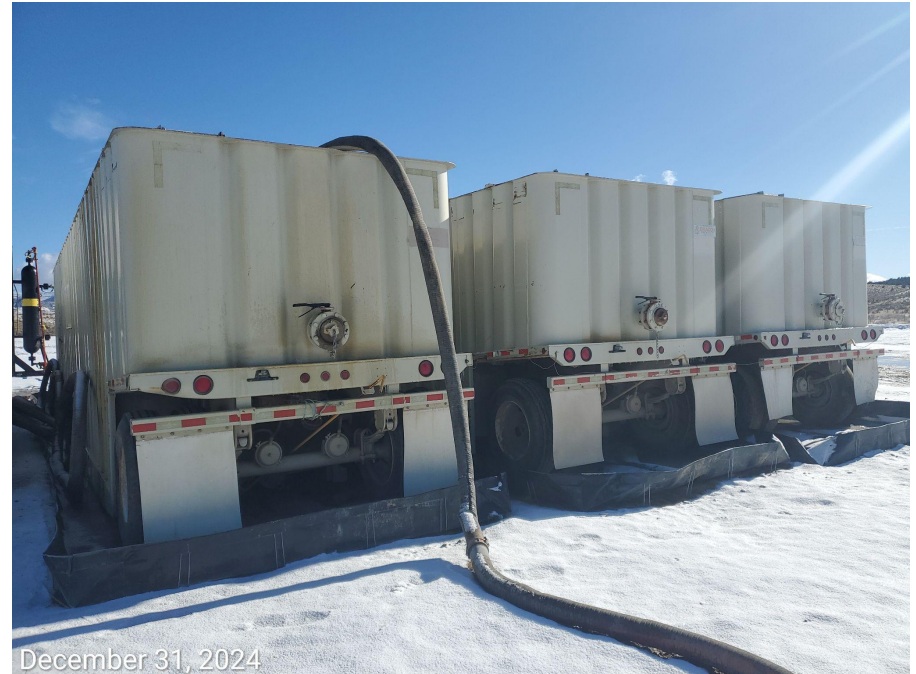
Photo 19: See comments under photo 18.
