Inspection Photos

12/31/2024

Operator: ANSCHUTZ EXPLORATION CORP -
3104

Location ID: 484545

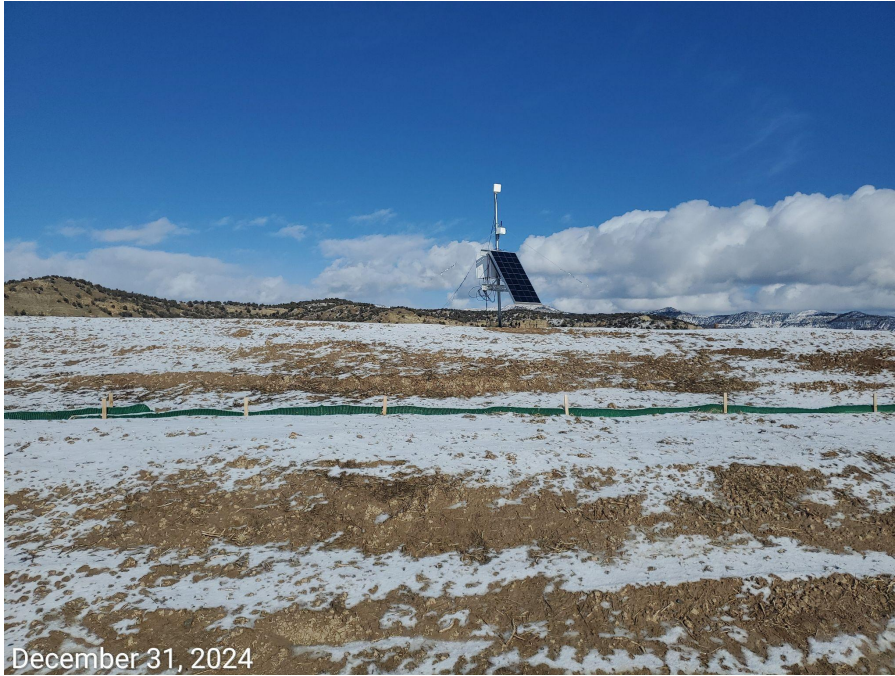
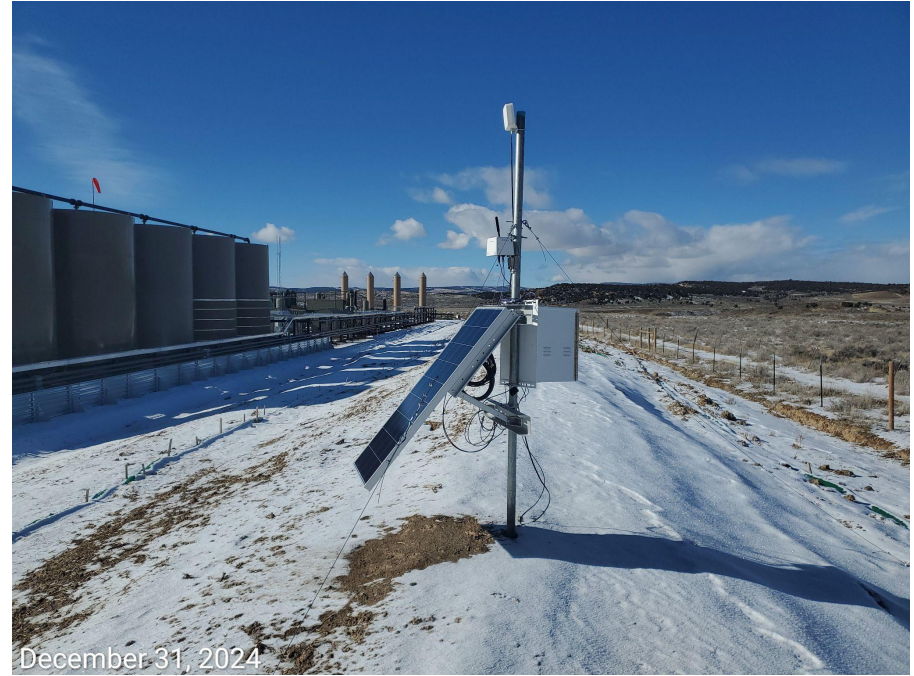
Photo 20: Photo taken from the topsoil stockpile on the northeast end of the Location. Photos show Operator has installed equipment on the topsoil stockpile. This does not comport with Rule 1002.c protection requirements.

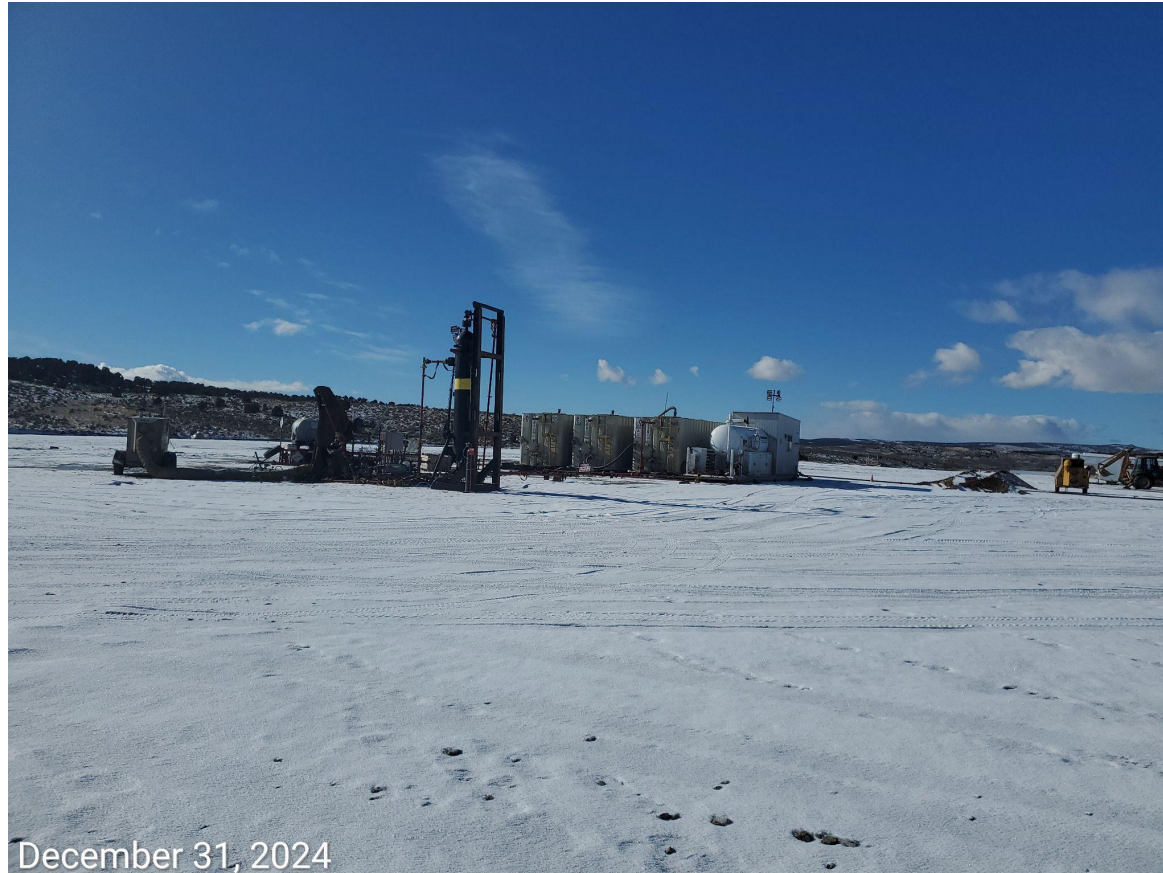
Photo 21: Frac operations in process.
