Spill ID: 488909

COLORADO
Energy & Carbon Management
Commission
Department of Natural Resources

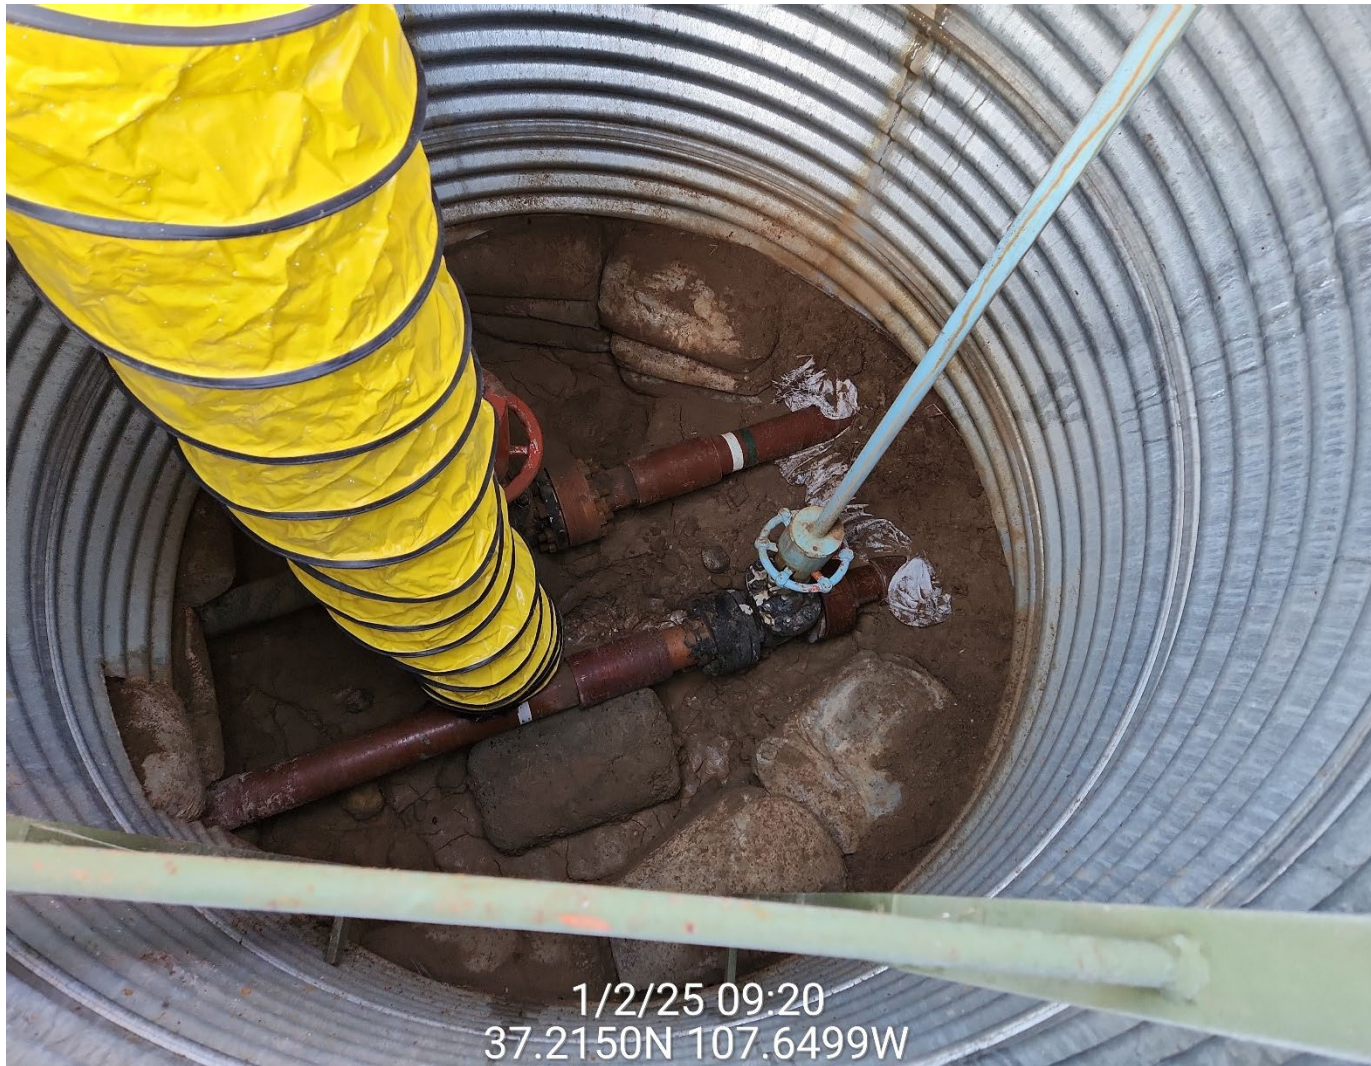
**Bell hole approximately 25 feet west of pipeline
rupture/spill**

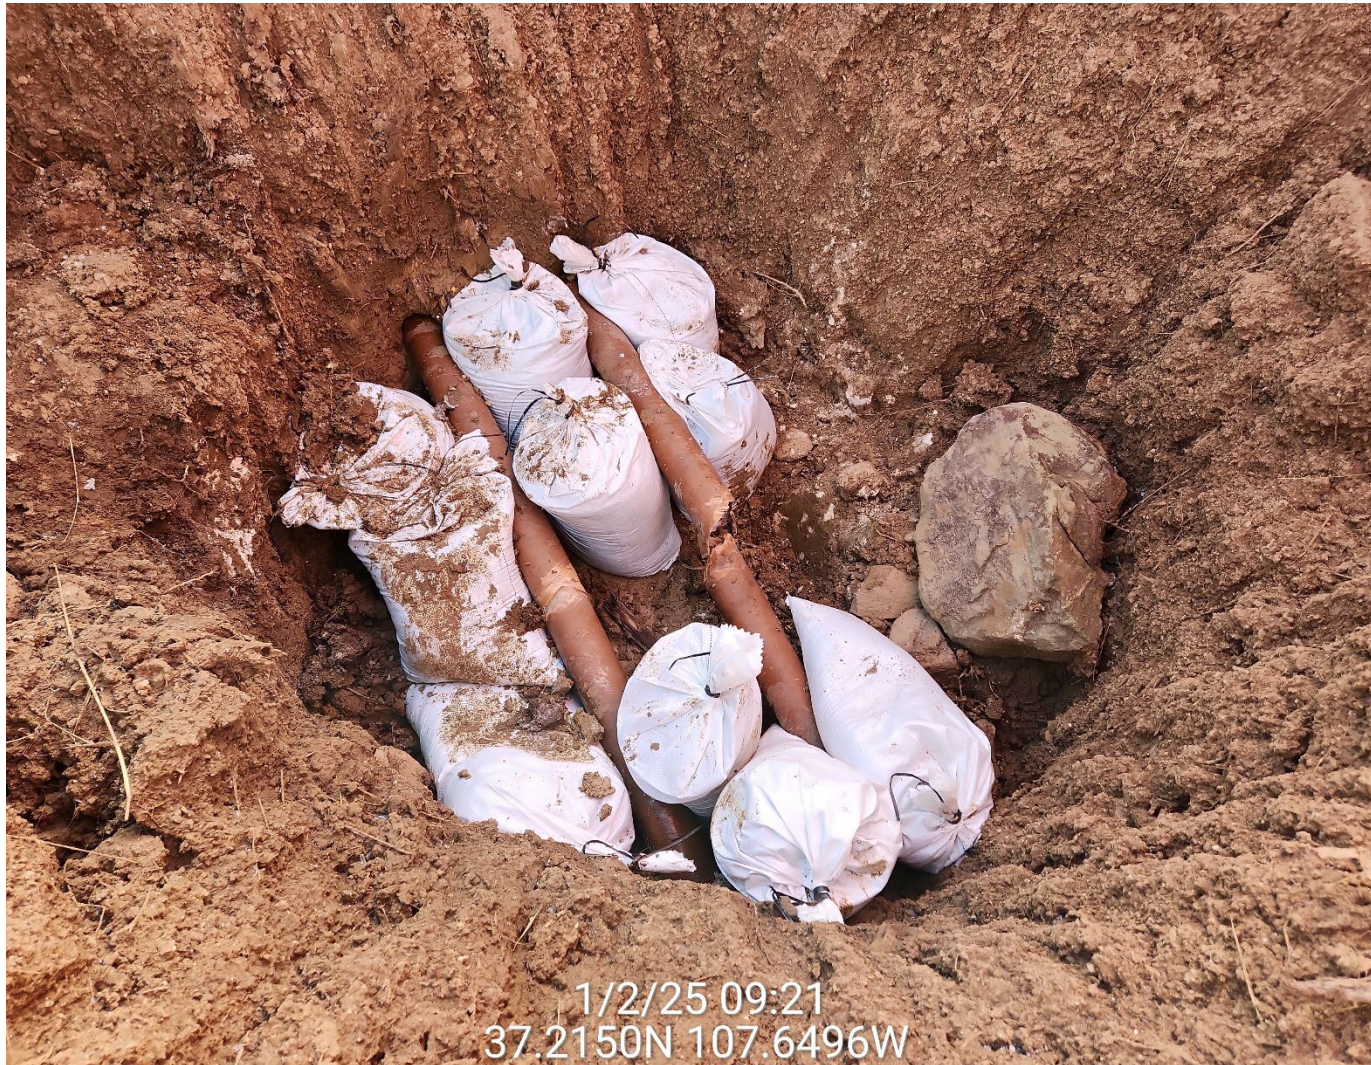
Source of spill was broken fiberglass flowline. Flowline adjacent has integrity issues on top of line.

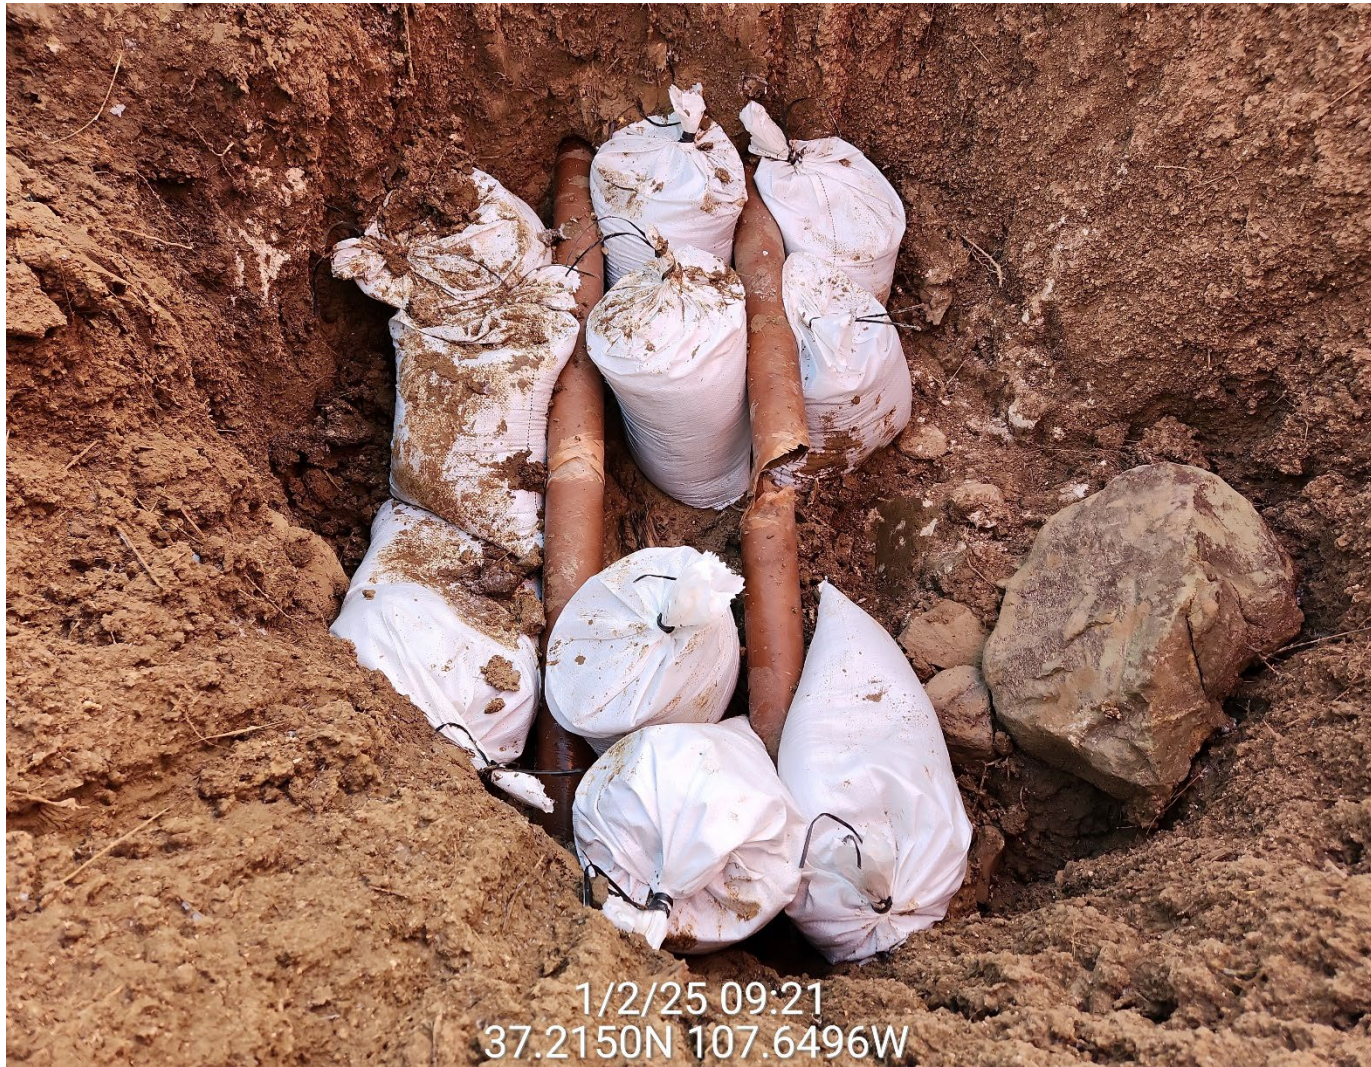
Source of spill was broken fiberglass flowline. Flowline adjacent has integrity issues on top of line.

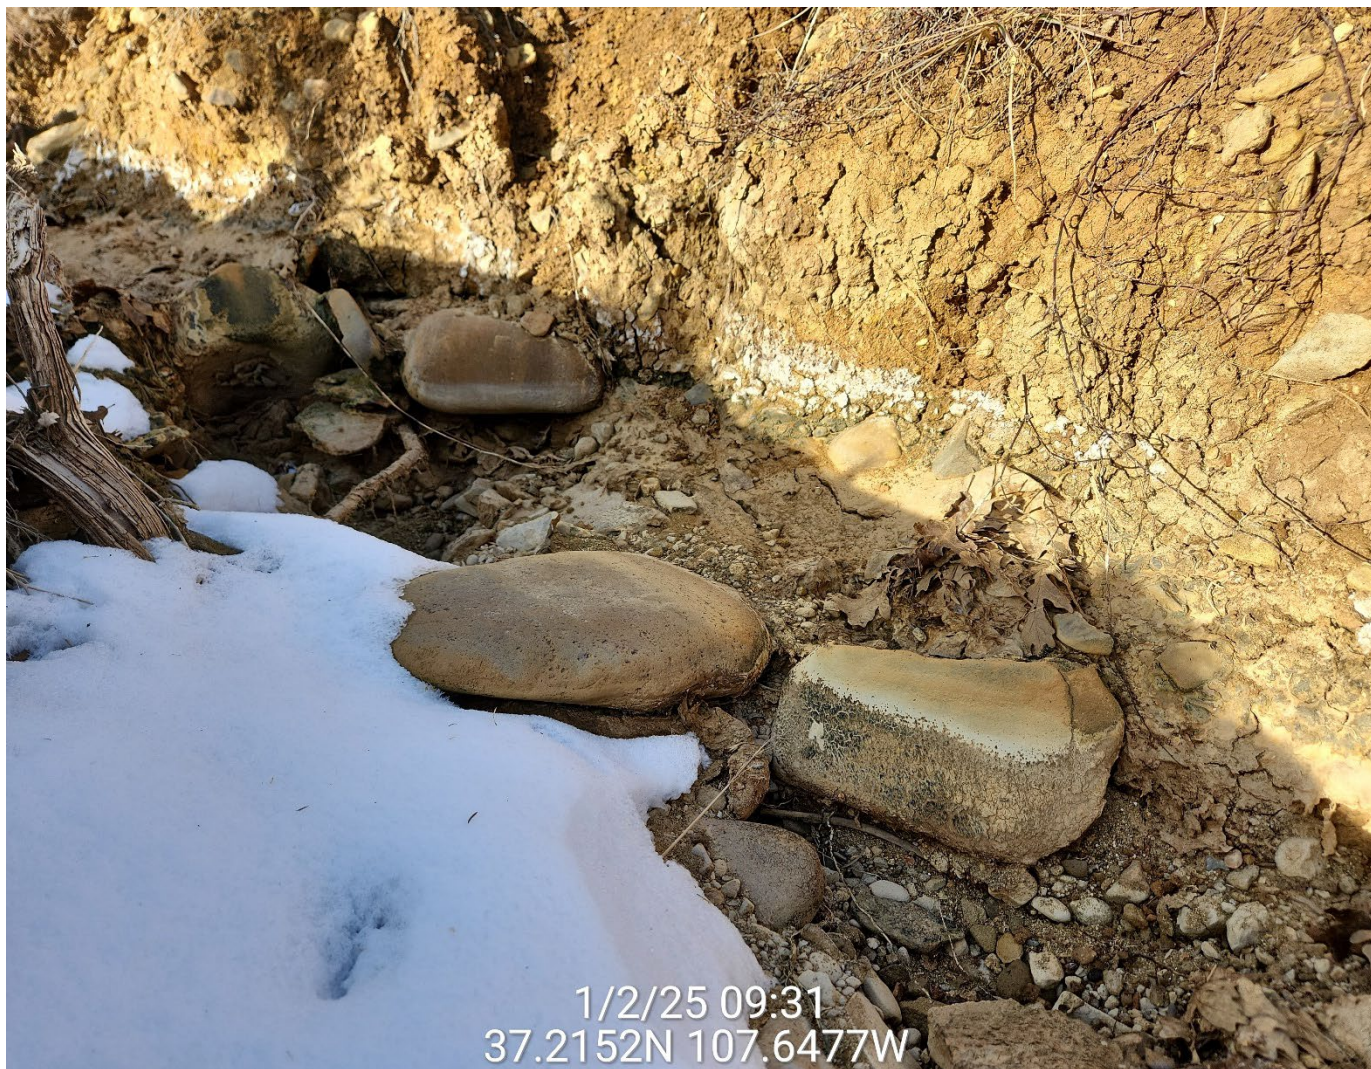
Flow path

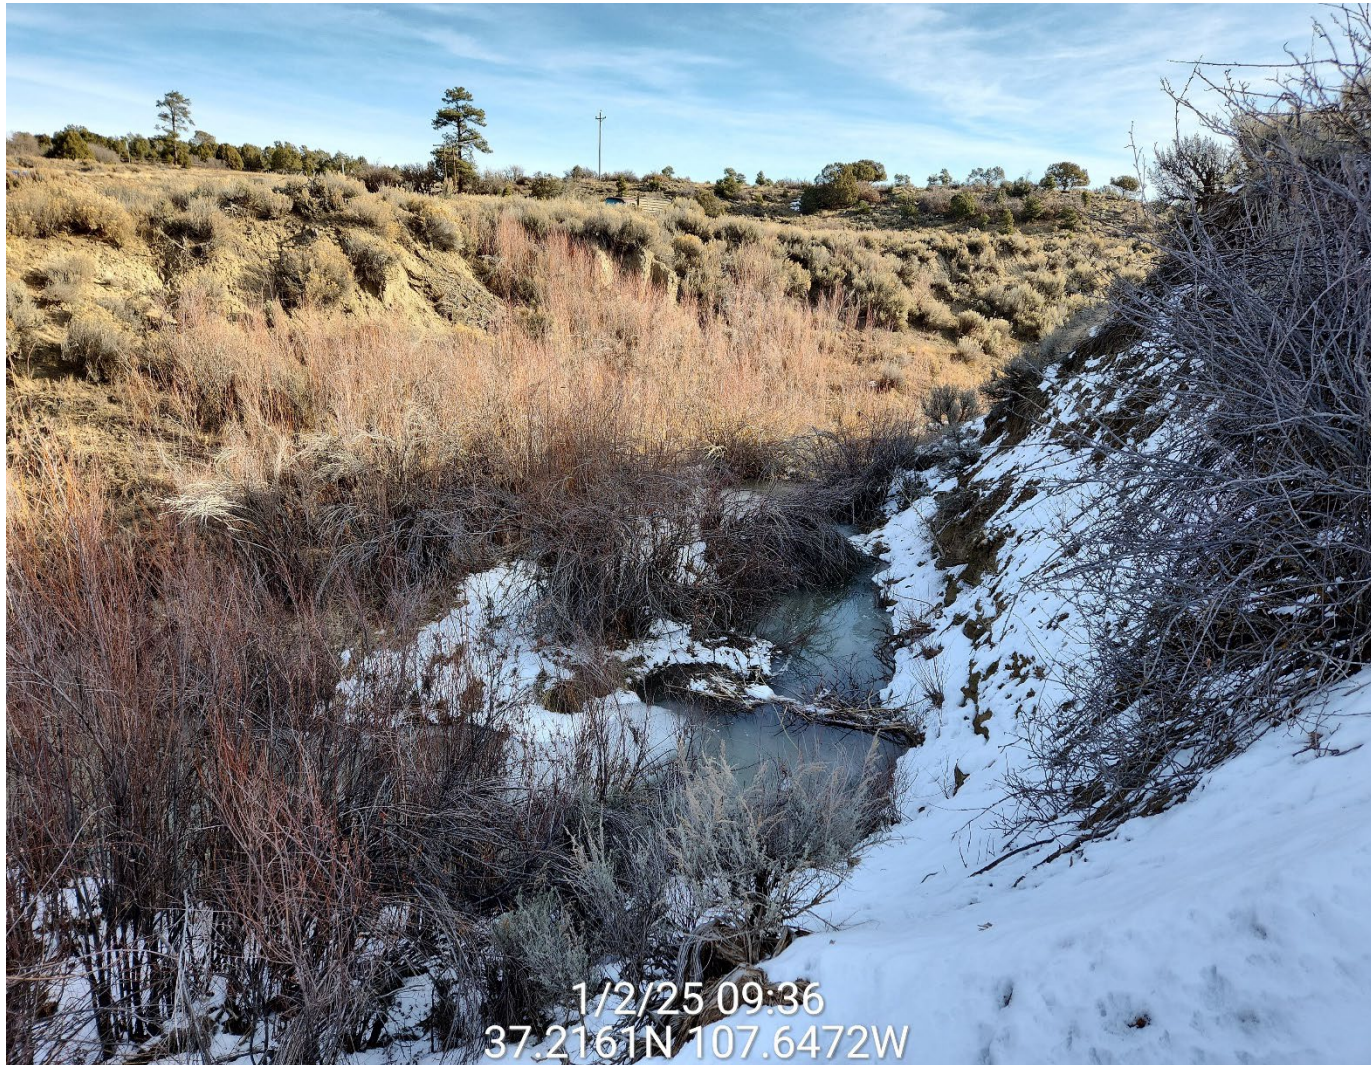
Looking downstream from where spill entered Dry Creek

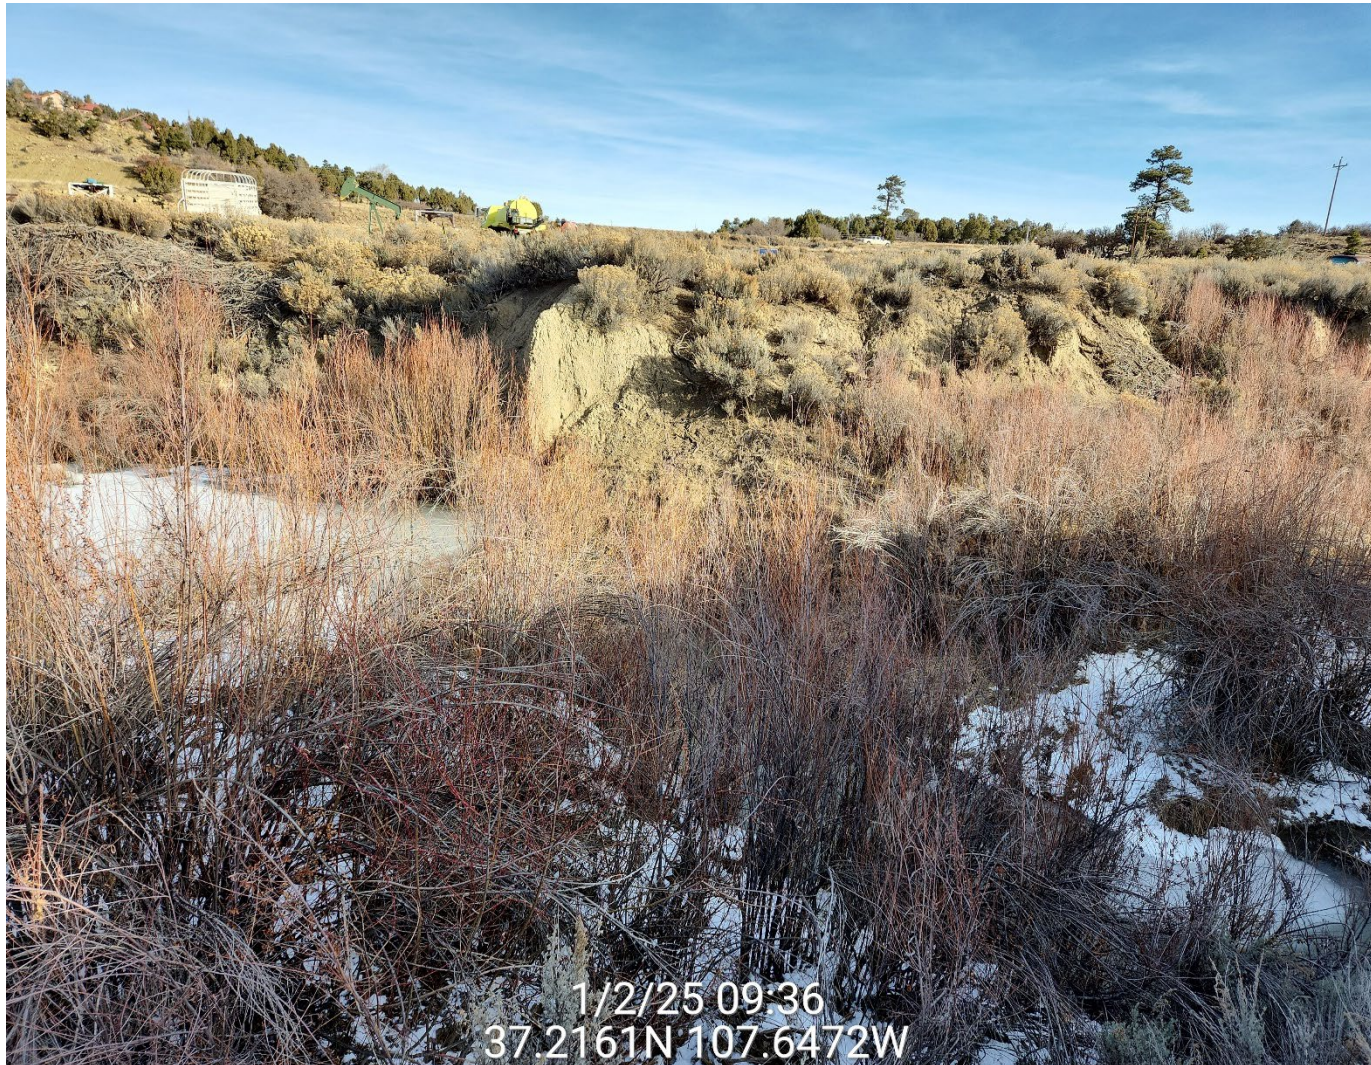
Location where spill entered Dry Creek

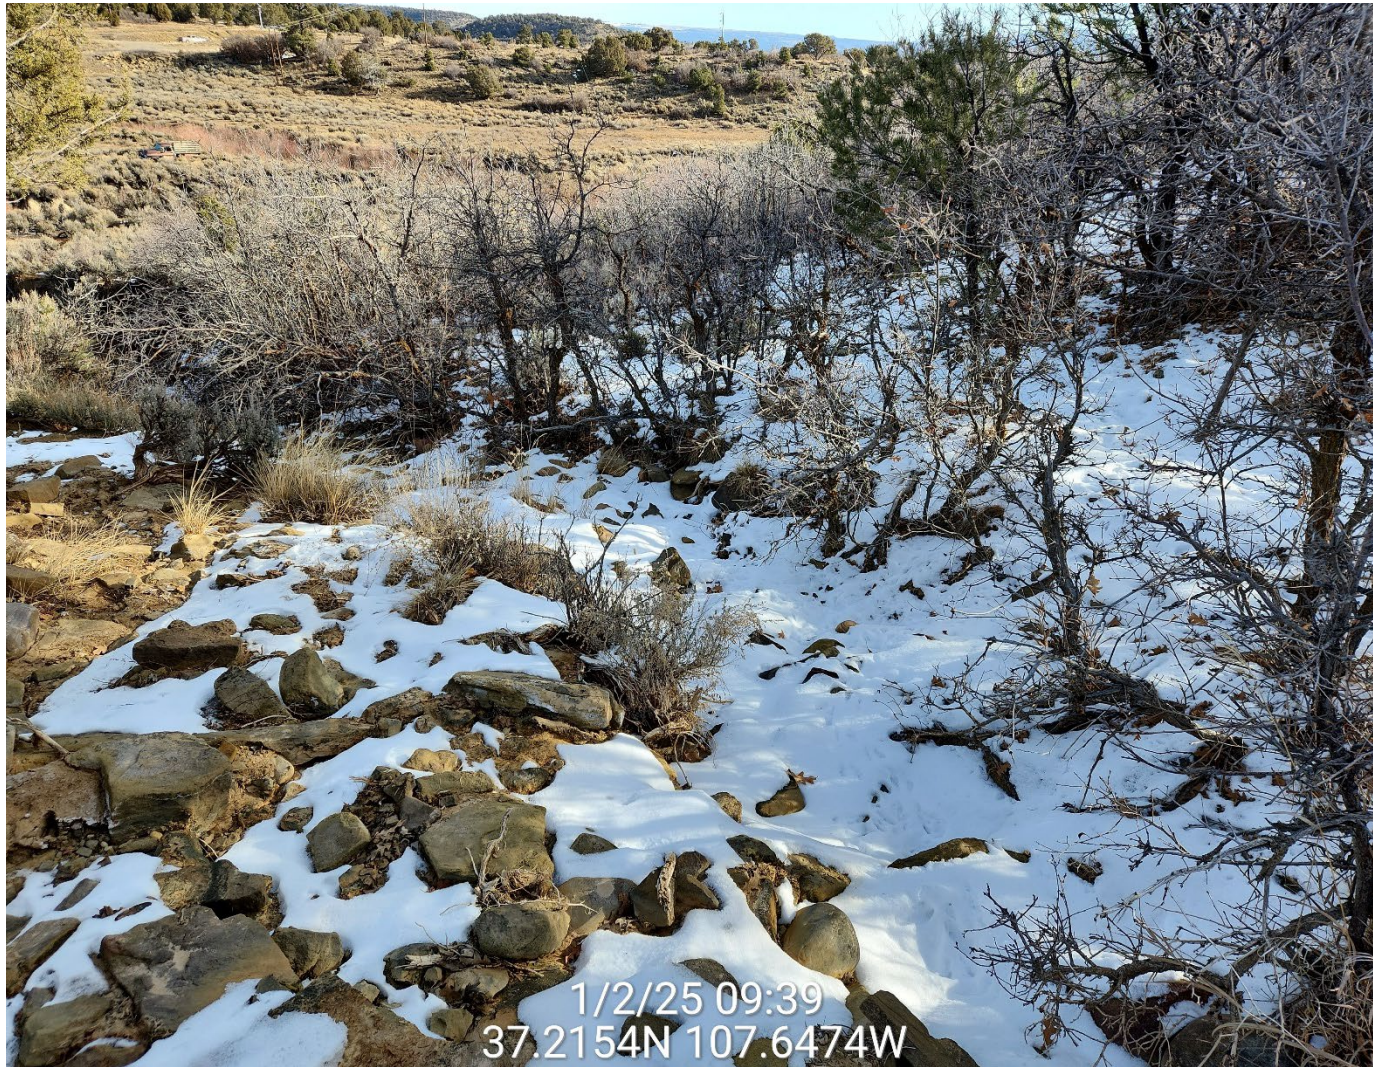
Flow path

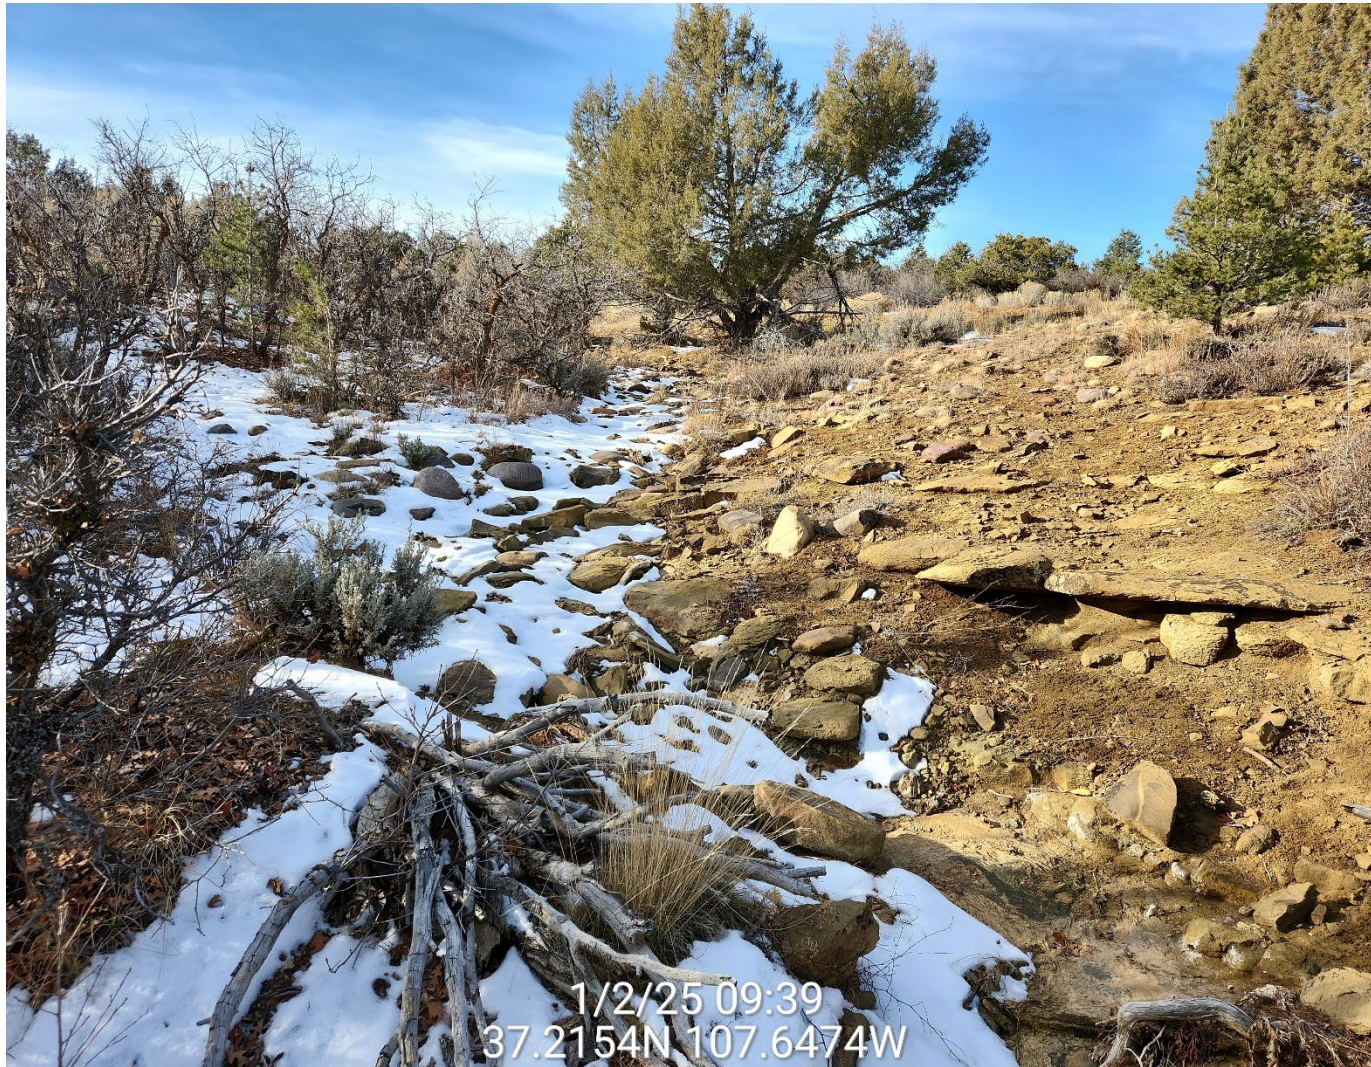
Flow path

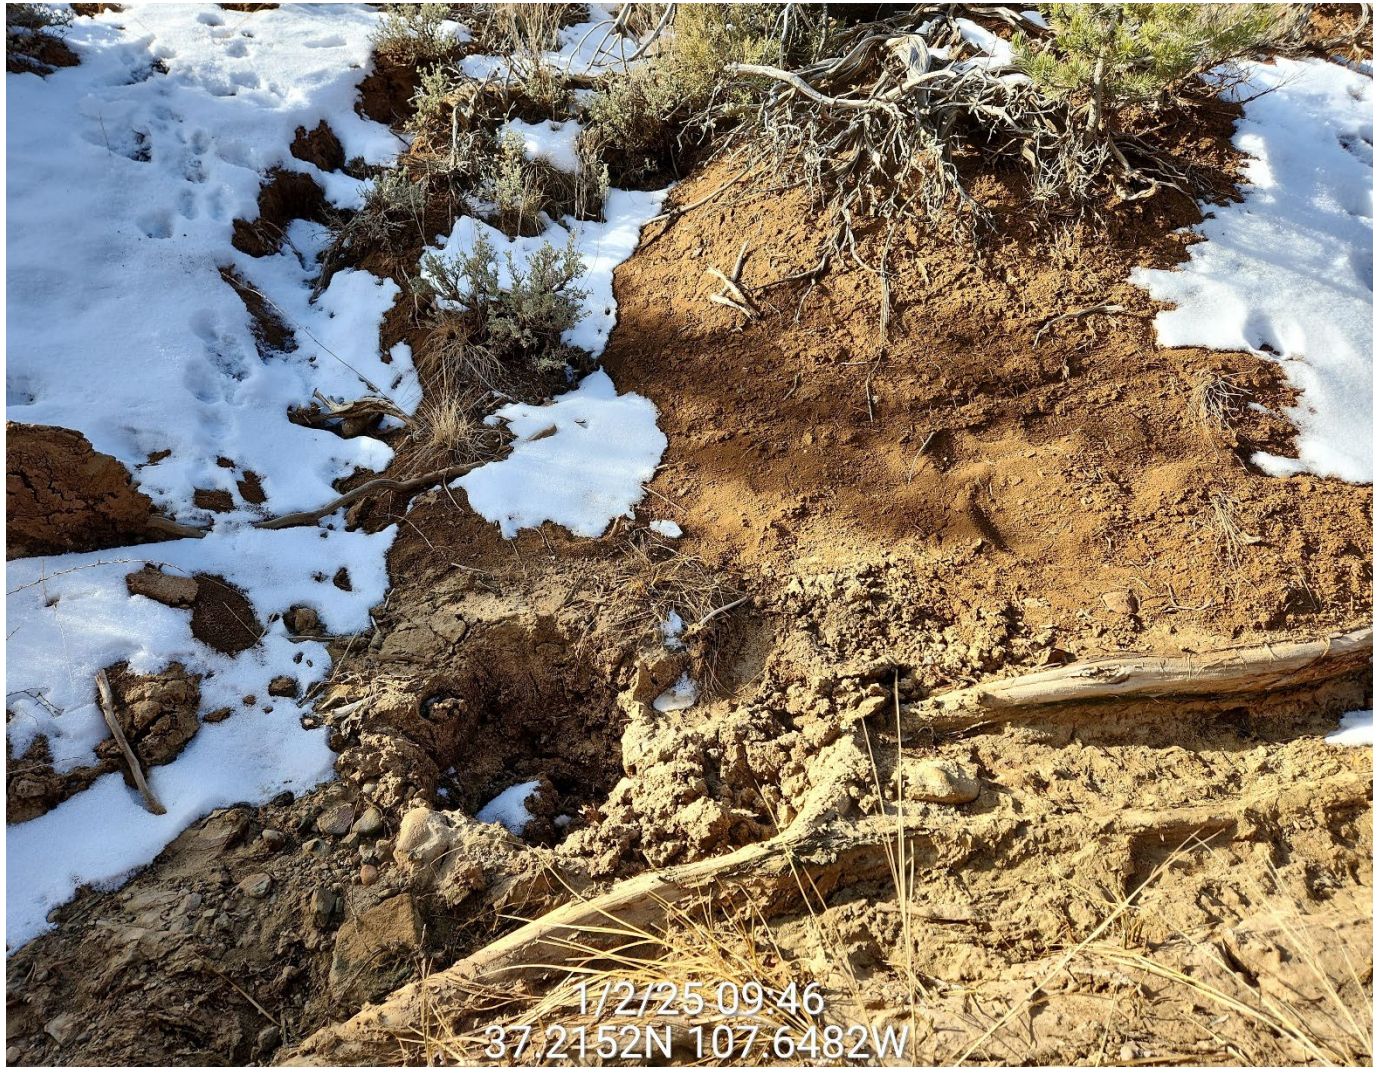
Flow path and soil sample location. Sample taken by
operator

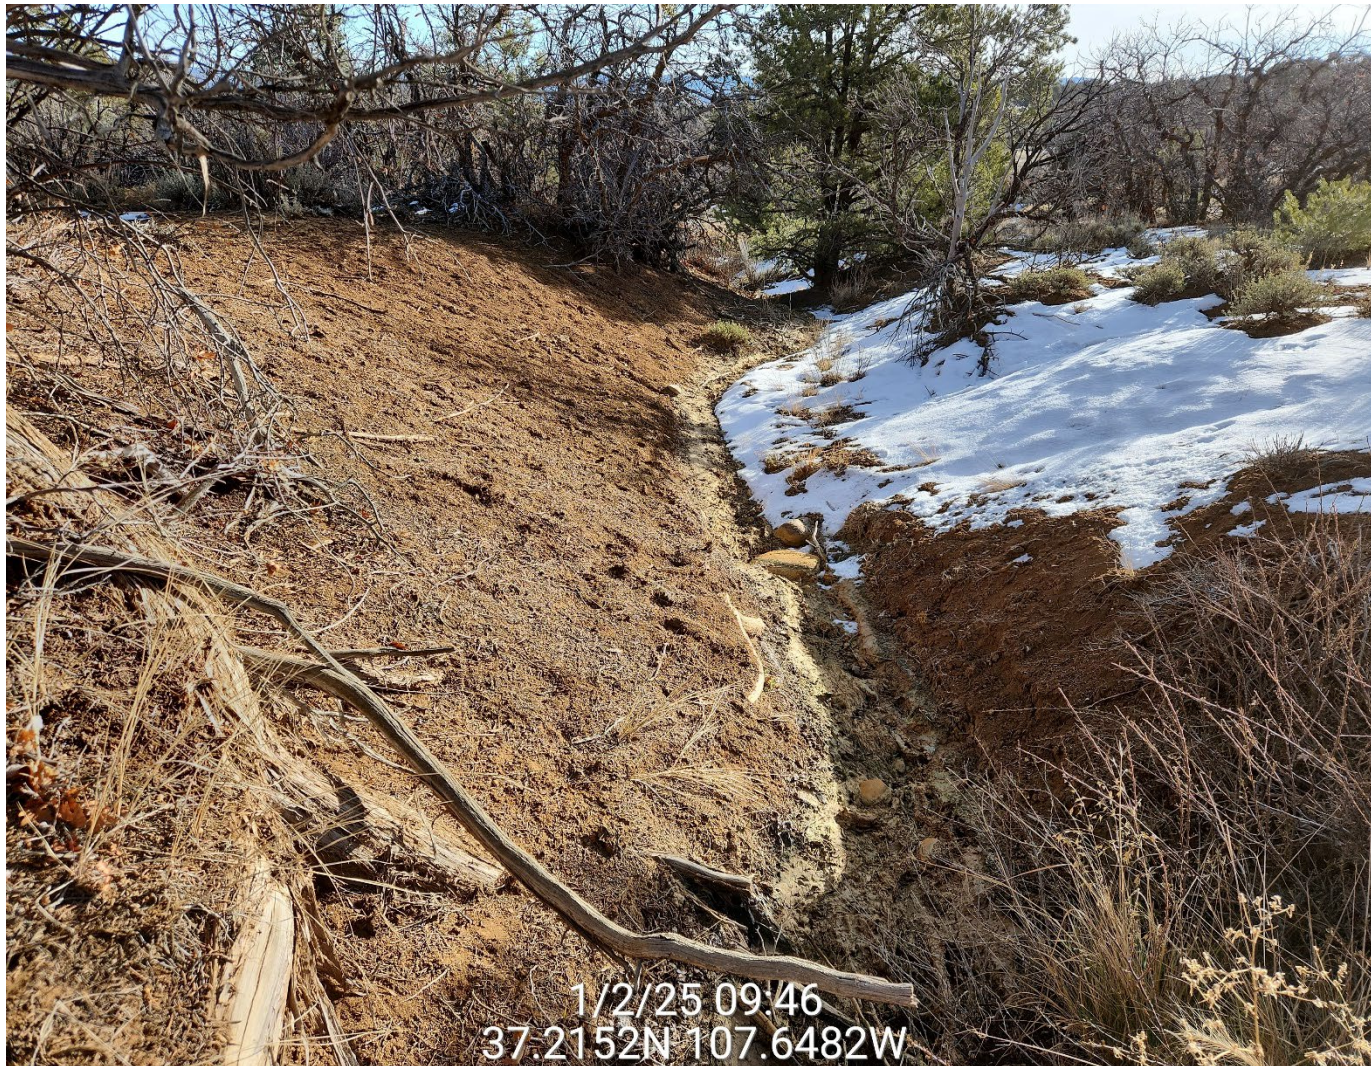
Flow path

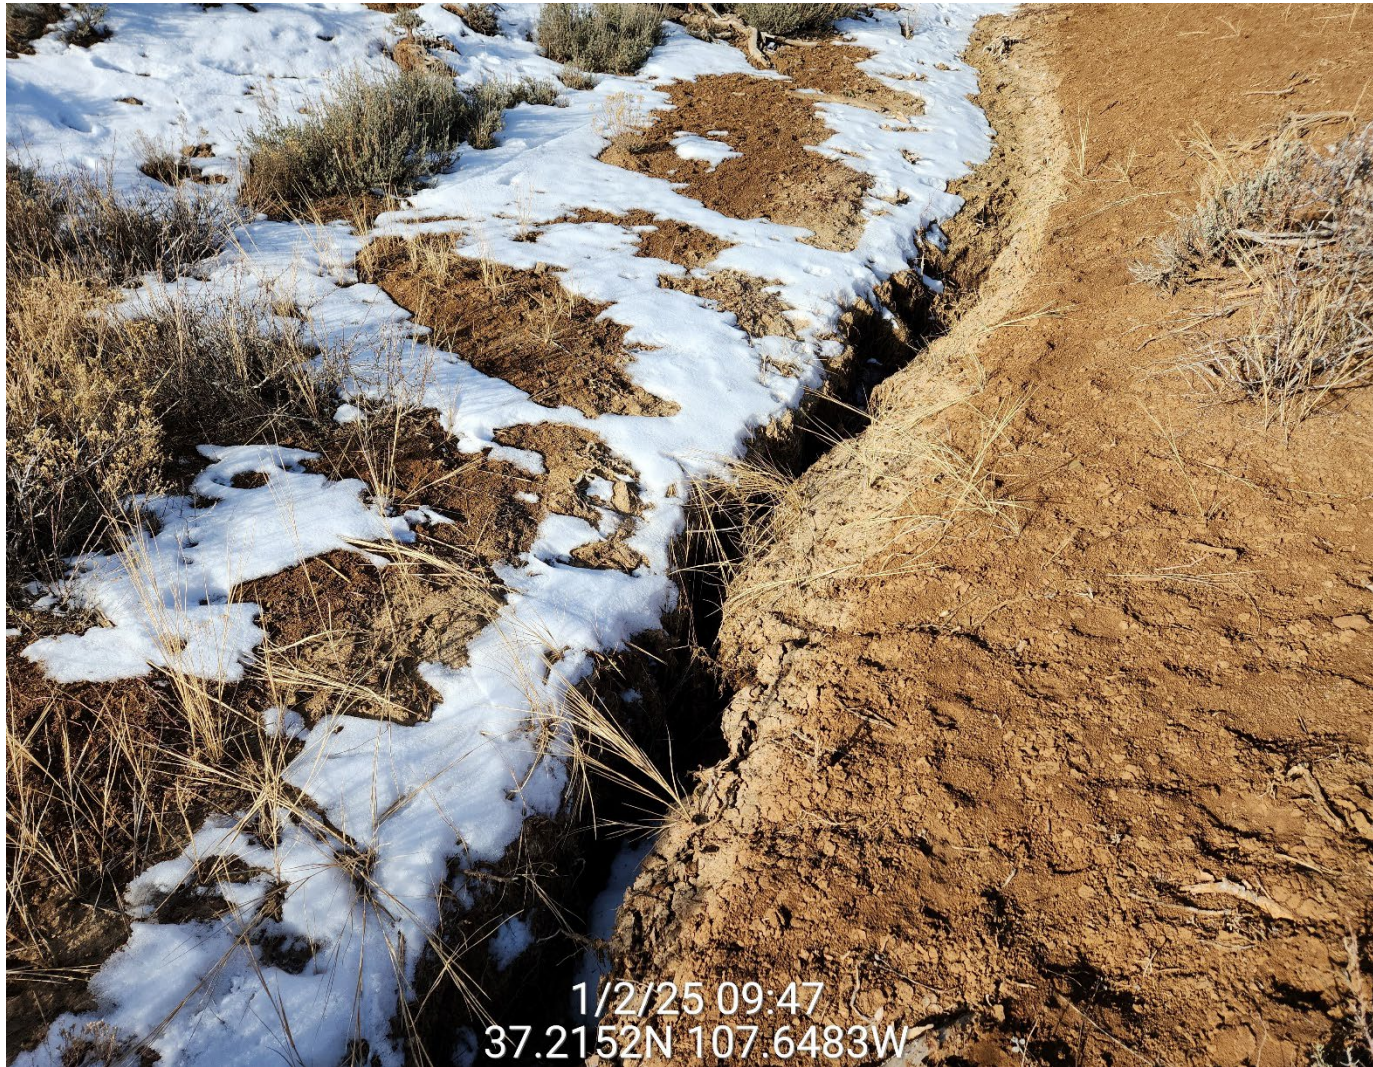
Flow path
