# Final Reclamation and Stormwater Inspection

Operator: STELBAR OIL CORP INC - 82470

Location ID: 317263

Inspection Photos  
Location Name: Young 2-35  
Location ID: 317263

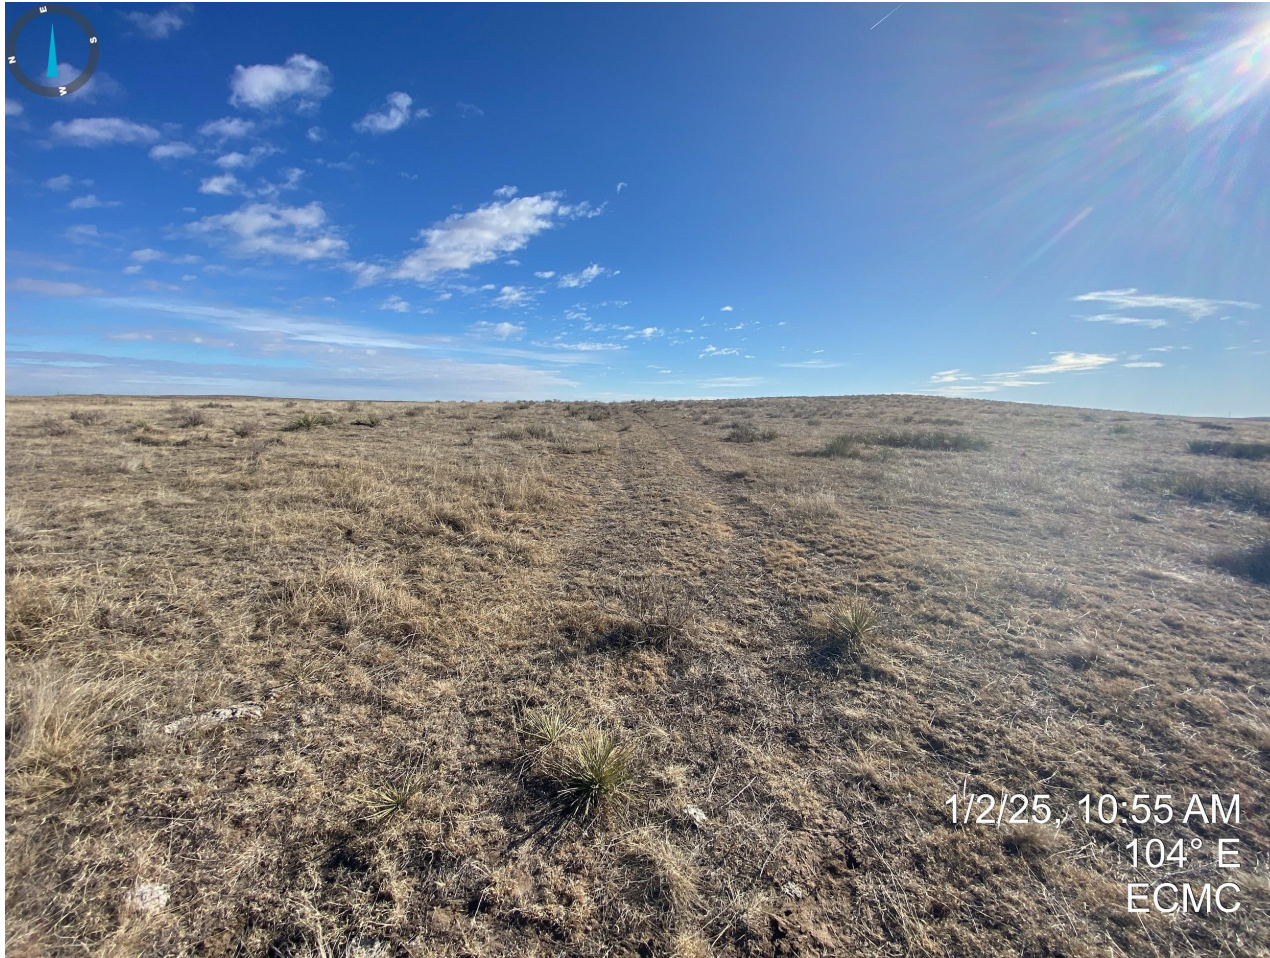
**Photo 1.** Taken from the start of the access road, west of the location. Portions of the former access road appear to be progressing towards reclamation standards and regulations.

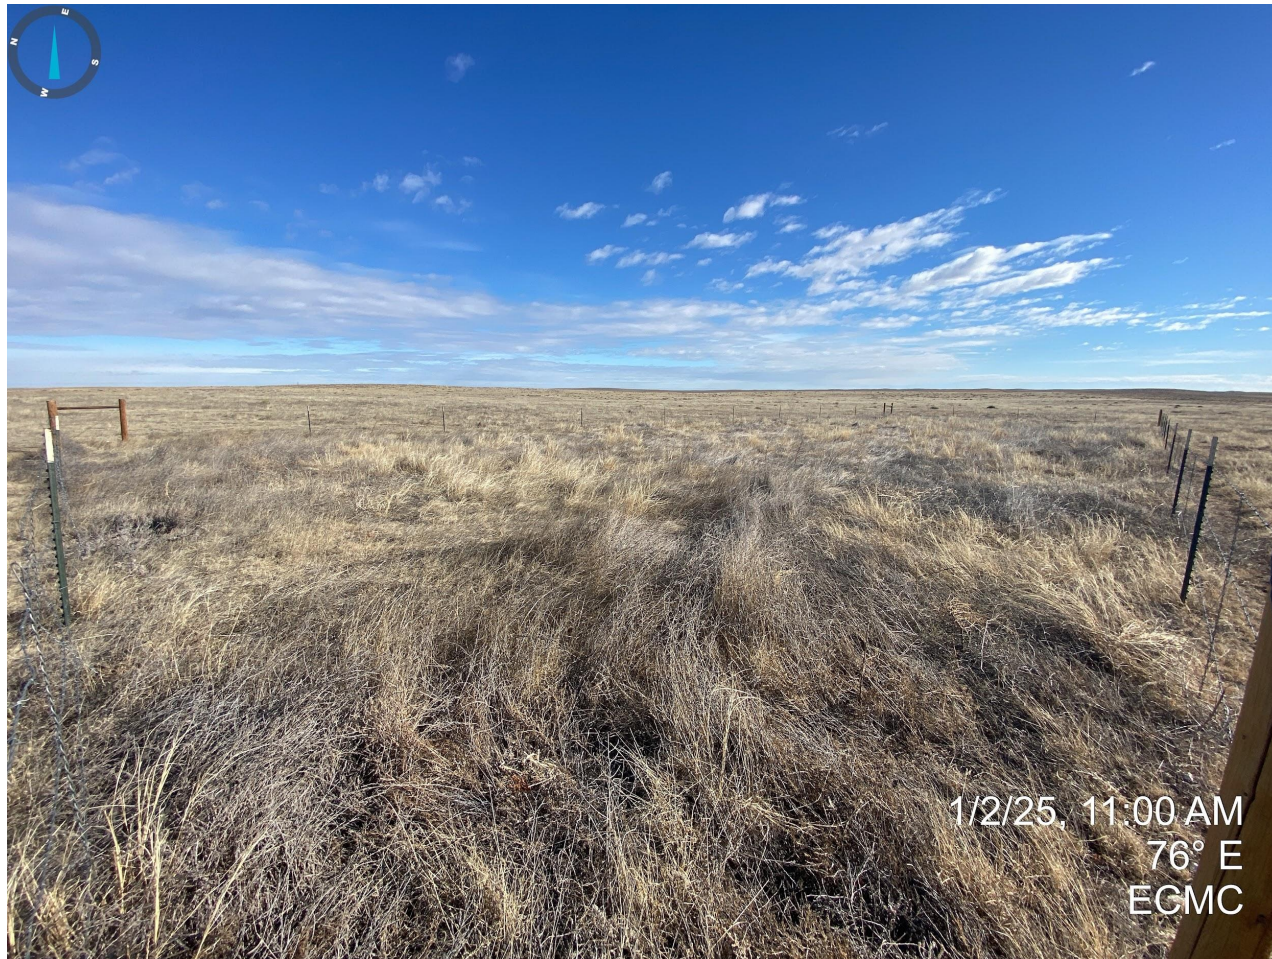
**Photo 2.** Photo taken from the southwest corner of the former location. Undesirable vegetation (russian thistle, kochia) was observed throughout the disturbance areas. Additional reclamation activities are required to establish desirable perennial vegetation that is reflective of the adjacent reference areas.

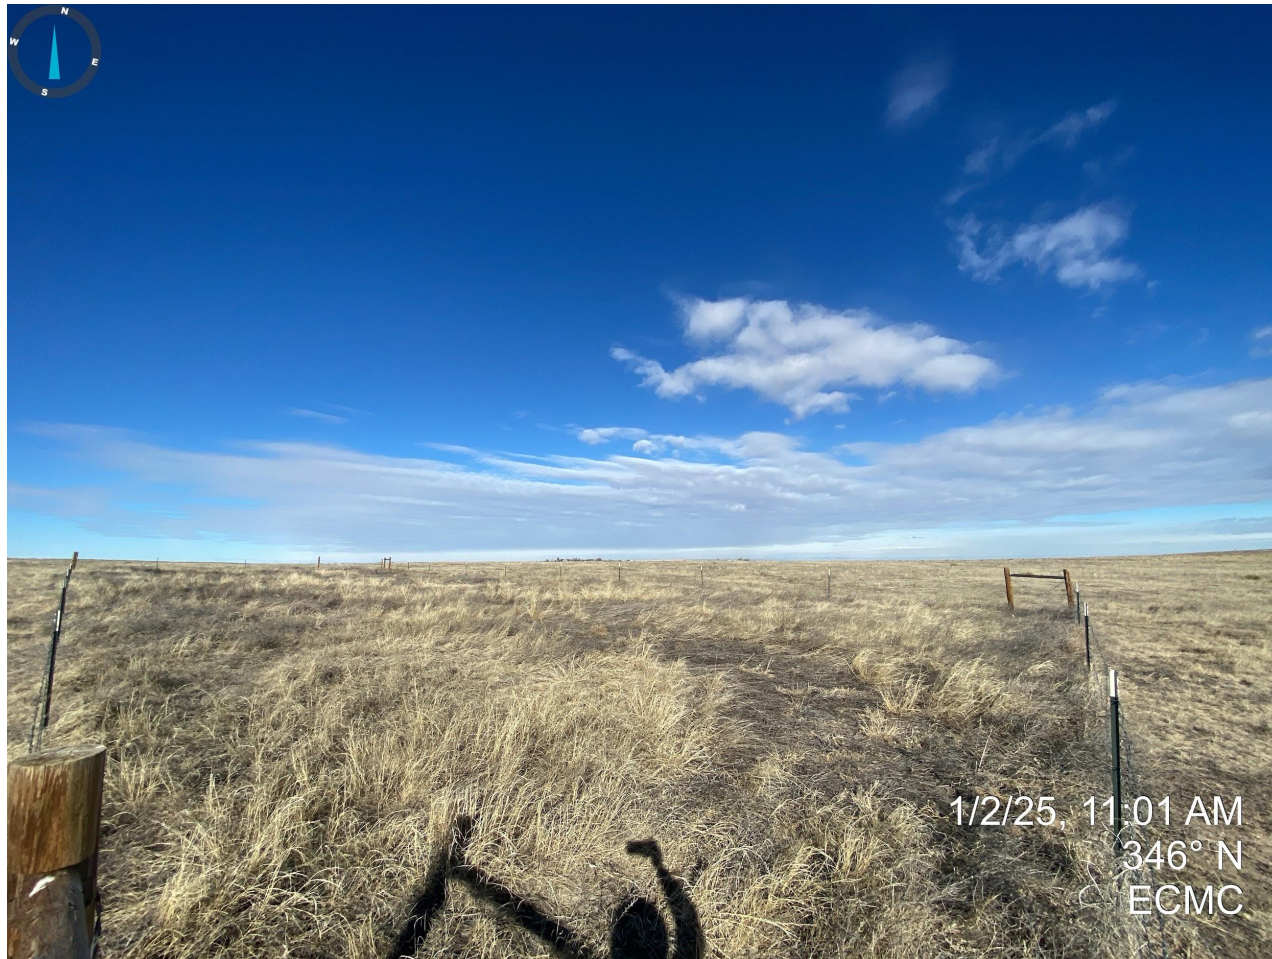
**Photo 3.** Photo taken from the southeast corner of the former location. See comments in Photo 2 for additional information.

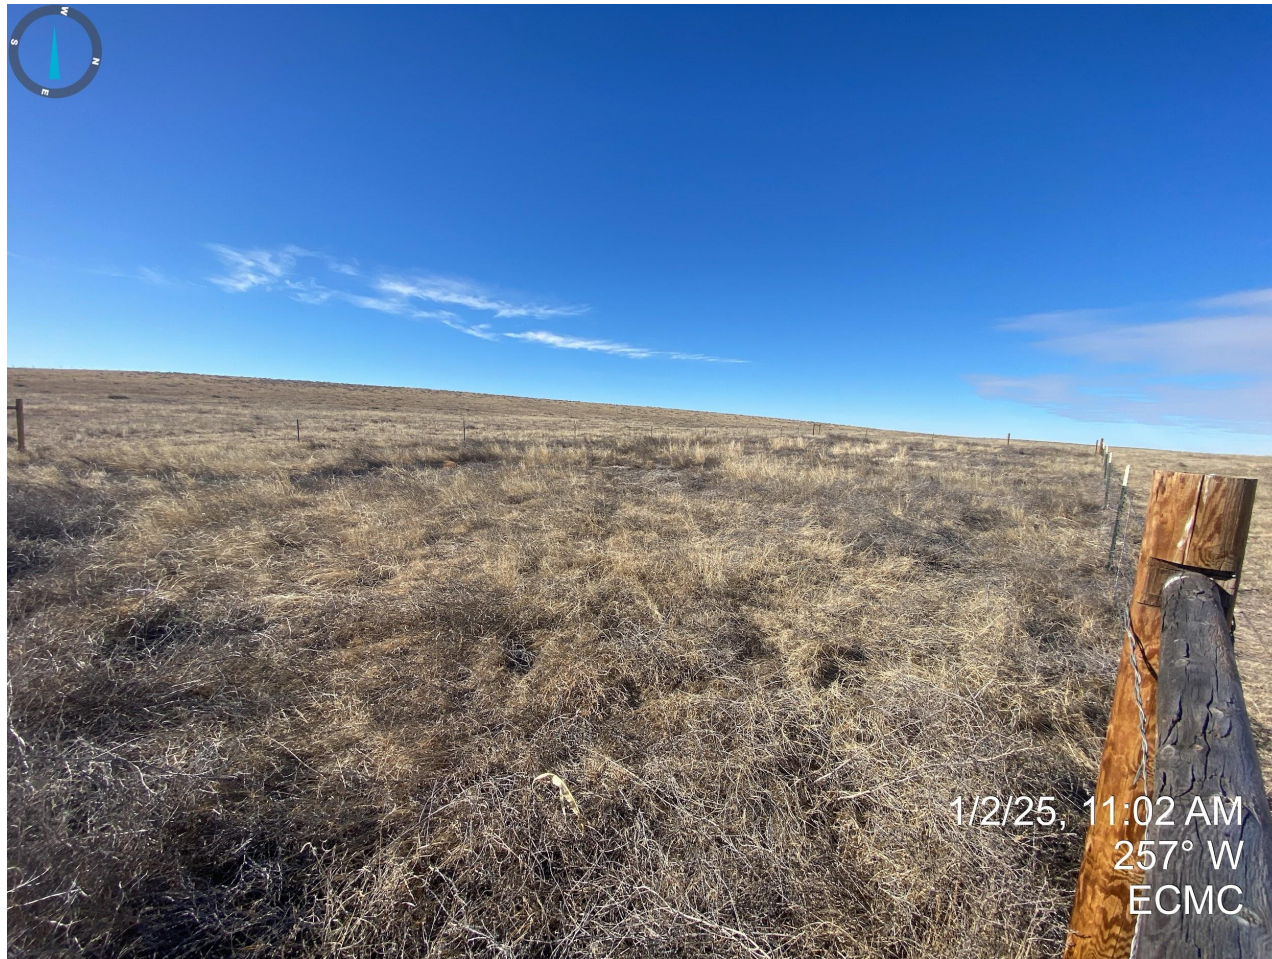
**Photo 4.** Photo taken from the northeast corner of the former location. See comments in Photo 2 for additional information.

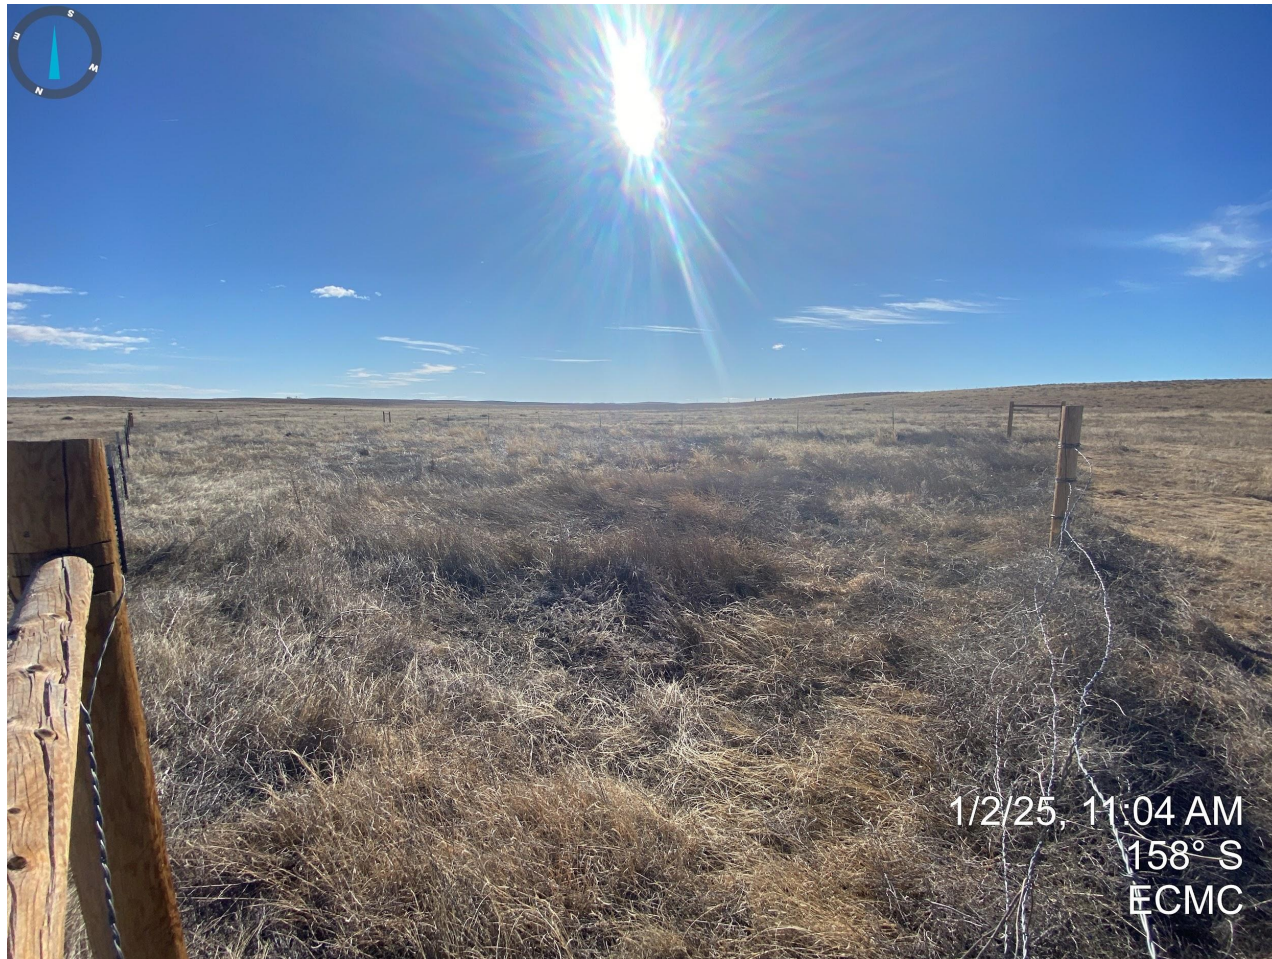
**Photo 5.** Photo taken from the northwest corner of the former location. See comments in Photo 2 for additional information.

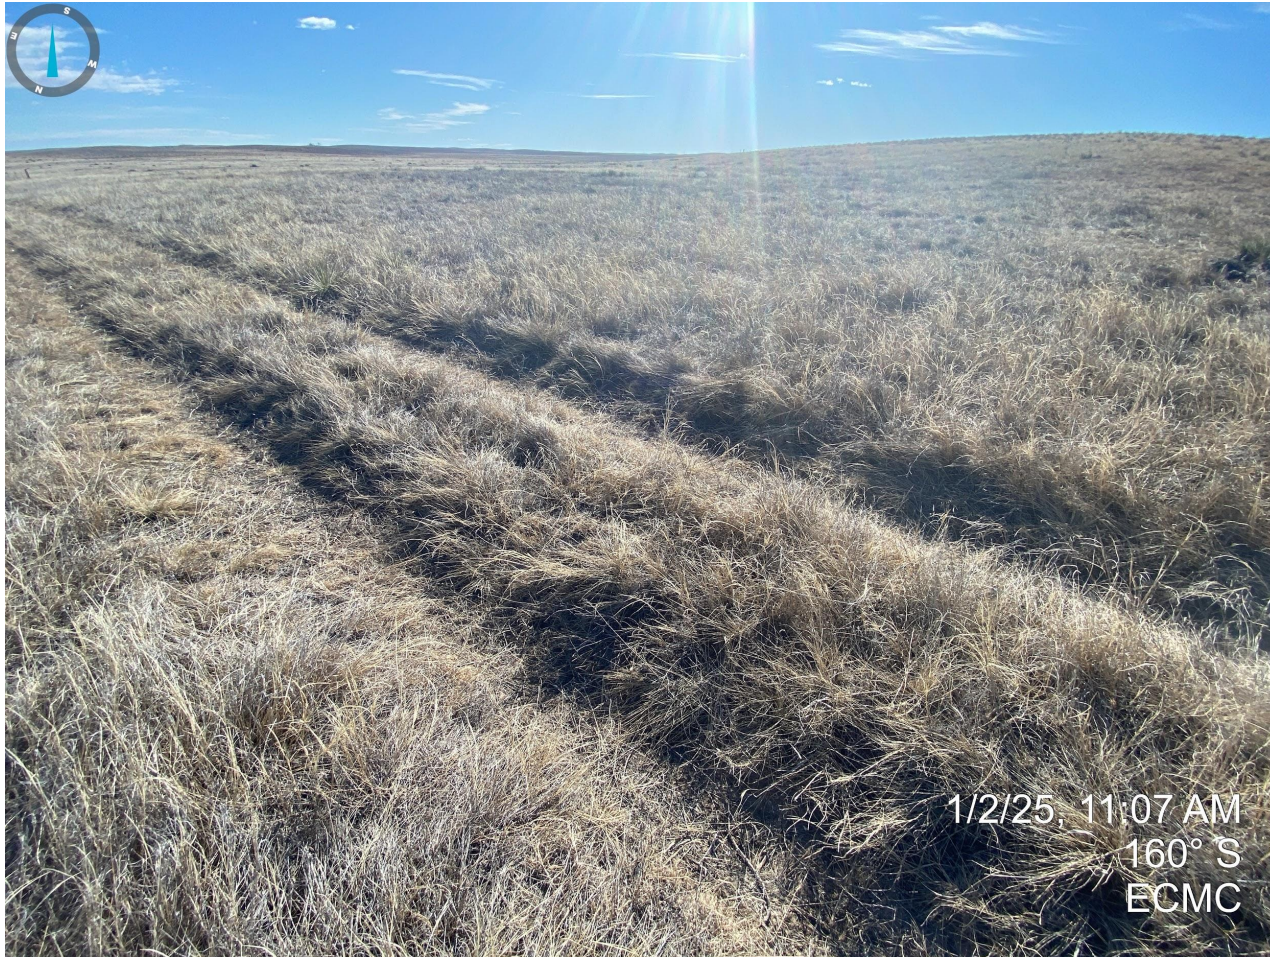
**Photo 6.** Access road Photo taken west of the location. Photo illustrates that portions of the access road do not appear to have been recontoured/graded to match the adjacent topography with ruts evident.

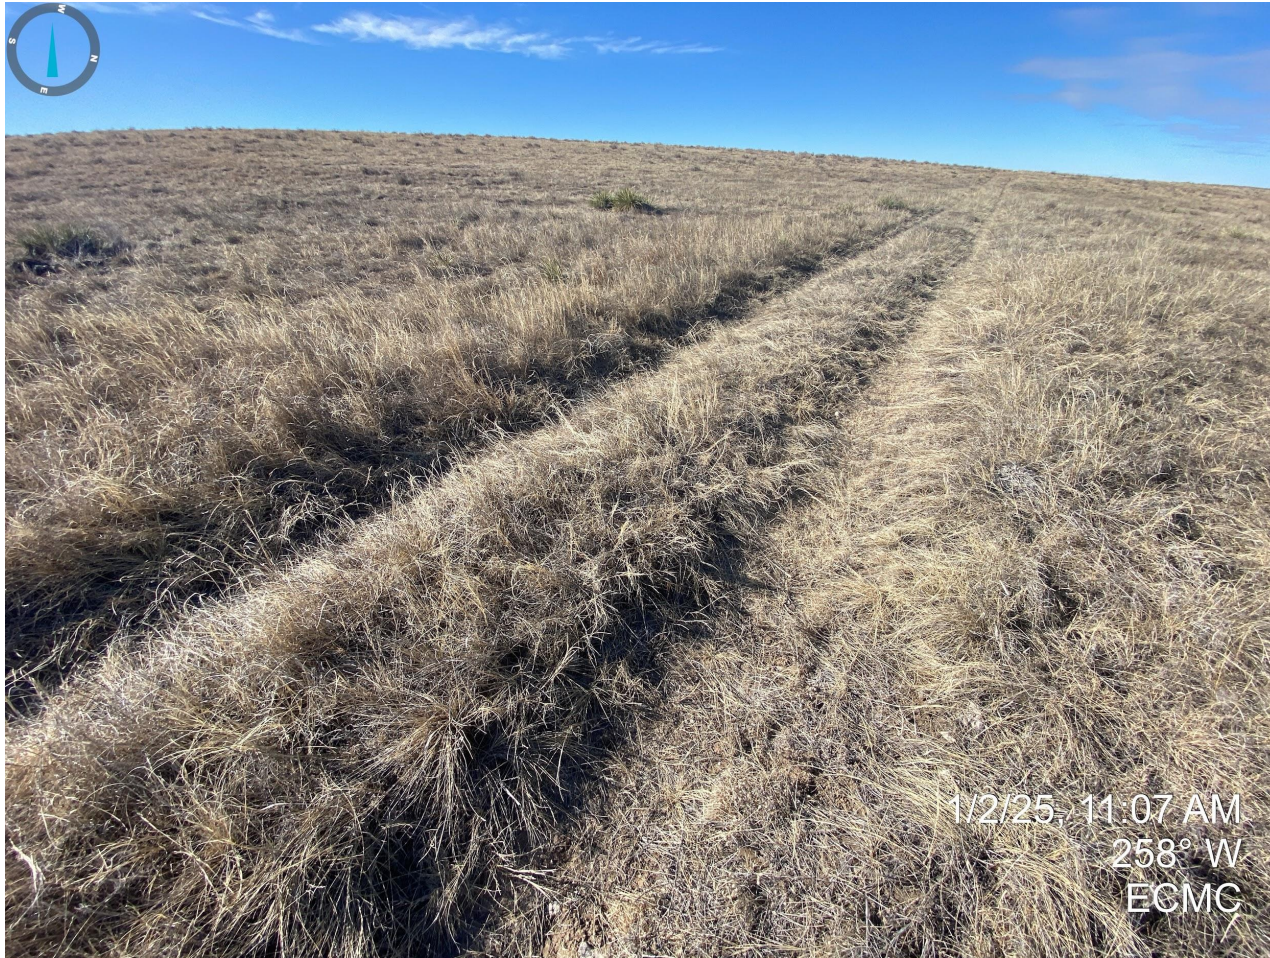
**Photo 7.** Continued from Photo 6; see comments in previous photo.

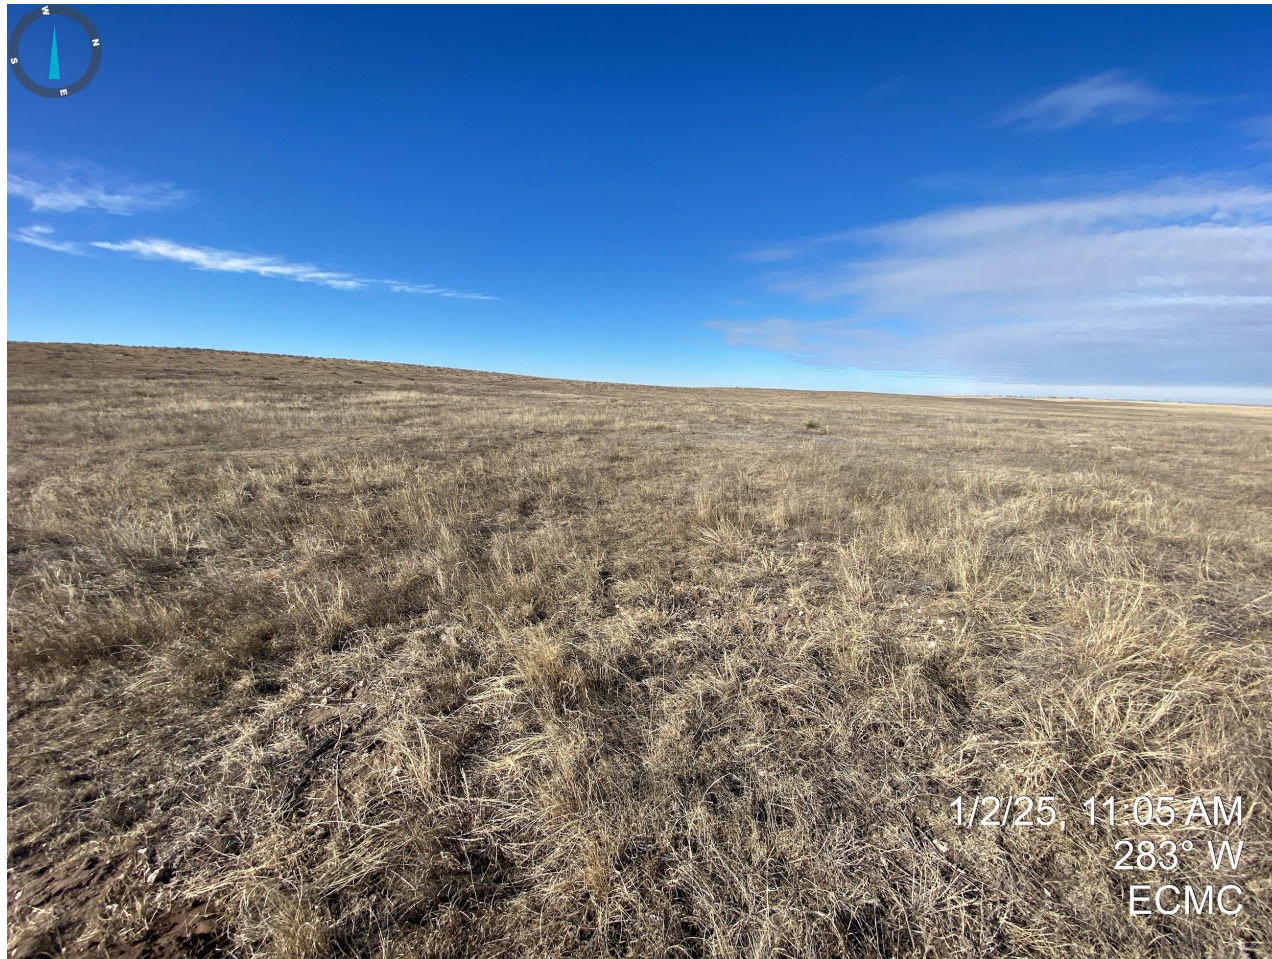
**Photo 8.** Reference area photo taken northwest of the former location.
