## Inspection Photos

Location Name: TEP ROCKY MOUNTAIN LLC WARE SR 23-12 Pad

Location ID: 449385

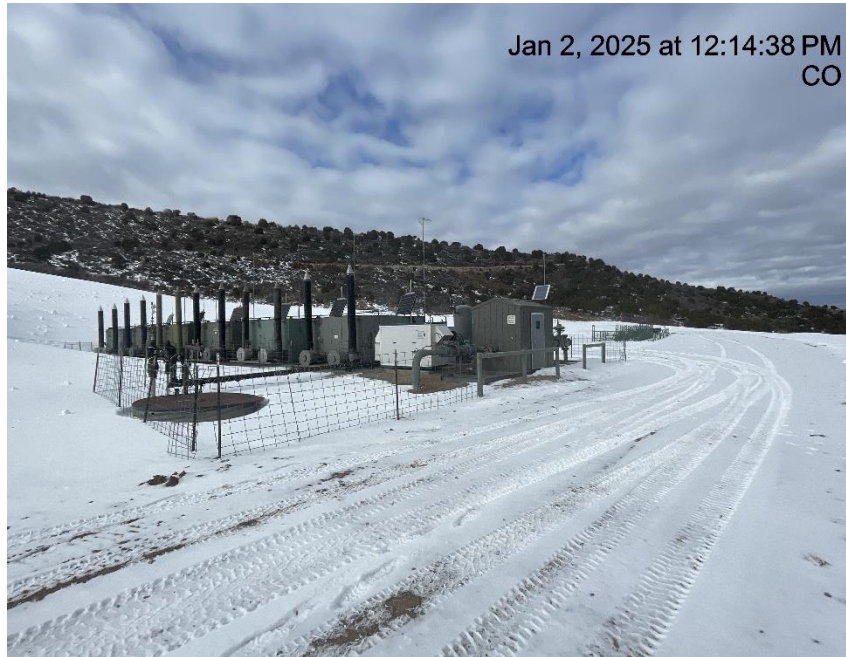
Photo # 6488 From entrance to location

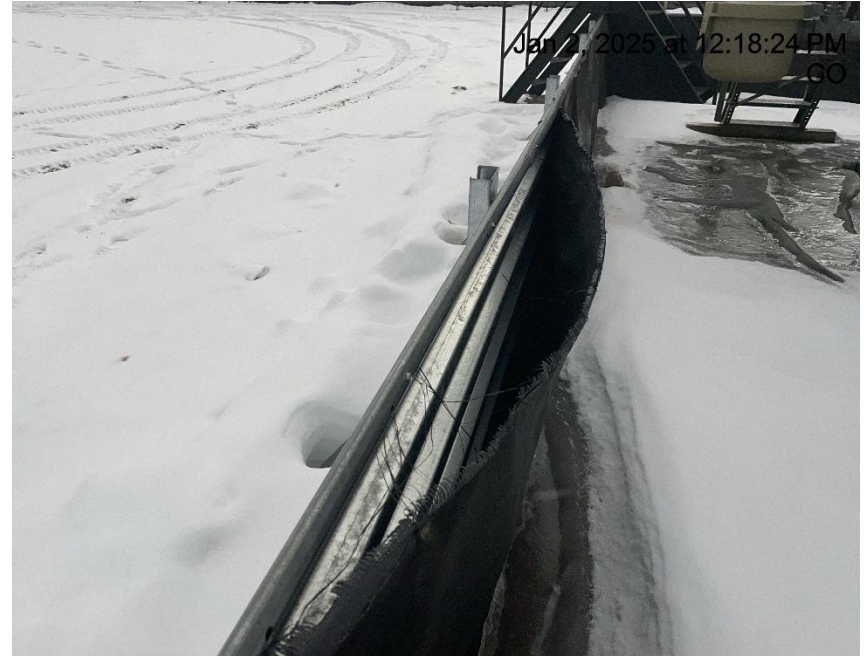
**Photo # 6499 Secondary containment liner showing signs of damage/disrepair near top of metal containment ring**

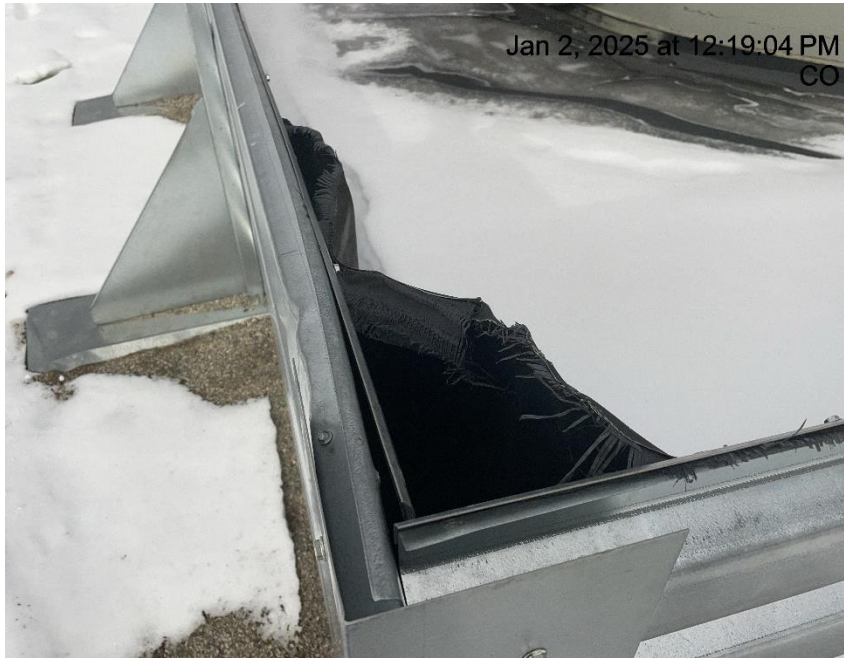
**Photo # 6500 Secondary containment liner showing signs of damage/disrepair near top of metal containment ring**
