Inspection Photos

Loc: 322234

Operator: **INCREMENTAL OIL & GAS (FLORENCE) LLC**

Inspection Date: 1/6/2025

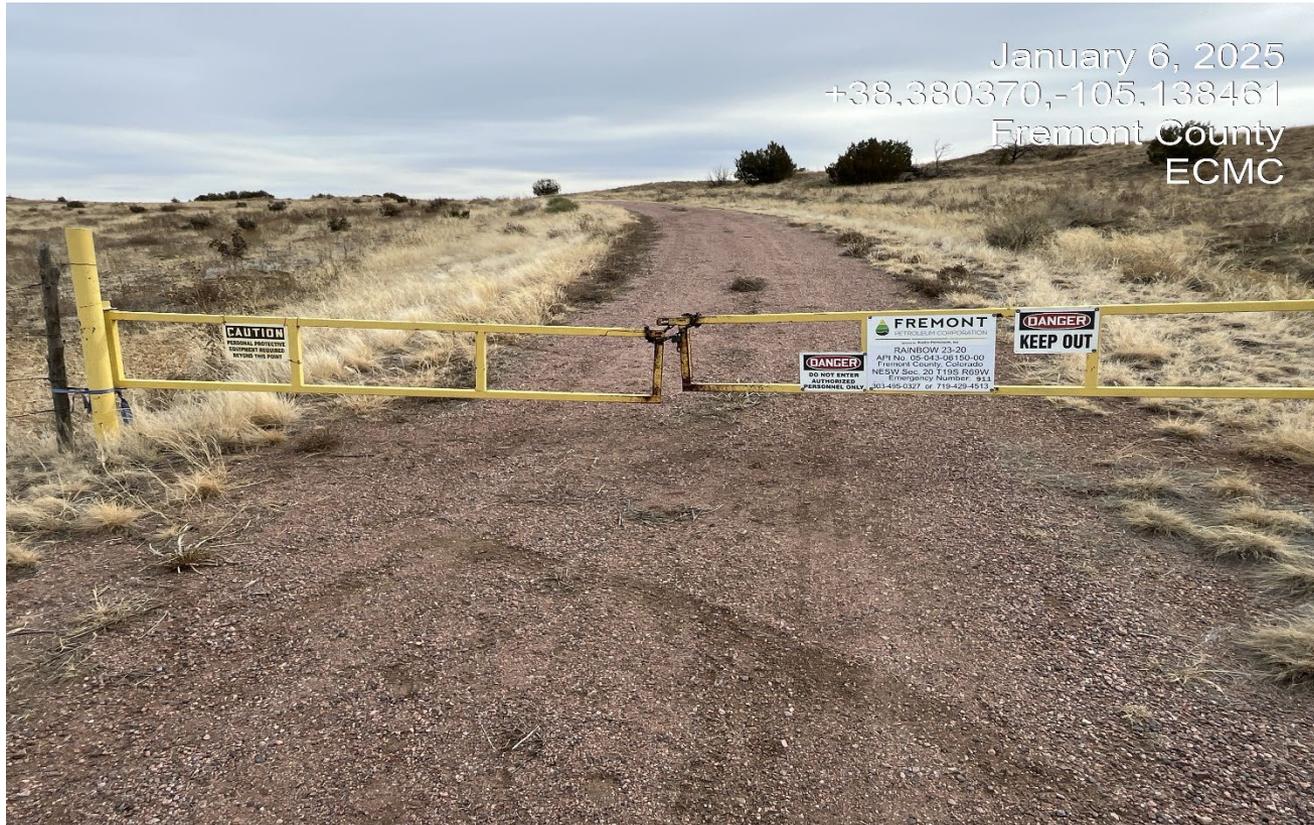
Photo 1. Facing southeast at the beginning of the access road. The access road has not been reclaimed.

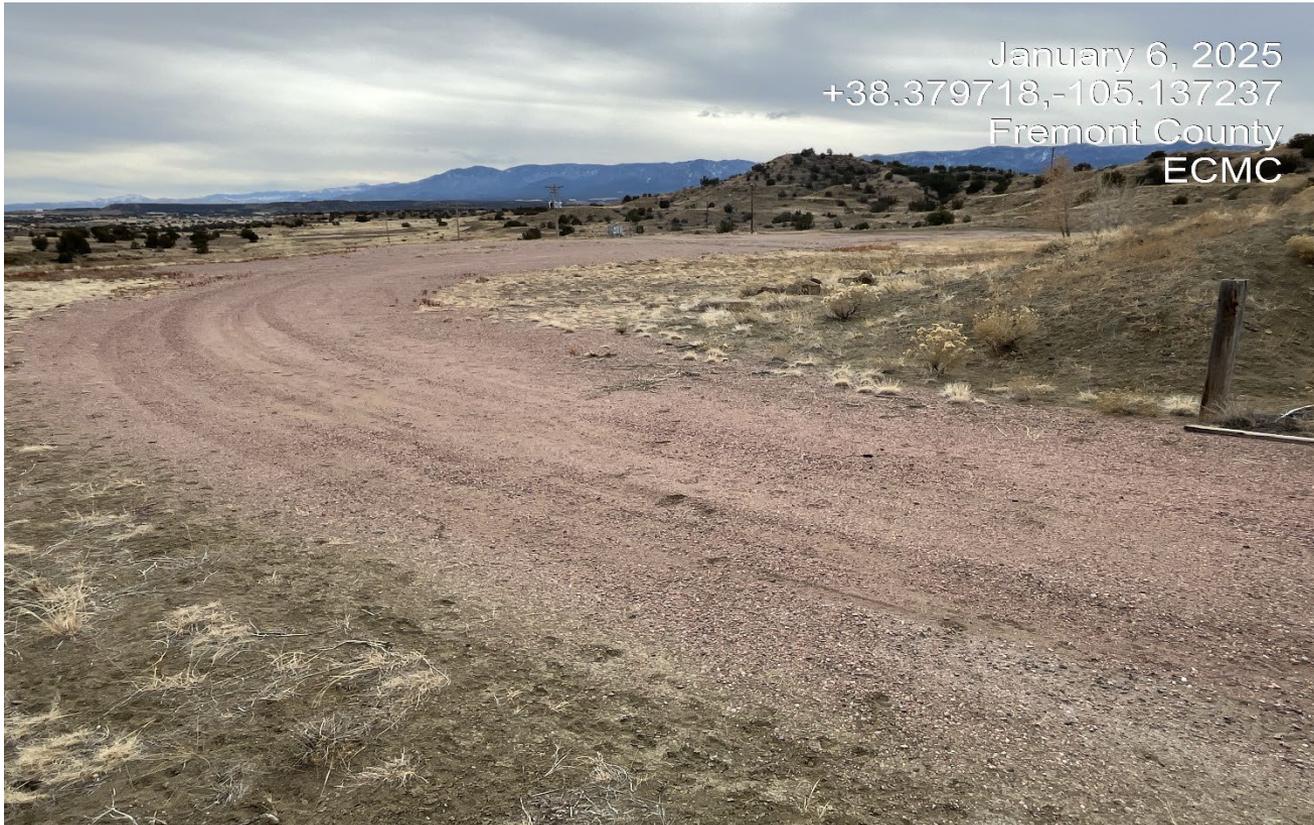
Photo 2. Facing south toward the location. The well has been plugged and abandoned however final reclamation has not been completed.

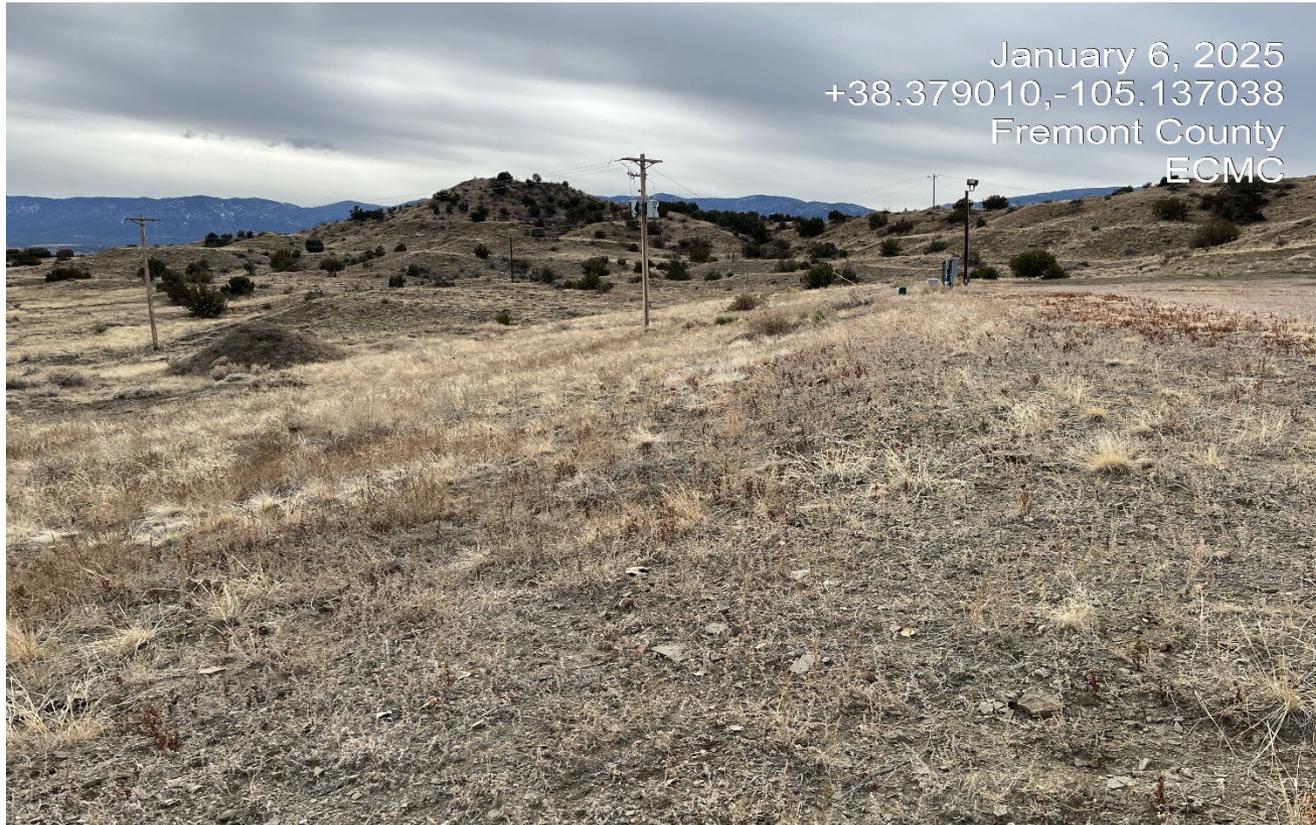
Photo 3. Facing southwest along the fill slope. The location will need to be recontoured back to the original slopes

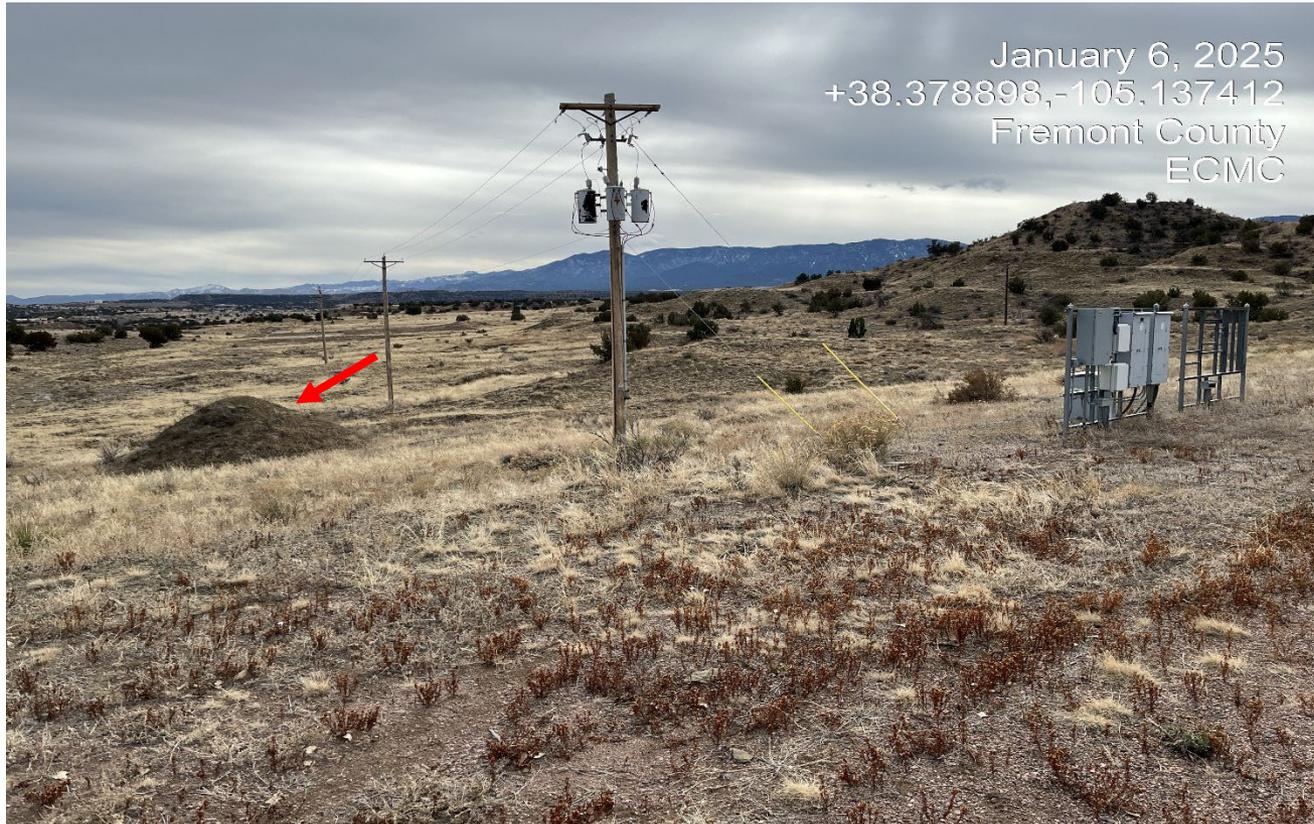
Photo 4. The electric utilities remain at the location and should have been removed with 3 months of abandonment. The entire powerline and poles servicing this location must be removed. There is a topsoil pile shown at red arrow.

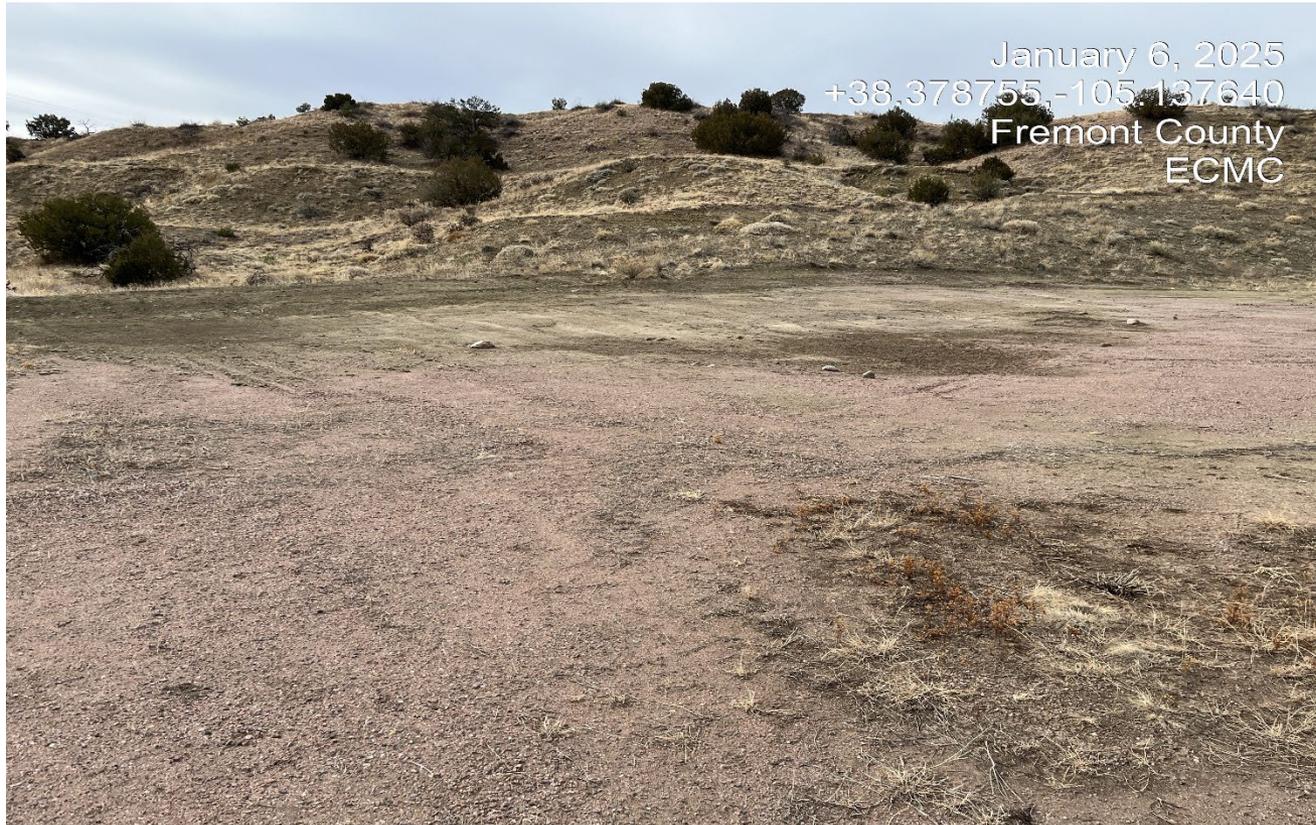
Photo 5. Facing toward the south side of the location where tank battery was located.

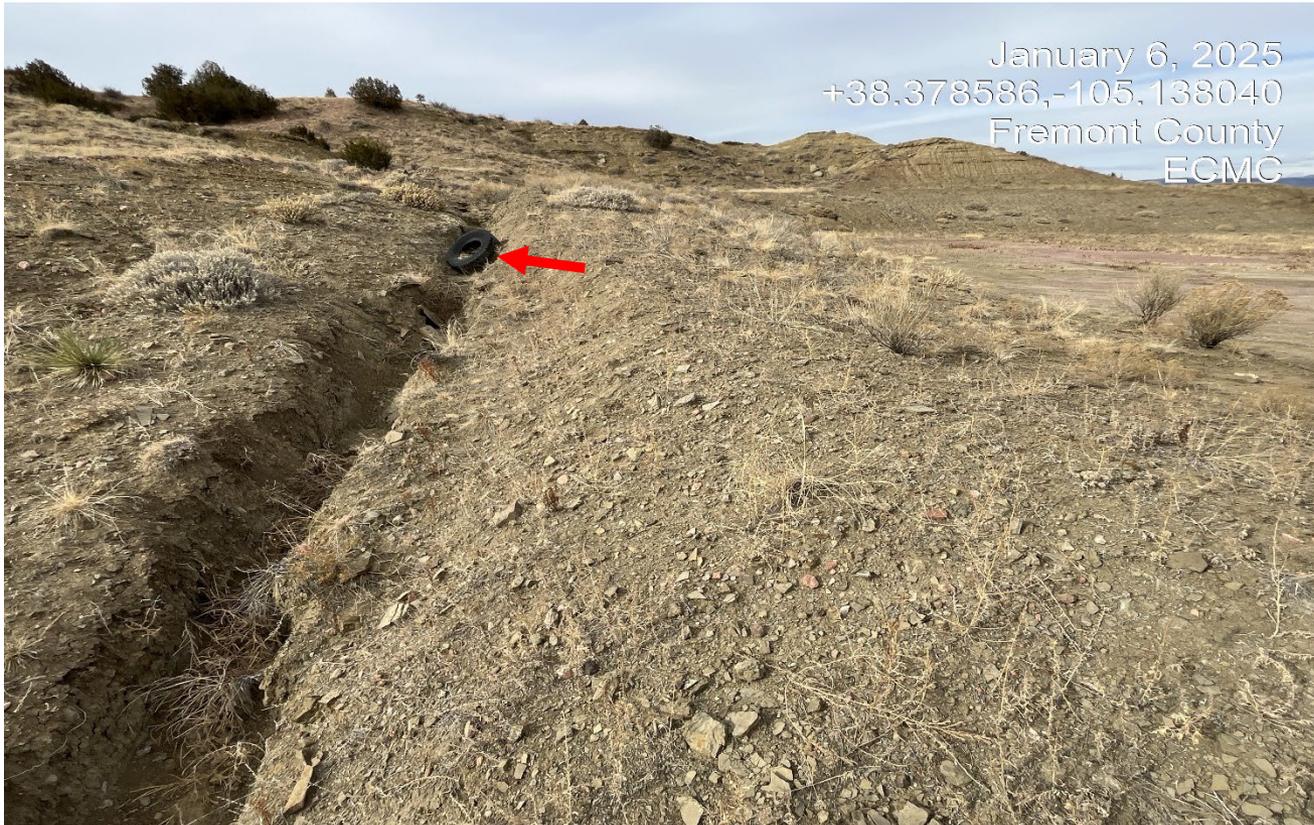
Photo 6. Facing southwest at the south side of the location. There is an erosion channel shown at red arrow which will need to be repaired and stabilized.

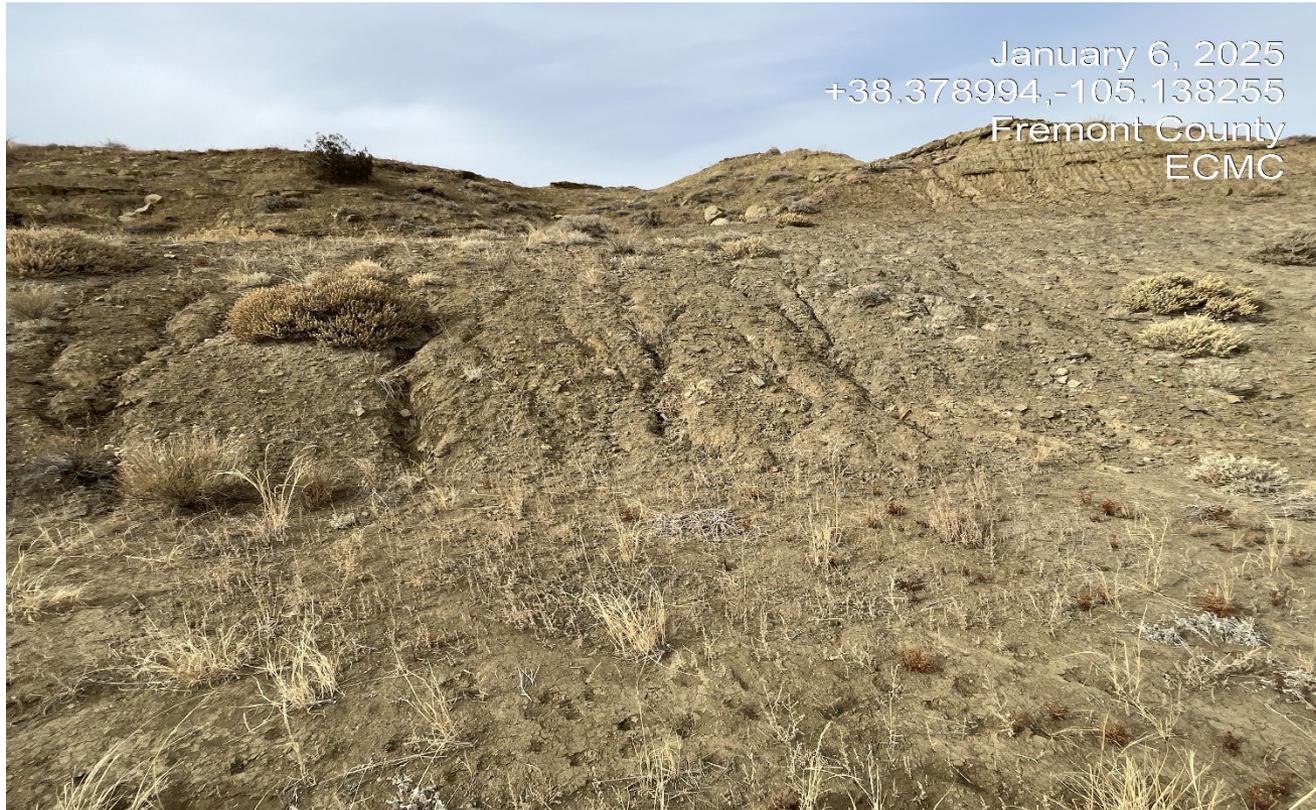
Photo 7. Facing toward the cut slope. There are riling erosion along the cut slope which is not stabilized. Previous CA was not completed.

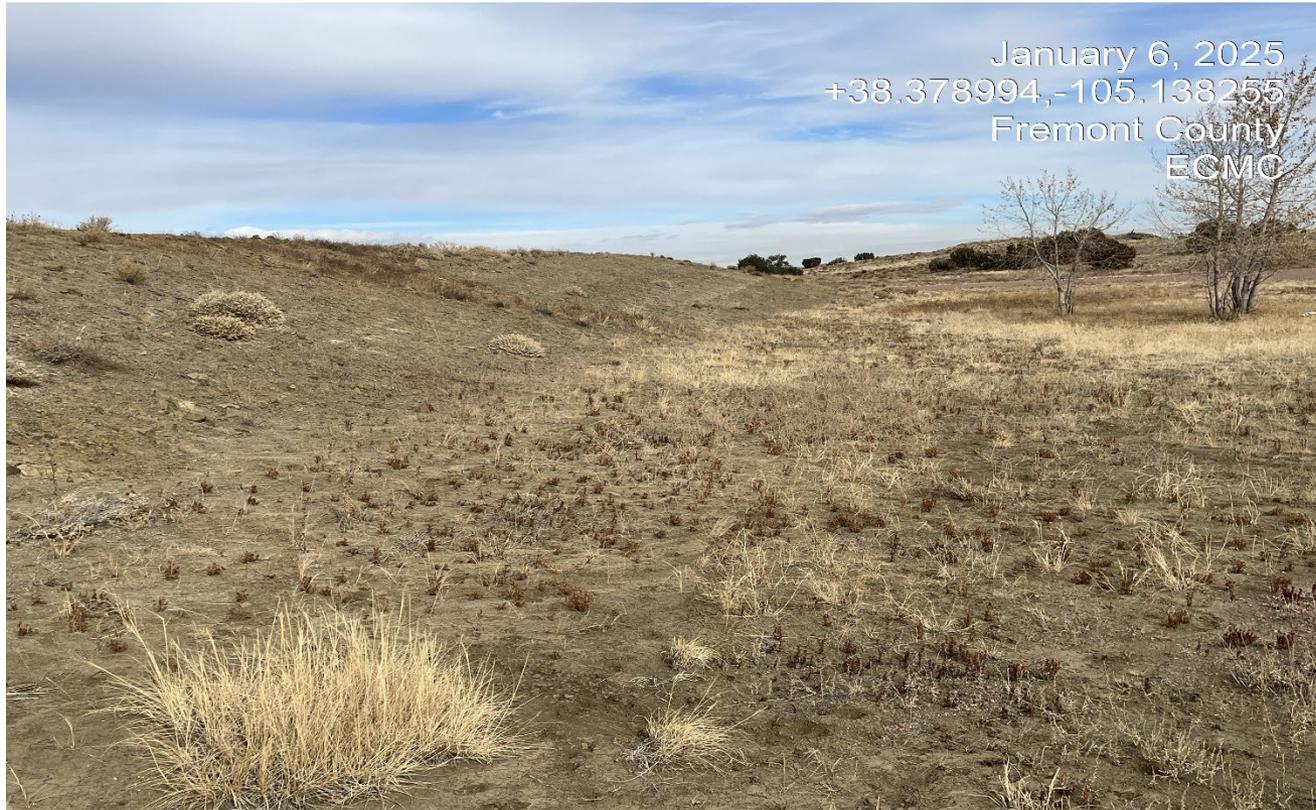
Photo 8. Facing northwest along the cut slope. There cut slope is not stabilized.

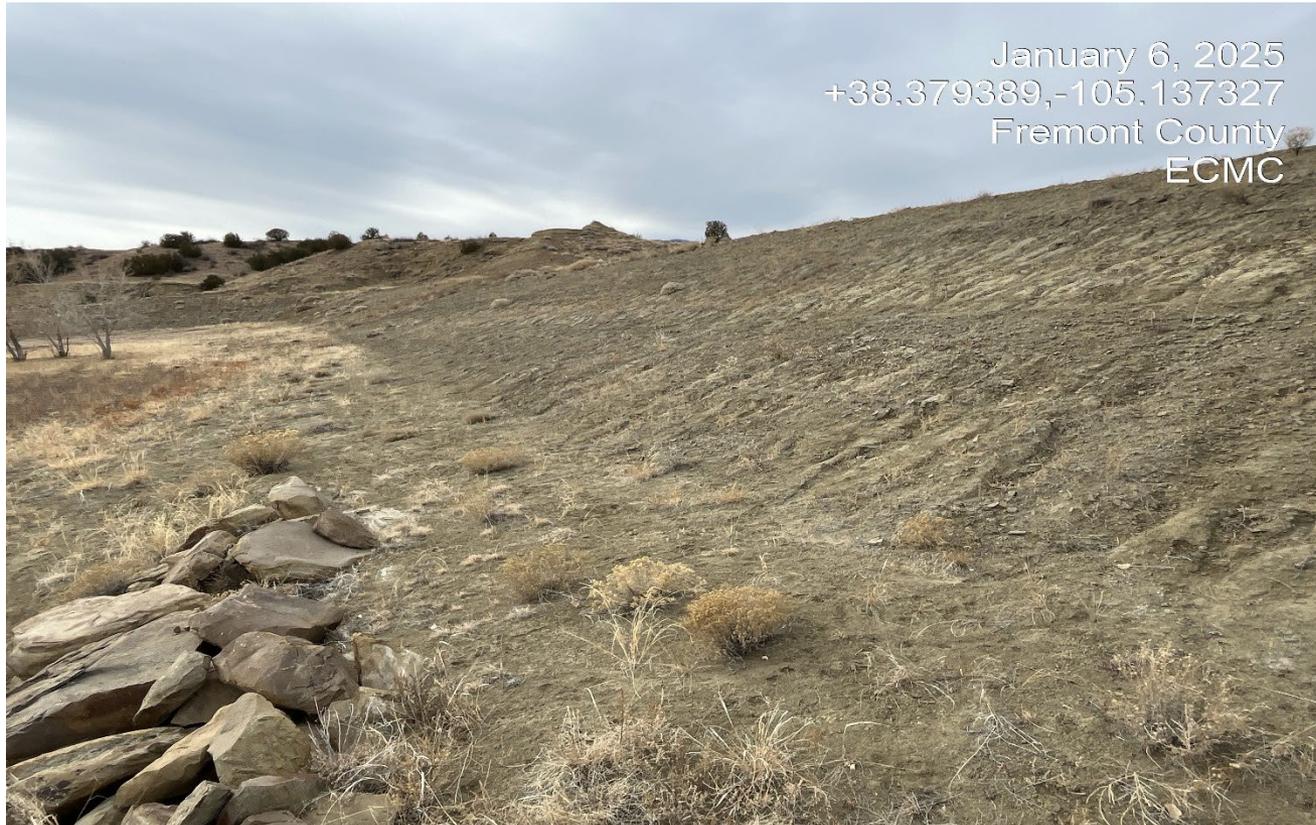
Photo 9. Facing south at the location standing from base of the cut slope.
