Inspection Photos

API: 043-06231

Operator: AUSCO PETROLEUM INC

Inspection Date: 1/6/2025

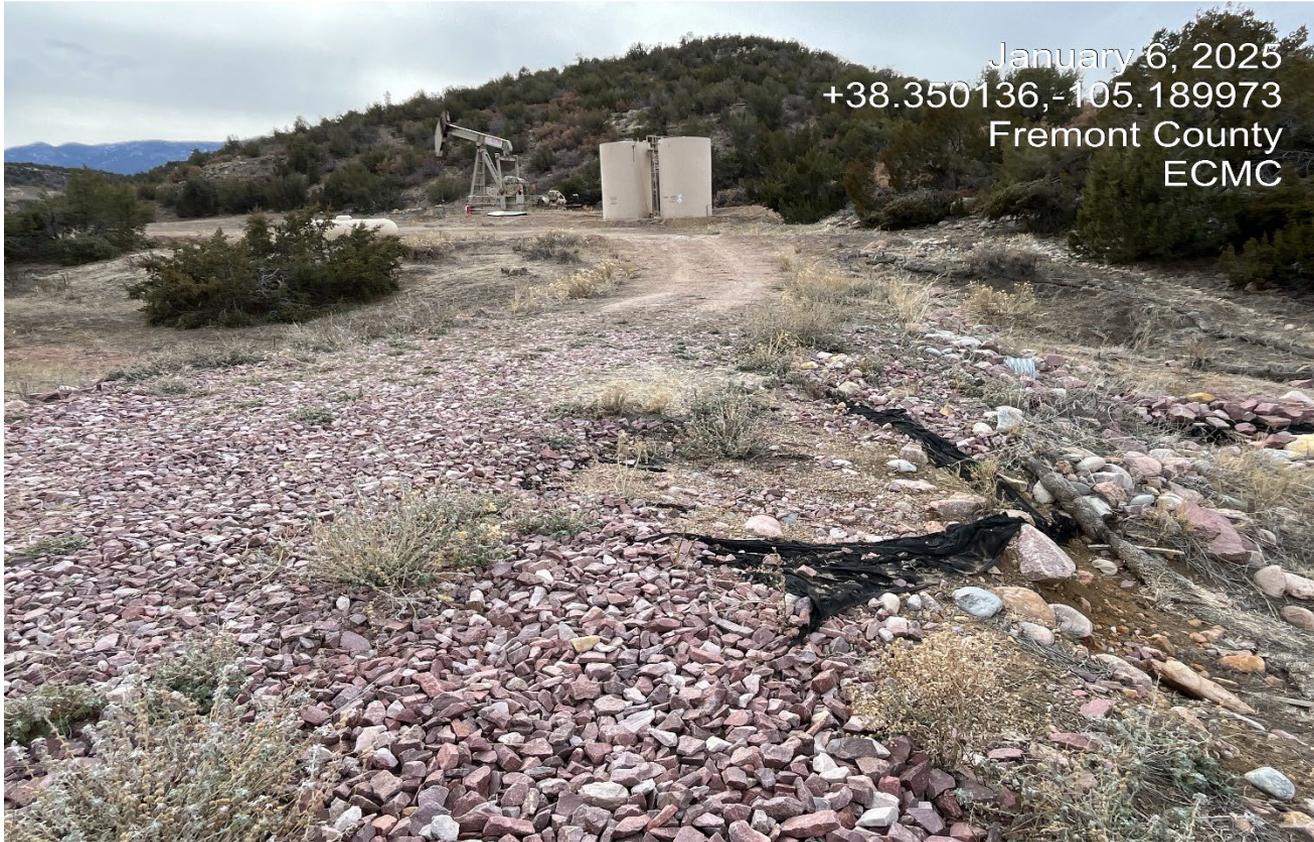
Photo 1. Facing toward the drainage crossing which has been washed out and has not been repaired. Previous corrective action was not completed.

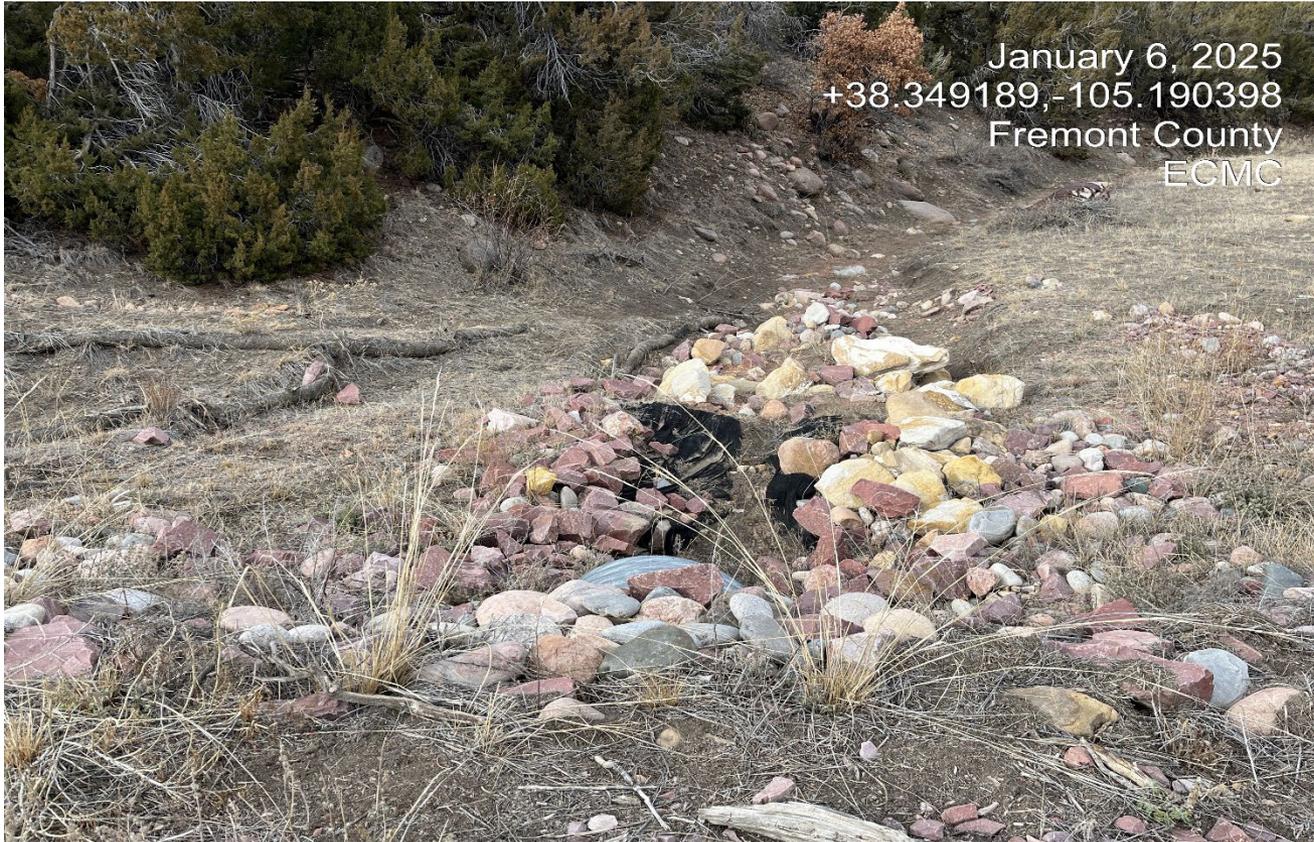
Photo 2. View of culvert outlet shows displaced rock. Outlet protection will need to be reinstalled. Previous corrective action was not completed.

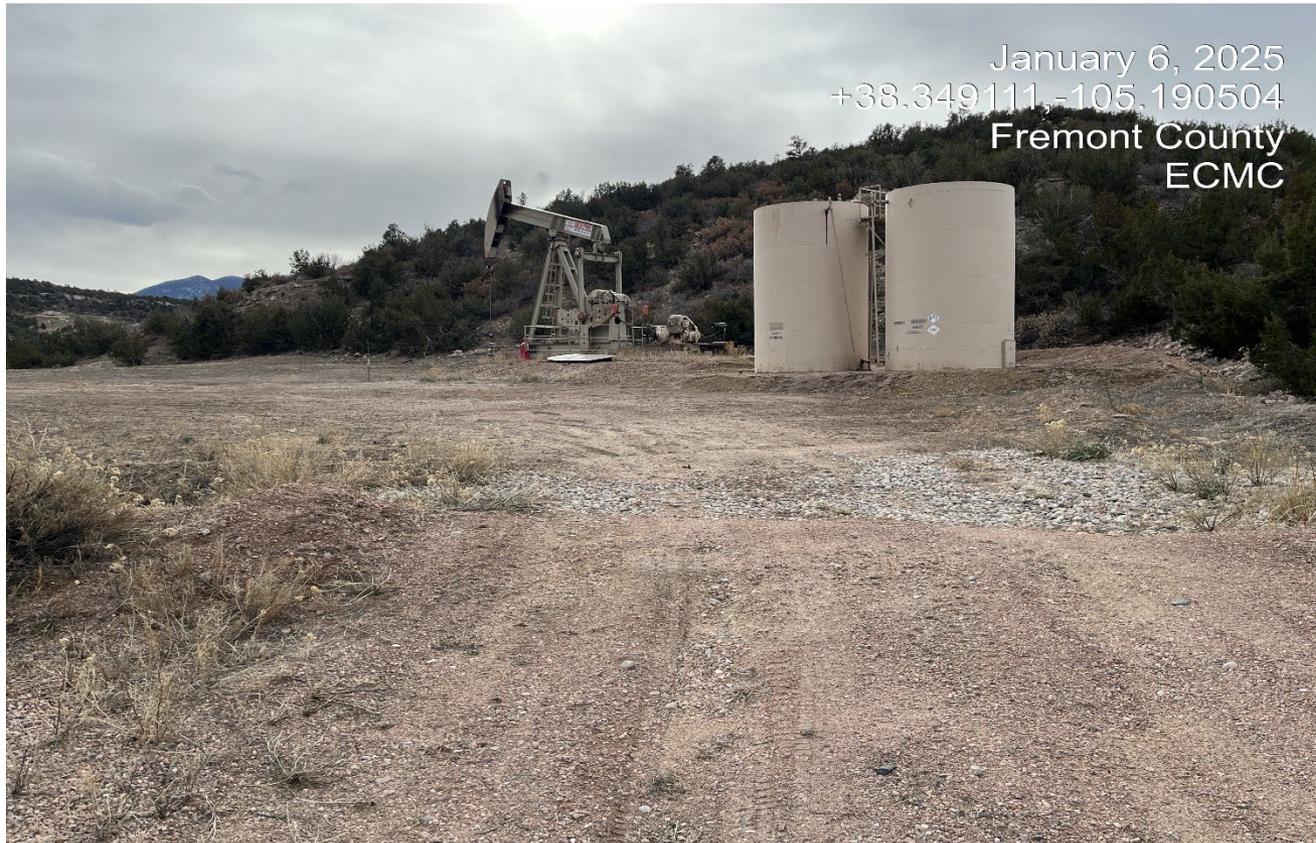
Photo 3. Facing southwest toward the wellsite. There are undesirable weeds around the equipment that need to be controlled. There are two new tanks brought to the location.

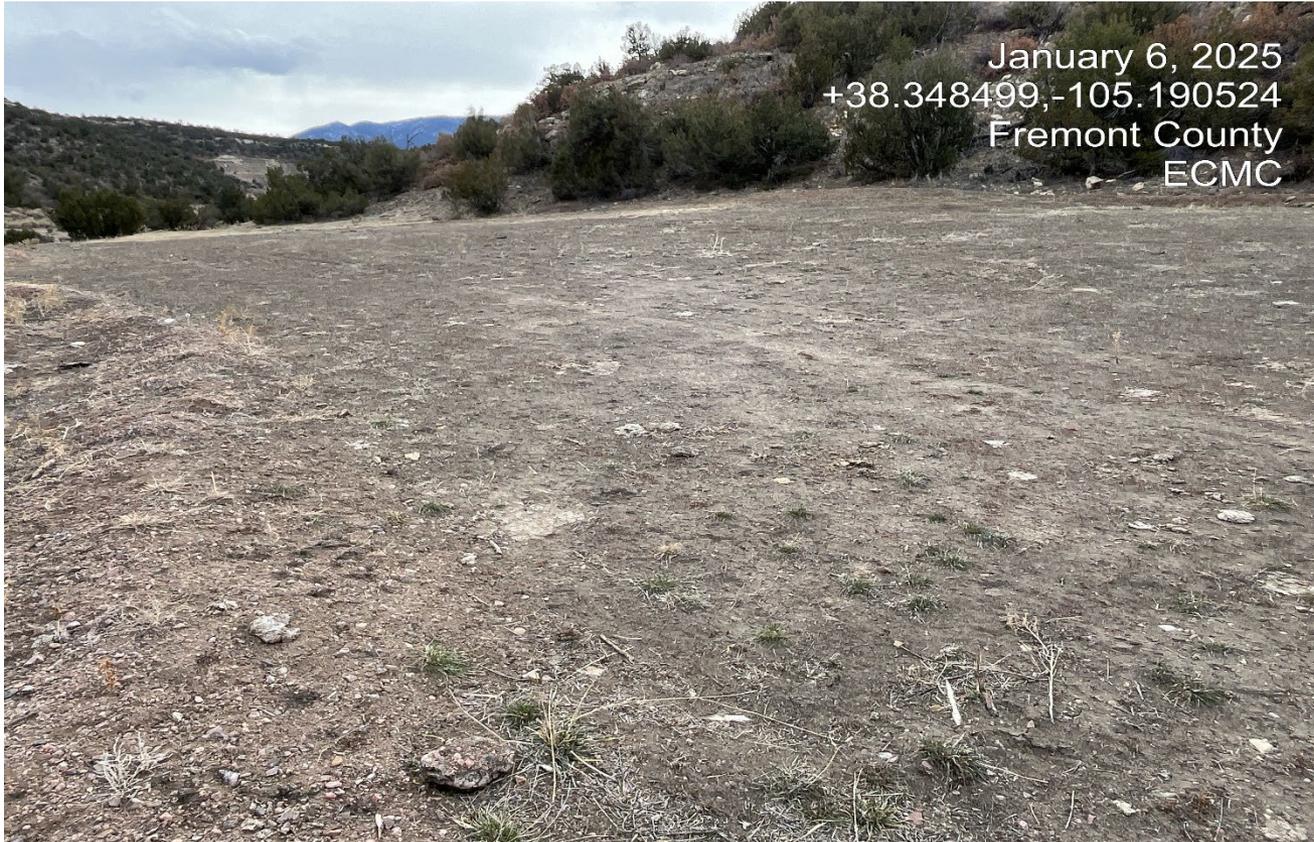
Photo 4. Facing southwest toward the interim reclamation area. The perennial vegetation has not established and this area has not been reseeded. Previous corrective action was not completed.

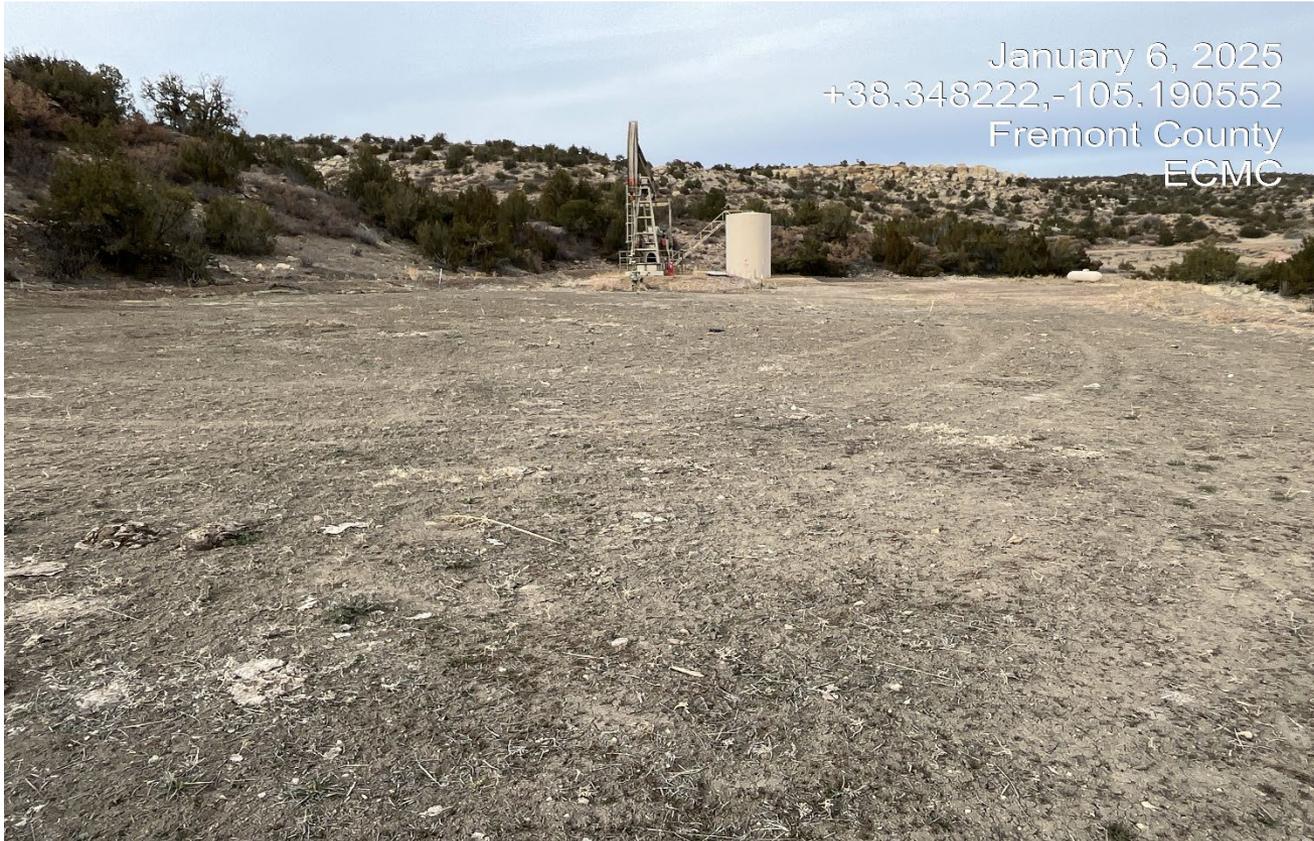
Photo 5. Facing northwest toward the interim reclamation area. The perennial vegetation has not established. This area will need weed control and reseeding. Previous corrective action was not completed.

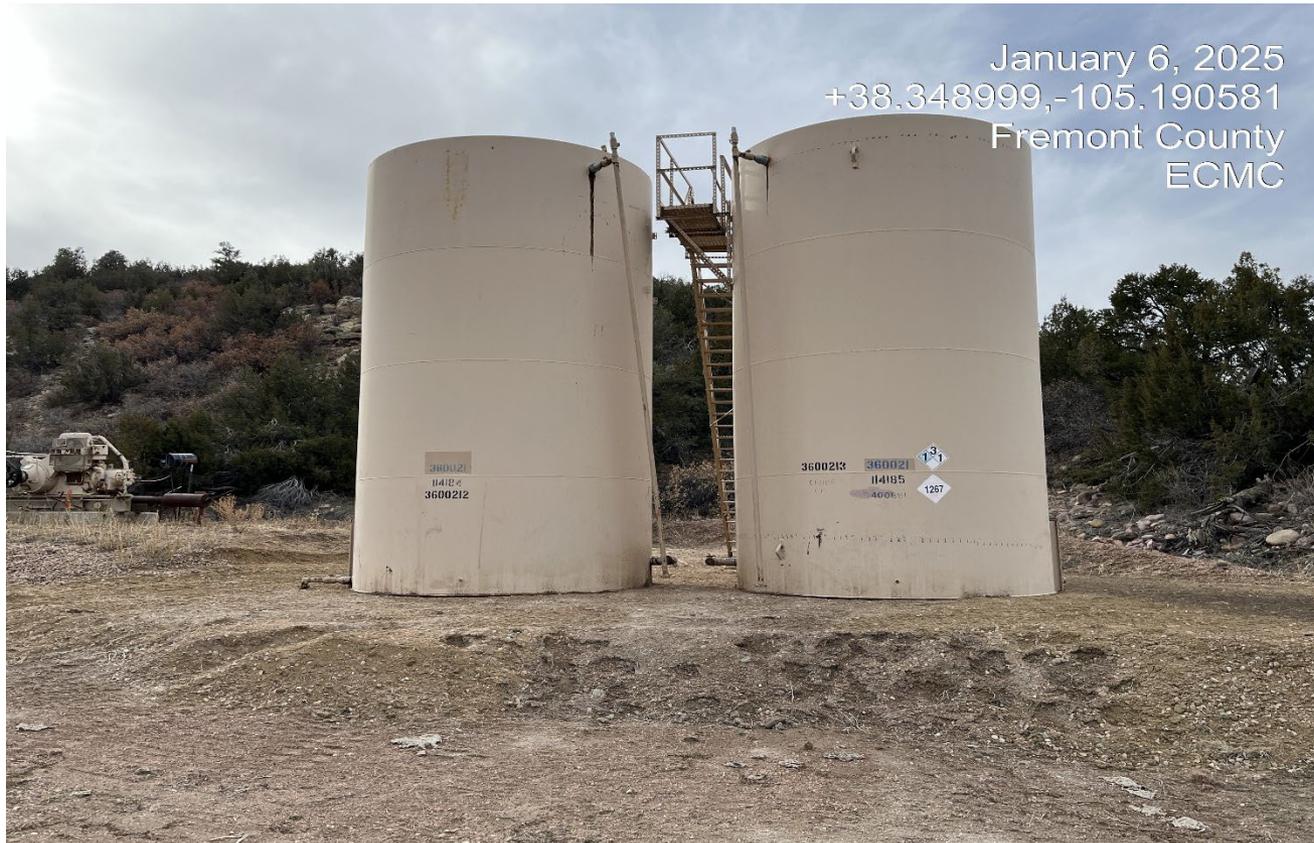
Photo 6. There has been two steel tanks brought into the location. Secondary containment must be installed per rule 603.o. which requires impervious liner and containment.
