Inspection Photos

API# 043-40014

Operator: **JAVERNICK OIL**

Inspection Date: 1/6/2025

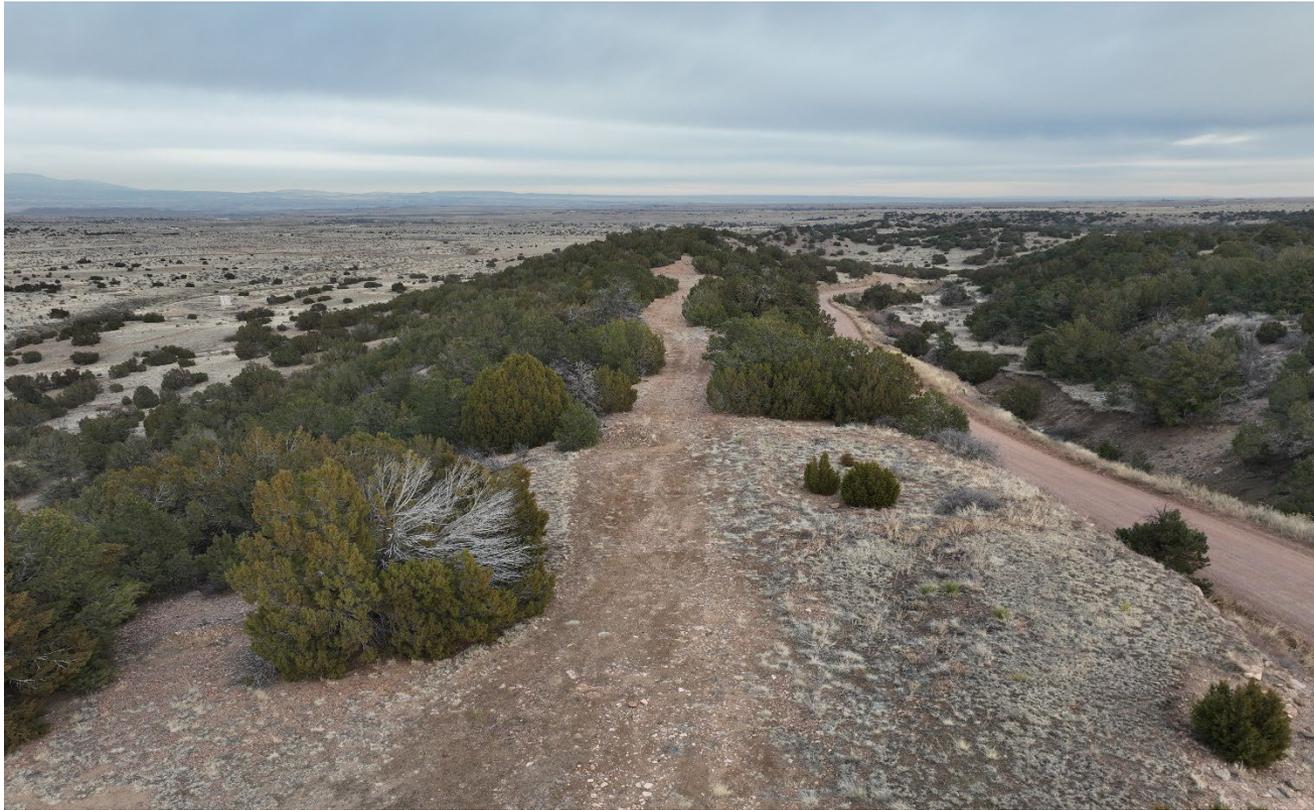
Photo 1. Drone aerial photo facing northeast. The former oil and gas access road has not been reclaimed and revegetated.

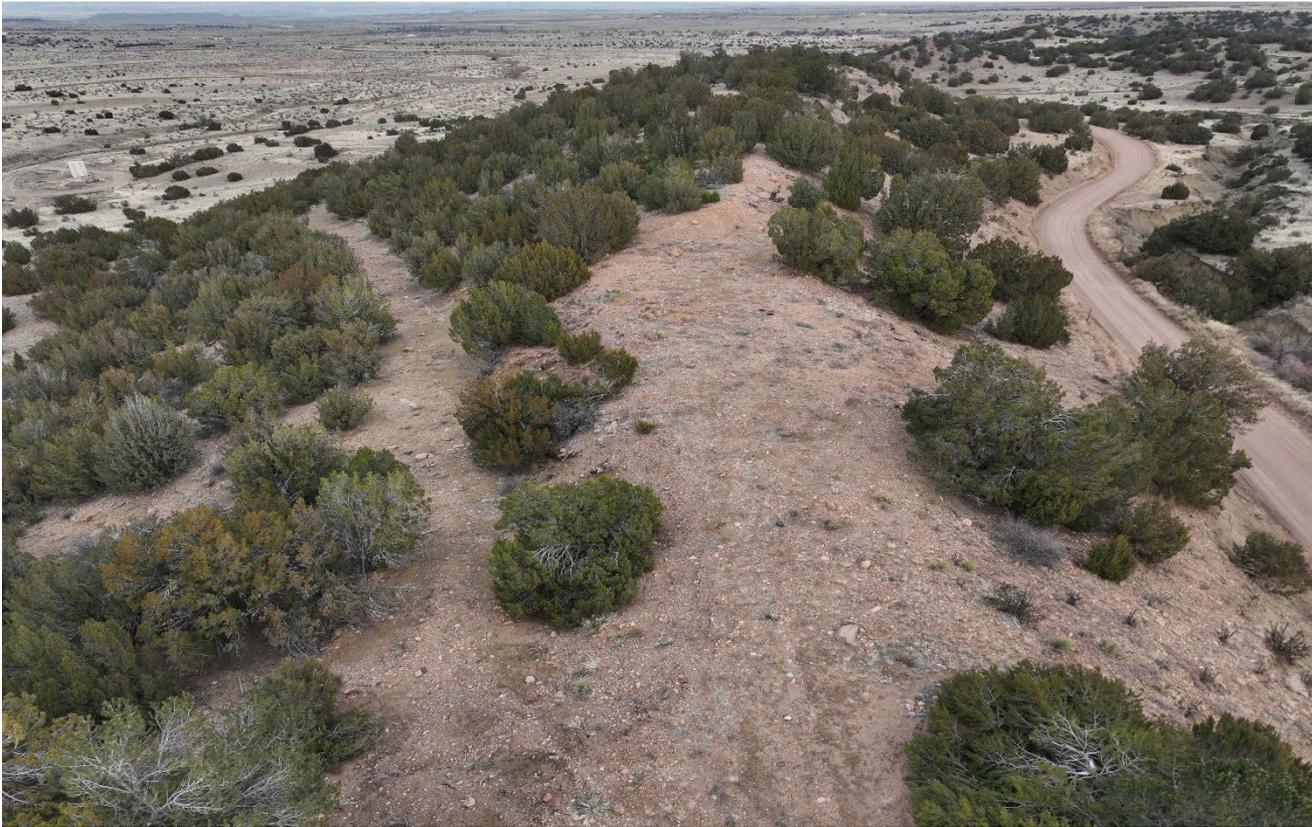
Photo 2. Drone aerial photo facing northeast toward the former wellsite. There was an access road that went to the left down toward the Drapper 4 wellsite.

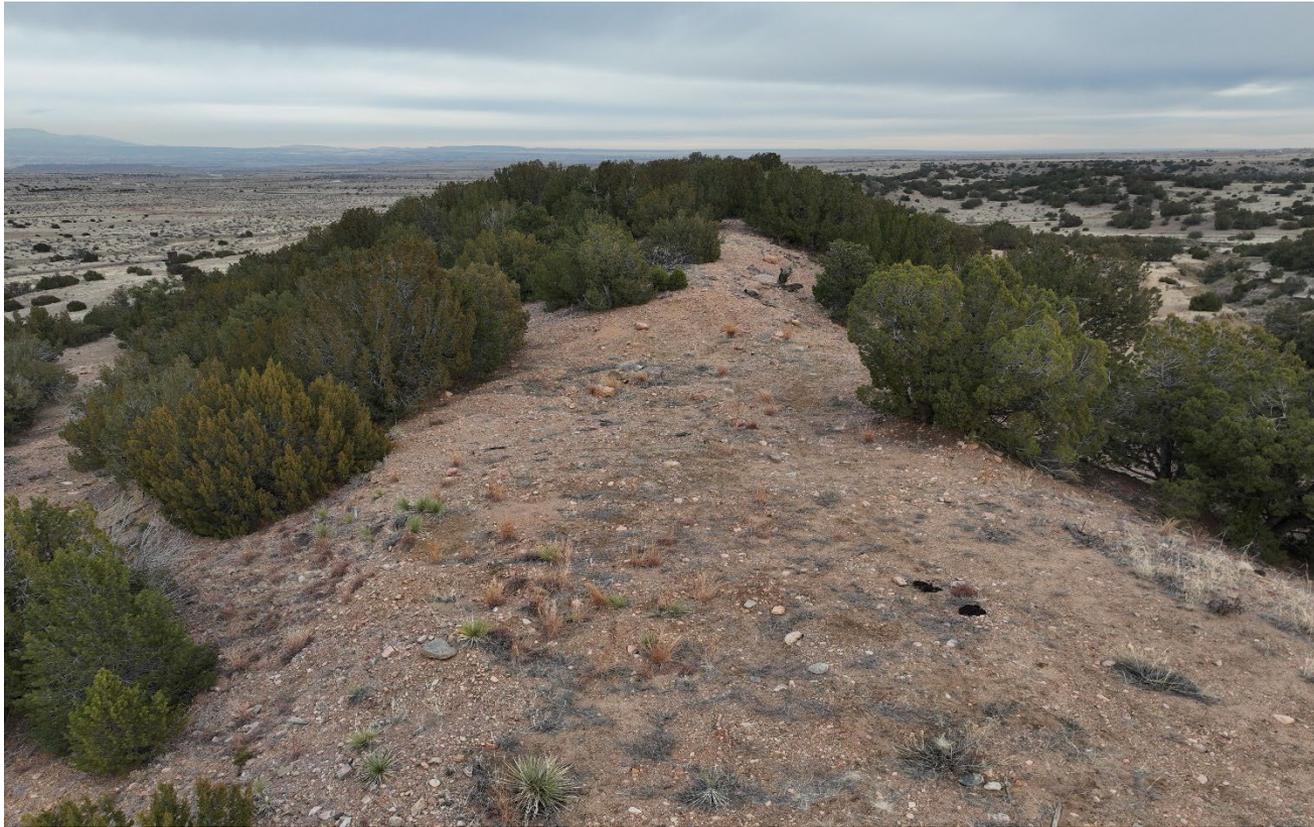
Photo 3. Drone aerial photo facing northeast toward the location.

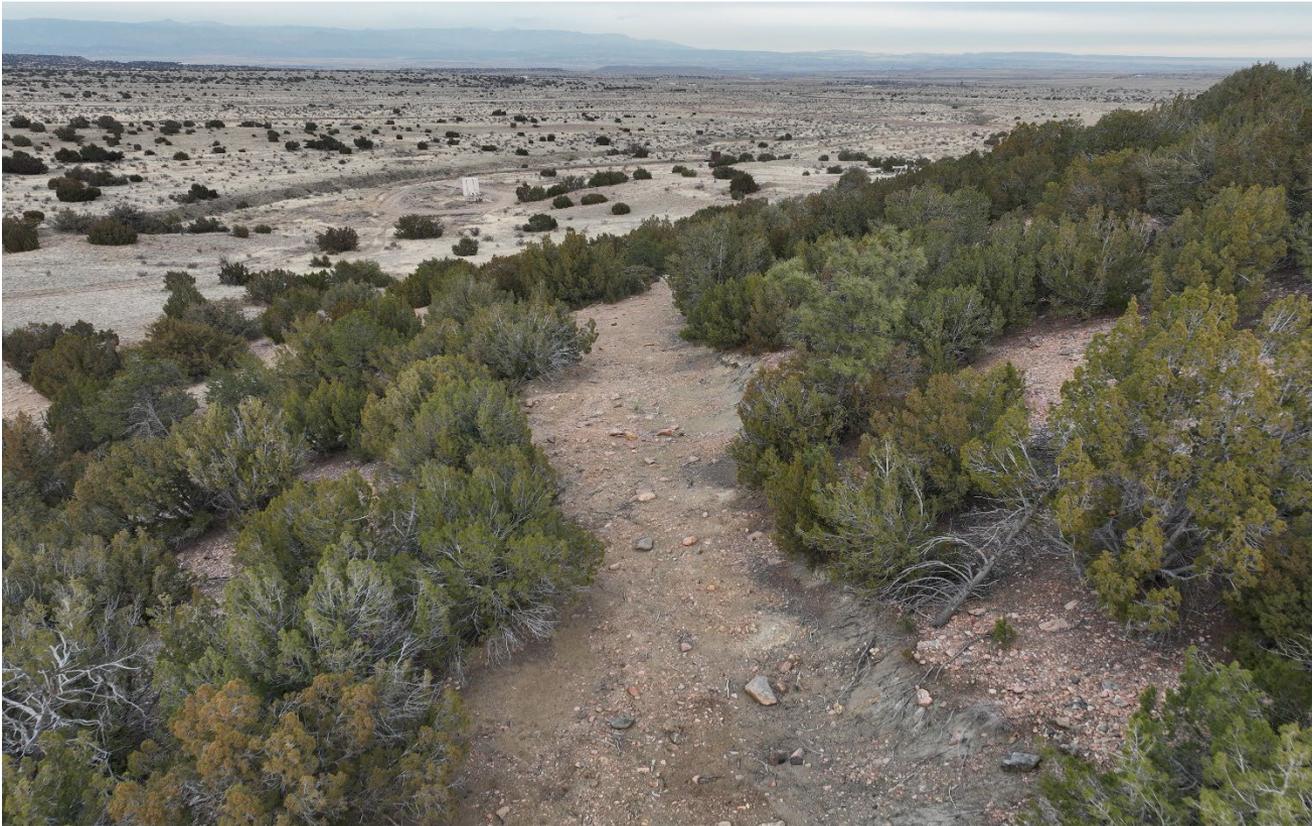
Photo 4. Drone aerial photo facing north. There was an additional access road that goes to the Drapper 4 wellsite. This road has not been reclaimed.

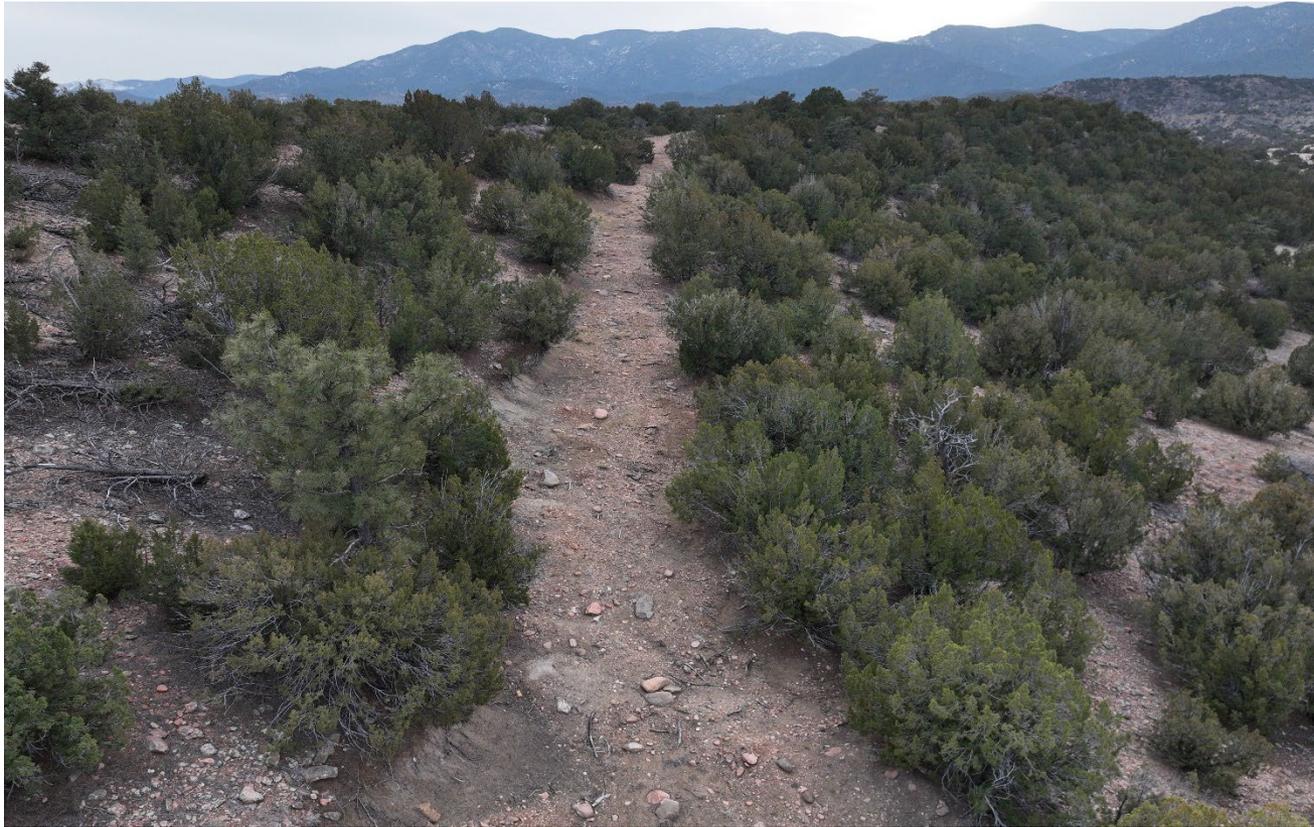
Photo 5. Facing south along the access road shown in the previous photo. This road is not reclaimed or stabilized.
