Inspection Photos

Location: TEP ROCKY MOUNTAIN LLC CHEVRON-65S97W/36SWSW (TR 14-36-597 PAD)

Location ID: 324303

Date: 1/6/2025

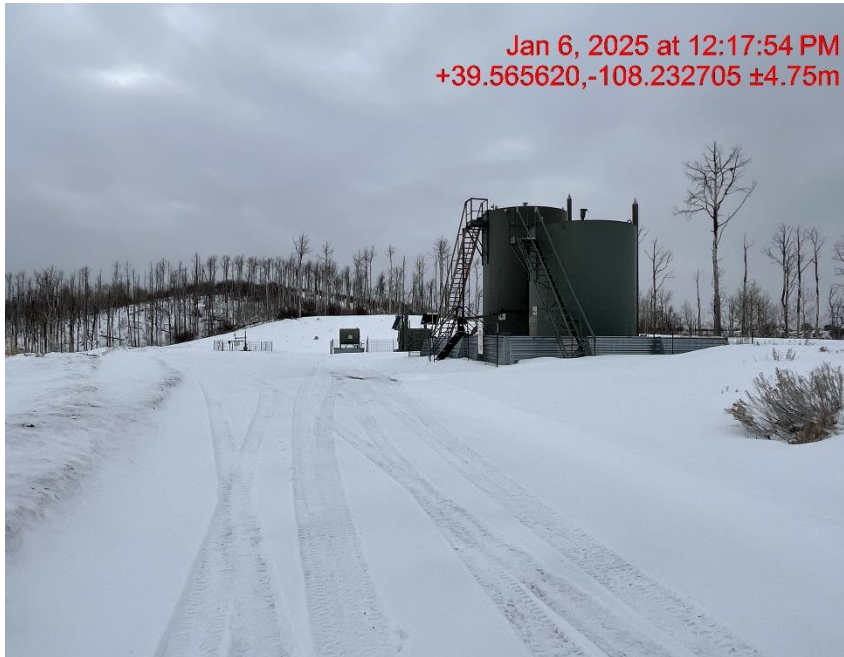
Photo # 1952 Entrance to location

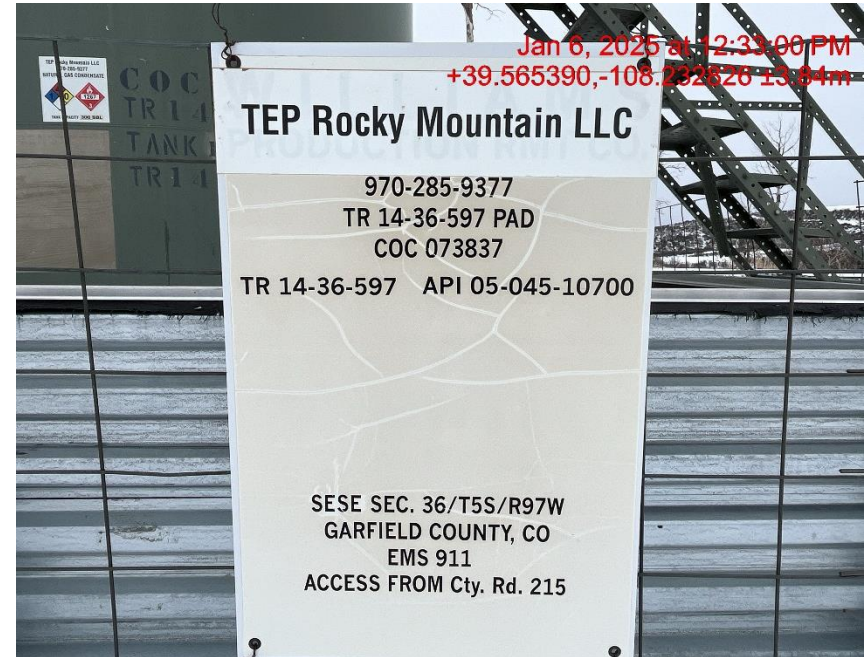
Photo # 1976 Location

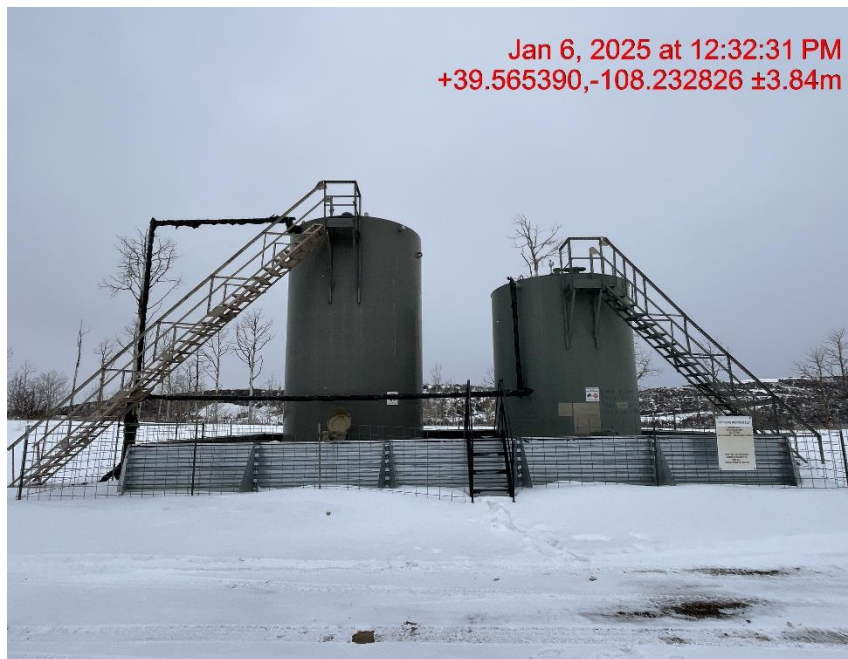
Photo # 1975 Location

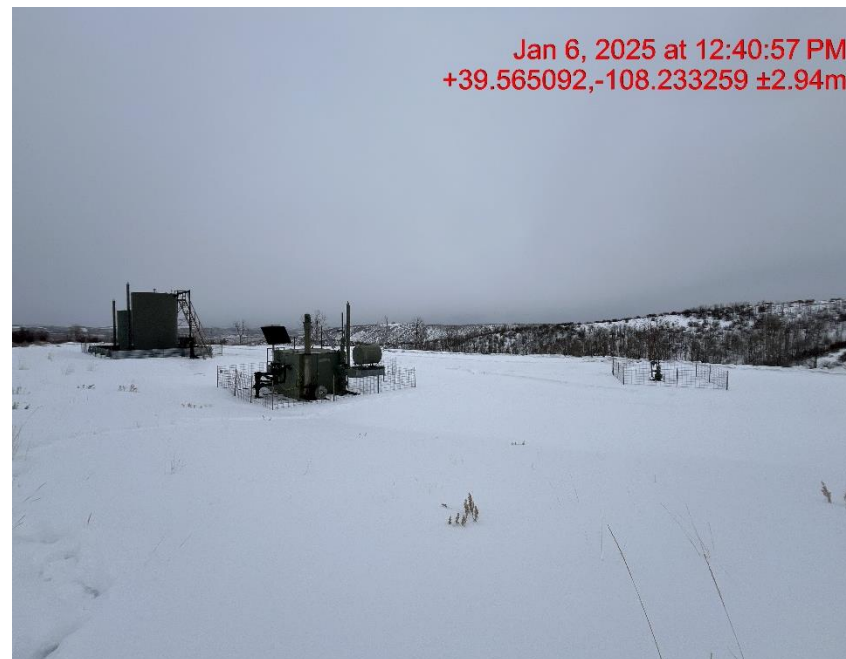
Photo # 1989 SW corner of location

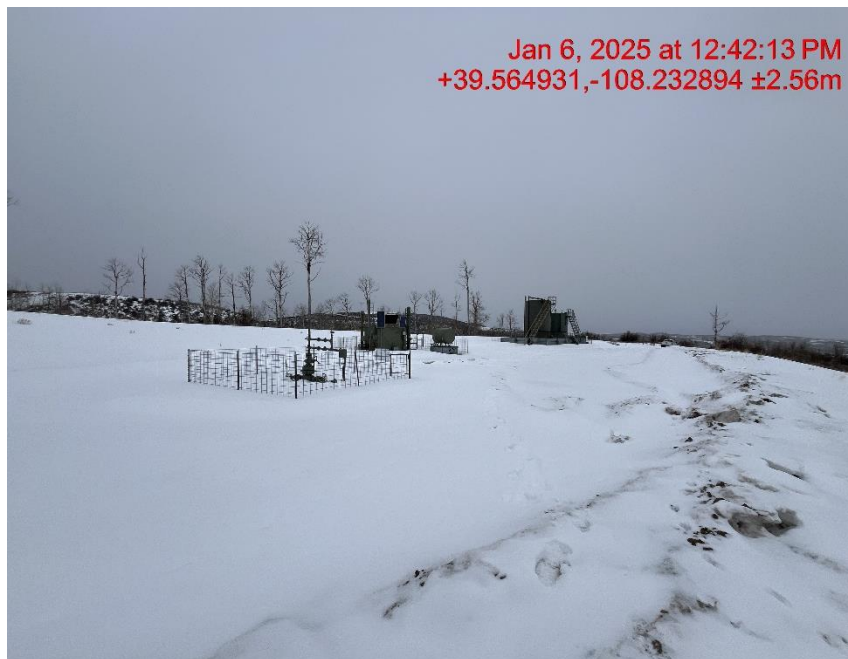
Photo # 1990 SE corner of location

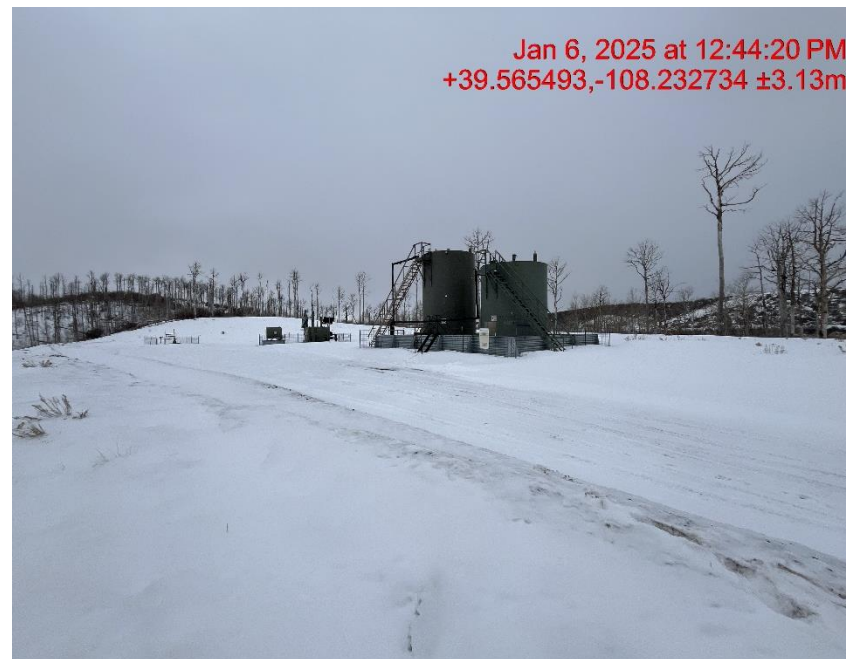
Photo # 1992 NE corner of location

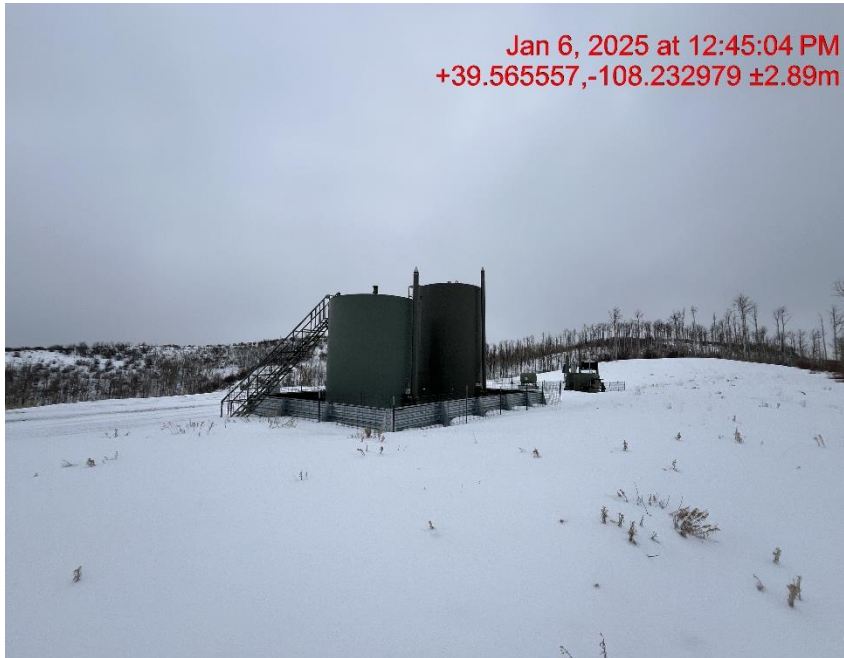
Photo # 1993 NW corner of location

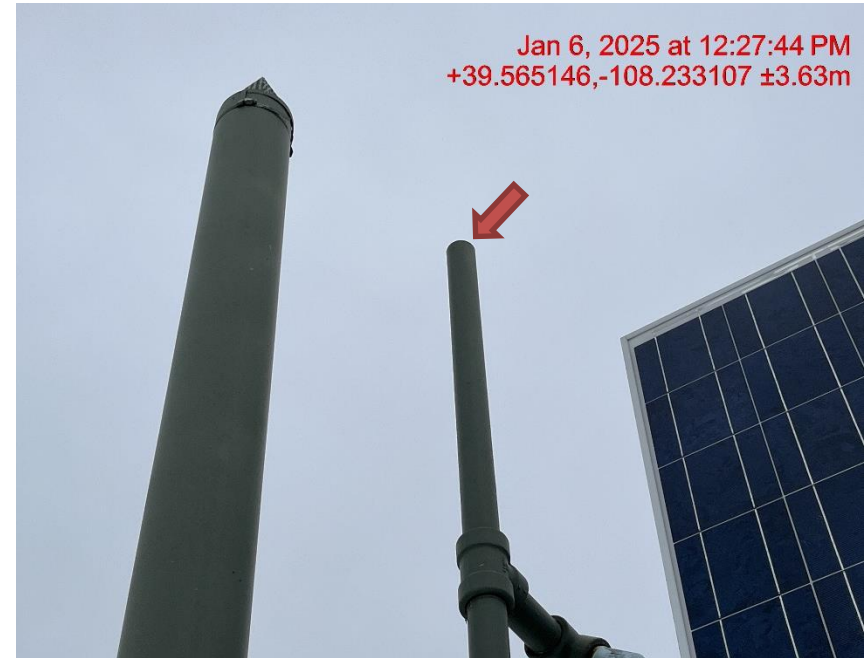
Photo # 1963 Wildlife hazard

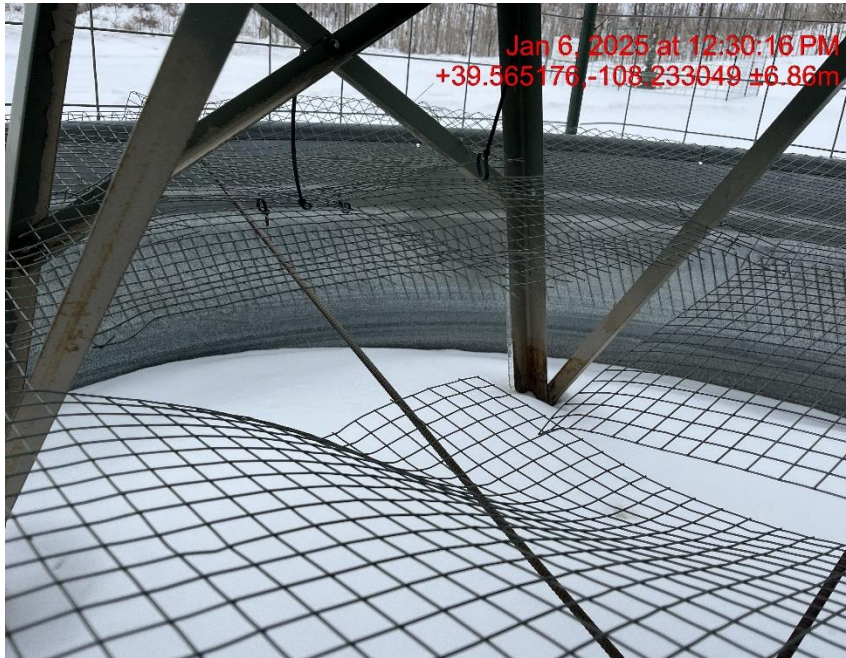
Photo # 1969 Wildlife hazard

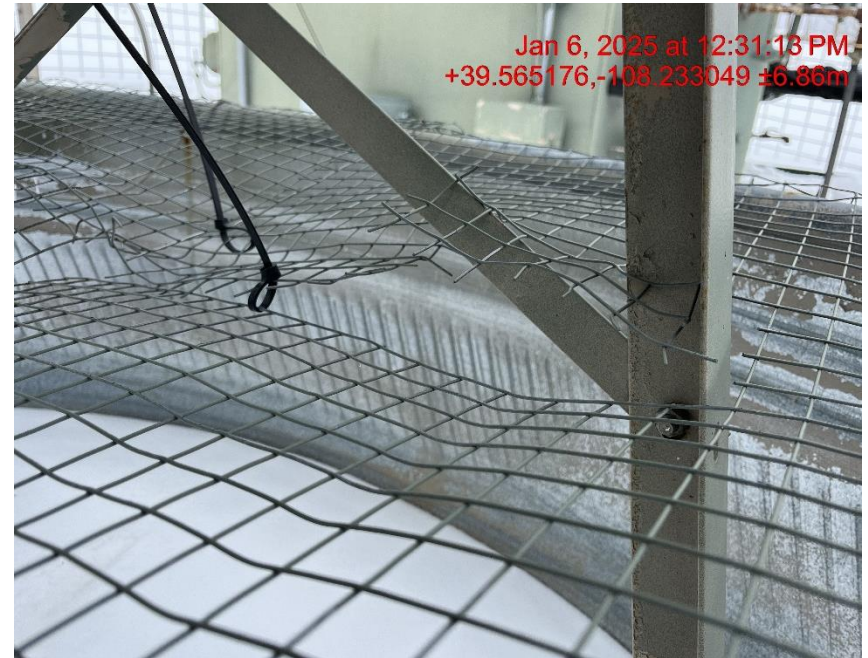
Photo # 1974 Wildlife hazard

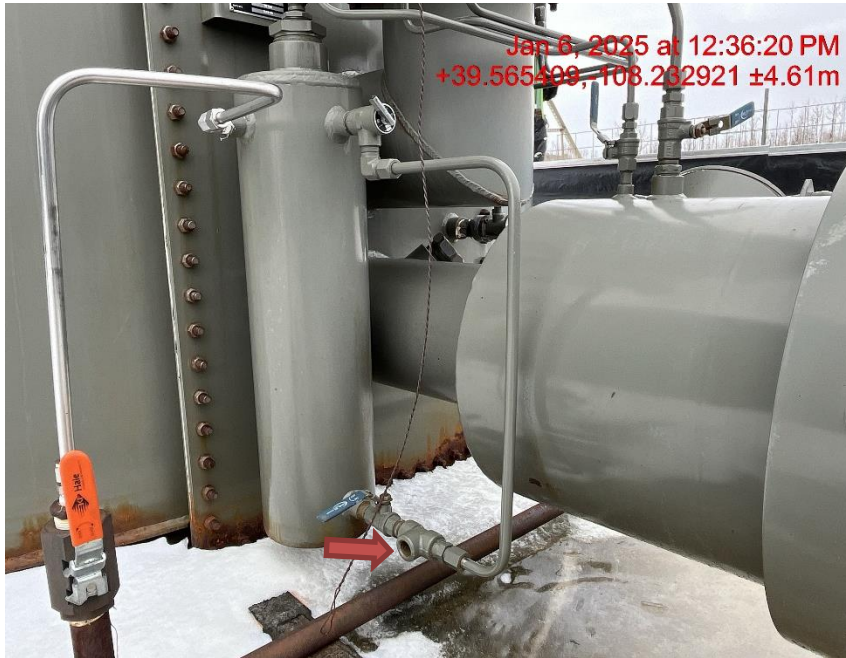
Photo # 1982 PRV vent line does not comply with CECMC pressure safety device rules

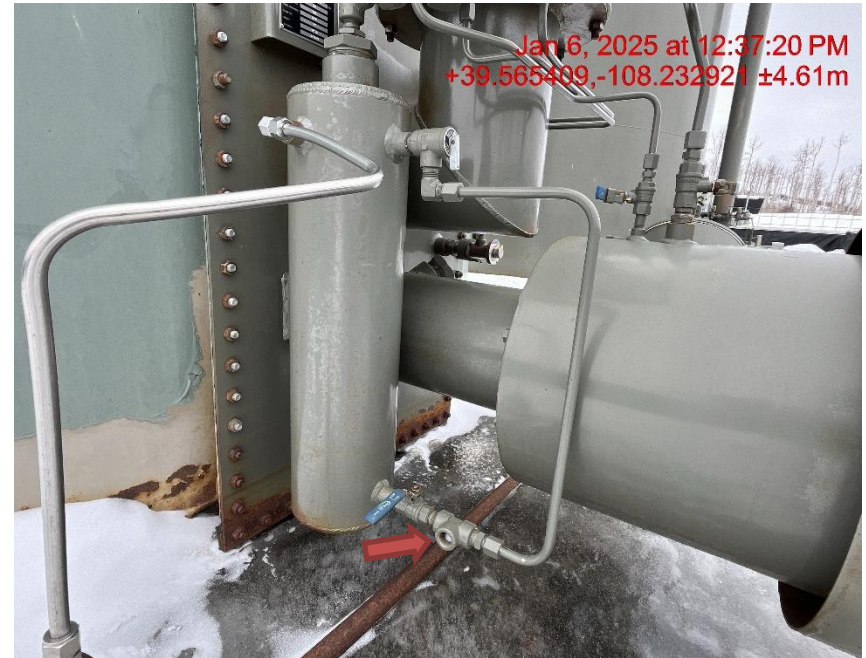
Photo # 1983 PRV vent line does not comply with CECMC pressure safety device rules

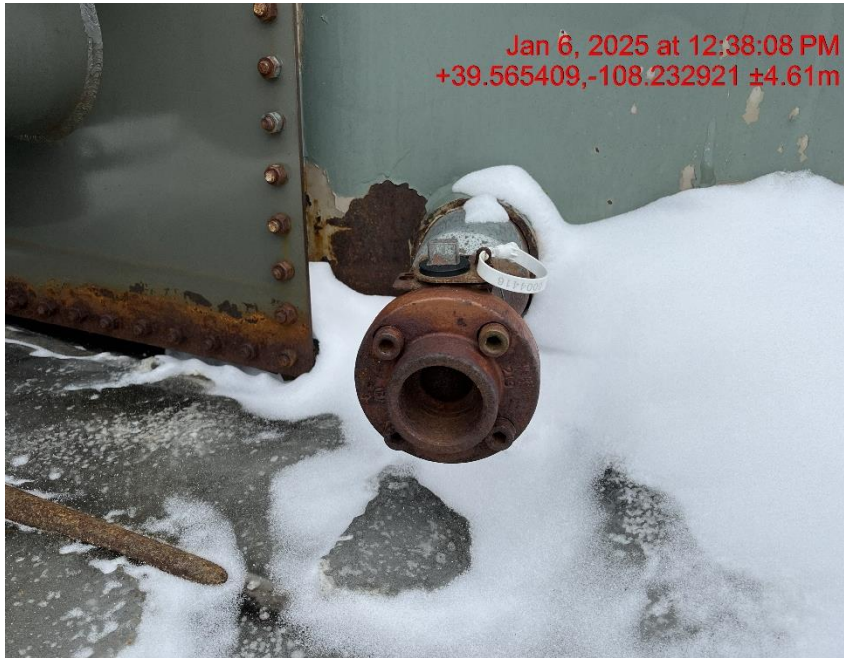
Photo # 1986 Open ended load line

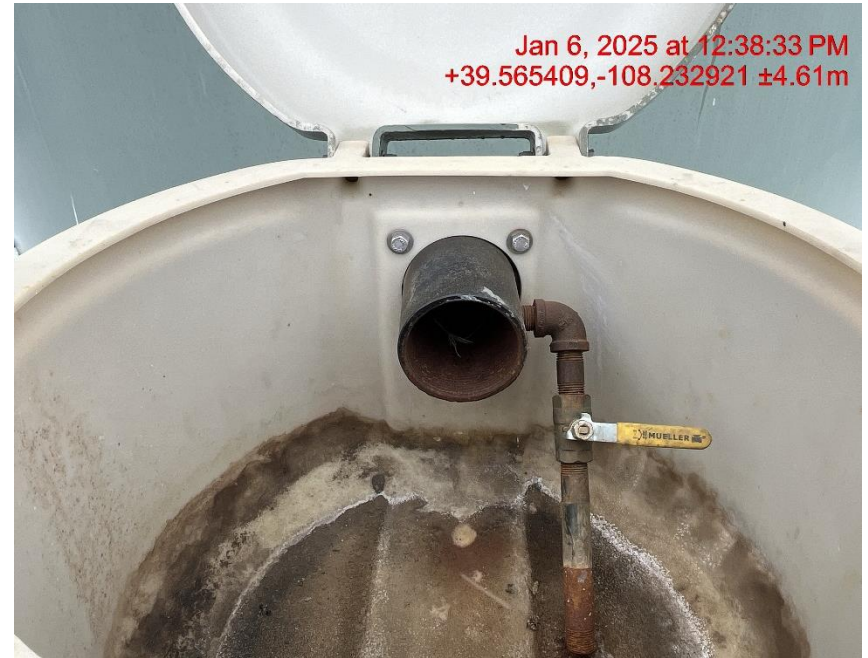
Photo # 1987 Open ended load line
