Inspection Photos
Location Name: CHAMPLIN 485 AMOCO #1
Location ID: 320071

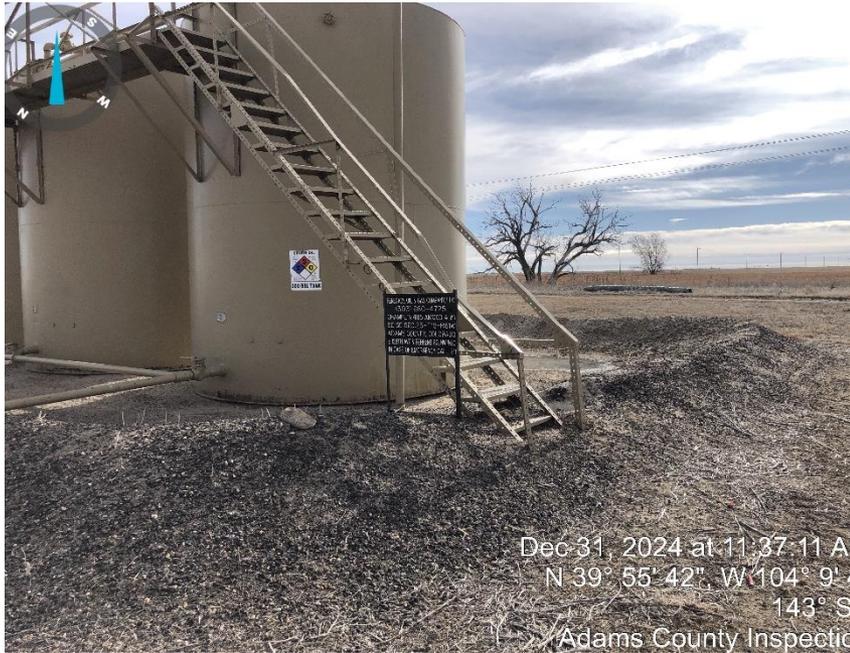
Photo #1 Location sign.

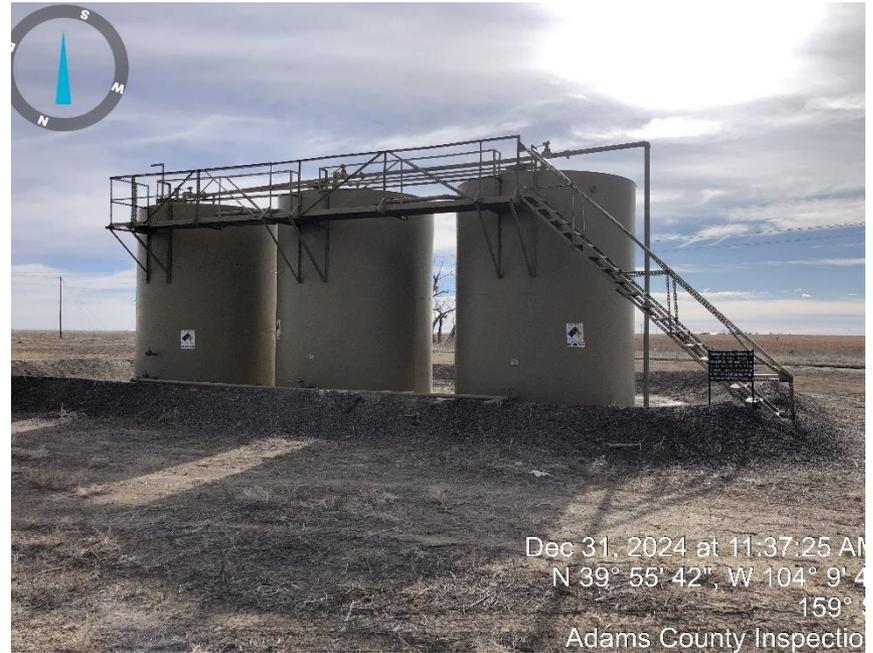
Photo #2 Tanks.

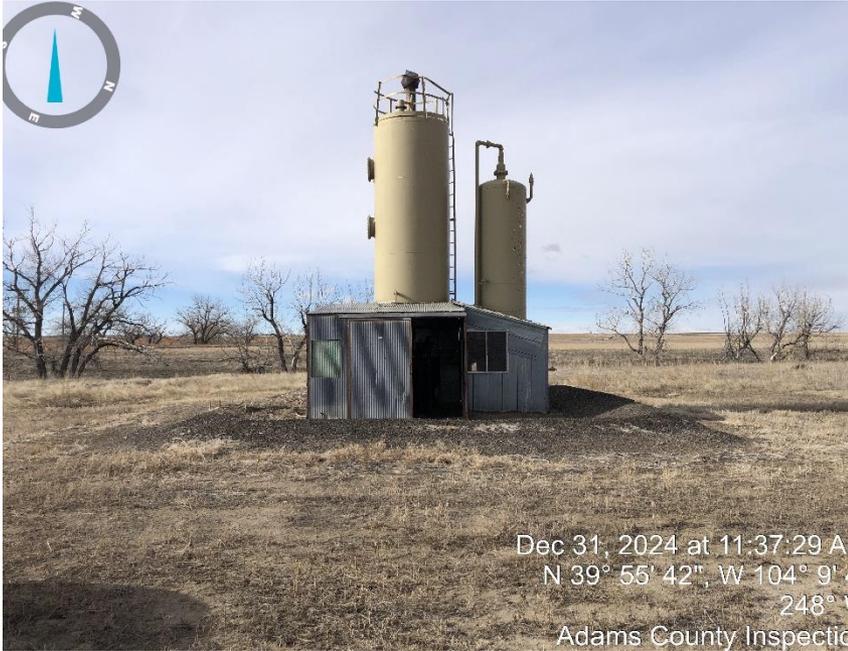
Photo # 3 Separators.

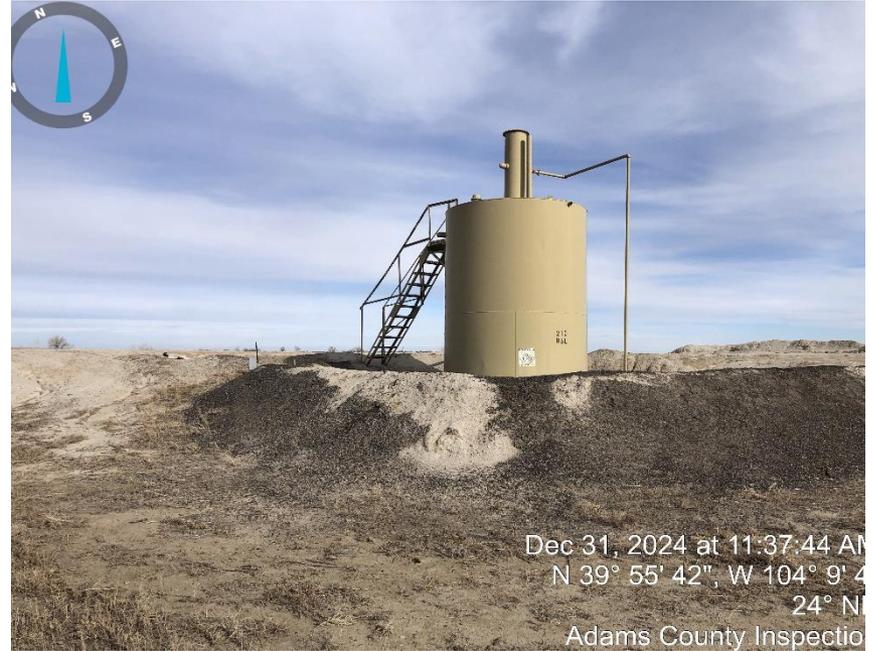
Photo #4 P/W tank.

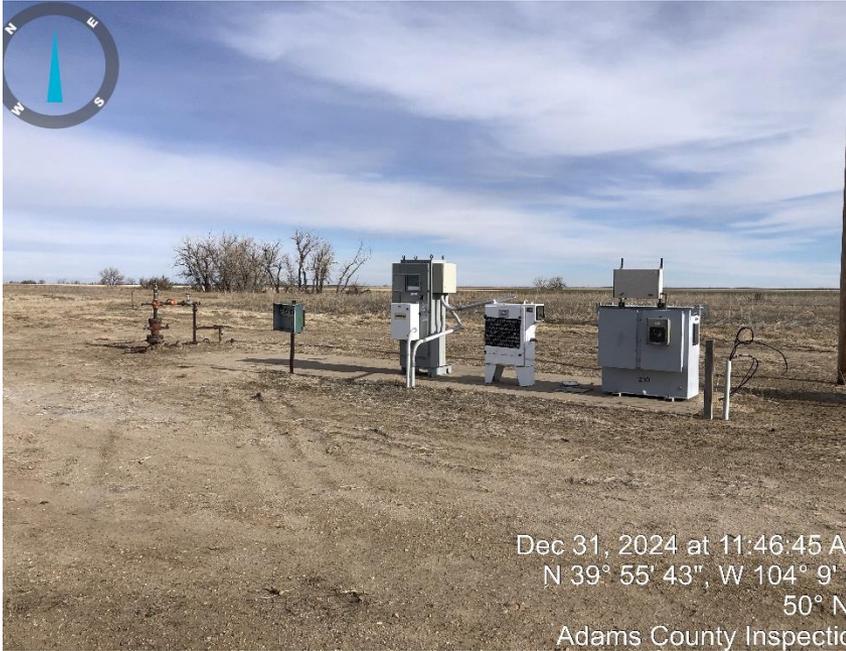
Photo #5 Ancillary equipment and well head.

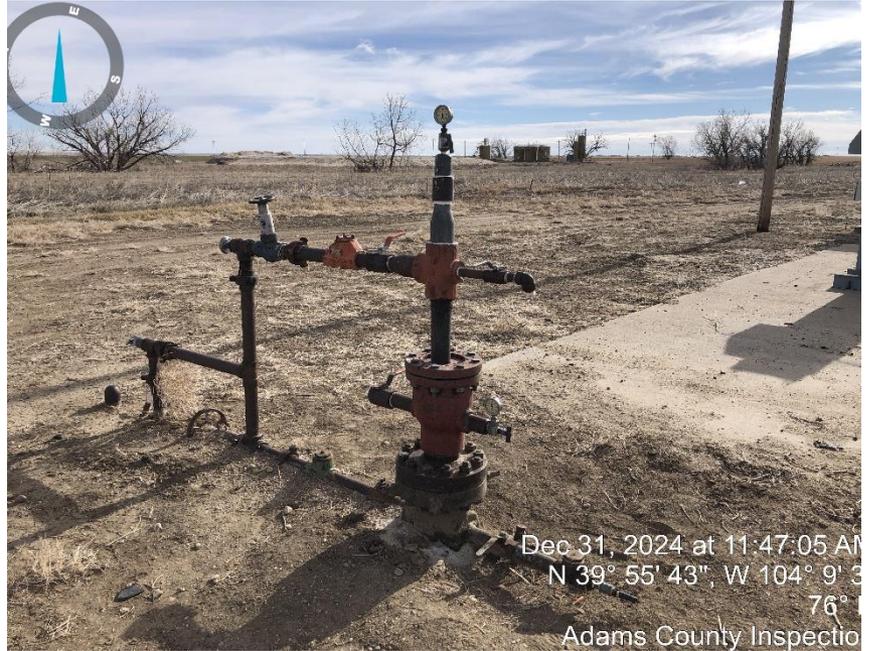
Photo #6 Well head.

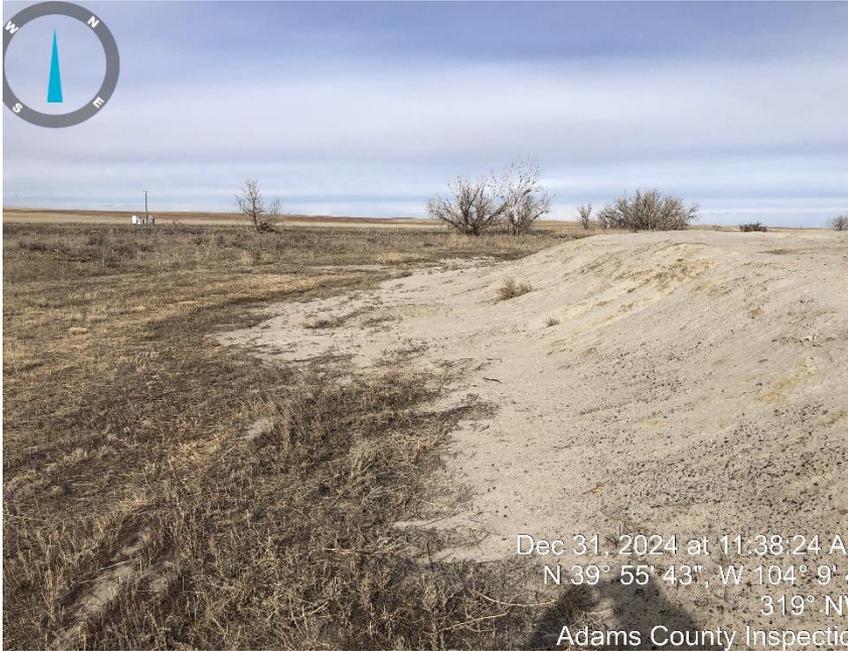
Photo #7 Erosion on west side of P/W pit.

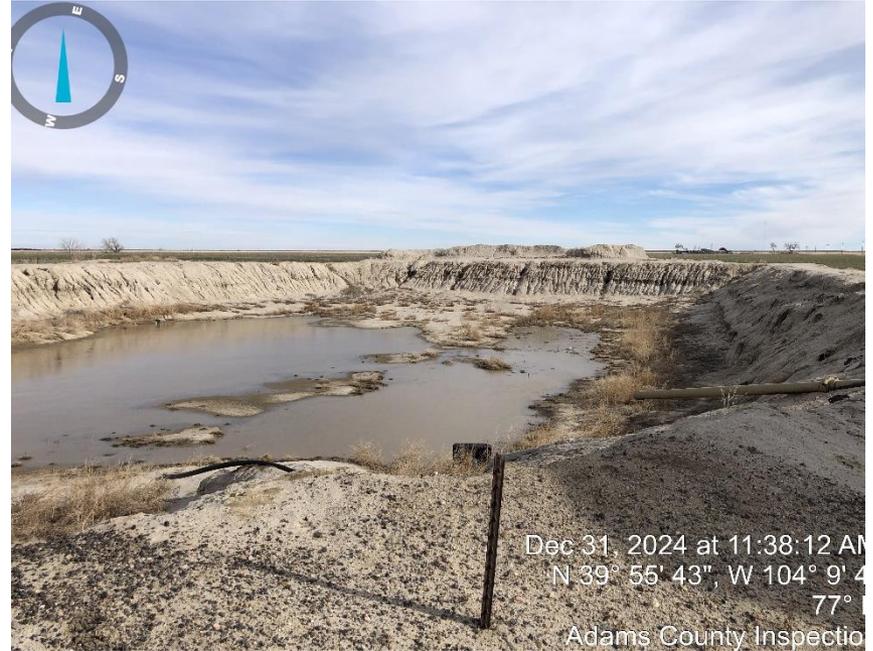
Photo #8 On the west side of pit facing north/east.

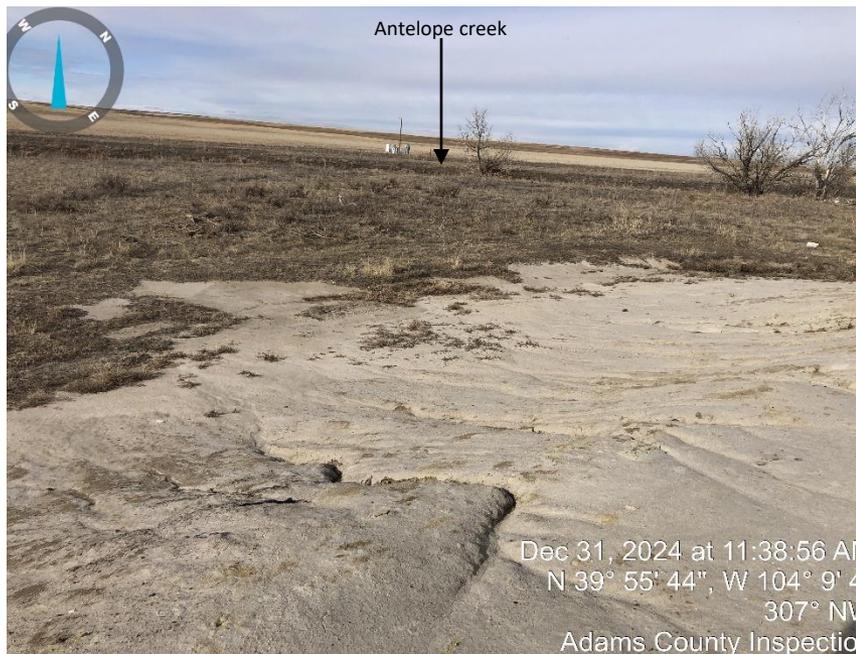
Photo #9 Erosion/fisher on west of pit facing west away from pit toward Antelope creek.

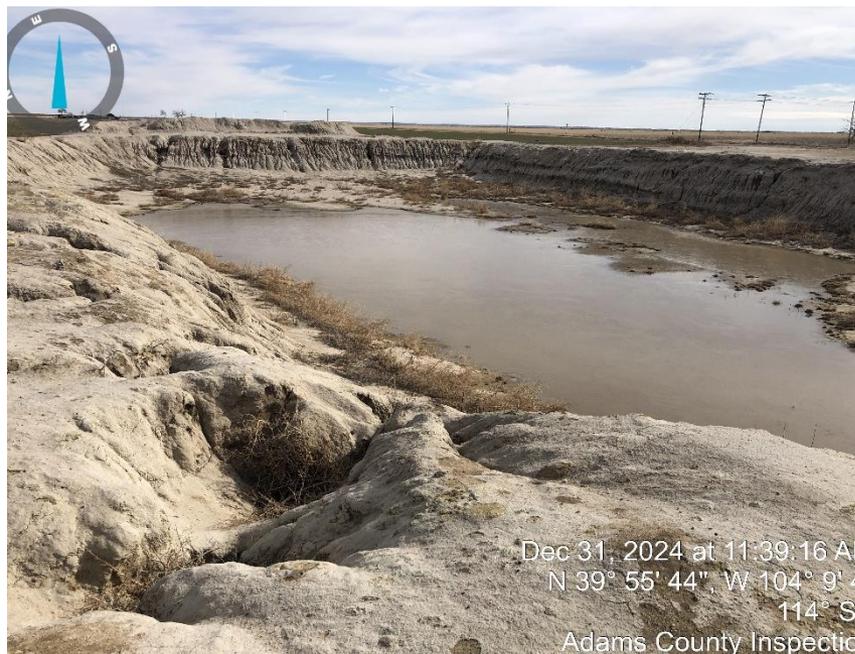
Photo #10 Erosion/fisher in pit on the west side facing south east.

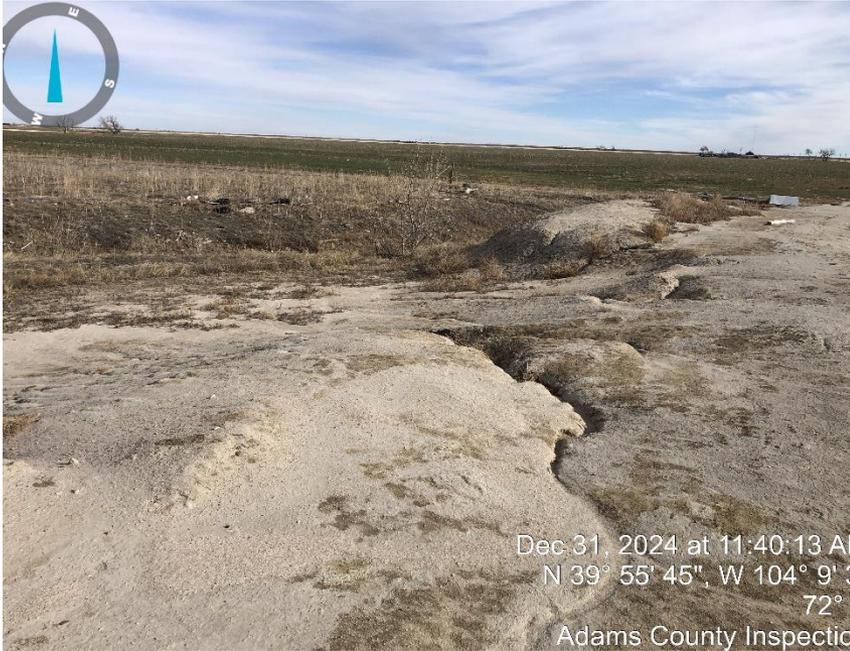
Photo #11 Erosion on the north side of pit facing north/east away from pit.

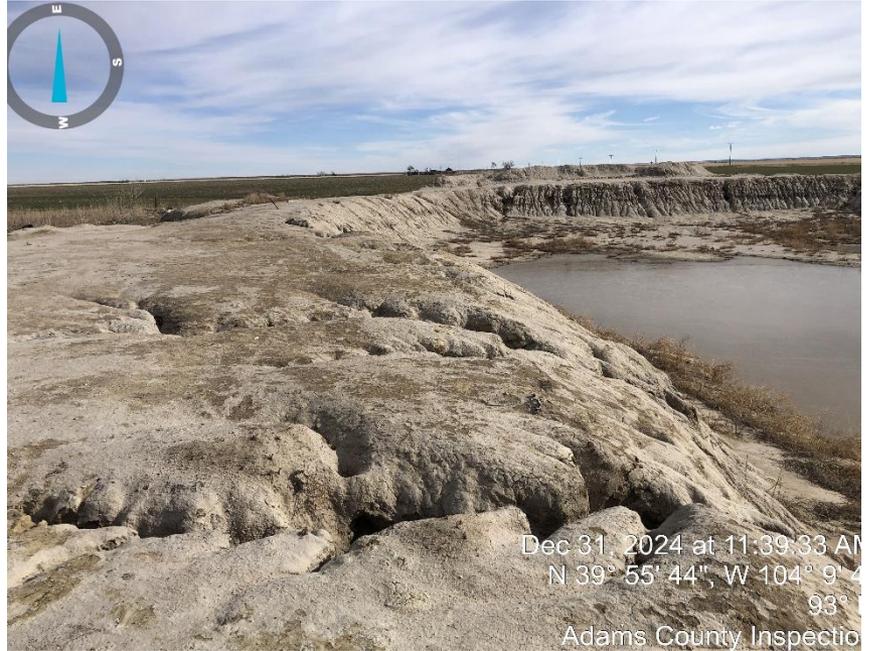
Photo #12 Erosion/fisher in pit, north side facing east.

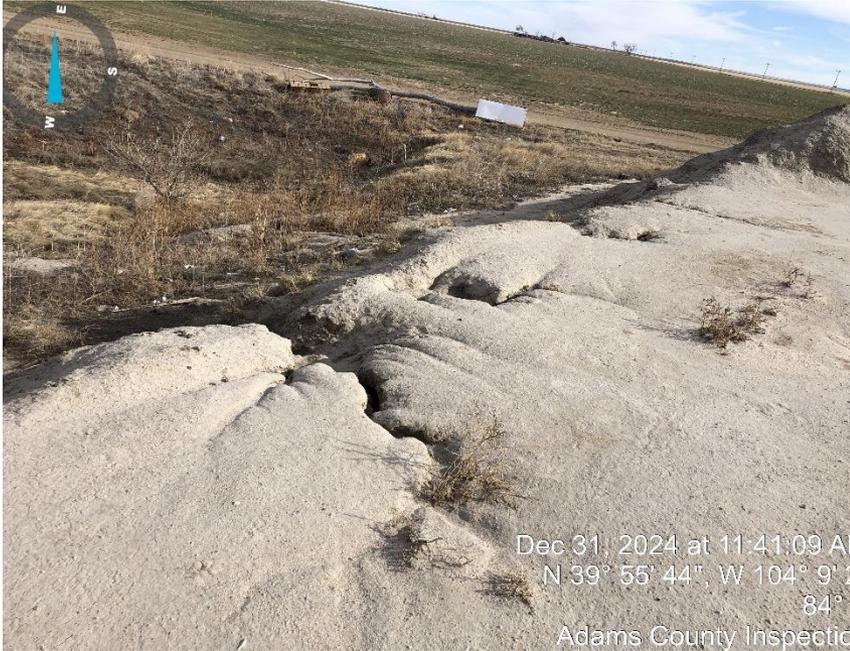
Photo #13 Erosion/fisher north side of pit facing east and away from pit.

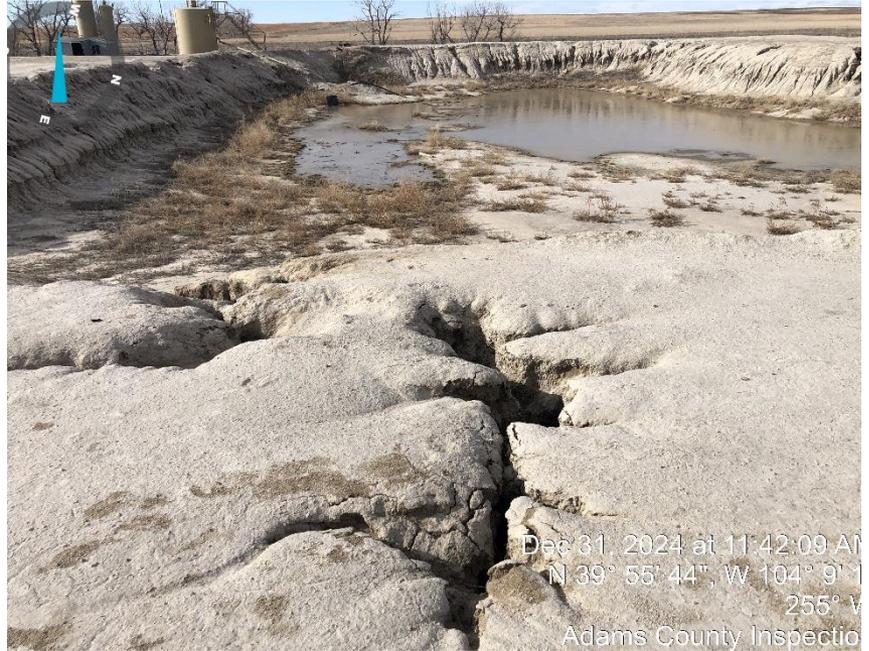
Photo #14 Erosion/fisher on east side of pit facing west.

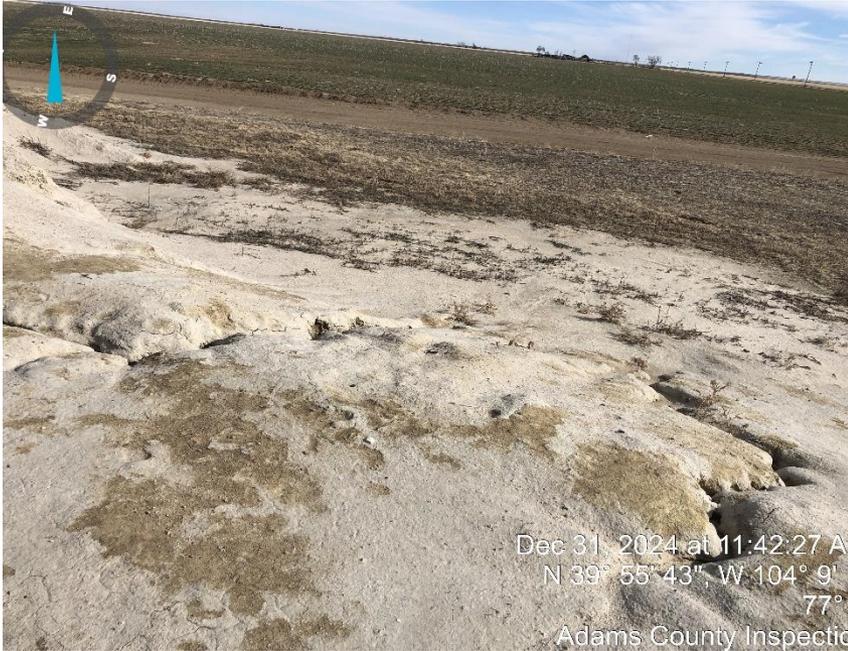
Photo # 15 Erosion/fishers south east side of pit facing east & away from pit.

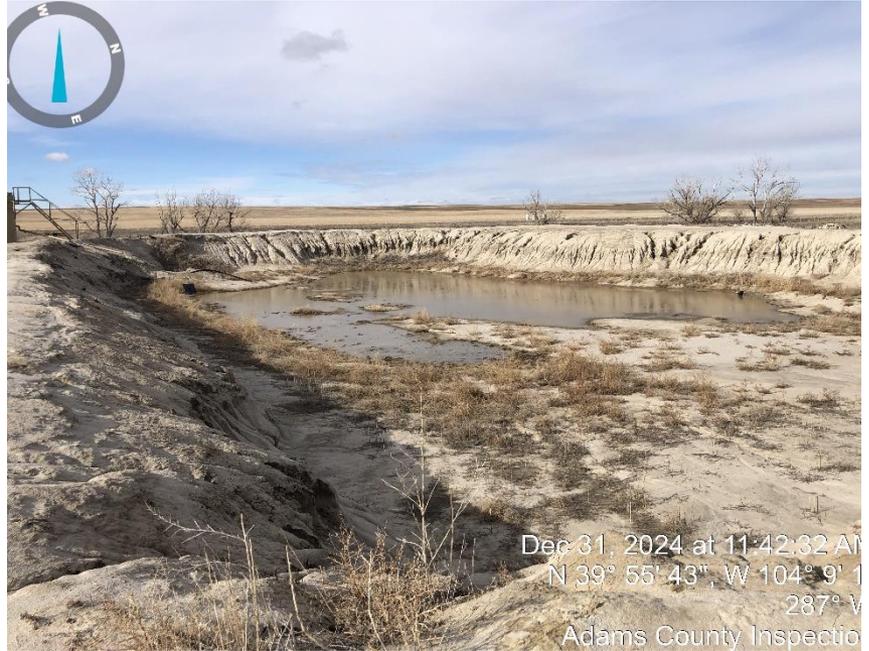
Photo #16 Erosion/fishers east side of pit facing west.

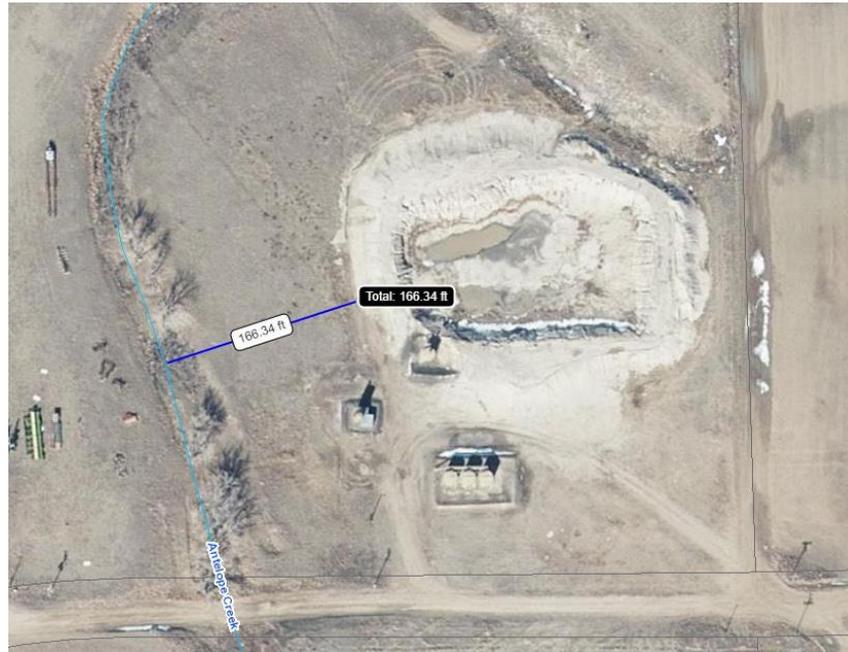
Photo # Aerial image with distance to antelope creek.
