Final Reclamation and Stormwater Inspection

January 6, 2025

Location ID: 306073

Well Name: AMATO #12-1

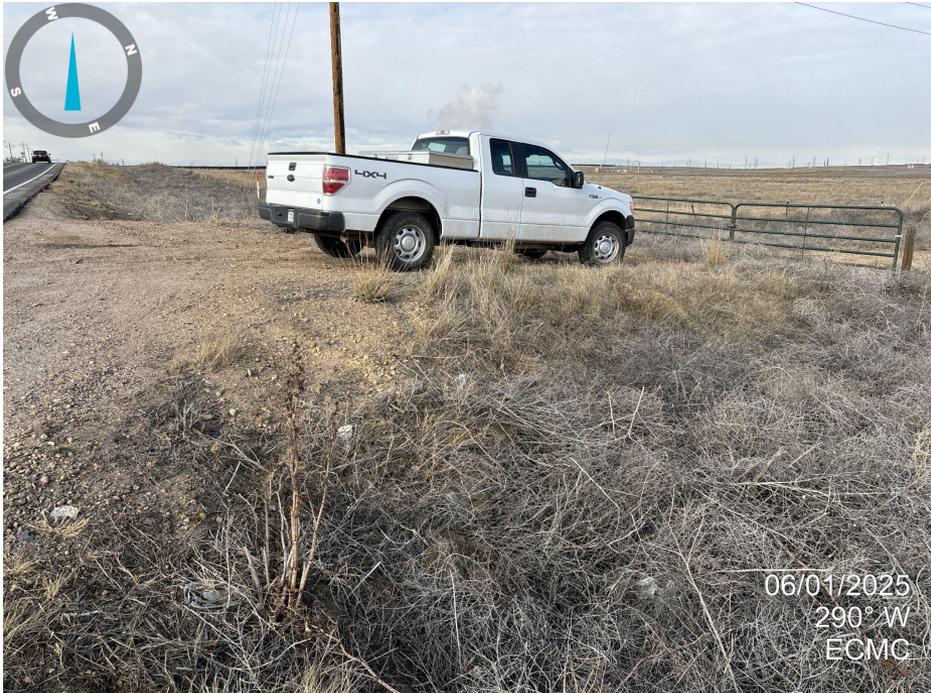
Photo 1. Photo taken at entrance to access road off SH53. Culvert remains in place at entrance to access road. Gravel remains inside and outside of fence..

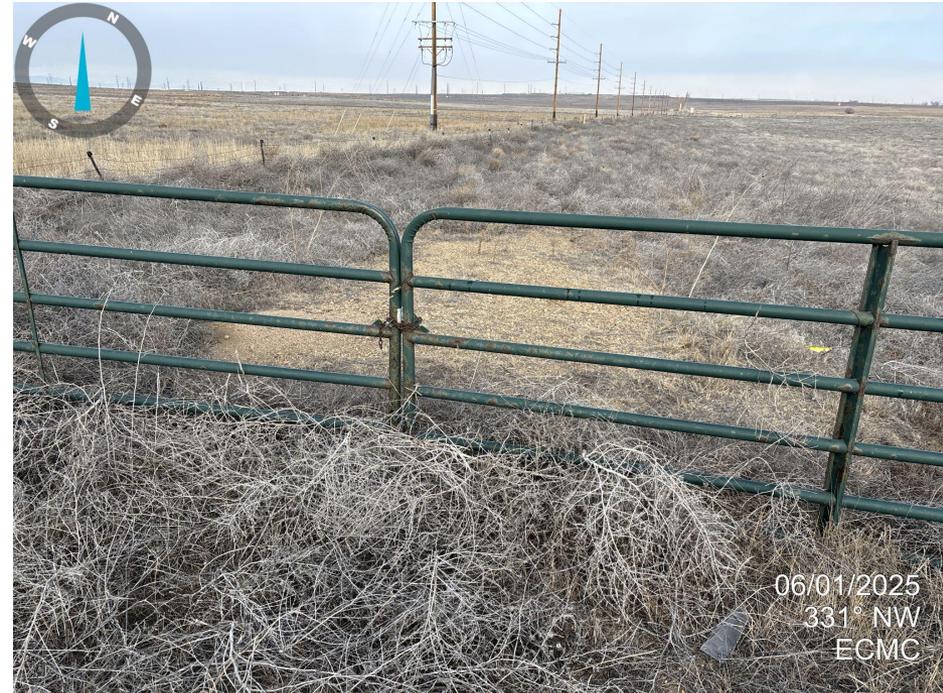
Photo 2. Looking north down access road. Gravel remains inside fence near entrance of access road. Undesirable annual plant species such as Russian thistle, Kochia and noxious weeds Downy brome and Scotch thistle are dominant throughout the location.

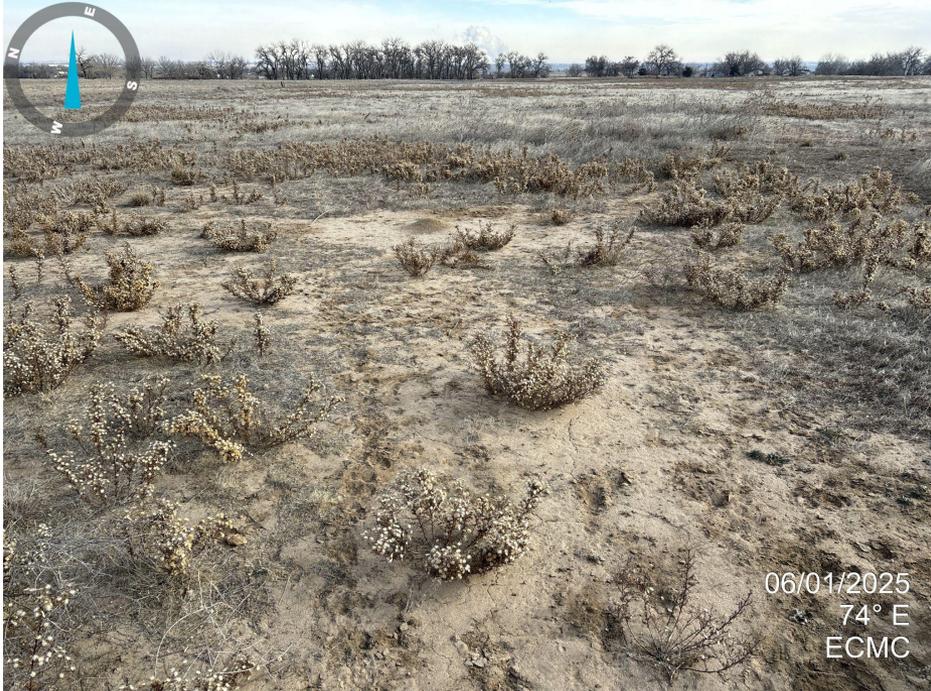
Photo 3. Looking east across the location. Well site has areas of bare soil. Desirable perennial vegetation has failed to establish. Undesirable annual plant species such as Russian thistle, Kochia and noxious weeds Downy brome and Scotch thistle are dominant throughout the location.

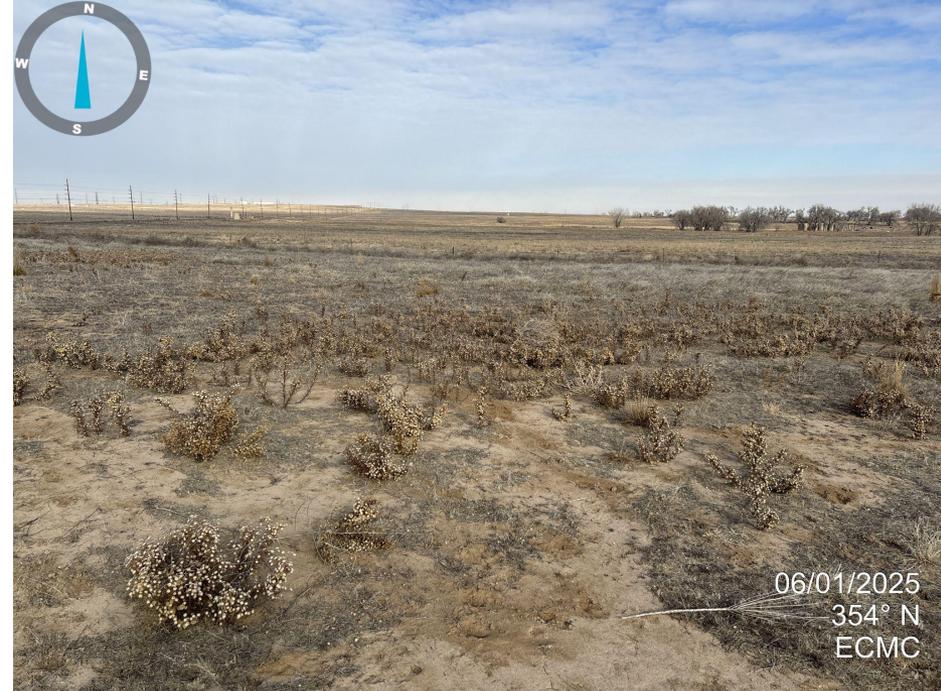
Photo 4. Looking north from the well site. See Photo 3 comments.

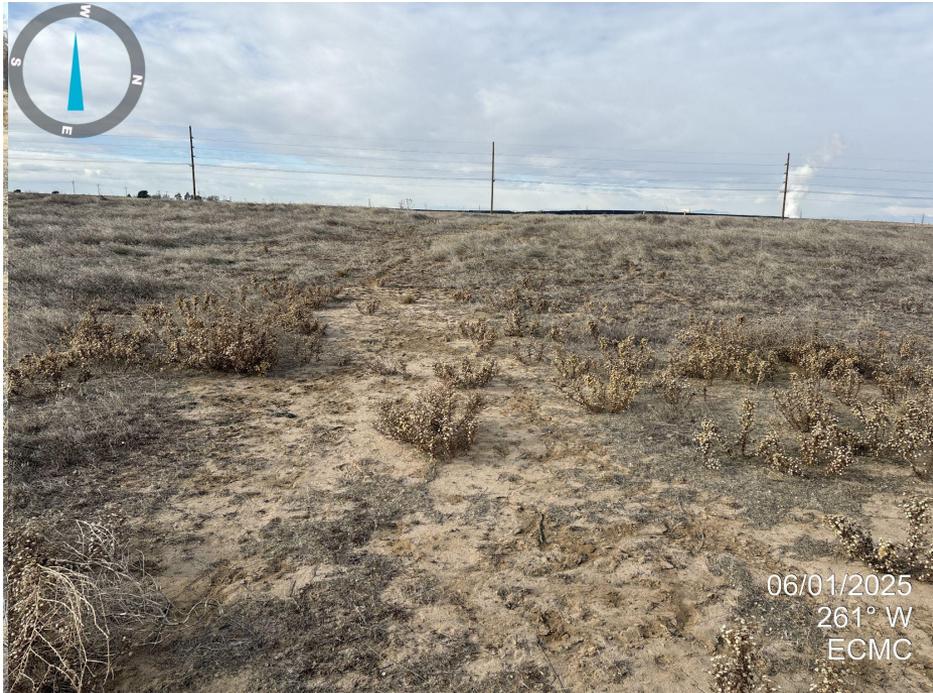
Photo 5. Looking west from the well site towards access road. See Photo 3 comments.

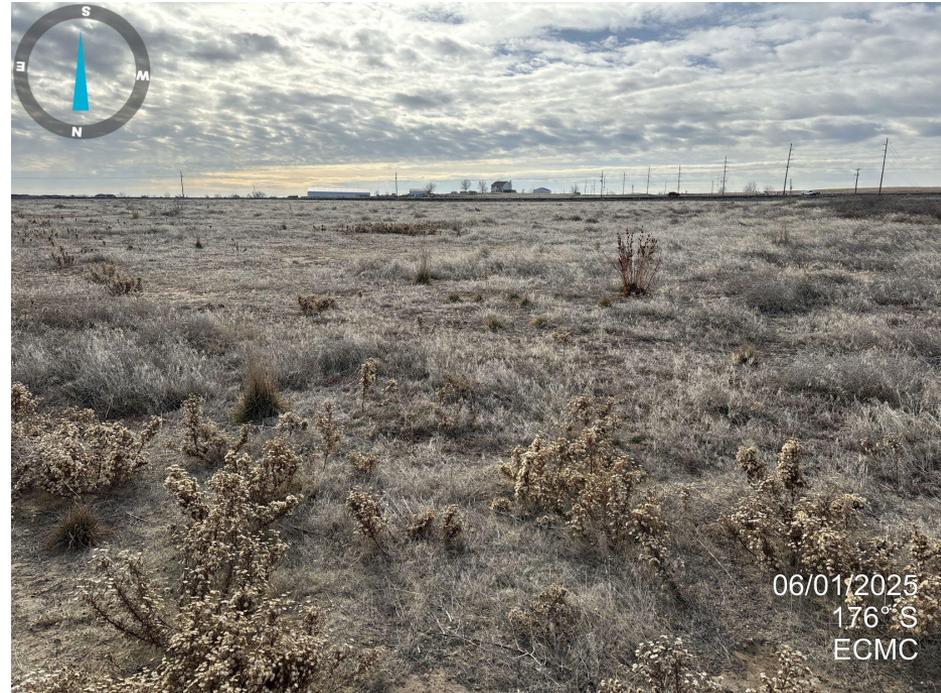
Photo 6. Looking south from the well site. See Photo 3 comments.
