KT Resources LLC  
Ant Hill Unit 16-22  
Location ID: 316298

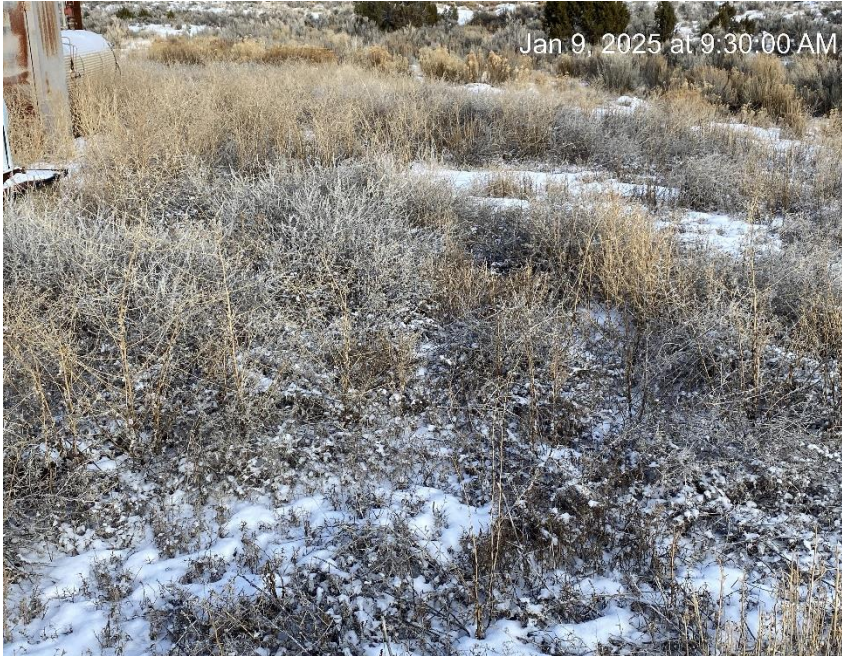
**Weeds. Lacking Stormwater BMPs.**

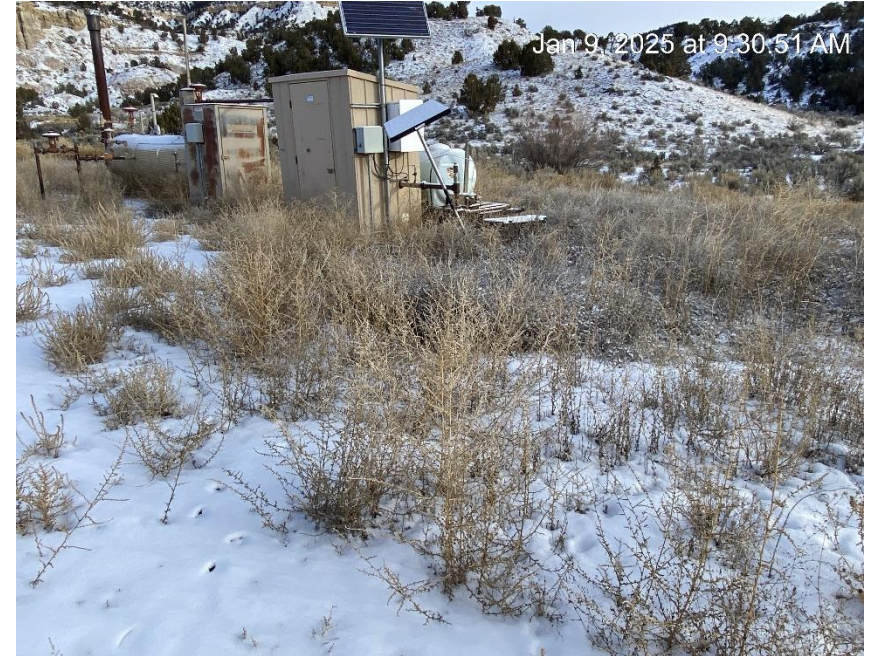
**Weeds. Lacking Stormwater BMPs.**

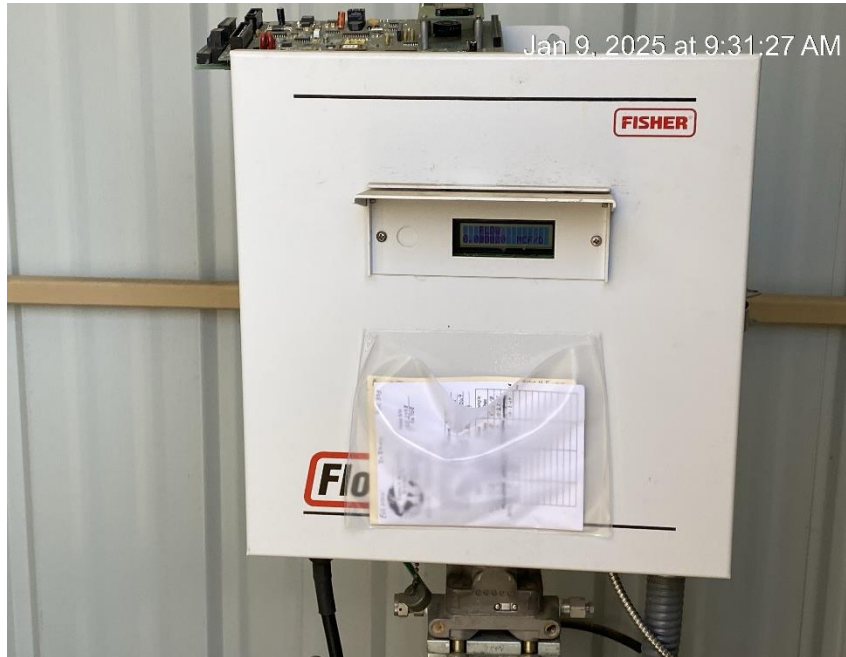
Gas calibration displayed

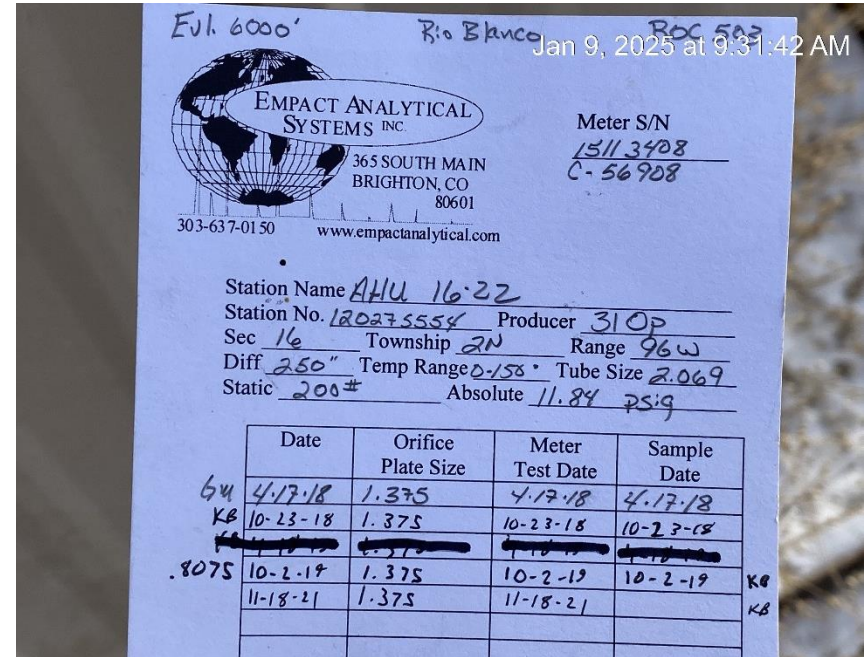
Calibration overdue

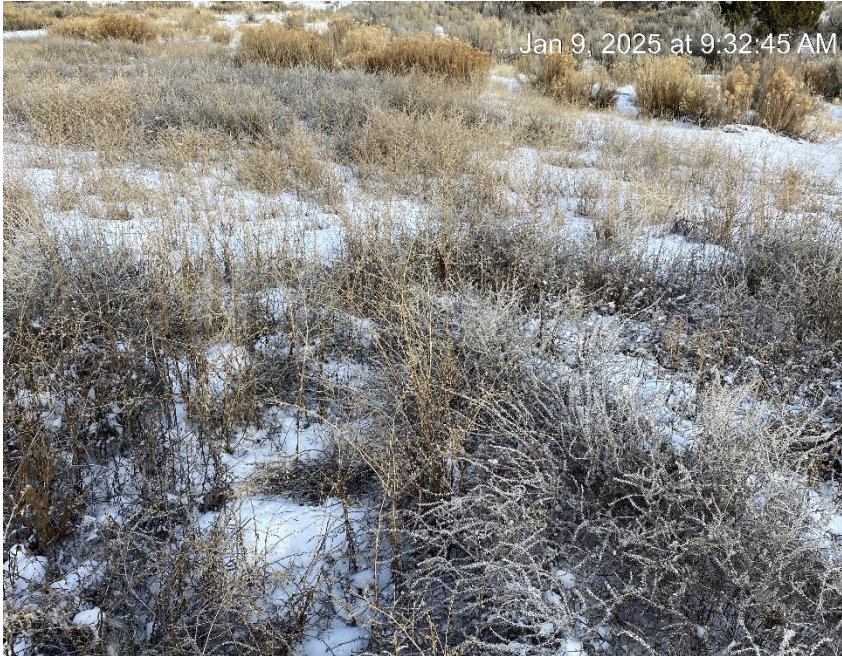
**Weeds. Lacking Stormwater BMPs.**

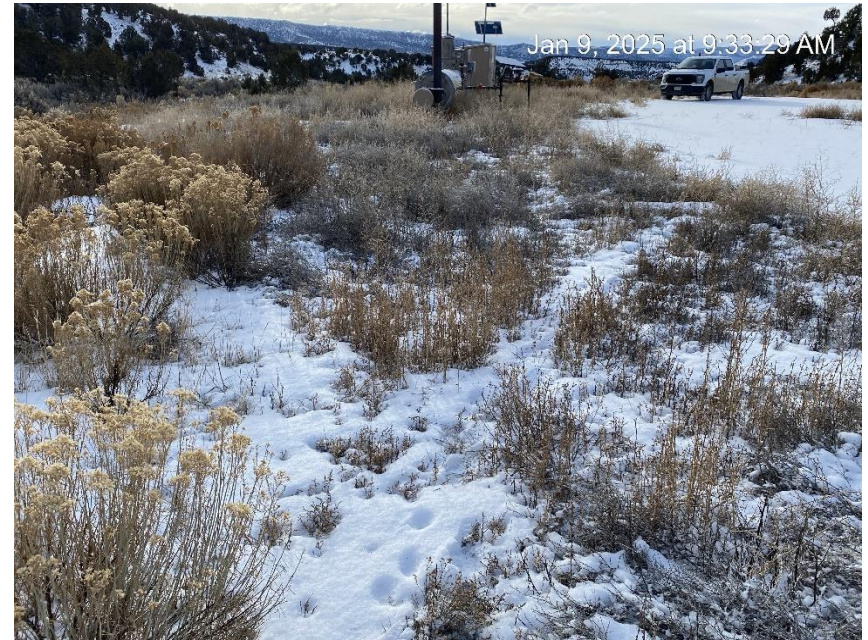
**Weeds. Lacking Stormwater BMPs.**

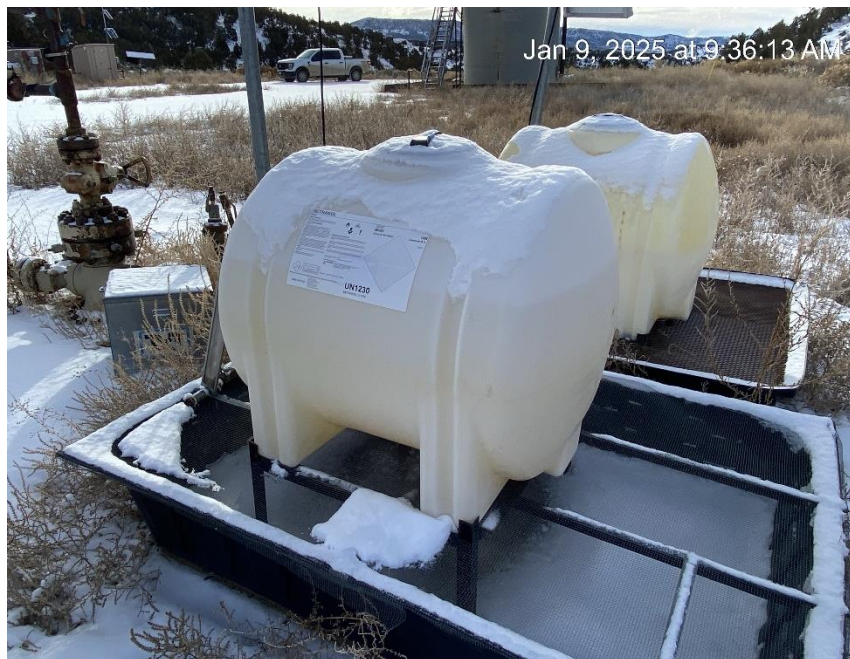
Faded chemical tank labels

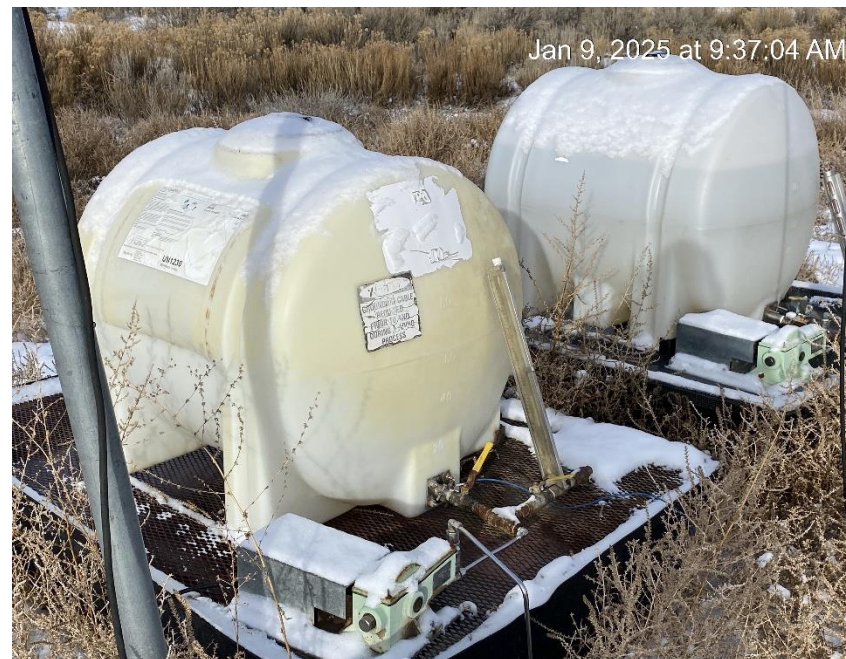
Faded chemical tank labels

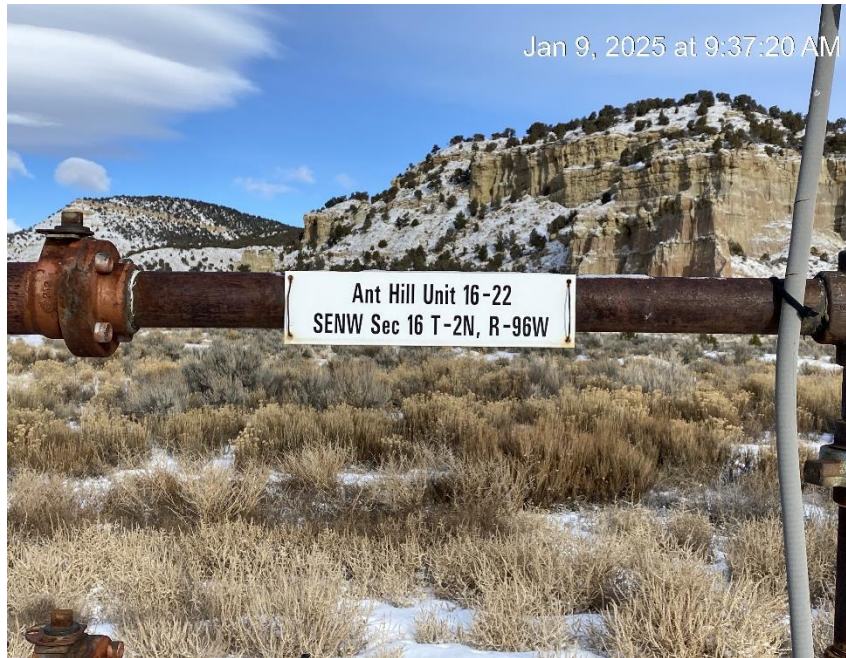
**When well sign is replaced additional information is required**

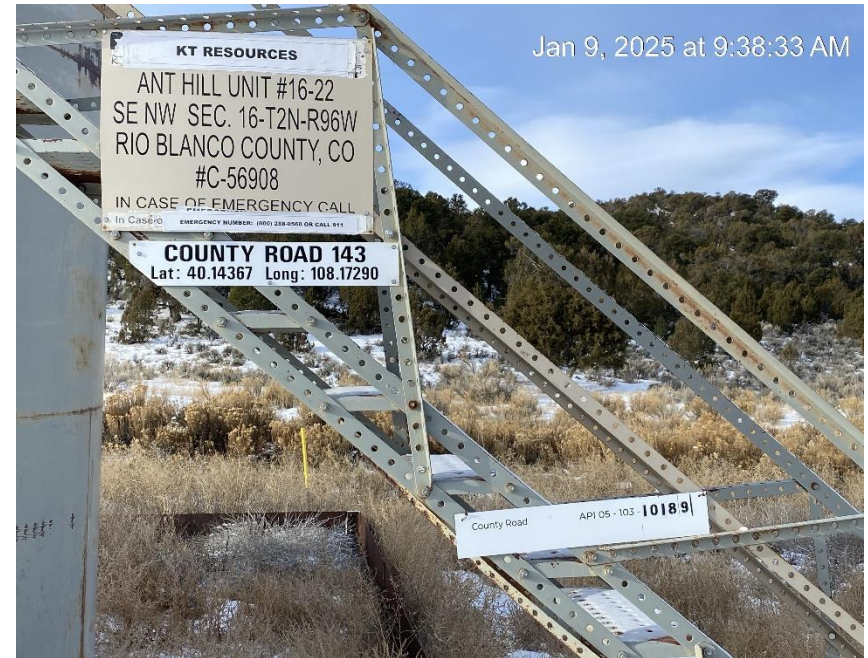
**Tank battery signs**

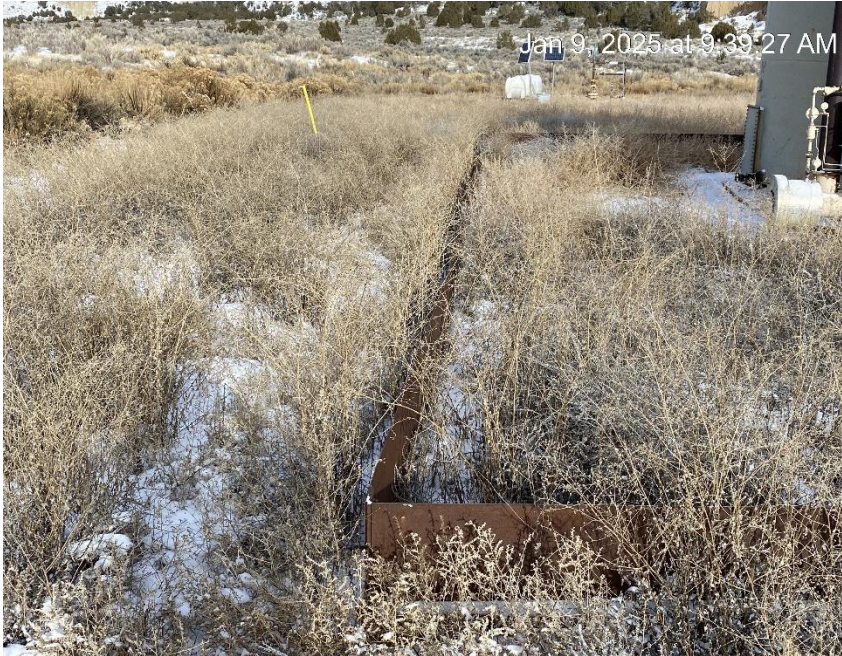
**Weeds**

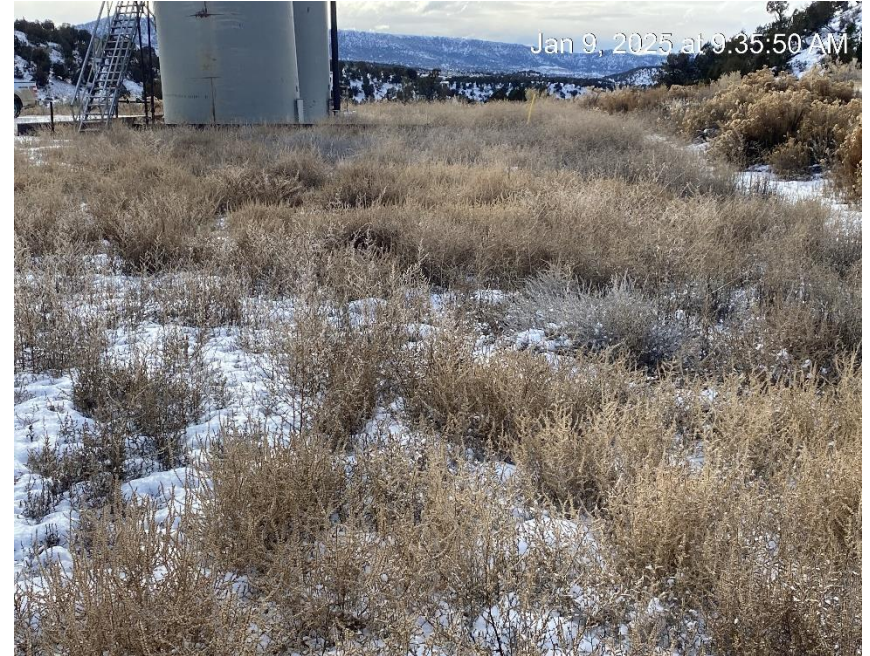
**Weeds**
