# Final Reclamation and Stormwater Inspection

Operator: KERR MCGEE OIL & GAS ONSHORE LP - 47120

Location ID: 305399

Well Name: AMATO #22-1

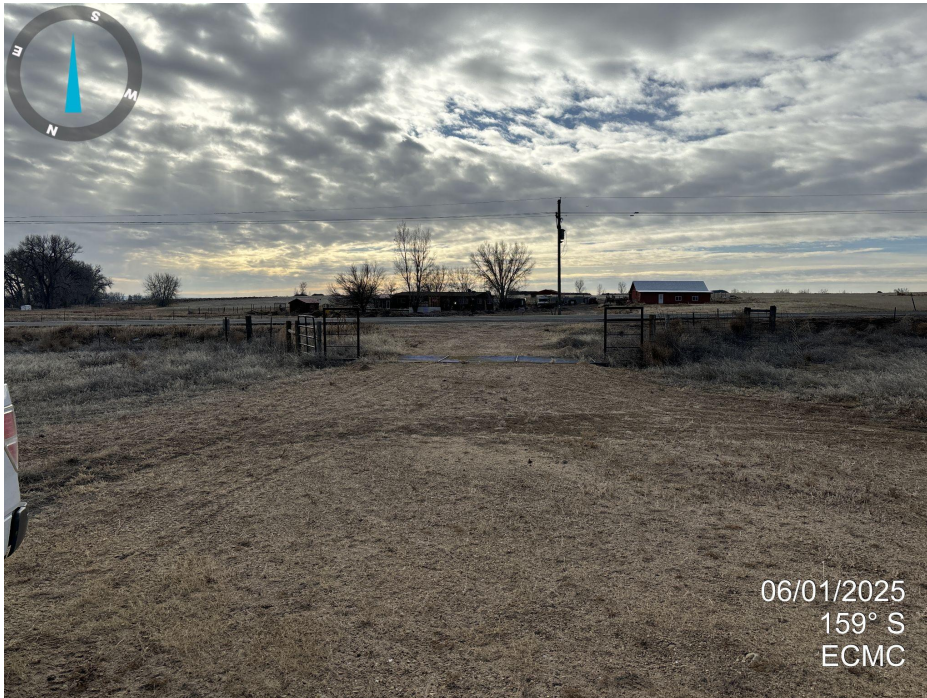
**Photo 1.** Photo taken looking east at entrance of location. Cattle guard remains in place off of sh52. Gravel has not been removed from site.

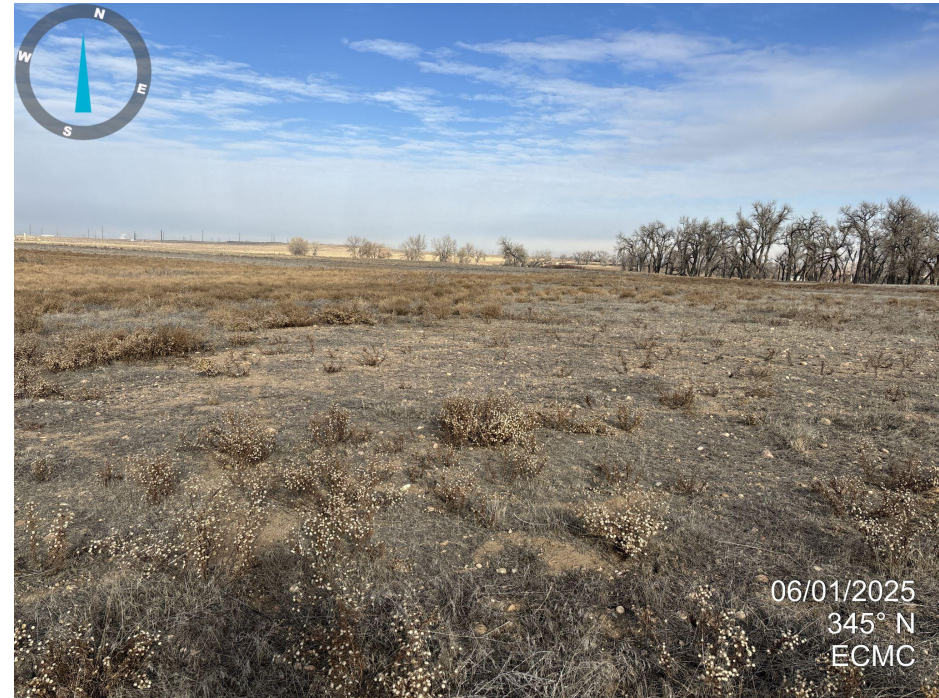
**Photo 2.** Looking north across well site. Desirable vegetation has failed to establish and well site has bare earth patches. Undesirable plant species such as Russian thistle, Kochia, and noxious weeds such as Downy Brome and Scotch thistle are dominant.

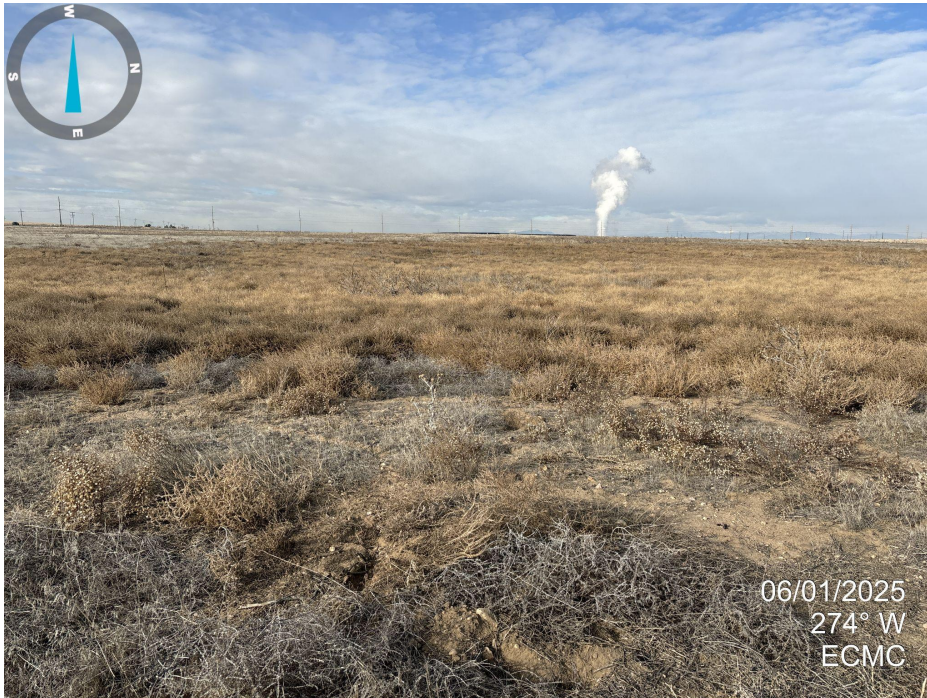
**Photo 3.** Picture taken looking west from well site. See Photo 2 comments.

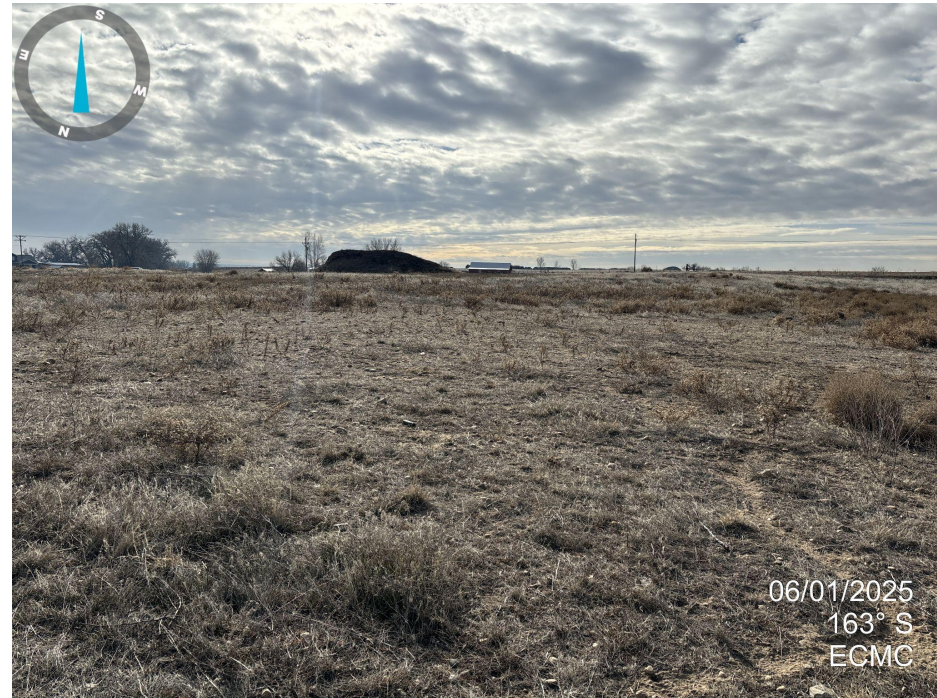
**Photo 4.** Photo looking south across wellsite towards former access road. Undesirable and noxious weeds are dominant on access road.

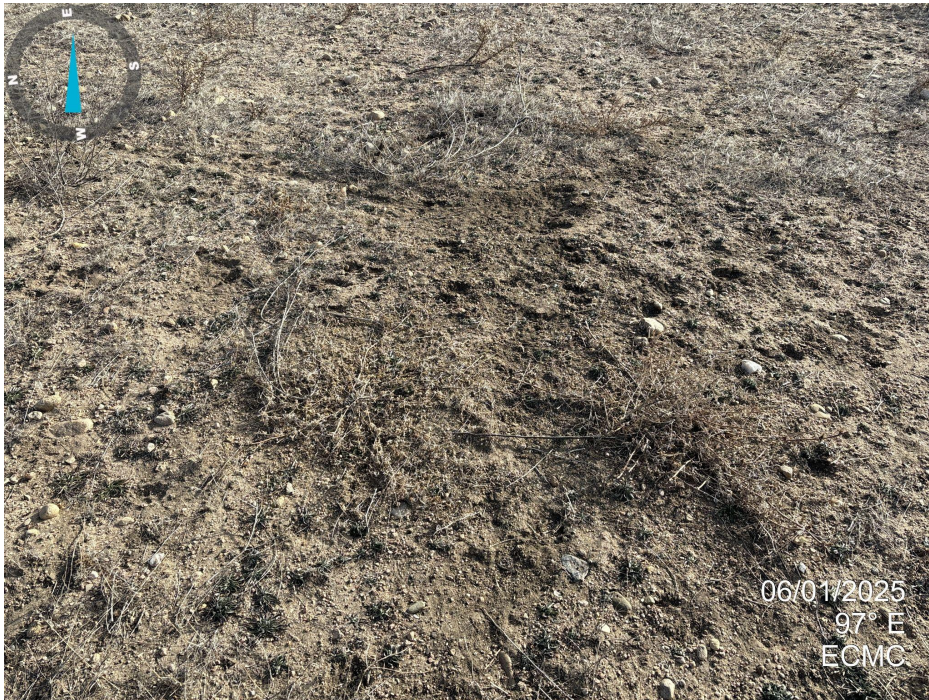
**Photo 5.** Example of groundcover taken at well site. Vegetative cover consists of undesirable or noxious plant species. Cobble and gravel is present.

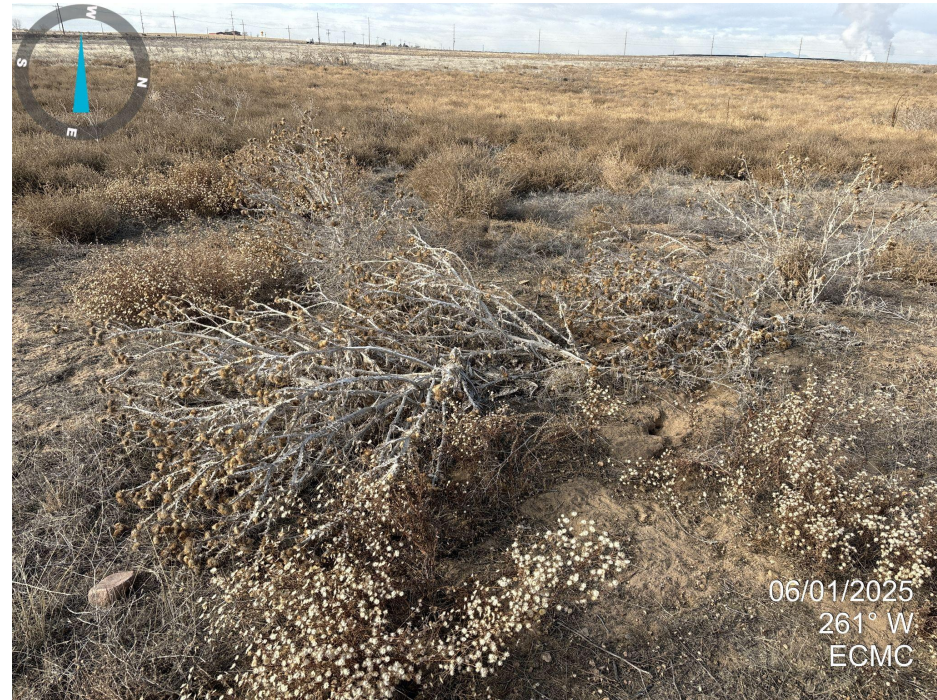
**Photo 6.** Looking west from the south side of well site. Class 2 noxious weed Scotch thistle is present on location.
