# Final Reclamation and Stormwater Inspection

Operator: KERR MCGEE OIL & GAS ONSHORE LP - 47120

Well Name: AMATO #11-1

Inspection Document #: 718600150

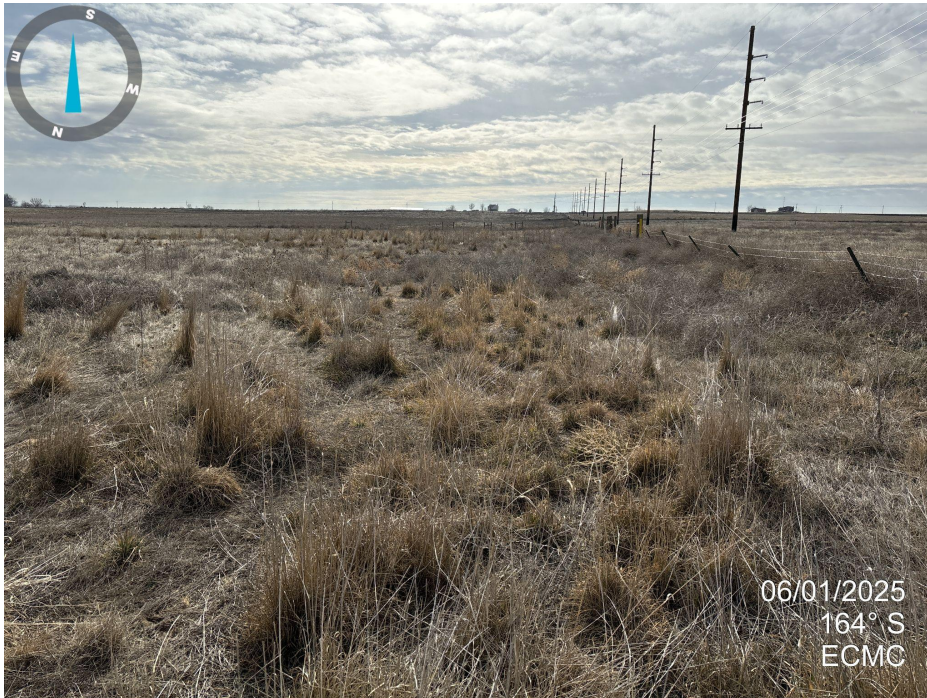
**Photo 1.** Looking south from nearby tank battery (Loc ID #409555) along former access road. Some desirable perennial plant species have established. Noxious weeds (Scotch thistle and Downy brome) are present. Undesirable plant species Russian thistle and Kochia are present throughout the location.

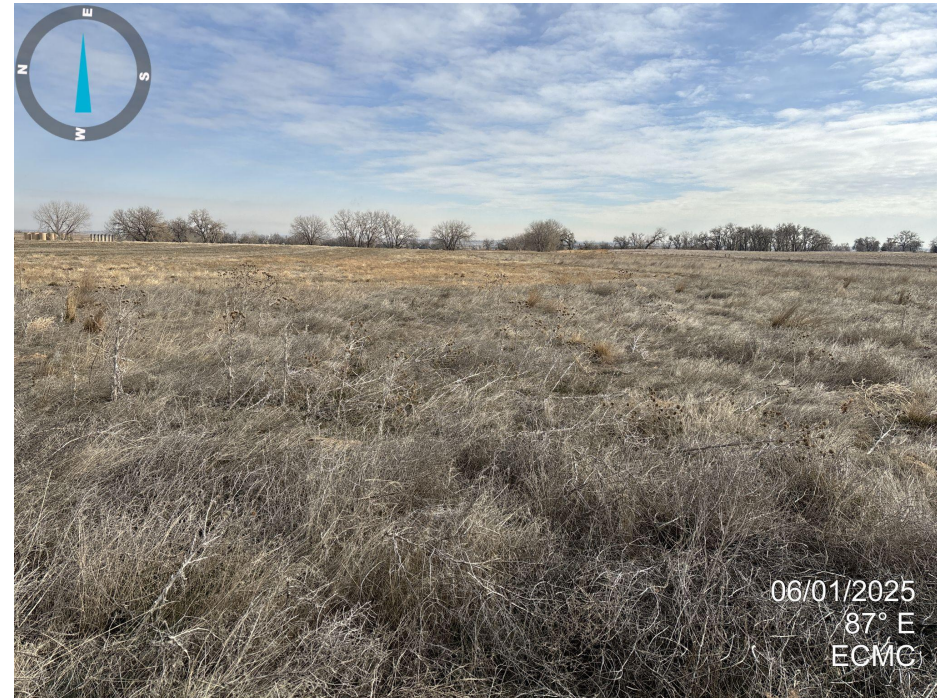
**Photo 2.** Looking east down former access road toward well site. See photo 1 comments.

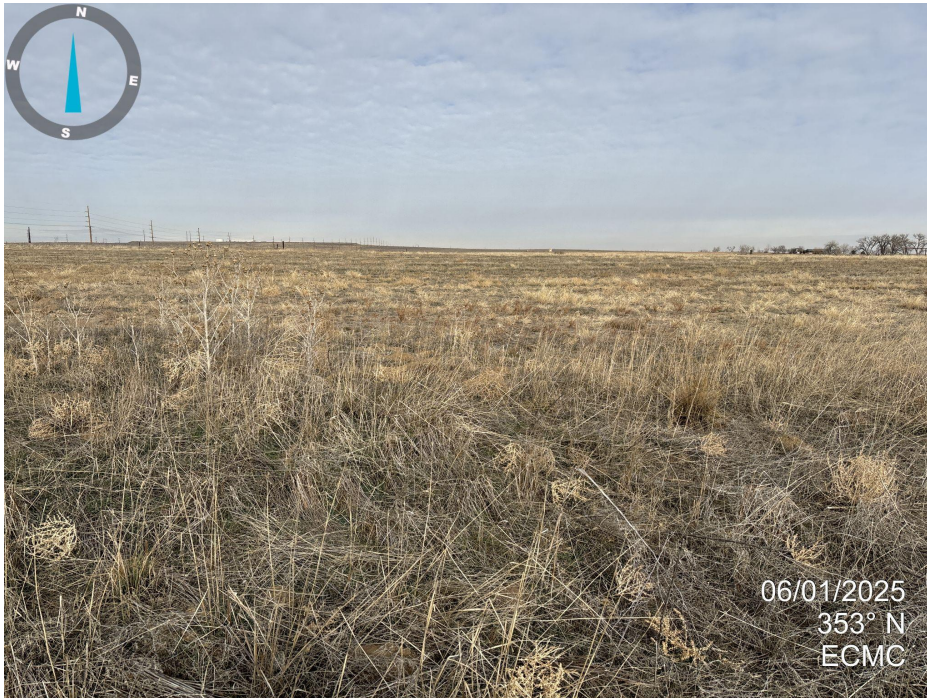
**Photo 3.** Looking north from wellsite. Nearby pasture has been mowed, well site does not appear to have been mowed. See Photo 1 comments.

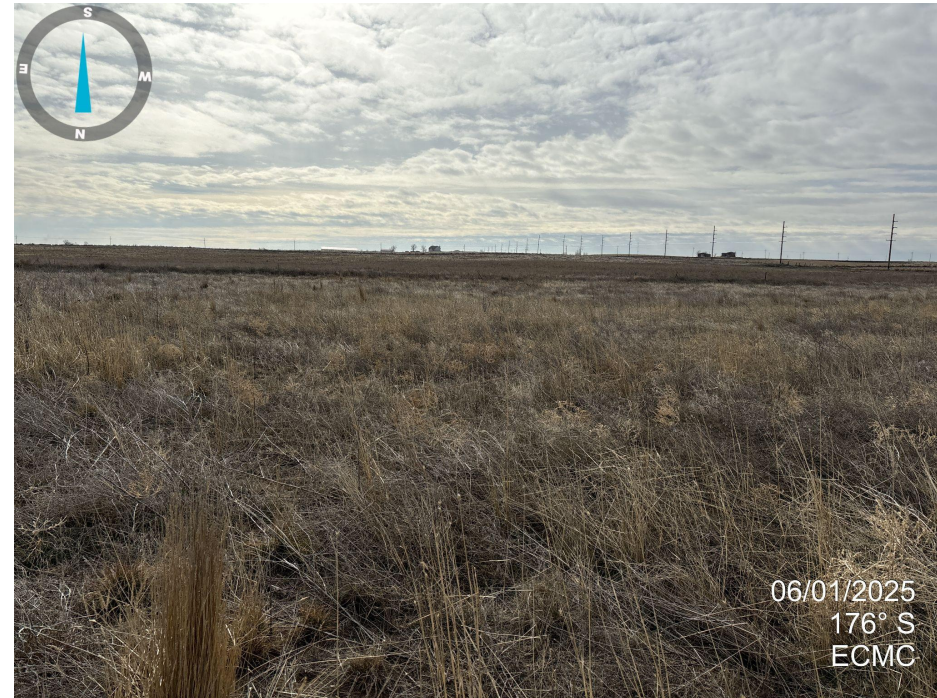
**Photo 4.** Photo looking south from wellsite. See Photo 1 comments.

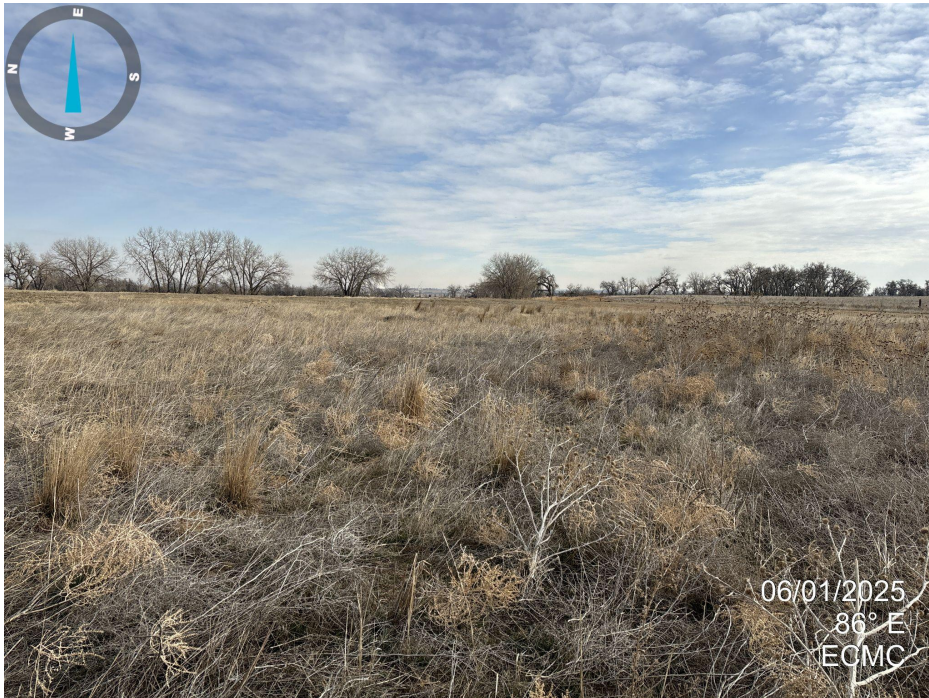
**Photo 5.** Looking east from wellsite. See Photo 1 comments.

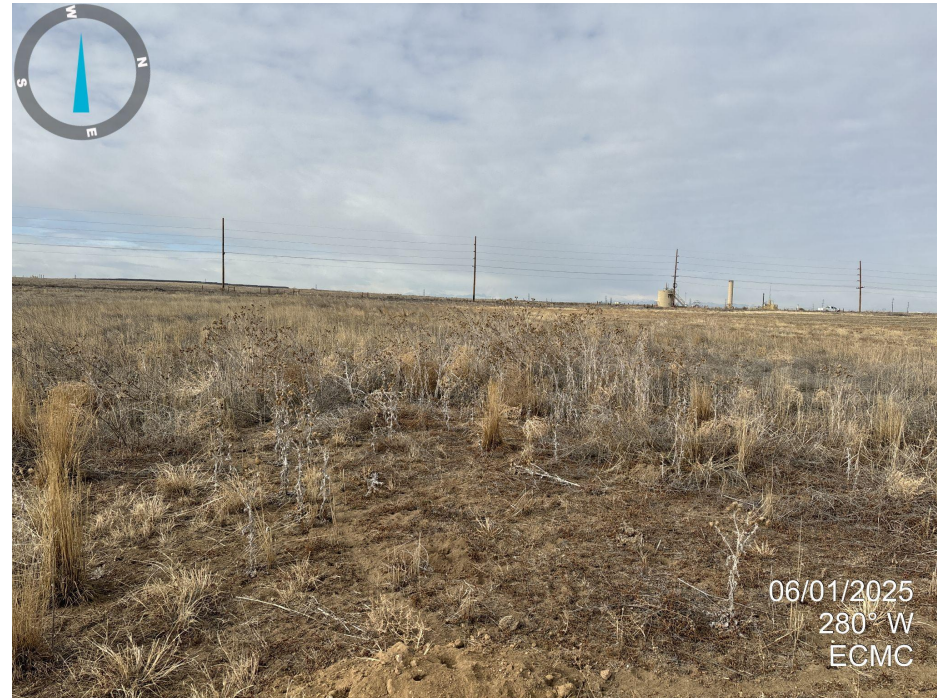
**Photo 6.** Looking west from the southeast side of well site. List B noxious weed Scotch thistle is present throughout location. Some bare areas are present.
