Inspection Photos

Location: TEP ROCKY MOUNTAIN LLC CHEVRON/TR 44-35-597 PAD

Location ID: 324298

Date: 01/6/2025

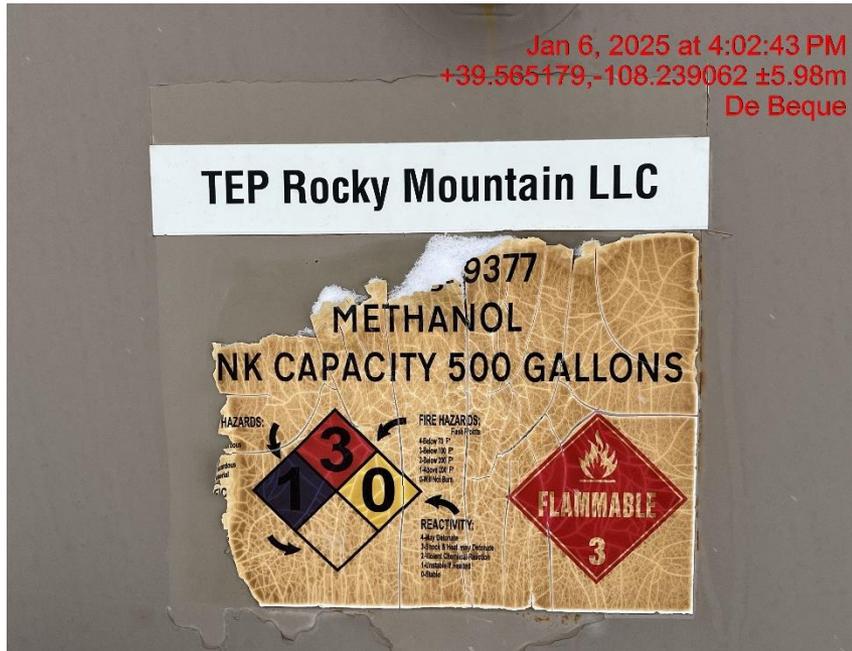
Photo # 2132 Lacks required information

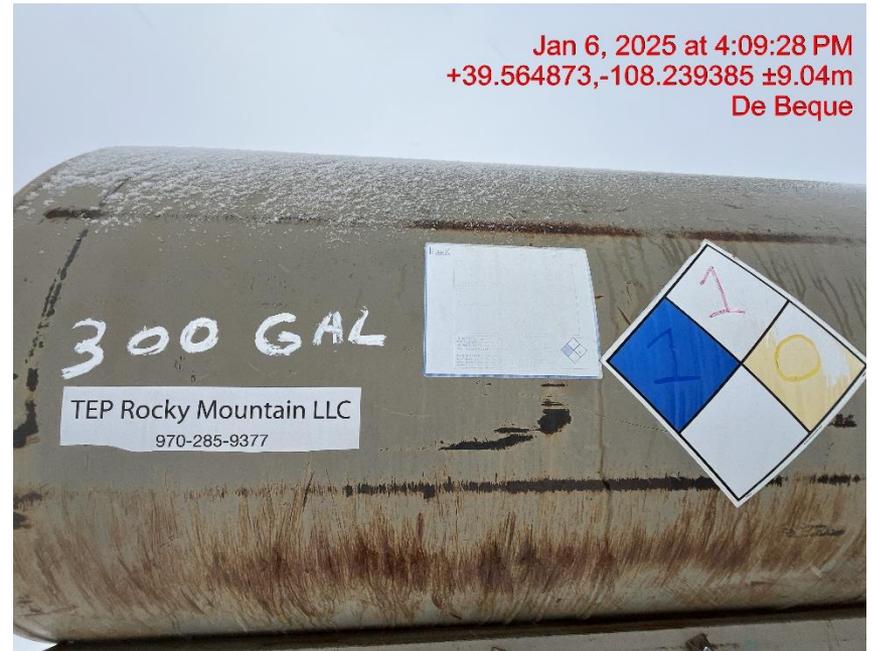
Photo # 2143 Lacks contents

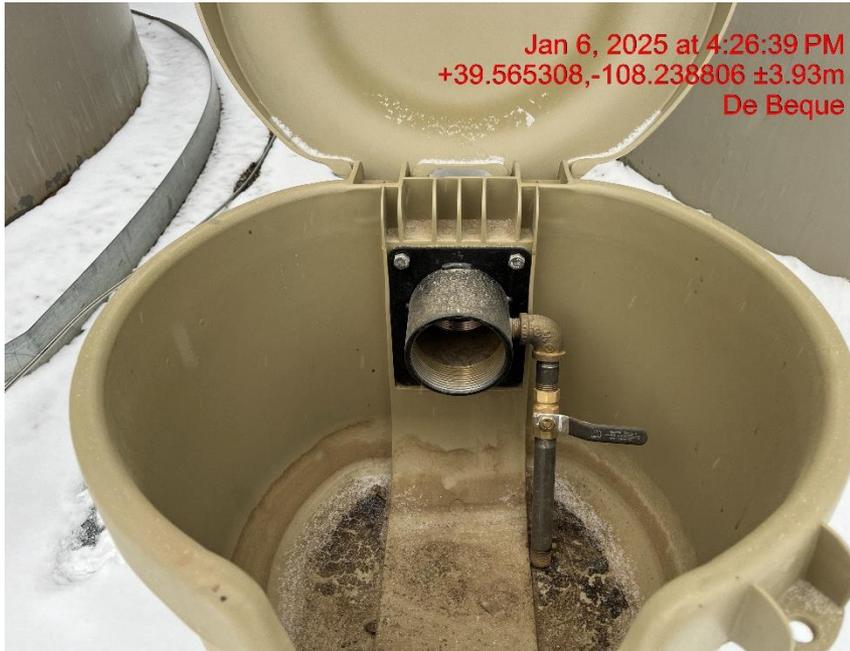
Photo # 2170 Open ended load line

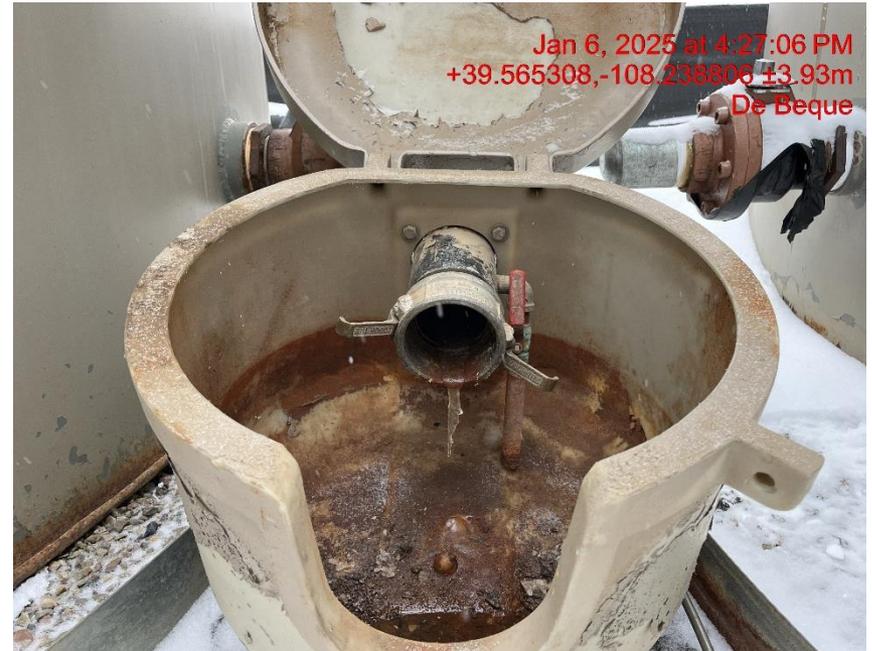
Photo # 2171 Open ended load line

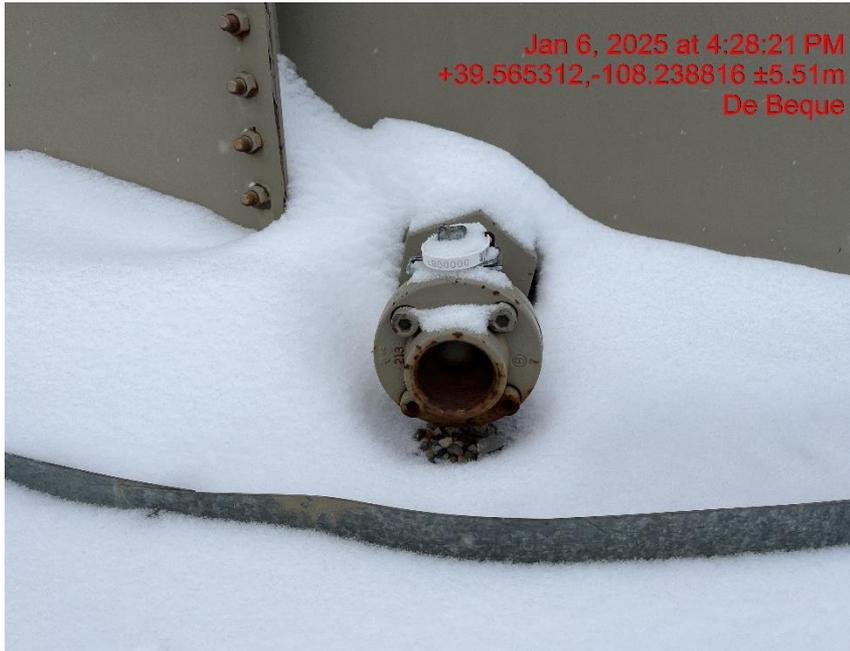
Photo # 2173 Open ended load line

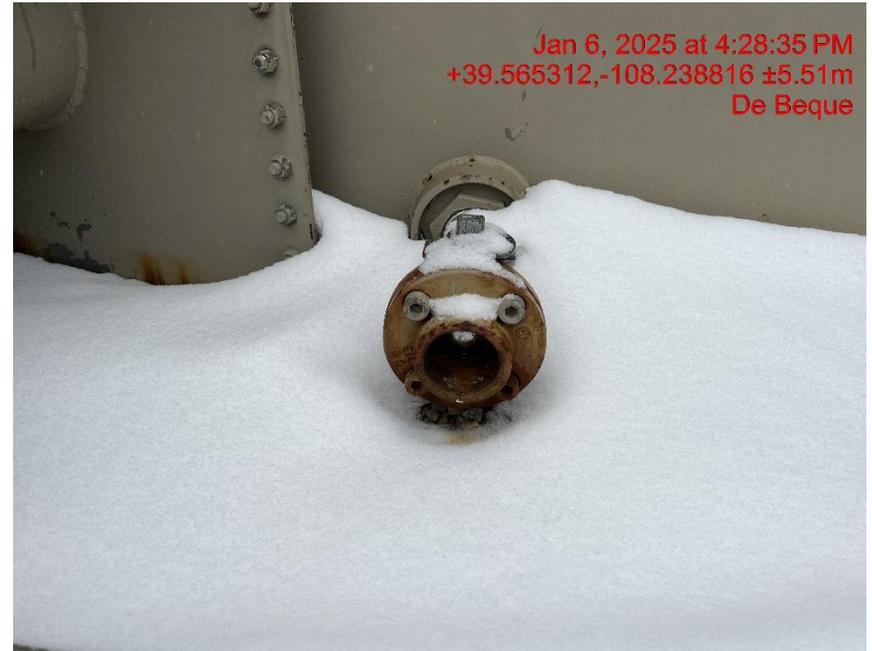
Photo # 2174 Open ended load line

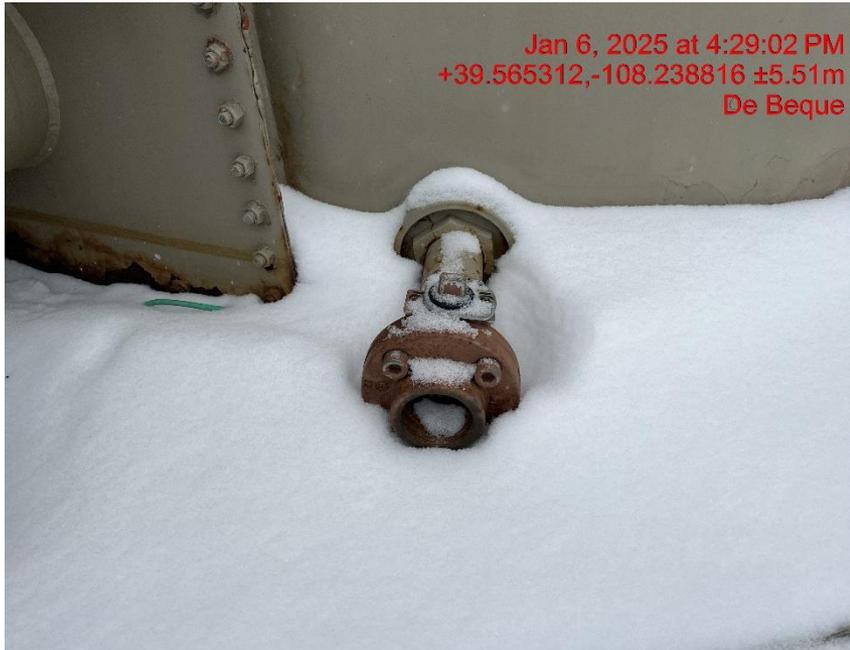
Photo # 2175 Open ended load line

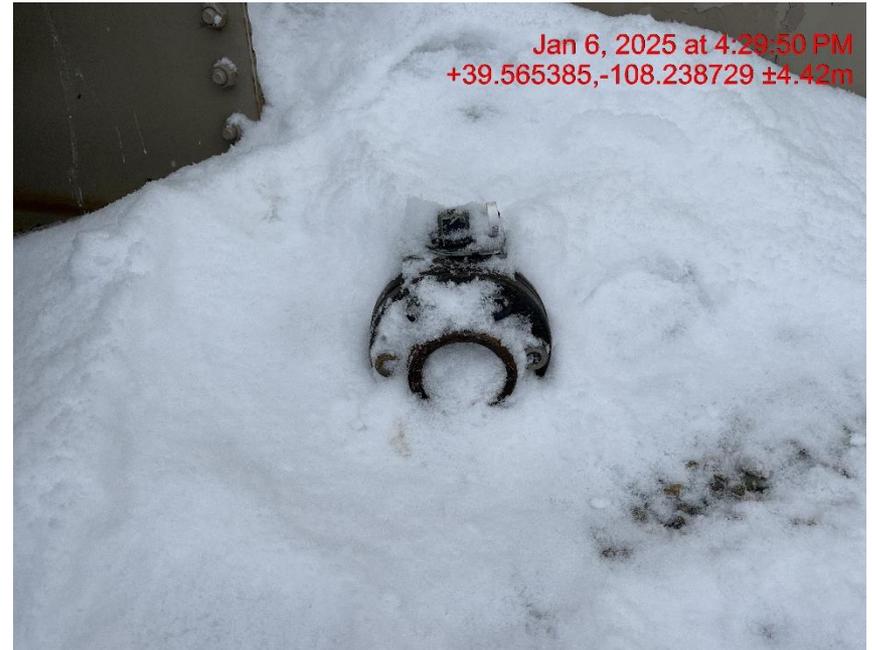
Photo # 2177 Open ended load line

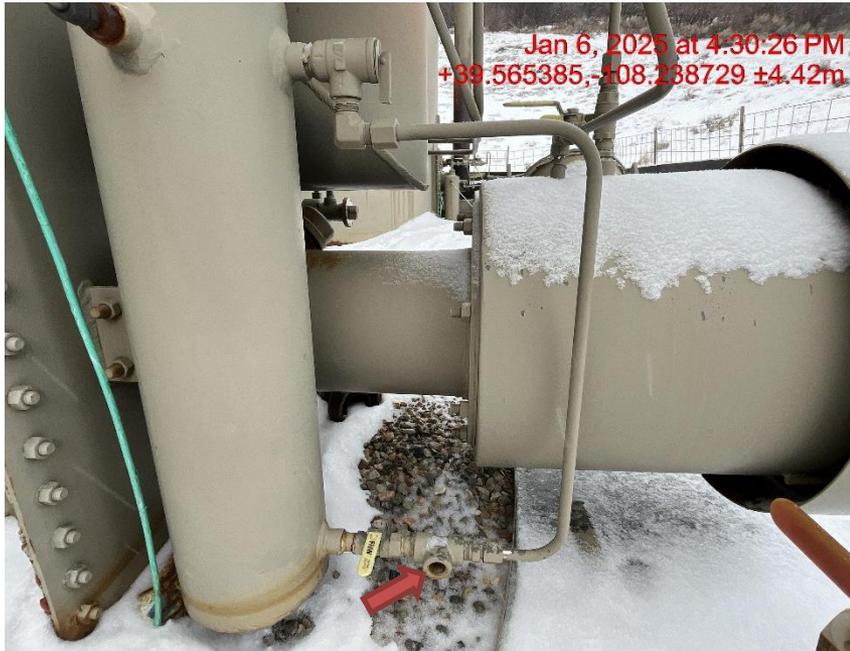
Photo # 2178 PRV vent line does not comply with CECMC pressure safety device rules

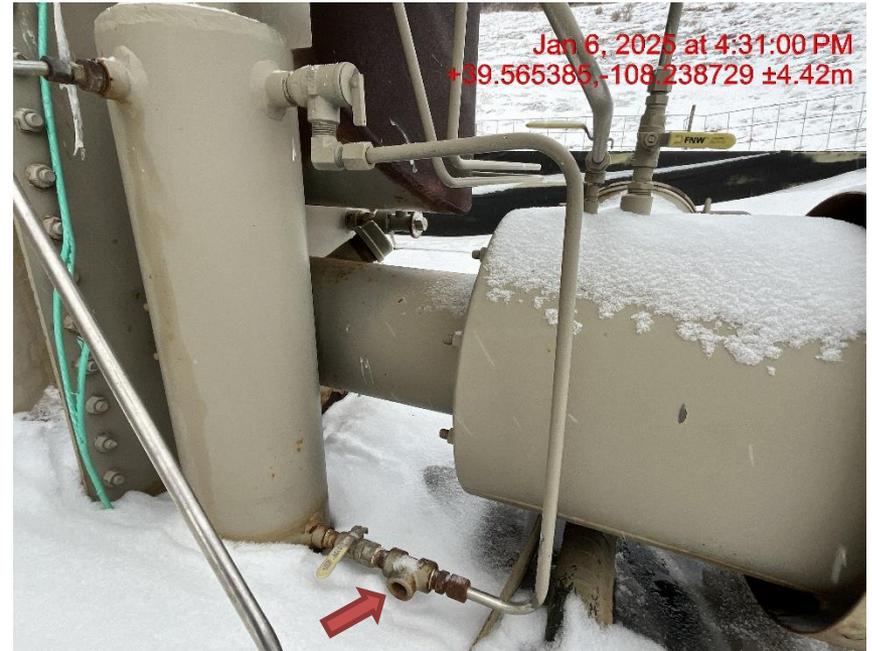
Photo # 2179 PRV vent line does not comply with CECMC pressure safety device rules

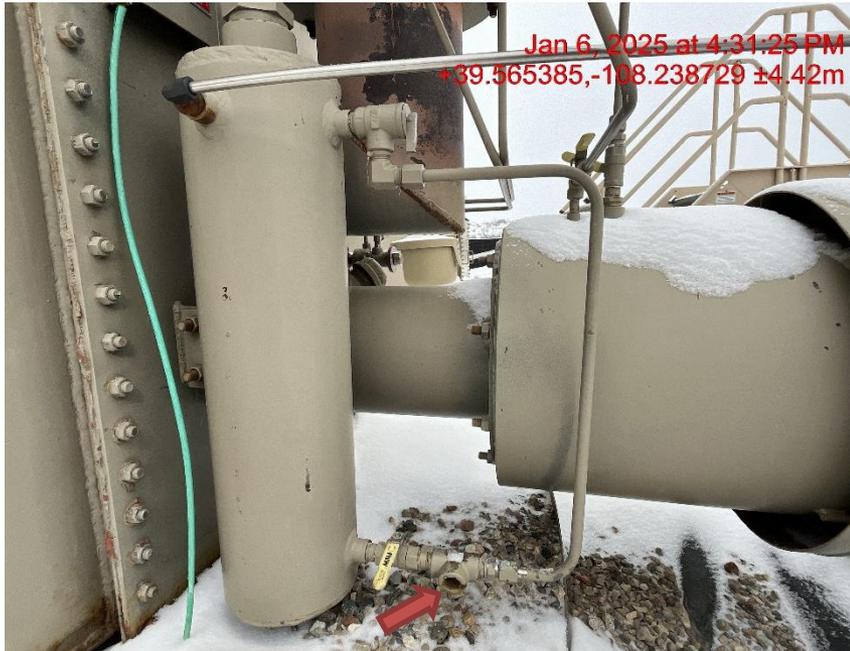
Photo # 2180 PRV vent line does not comply with CECMC pressure safety device rules

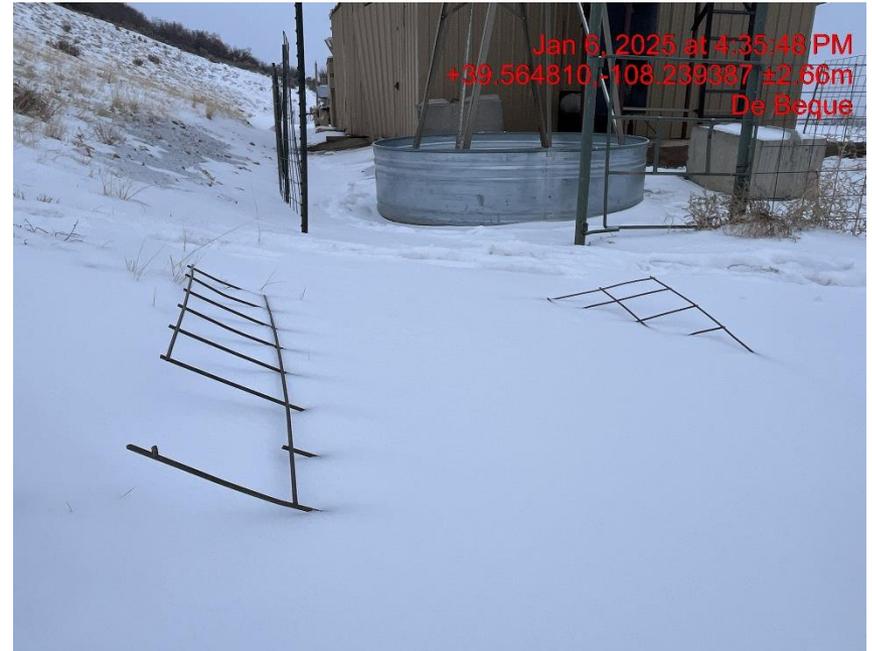
Photo # 2183 Debris

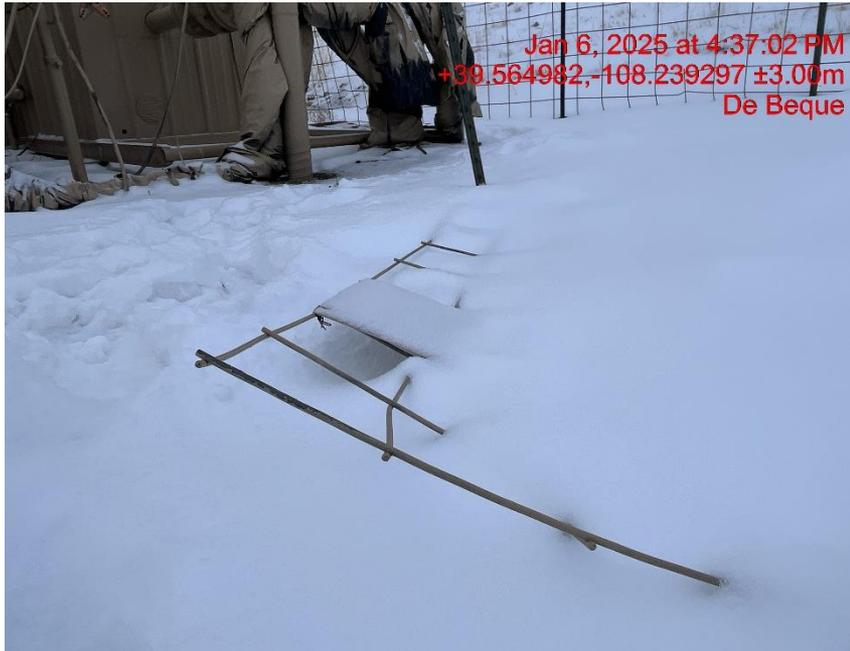
Photo # 2185 Debris

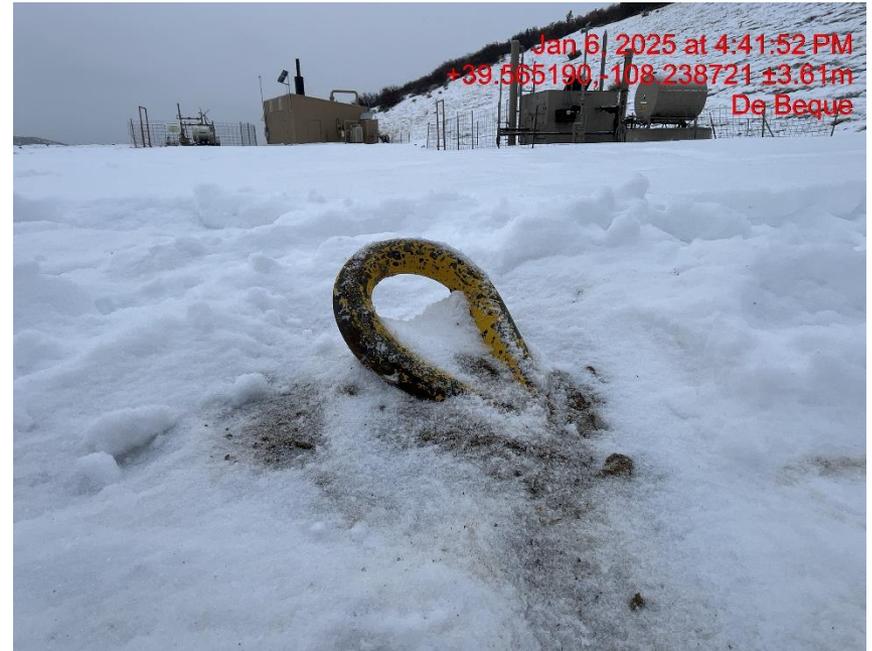
Photo # 2189 Unmarked Deadman
