## Annual Reclamation Assessment Report (2024)

<b>ECMC Location Name (ID)</b>	MATT-64N67W /24NWSW (331001)
<b>Operator Location Name</b>	Matt 1 Well Pad & Facility
<b>ECMC Operator Name (ID)</b>	PDC ENERGY, INC (69175)
<b>Legal Description</b>	NWSW Sec. 24 T4N-R67W
<b>Well Pad Geographic Coordinates (WGS84)</b>	40.295627/ -104.846841
<b>Facility Pad Geographic Coordinates (WGS84)</b>	40.294865/-104.848239

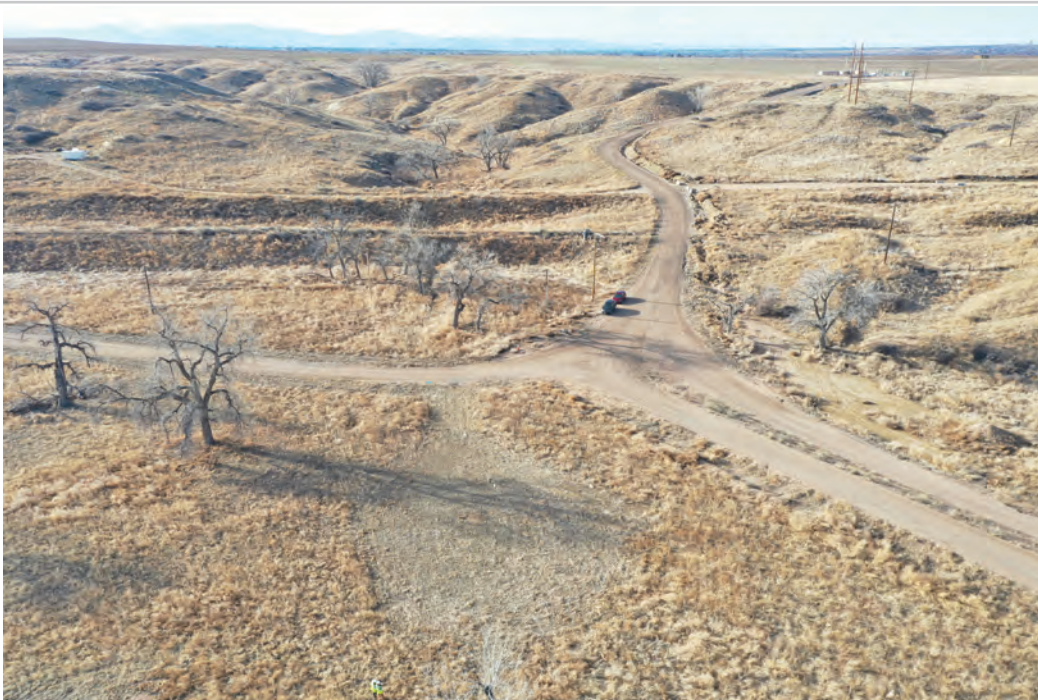
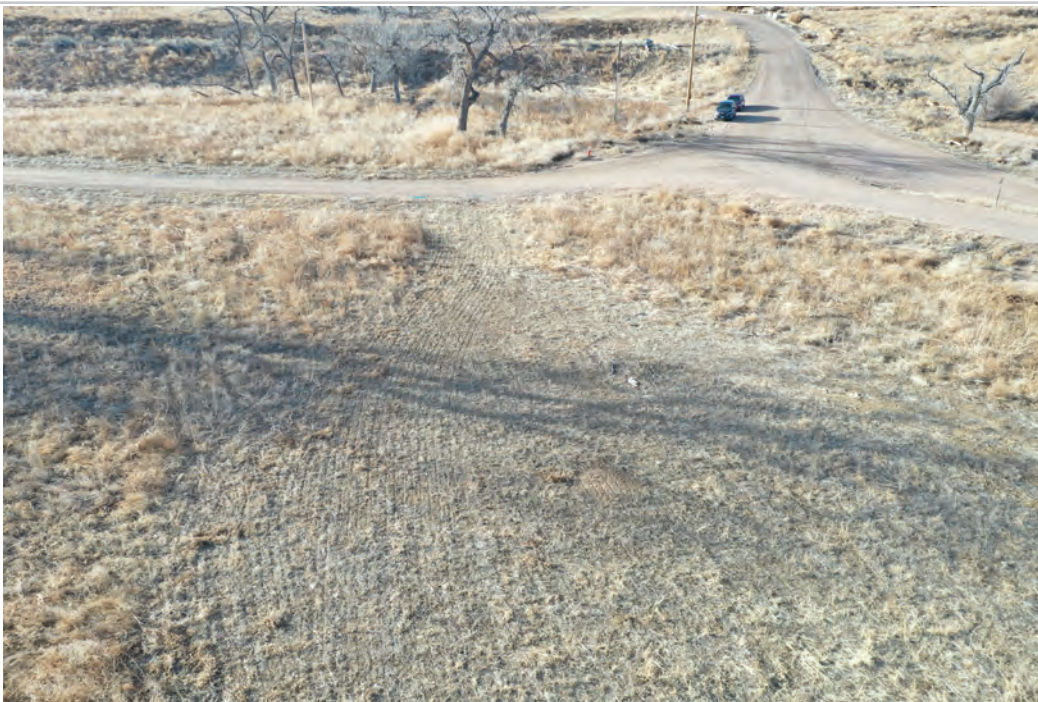
**PRIMARY SITE RECOMMENDATION: Variance / Surface Owner Consultation**

Primary Recommendation:	Rationale:	Description:
Variance / Surface Owner Consultation	Run-on from the off-Location railroad culvert has caused site degradation.	Since off-Location run-on is resulting in site degradation and is not in the control of PDC, a variance is recommended to request waiver from final reclamation vegetation establishment requirements.

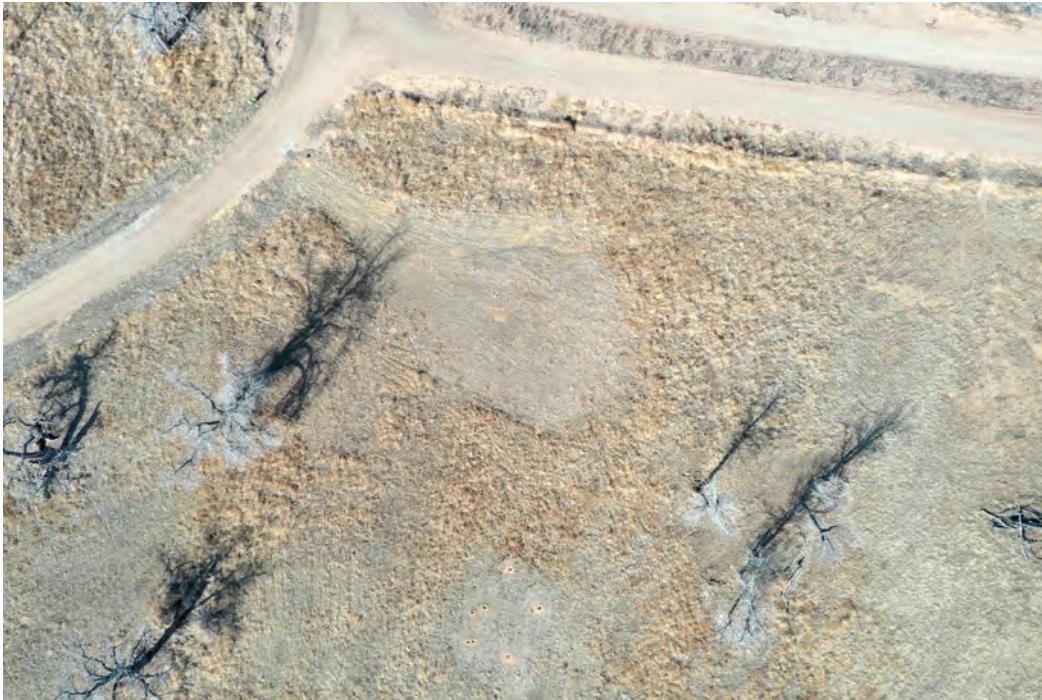
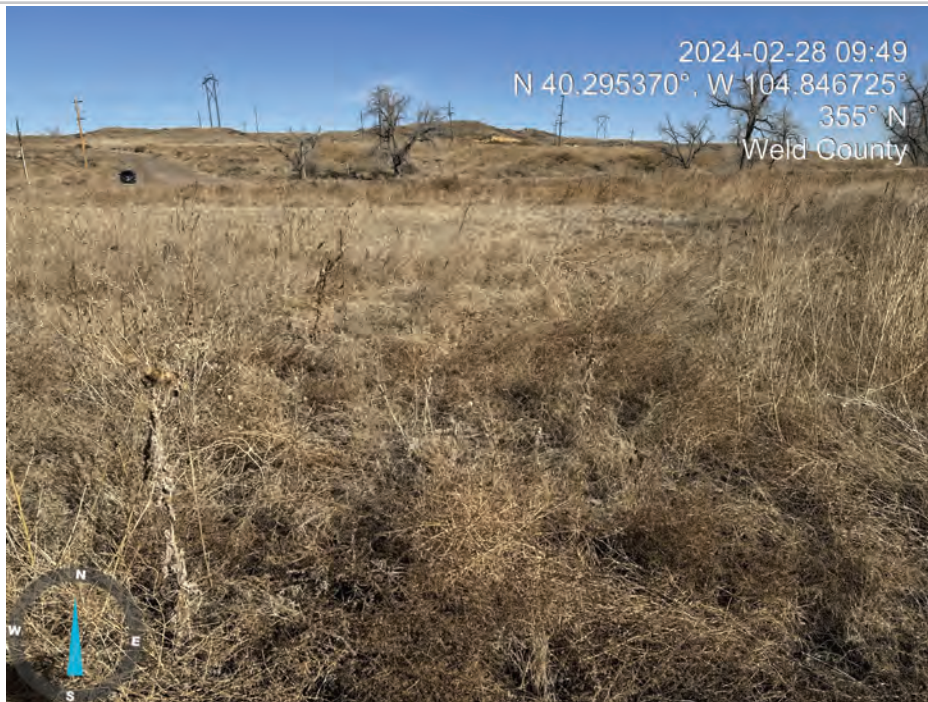
**SECONDARY SITE RECOMMENDATION: Maintenance**

Secondary Recommendation:	Rationale:	Description:
Maintenance	Noxious and undesirable vegetation doiminate the reclaim.	Mechanical weed management (mowing with bagging attachment) is recommended on the full extent of the well pad reclaimed surface. Currently, only a portion of the historical surface disturbance has been mowed. This will help to remove developed weed seeds. If possible, and pending surface owner approval, the adjacent reference area dominated with weeds should be mowed as well to prevent migration of weeds from the reference into the reclaim. Chemical weed management is not recommended until seeded grasses germinate and become established.

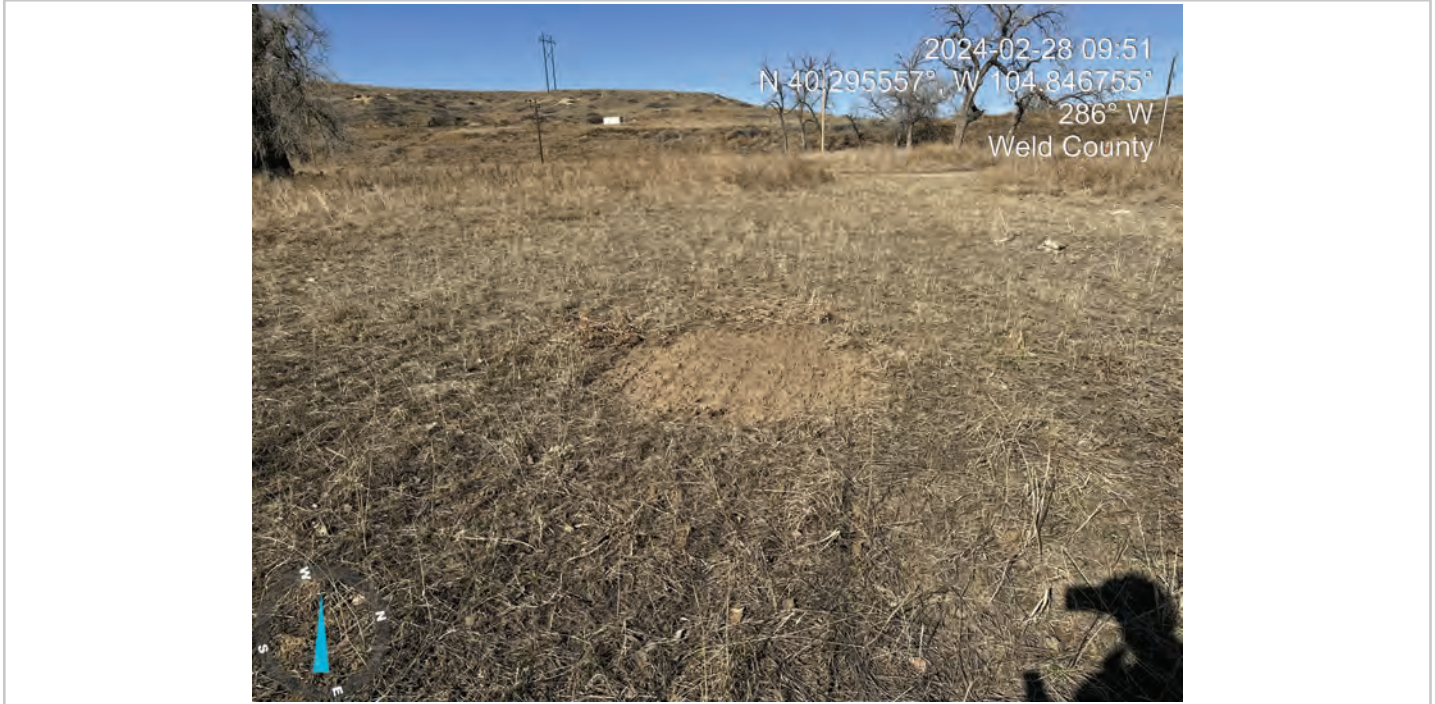
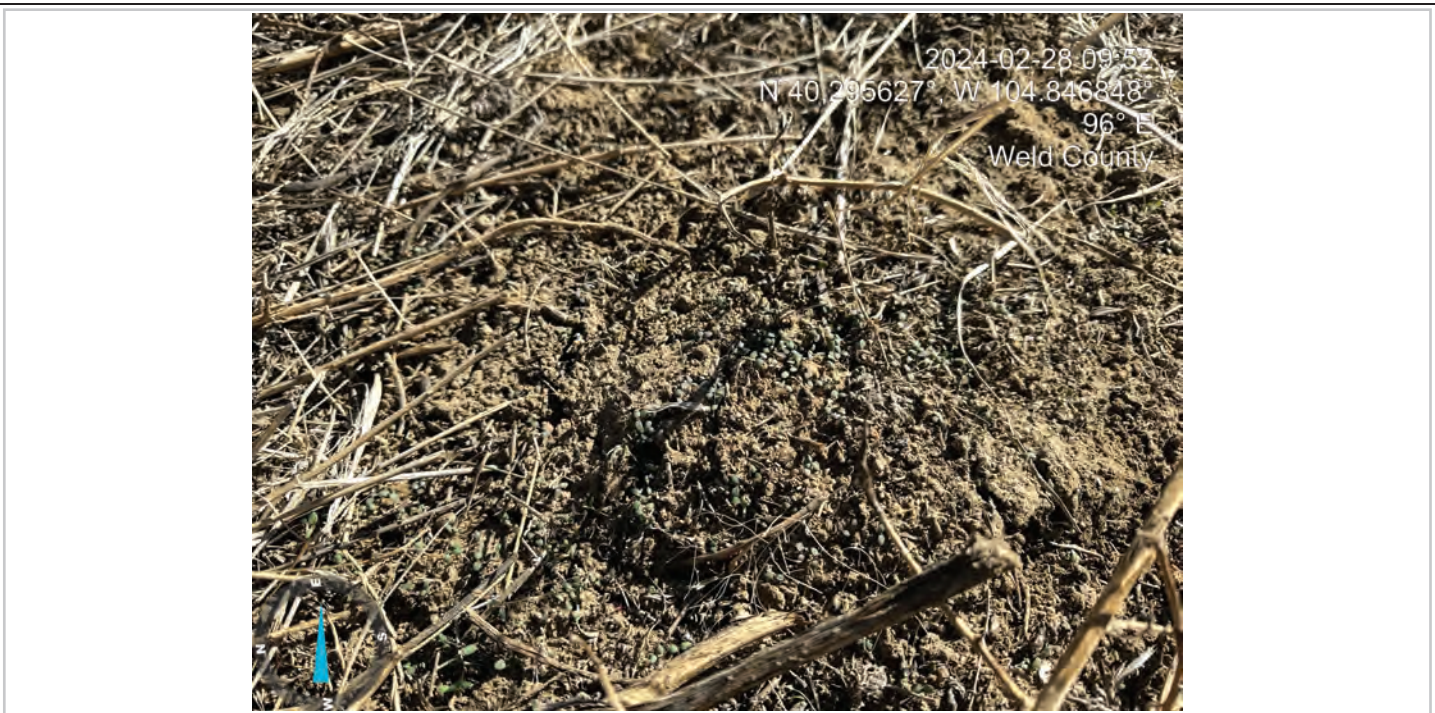
TERTIARY SITE RECOMMENDATION: Continue Monitoring

Tertiary Recommendation:	Rationale:	Description:
Continued Monitoring	Reclamation area was dormant at time of inspection.	Continued monitoring is recommended to evaluate reclamation trajectory once seeded and existing perennial vegetation begin growing.

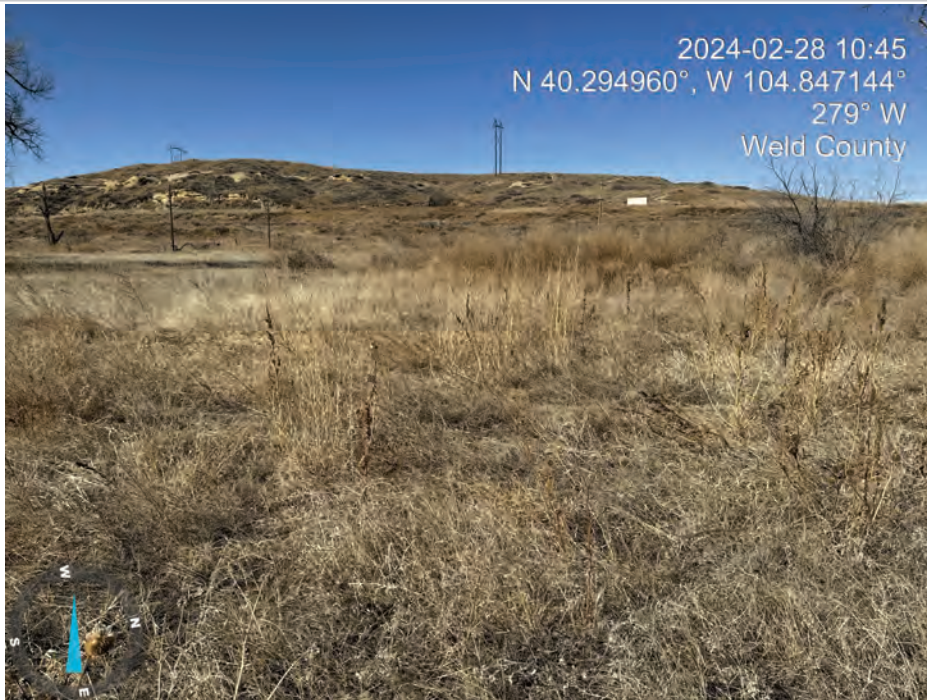
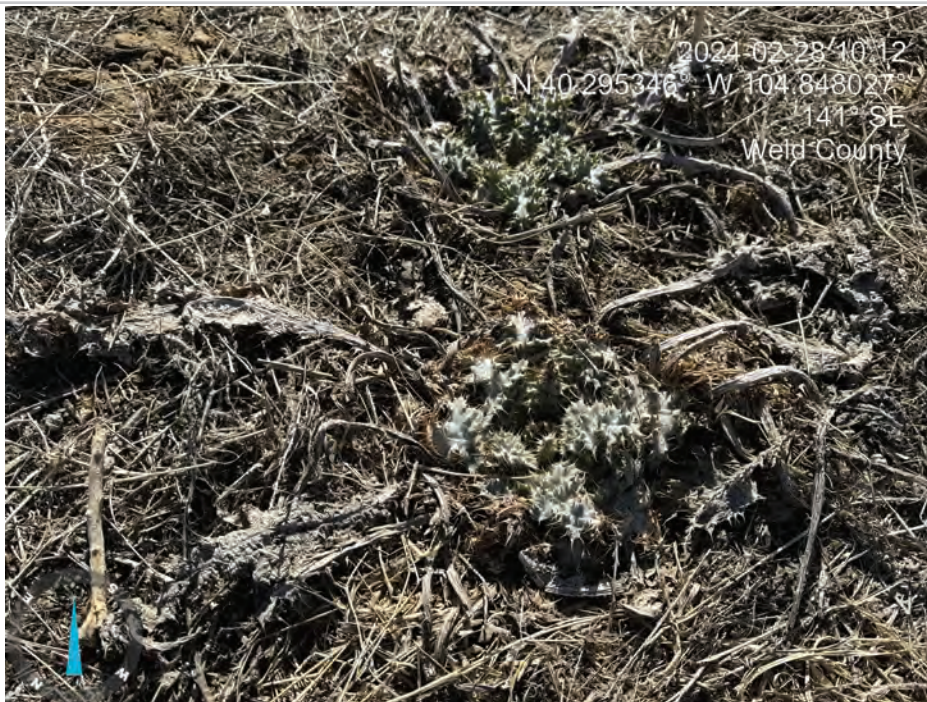
PRIMARY SITE RECOMMENDATION: Maintenance

Coordination with the surface owner is recommended to encourage him to manage Noxious weed establishment along the access road north of the Location. No Noxious vegetation is present within the reclaimed surface, however, developed seeds are present on remnant vegetation from the previous growing season. Without intervention it is highly likely that these noxious weeds will encroach and become established within the reclaimed surface. Mechanical weed management (mowing with a bagging attachment) is recommended followed by targeted chemical weed management to manage Noxious thistle species.

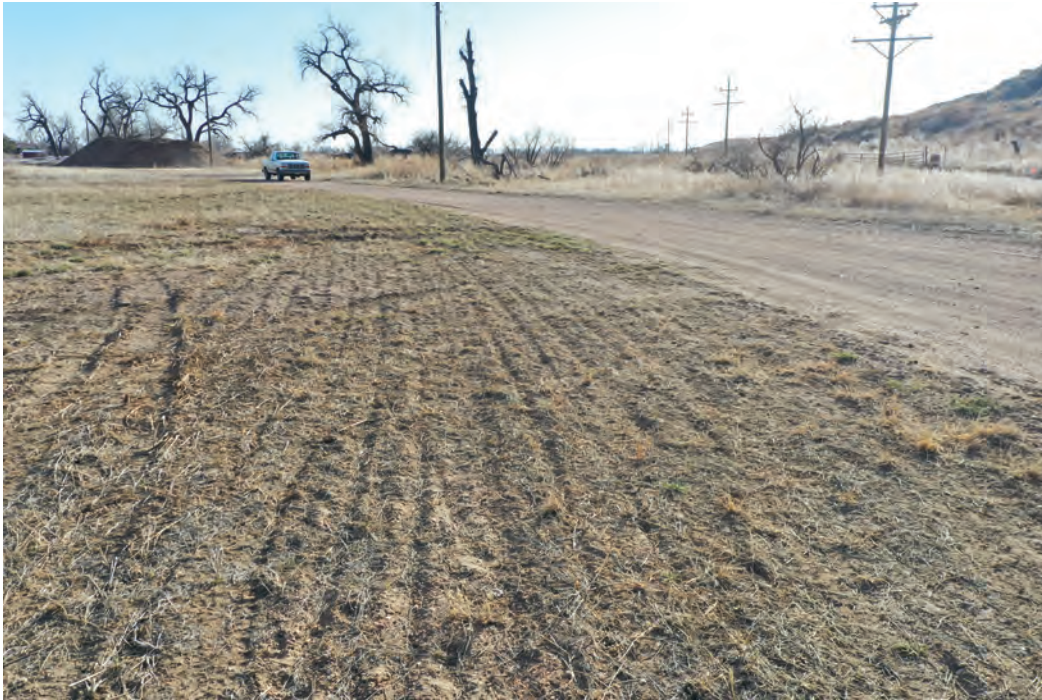
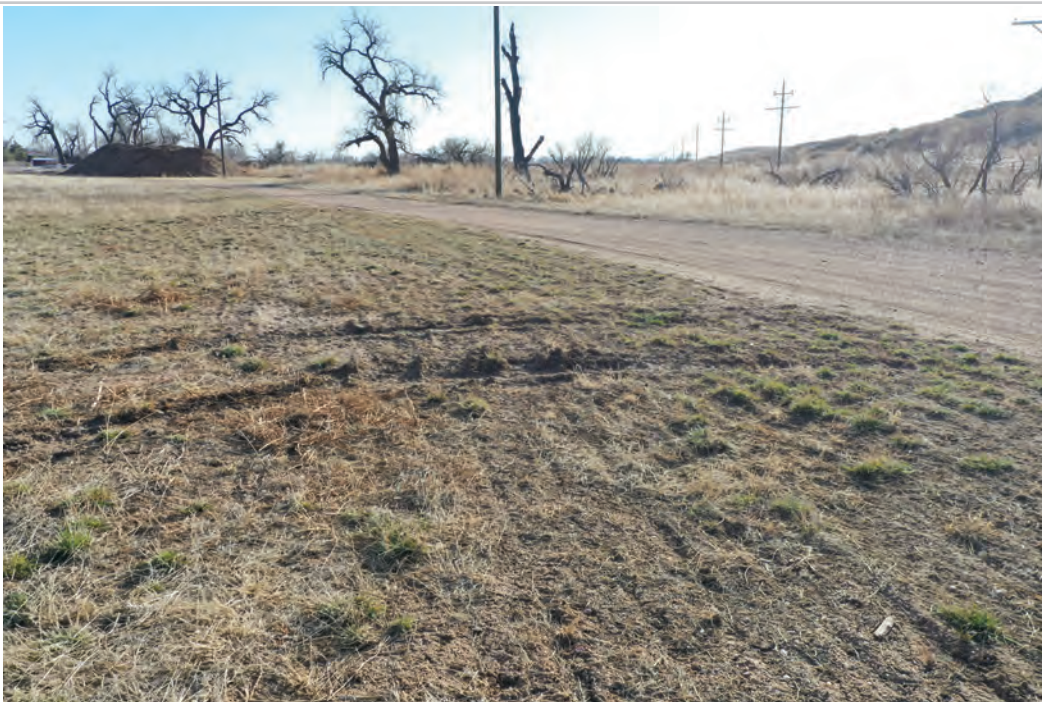
SECONDARY SITE RECOMMENDATION: Continue Monitoring

Continued monitoring is recommended to evaluate reclamation trajectory once seeded and existing perennial vegetation begin growing.

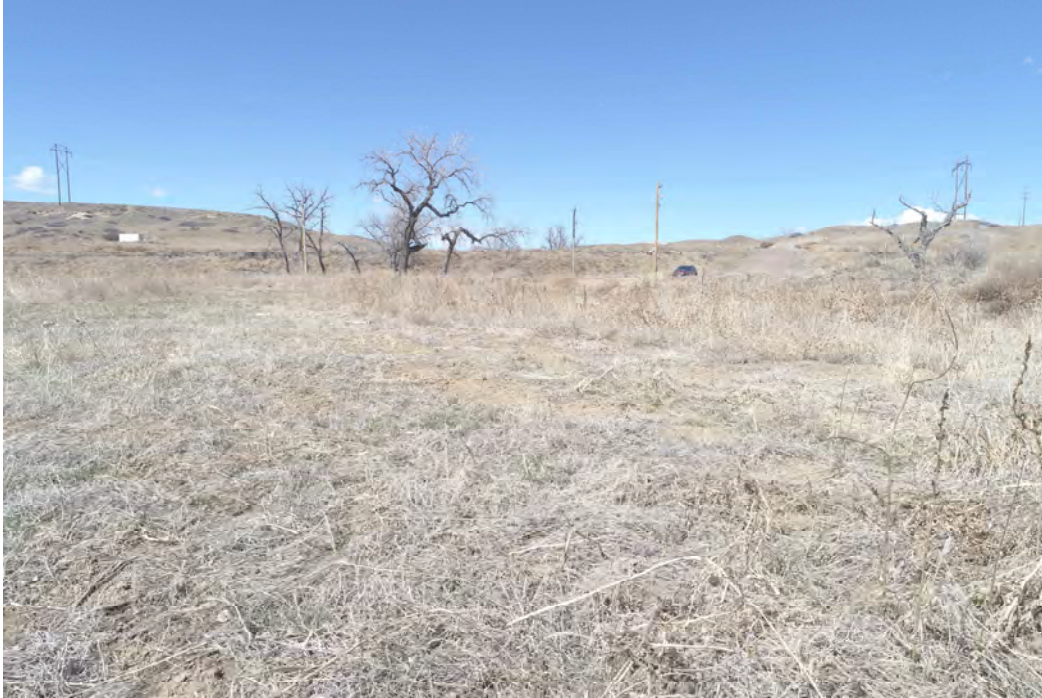
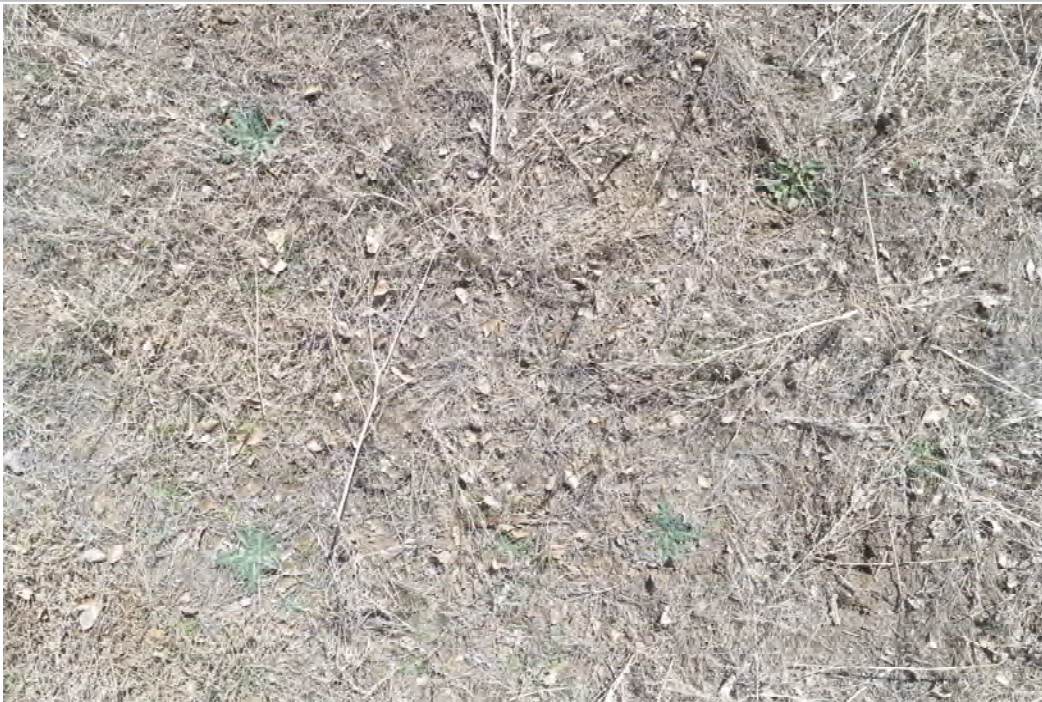
**PRIMARY SITE RECOMMENDATION: Maintenance**

Primary Recommendation:	Rationale:	Description:
Maintenance	Noxious and undesirable vegetation dominate the reclaim.	Coordination with the surface owner is recommended to discuss the most desirable approach to weed management on location. Spot treating noxious thistle species is recommended for best management and to reduce potential for further encroachment of noxious vegetation within the reclaim. Another recommended approach would be to mow the historical surface disturbance and adjacent reference area to help remove developed weed seeds and reduce further migration of weeds from the reference into the reclaim.
