KT Resources LLC
 WRD Wyatt-62N97W 25SESE
 Location ID: 336393

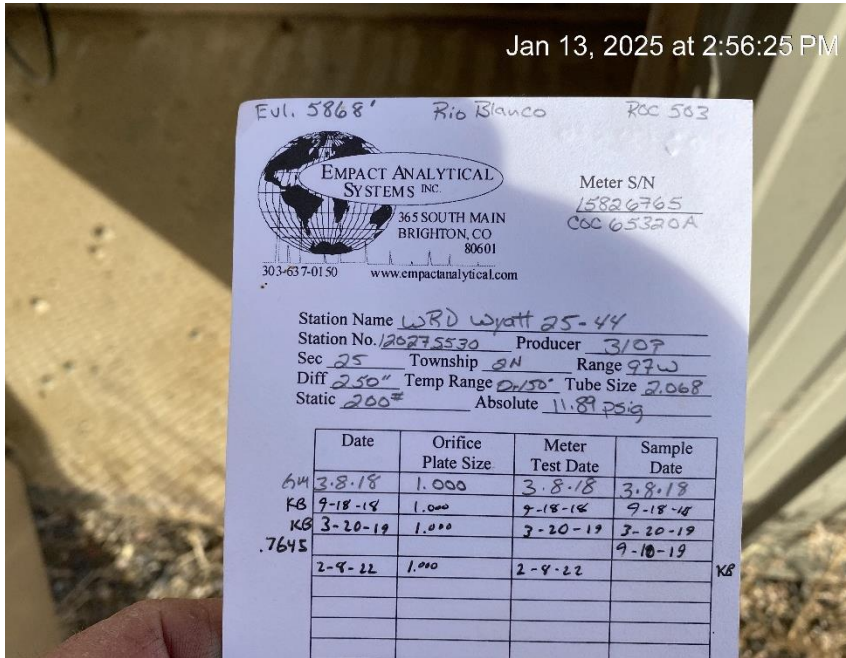
25-44. Gas calibration overdue.

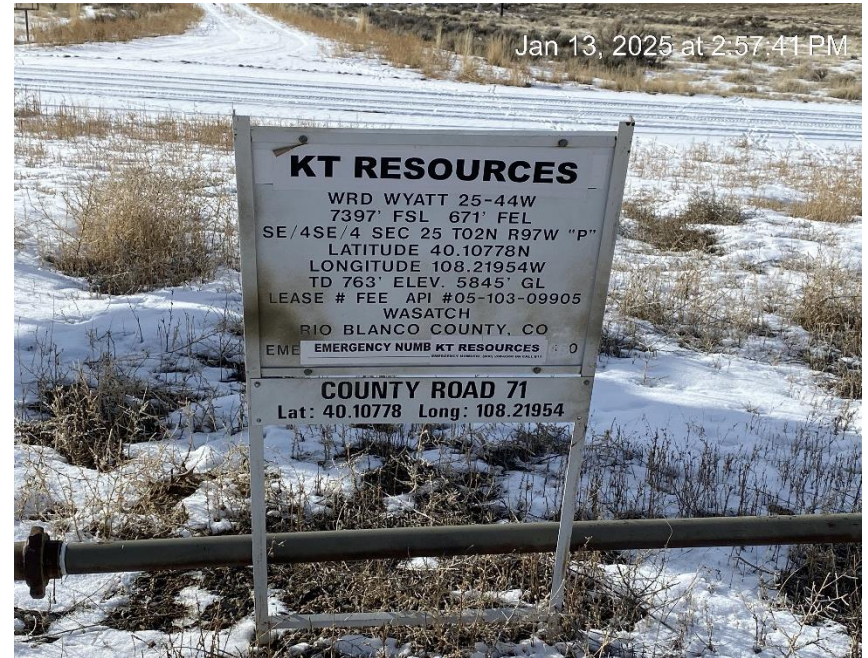
Sign along flow line. No production equipment.

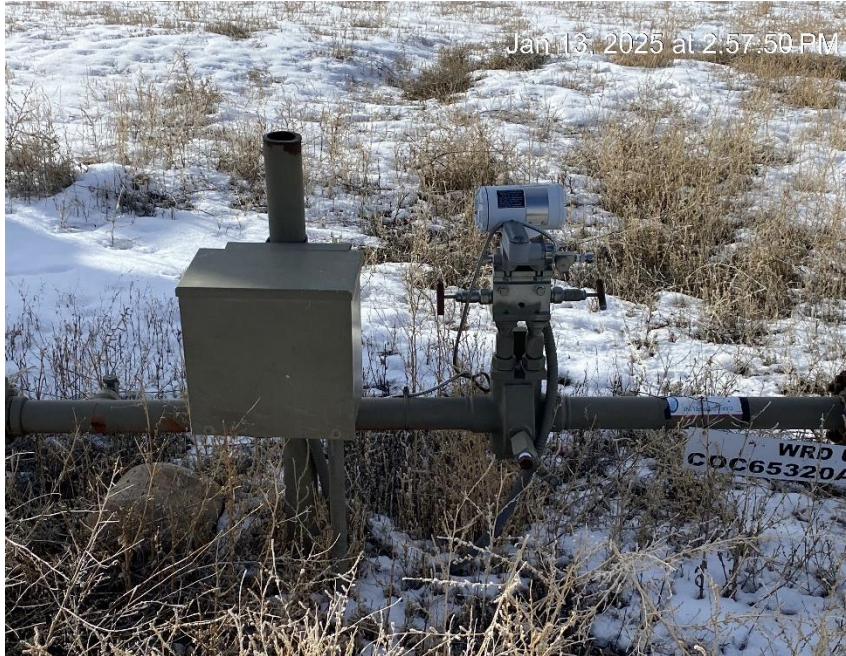
25-44W. No calibration card.

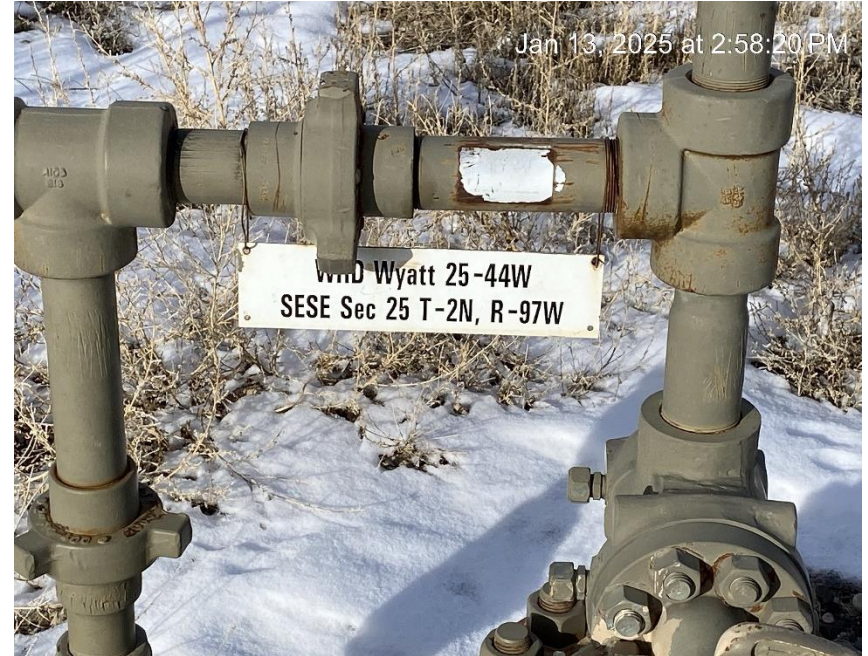
When replaced additional information is required

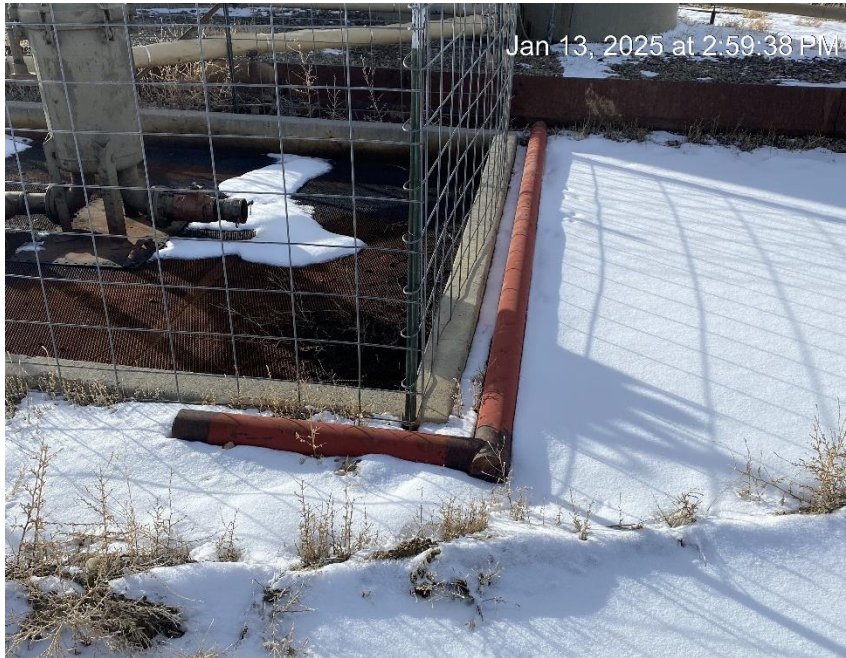
Debris

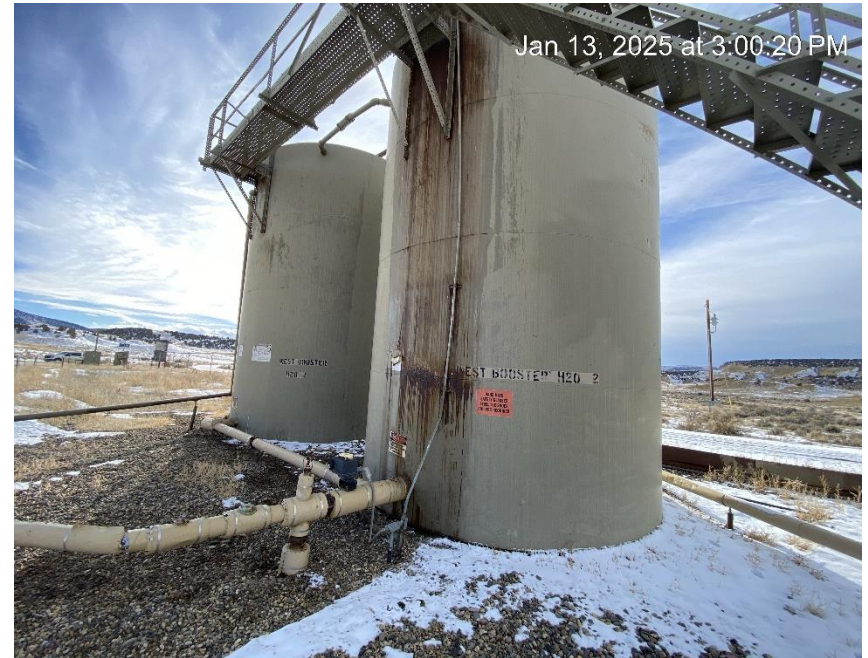
Previous spill and stained soils

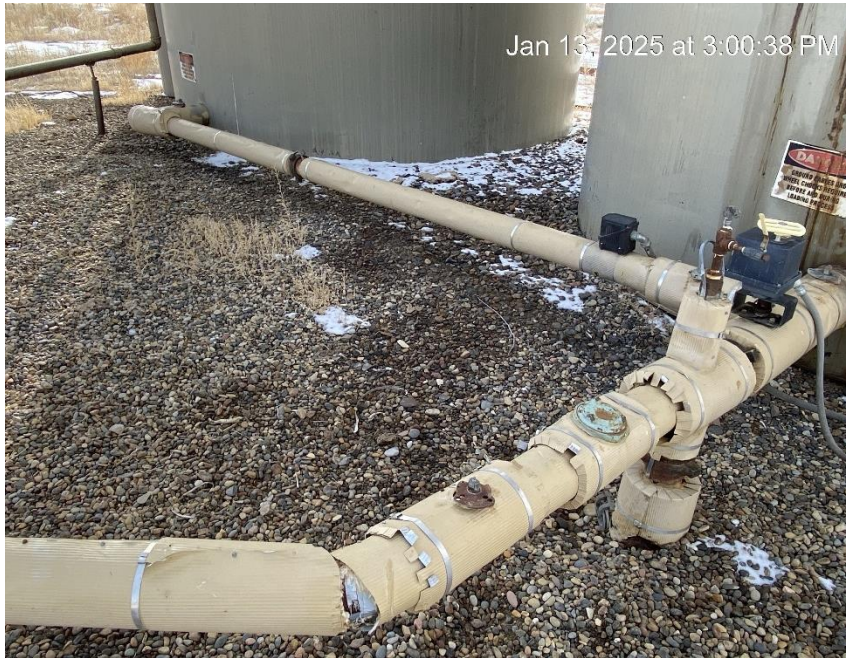
Soil staining

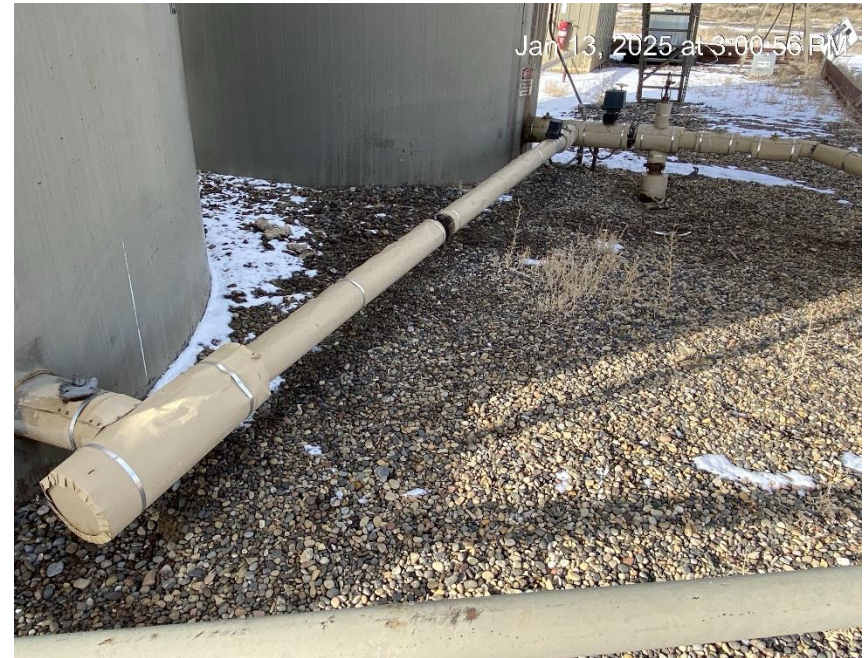
Soil staining

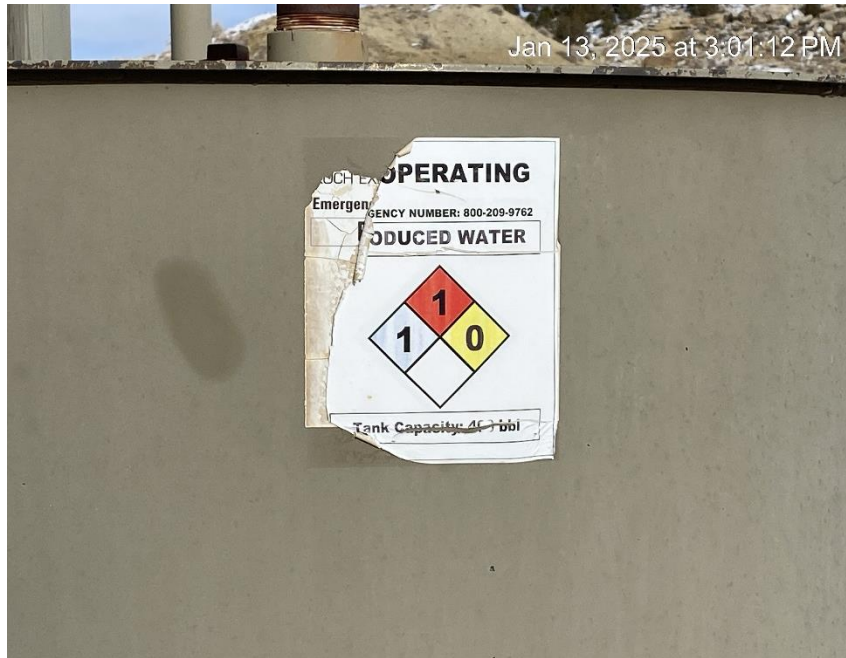
Damaged tank label

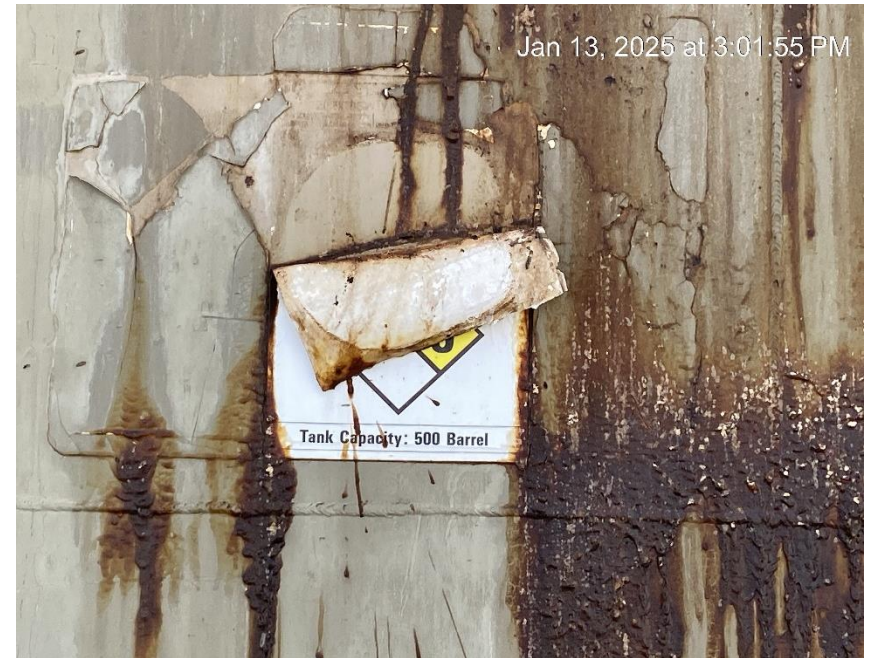
Oily waste. Damaged tank label.

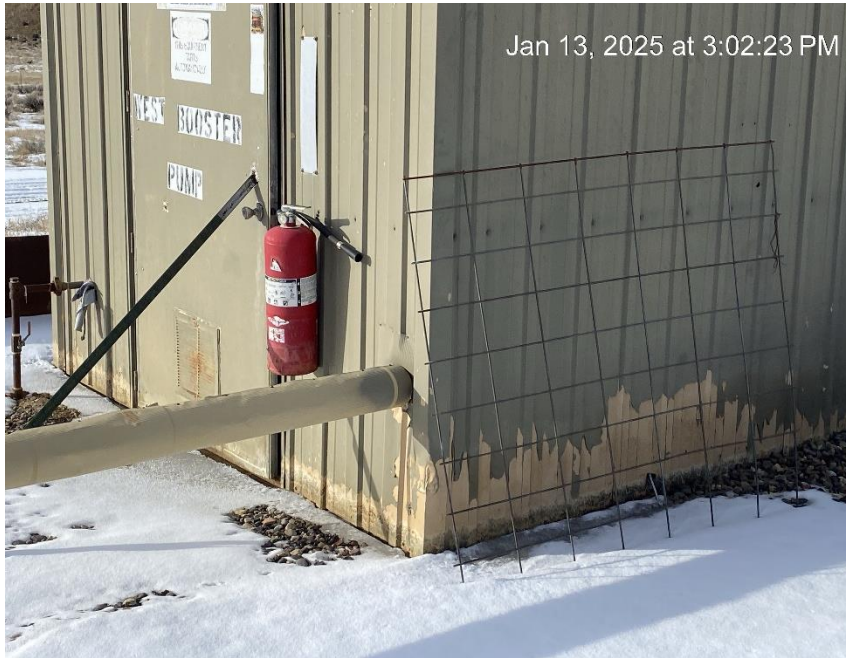
Debris

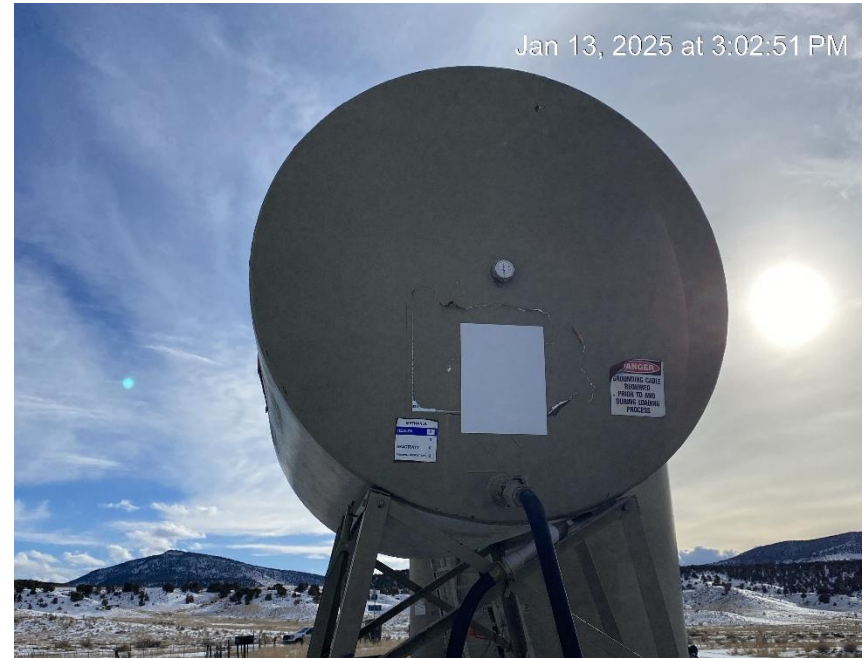
Illegible label

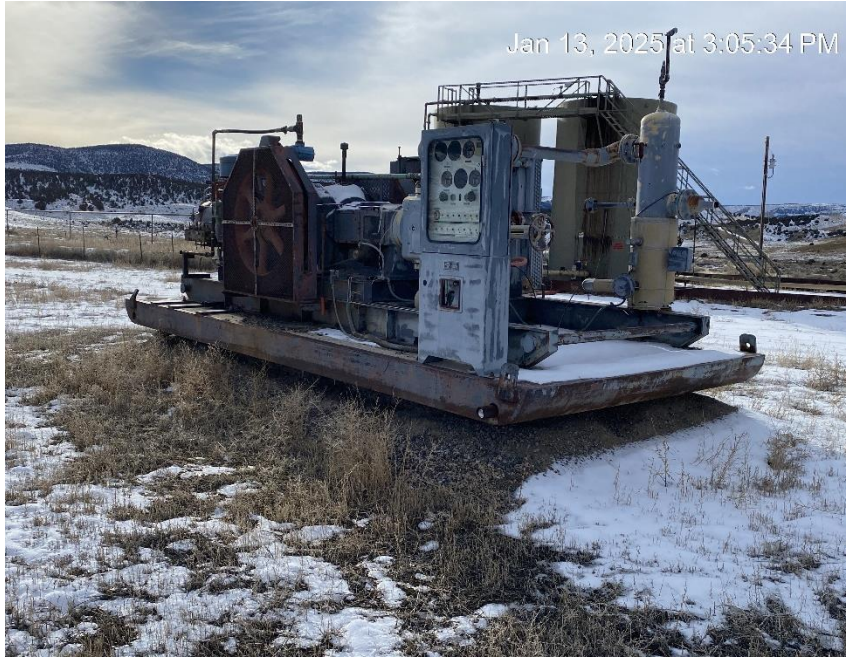
Unused equipment

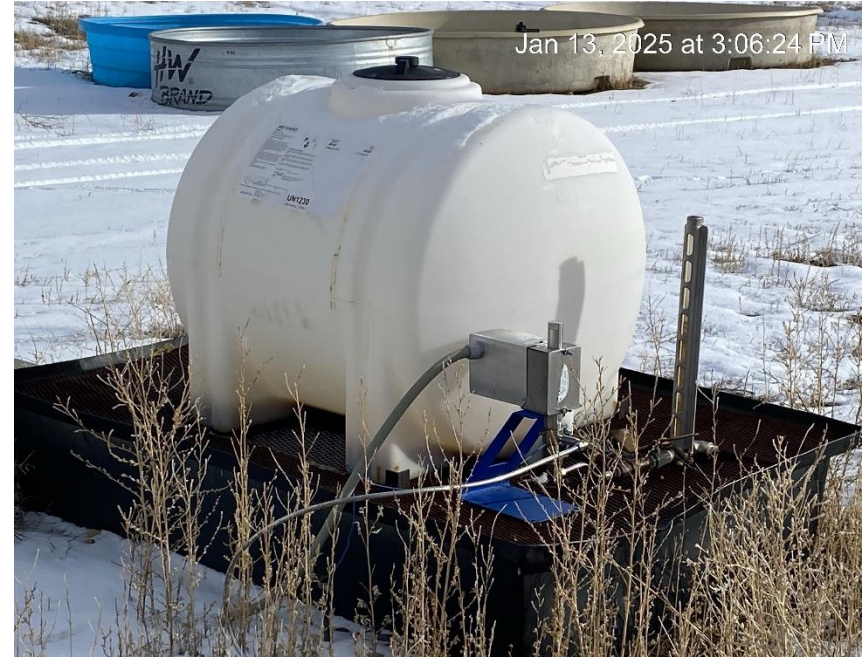
Illegible label

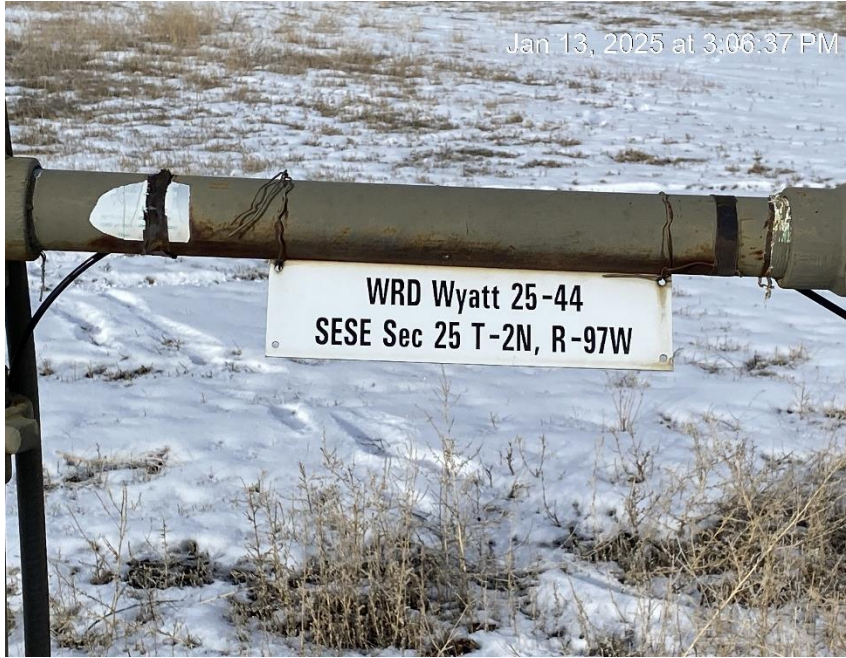
When replaced additional information is required

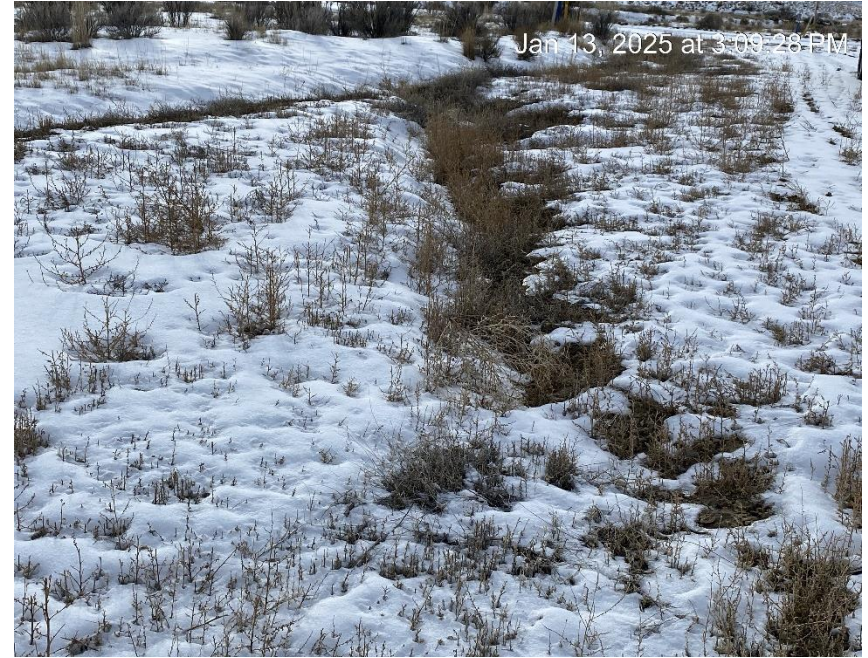
Erosion and sediment migration

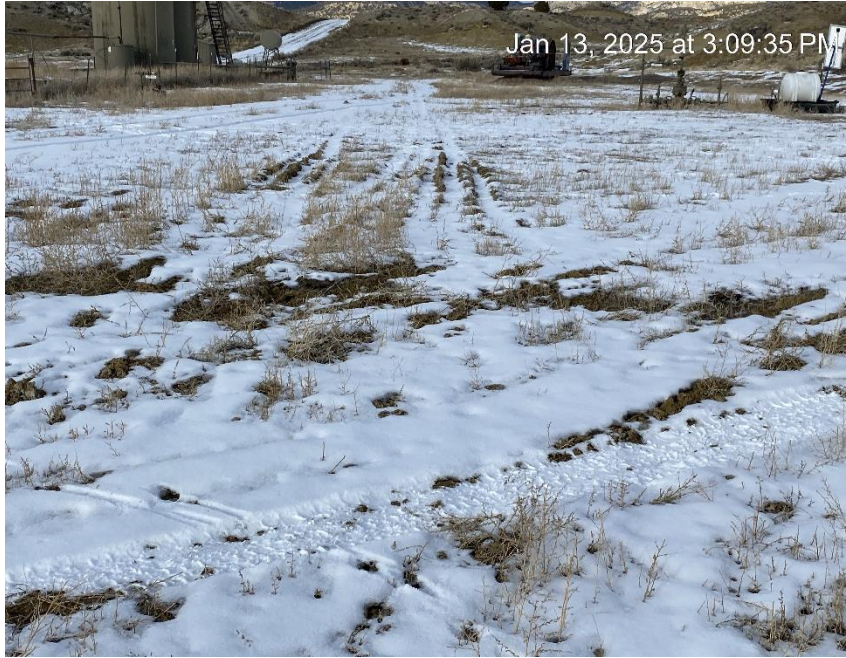
Vehicle tracking

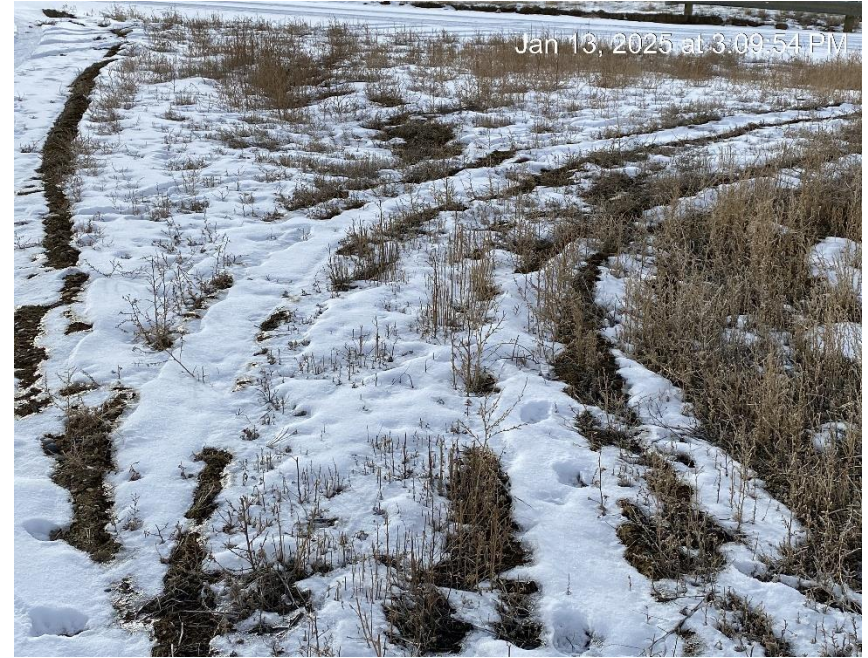
Erosion and vehicle tracking
