Inspection Photos
Location Name: UPRC 33-11J5
Location ID: 329677

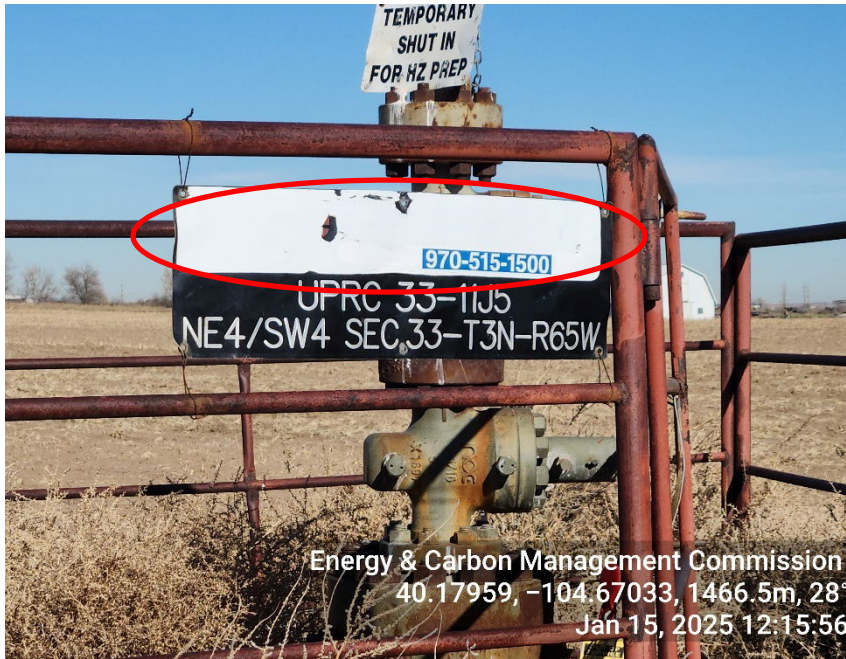
Photo 1: Wellhead Sign, operator name no longer legible

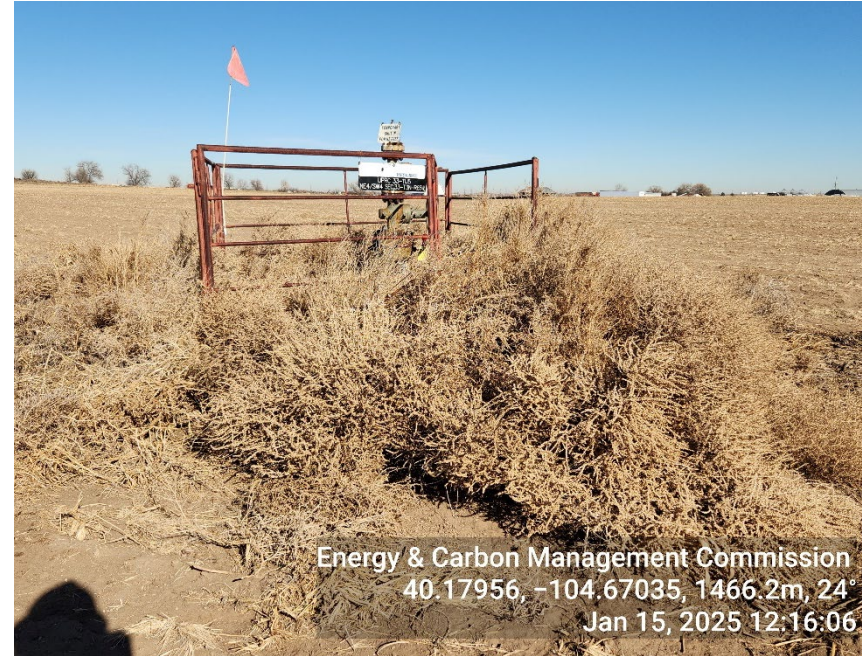
Photo 2: Dead, overgrown vegetation

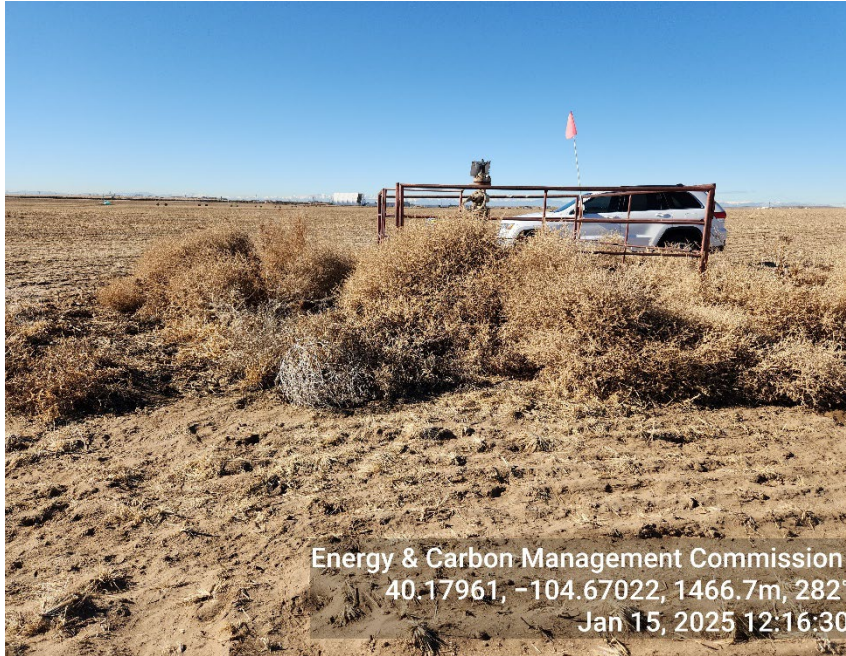
Photo 3: Dead, overgrown vegetation

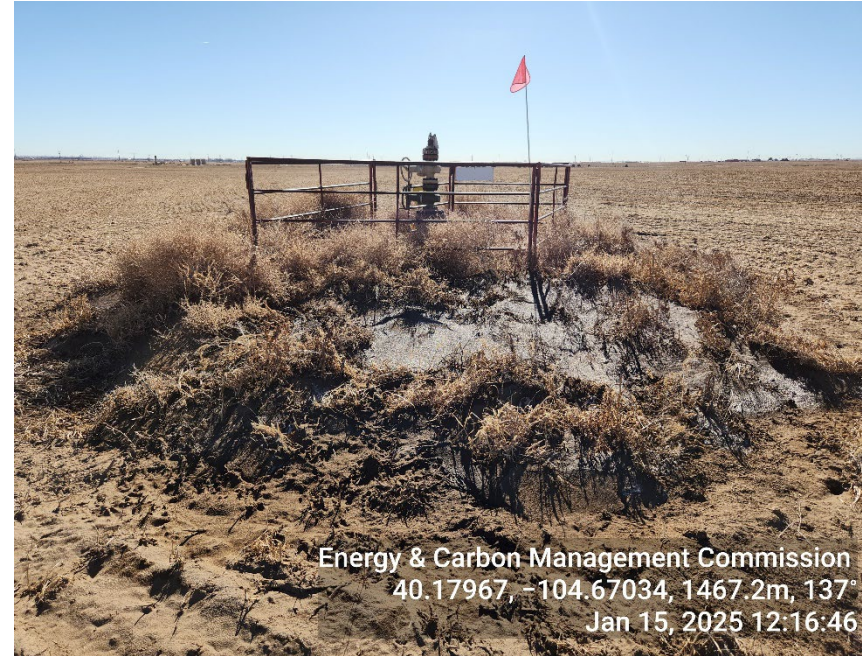
Photo 4: Dead, overgrown vegetation

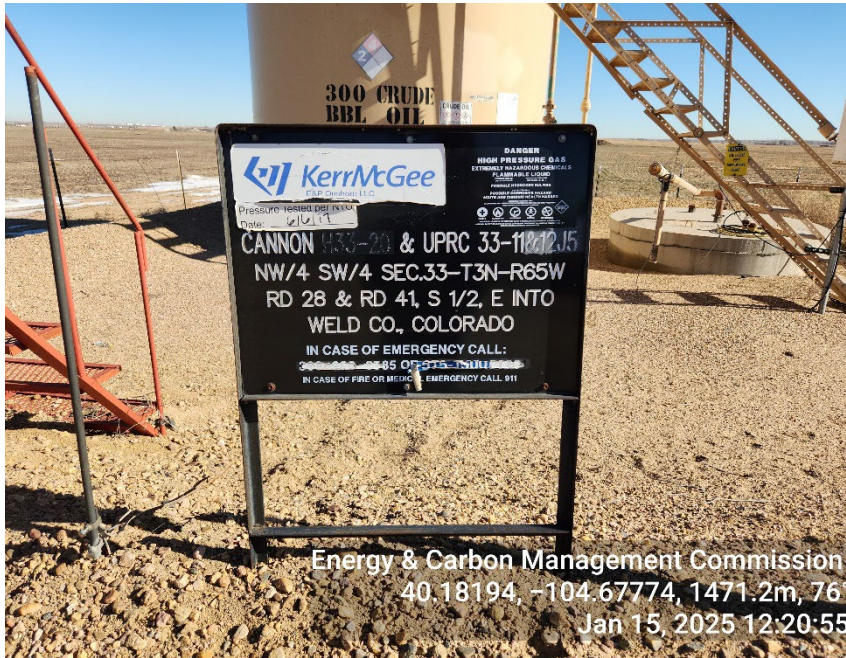
Photo 5: Tank Battery Sign

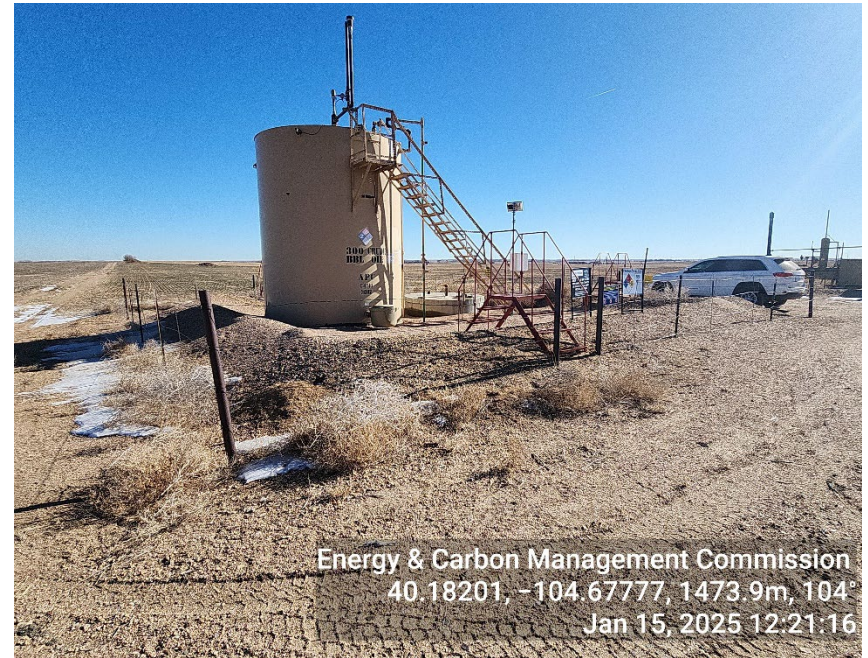
Photo 6: Dead, overgrown vegetation/debris

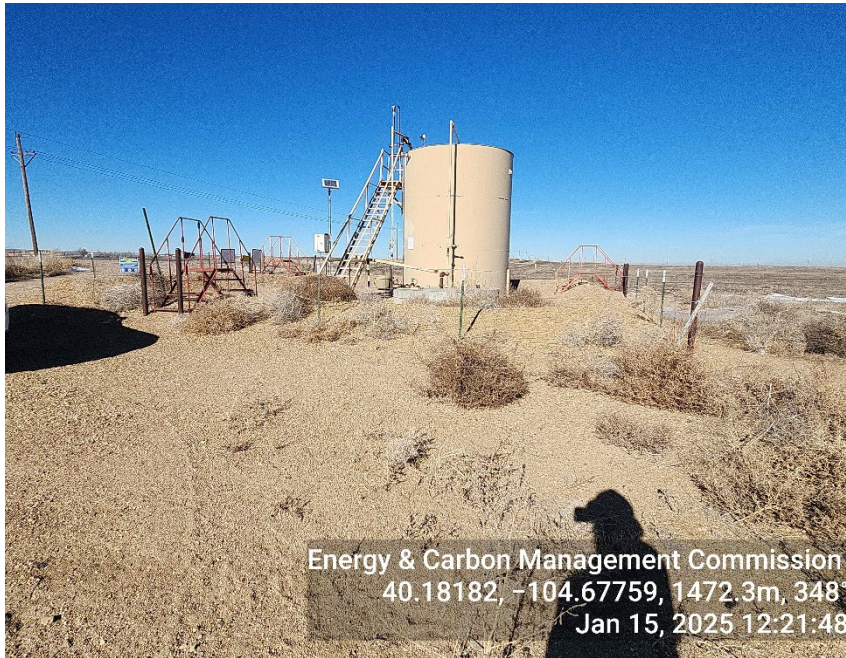
Photo 7: Dead, overgrown vegetation/debris

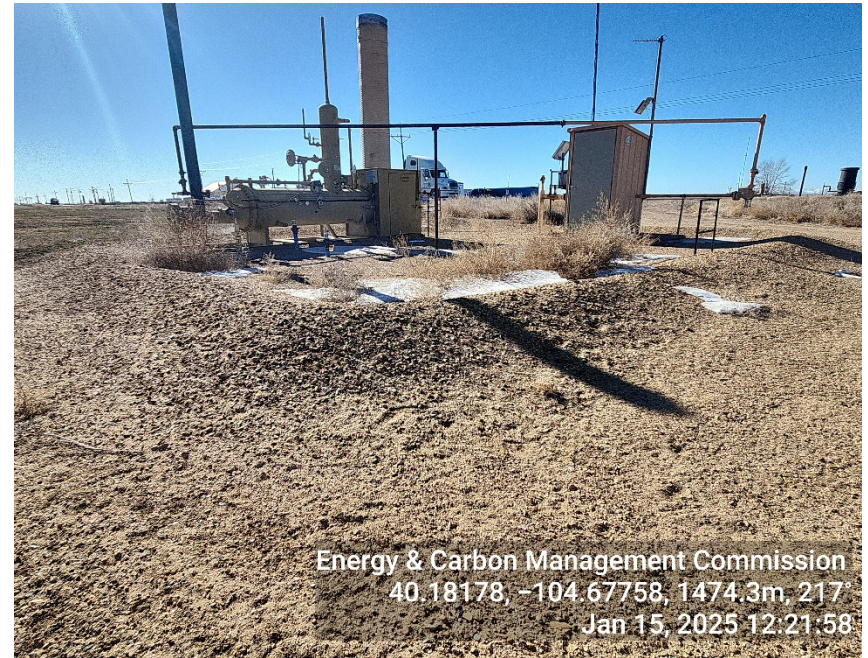
Photo 8: Dead, overgrown vegetation/debris. Not maintained earth berm

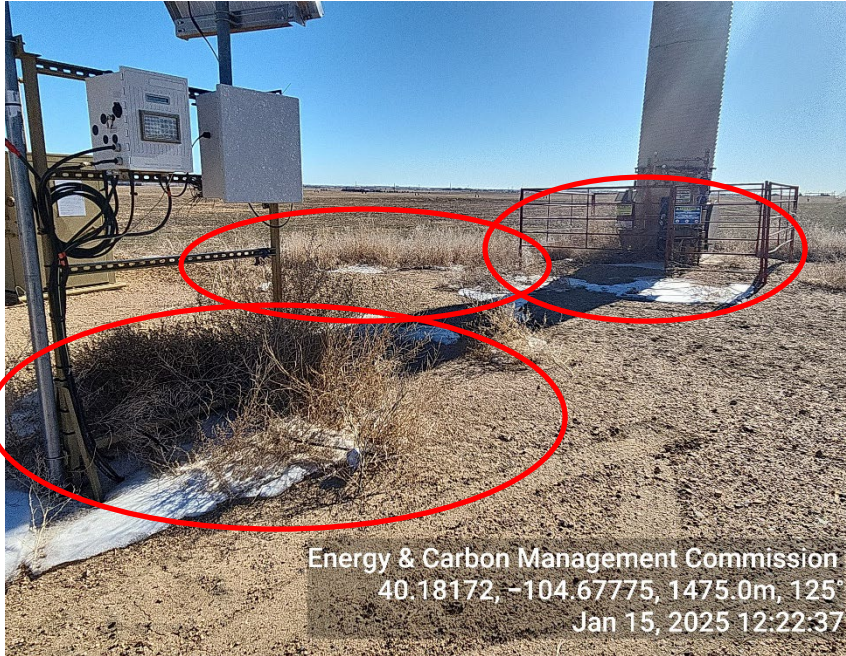
Photo 9: Dead, overgrown vegetation/debris
