Inspection Photos  
Location Name: Korf Robert 2  
API Number: 125-06181

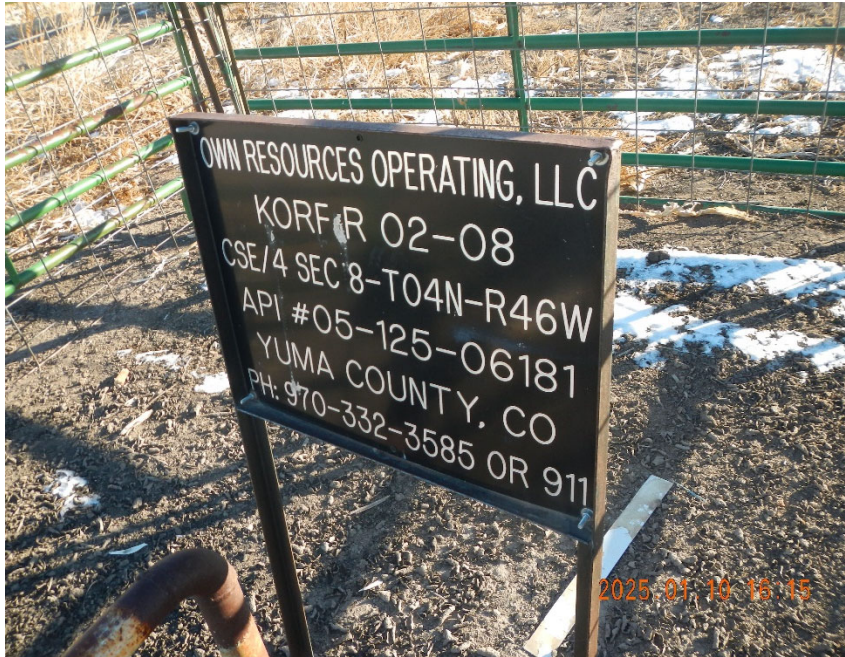
1. Lease sign at well location.

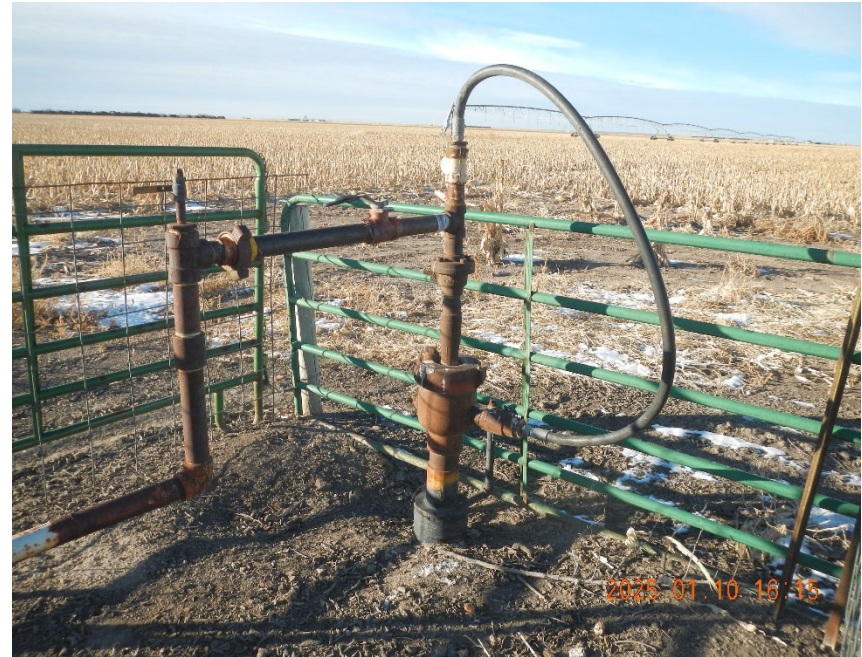
2. View of wellhead.

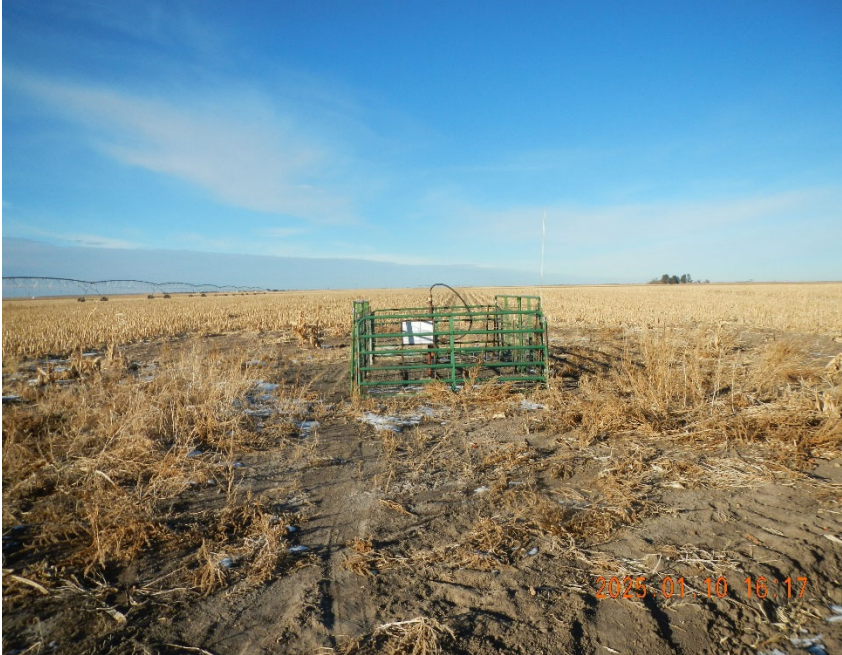
3. Well location overview.

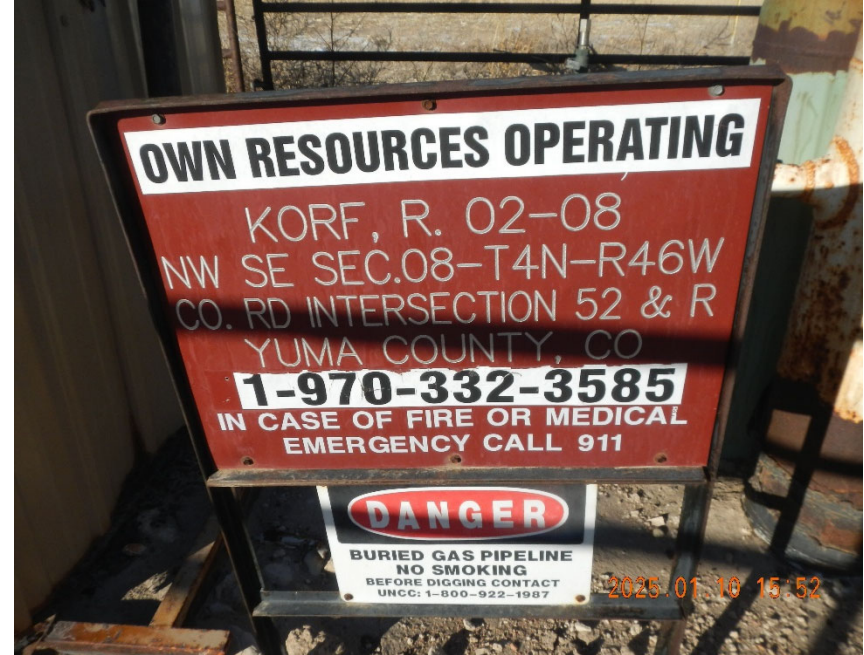
4. Lease sign at gathering location.

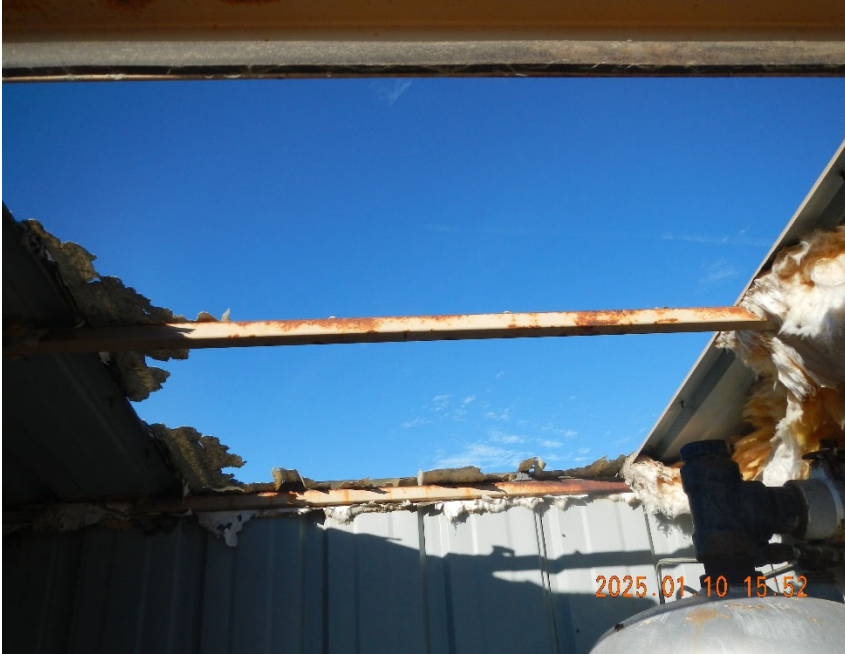
**5. Roof damage on separator shed.**

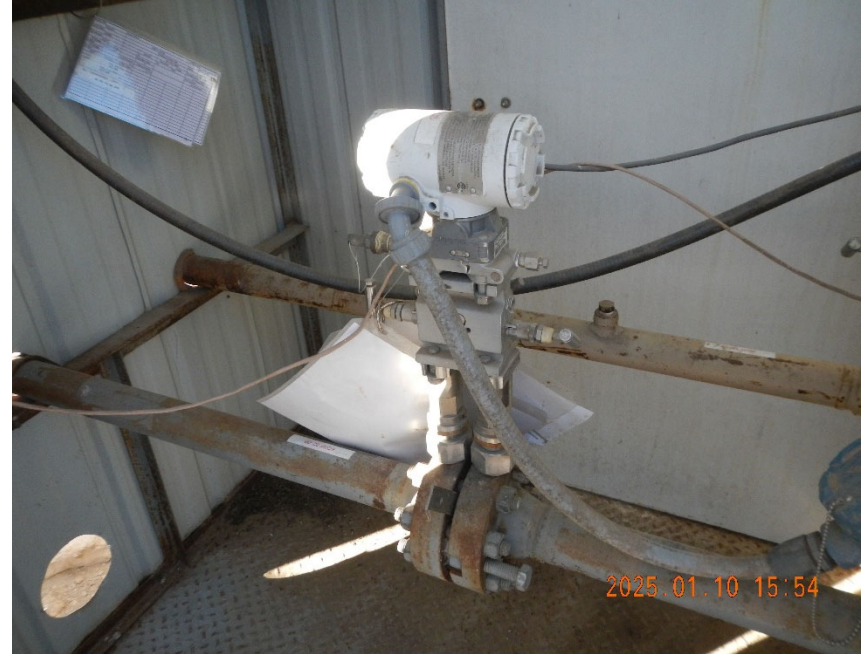
**6. Gas meter inside meter shed.**

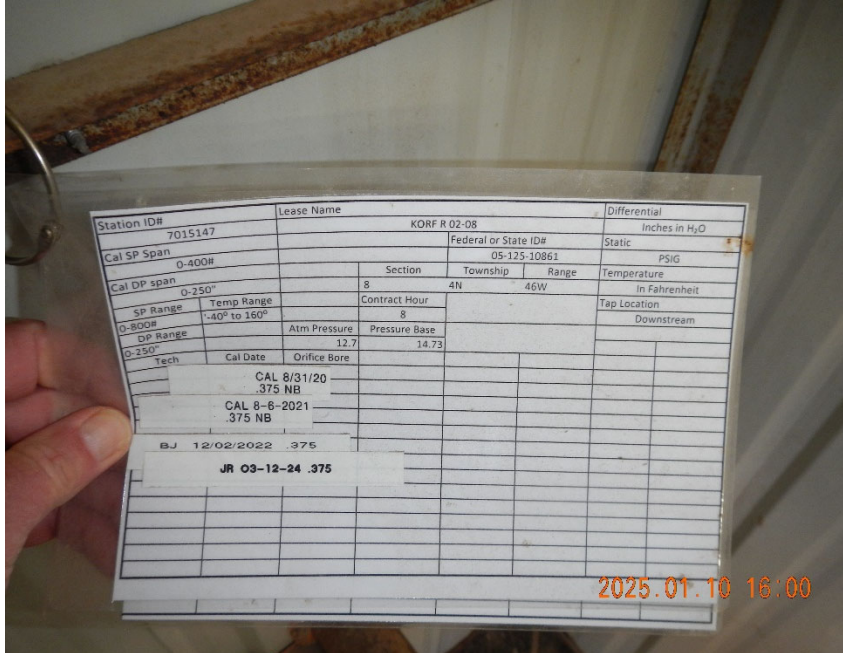
**7. Calibration log with incorrect API number.**

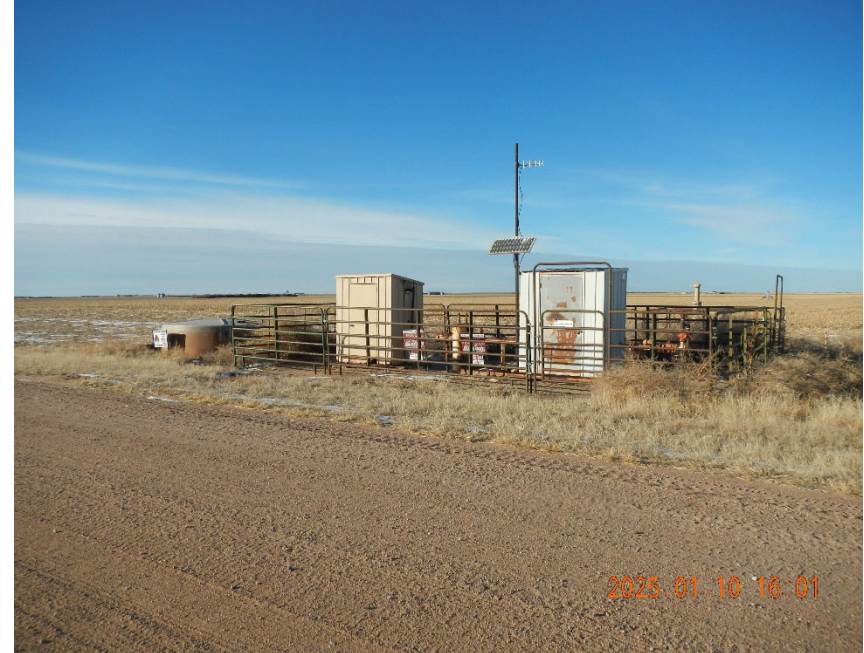
**8. Gathering location overview.**
