Inspection Photos

API: 061-06021

Operator: CIMARRON OIL & GAS CO INC

Inspection Date: 1/14/2025

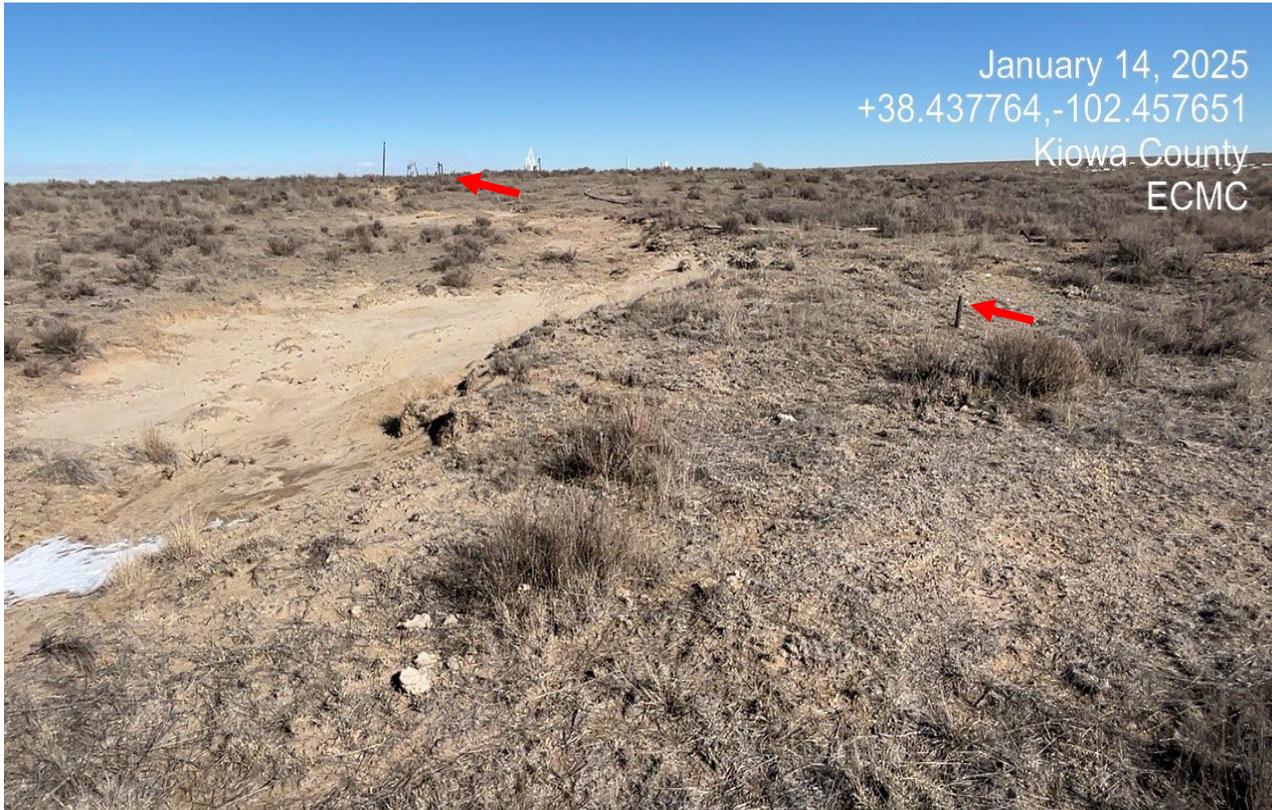
Photo 1. Facing northeast at the former wellsite. There appears to have been a historic impact where vegetation is not establishing. There are abandoned pipe risers shown at red arrows.

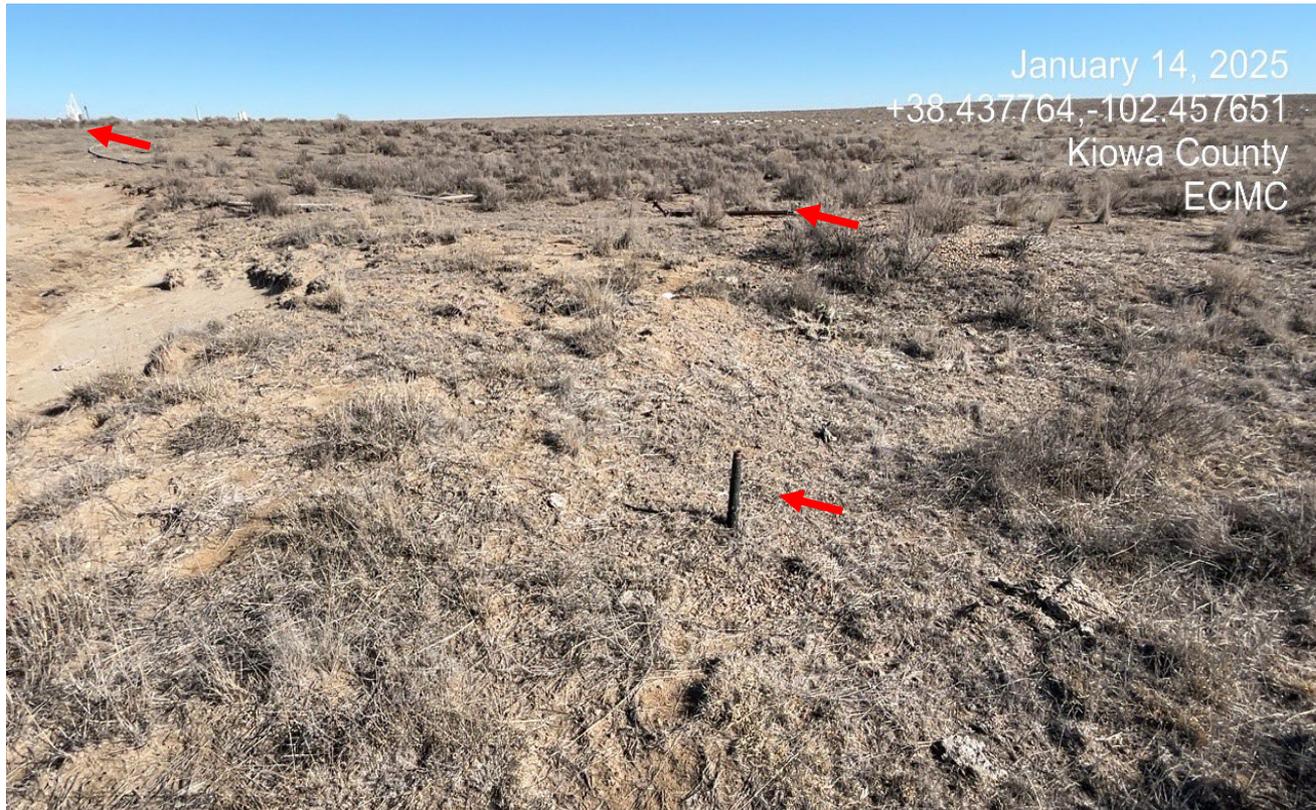
Photo 2. There are abandoned pipe risers shown at red arrows.

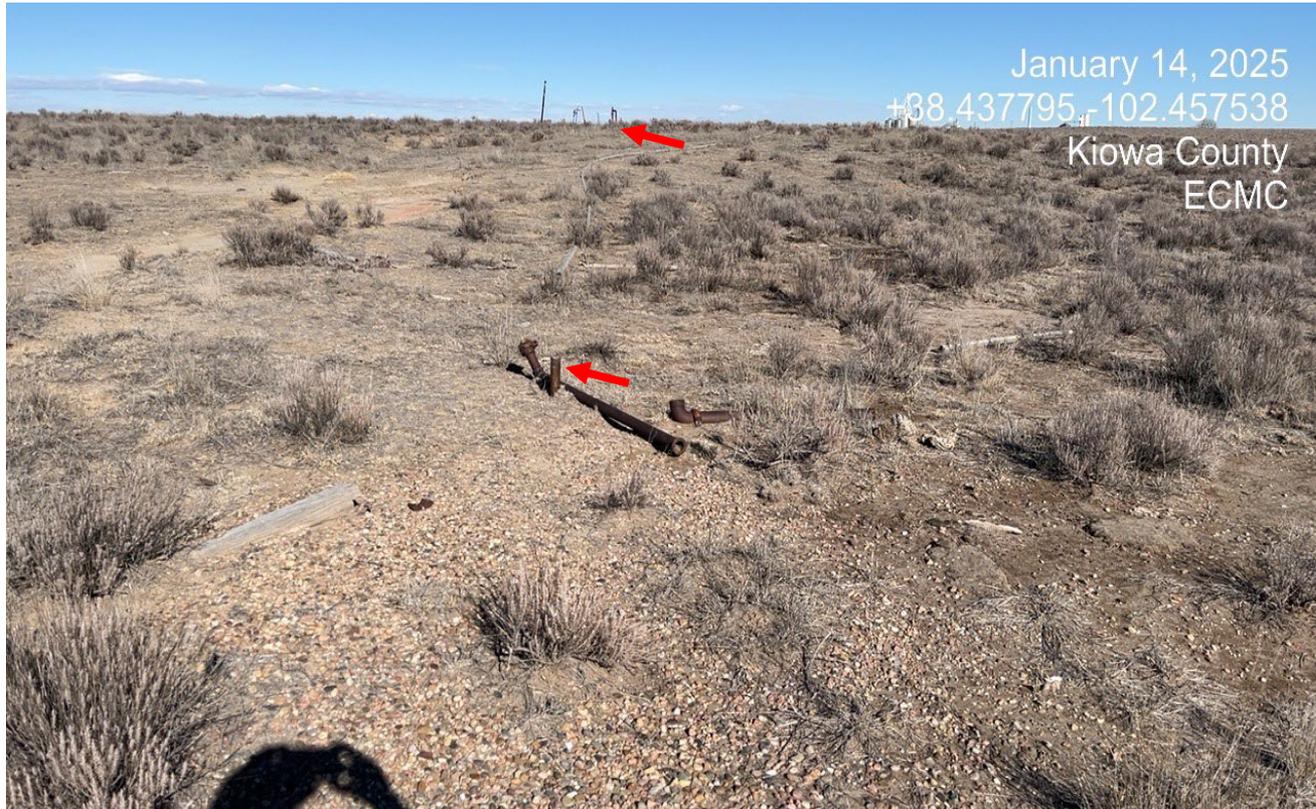
Photo 3. Facing northeast at the location. There are abandoned pipe risers shown at red arrows.

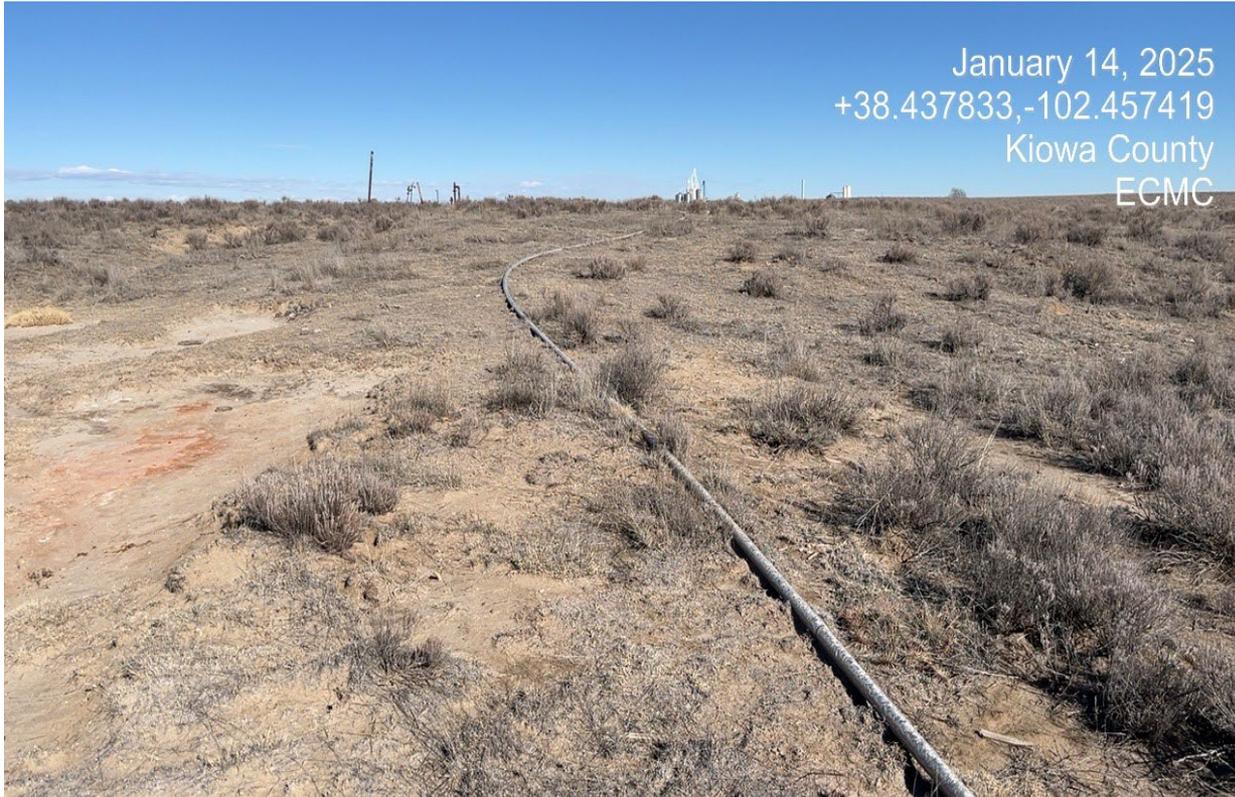
Photo 4. Facing northeast. There is a fiberglass pipe on the surface approximately 150' in length.

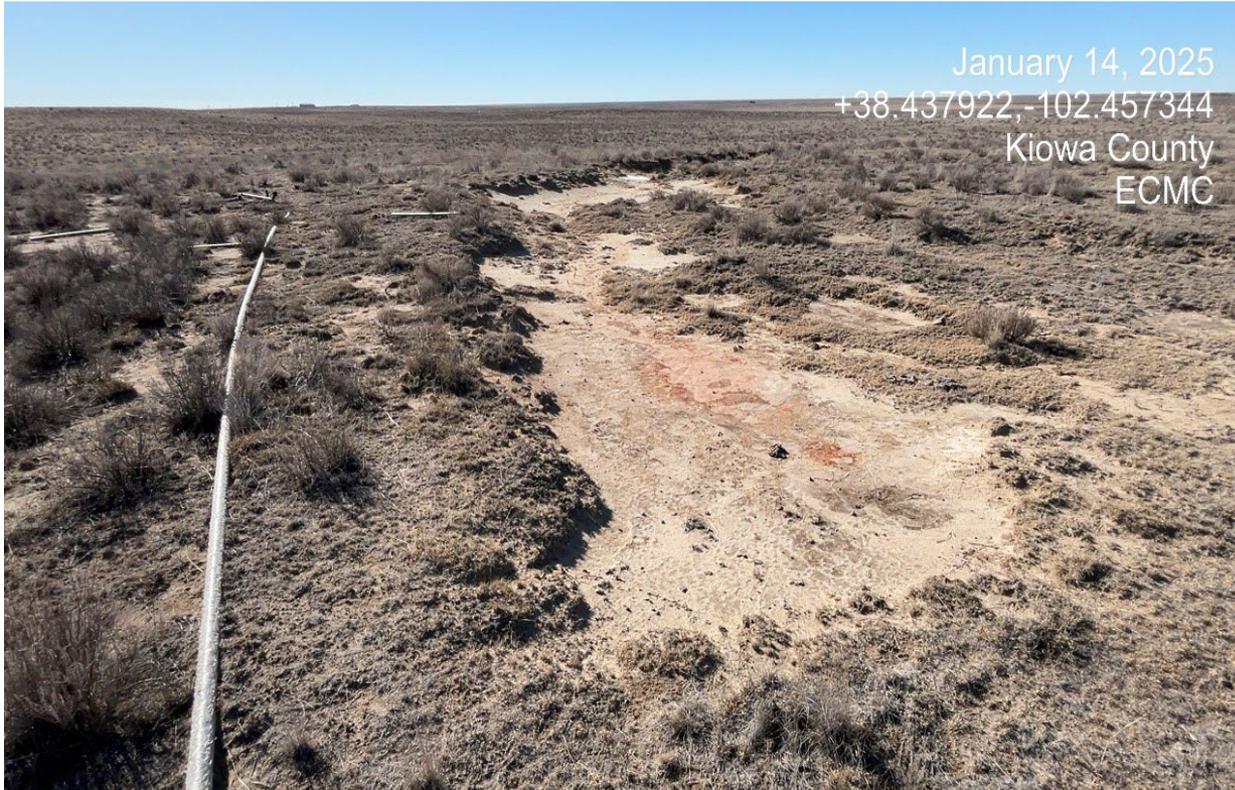
Photo 5. Facing back to the west. There appears to have been a historic spill impact where vegetation is not establishing and erosion has occurred.

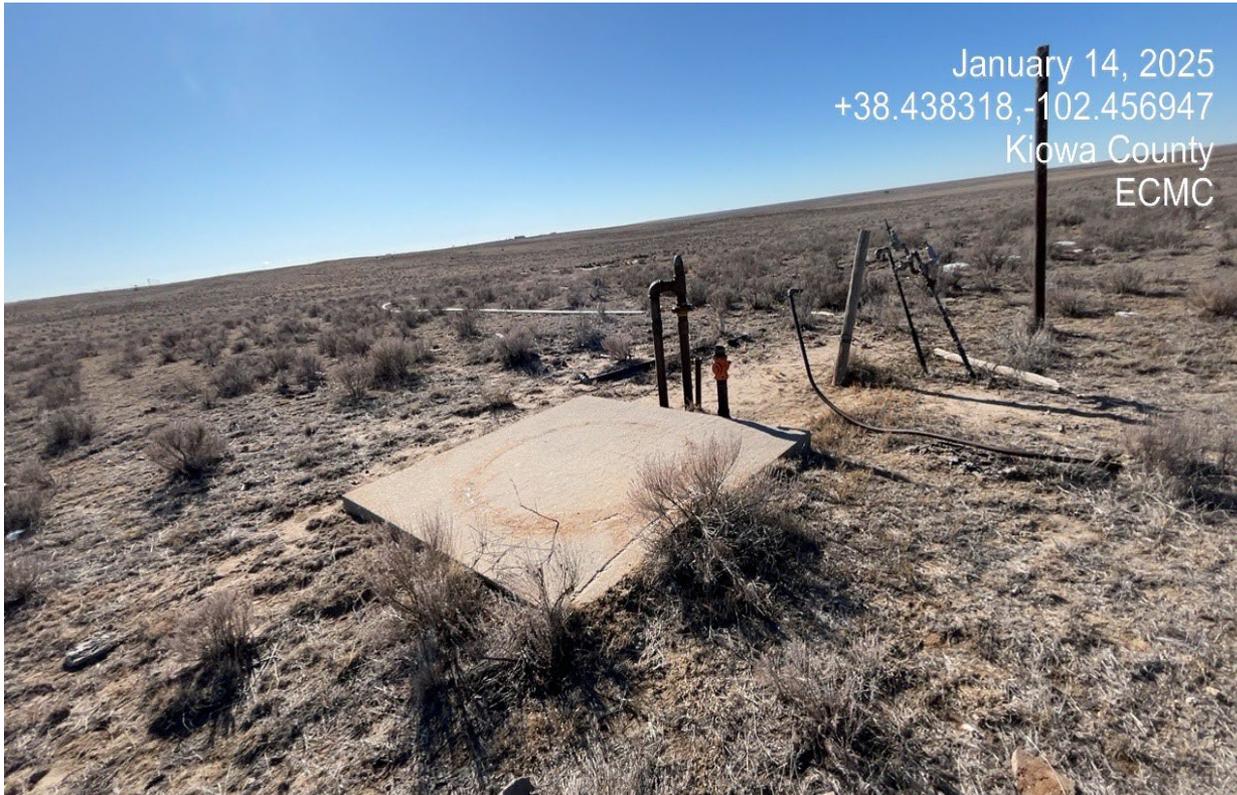
Photo 6. Facing west at the east side of the location. There is multiple abandoned pipe risers and a cement pad.

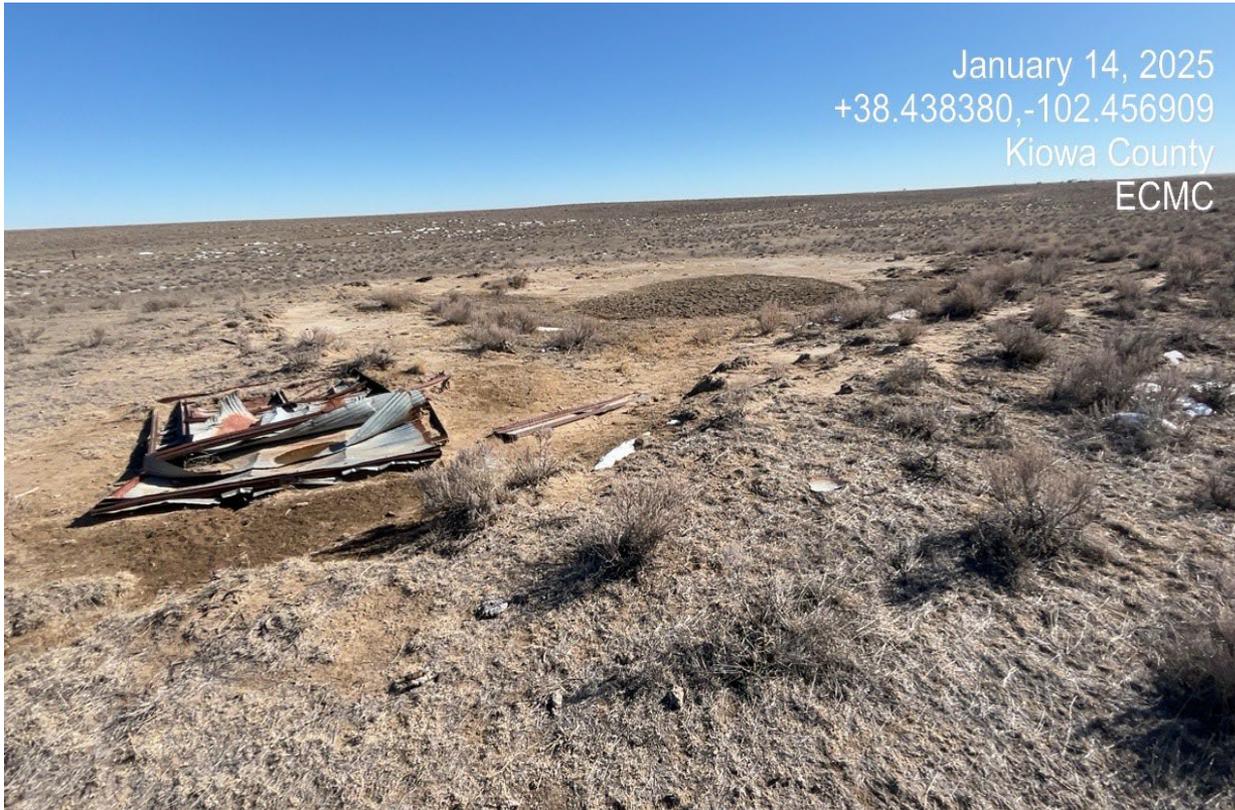
Photo 7. Facing southeast at the location. There appears to have been an historic spill impact in this area with no vegetation establishment. There is a dilapidated shed that remains.

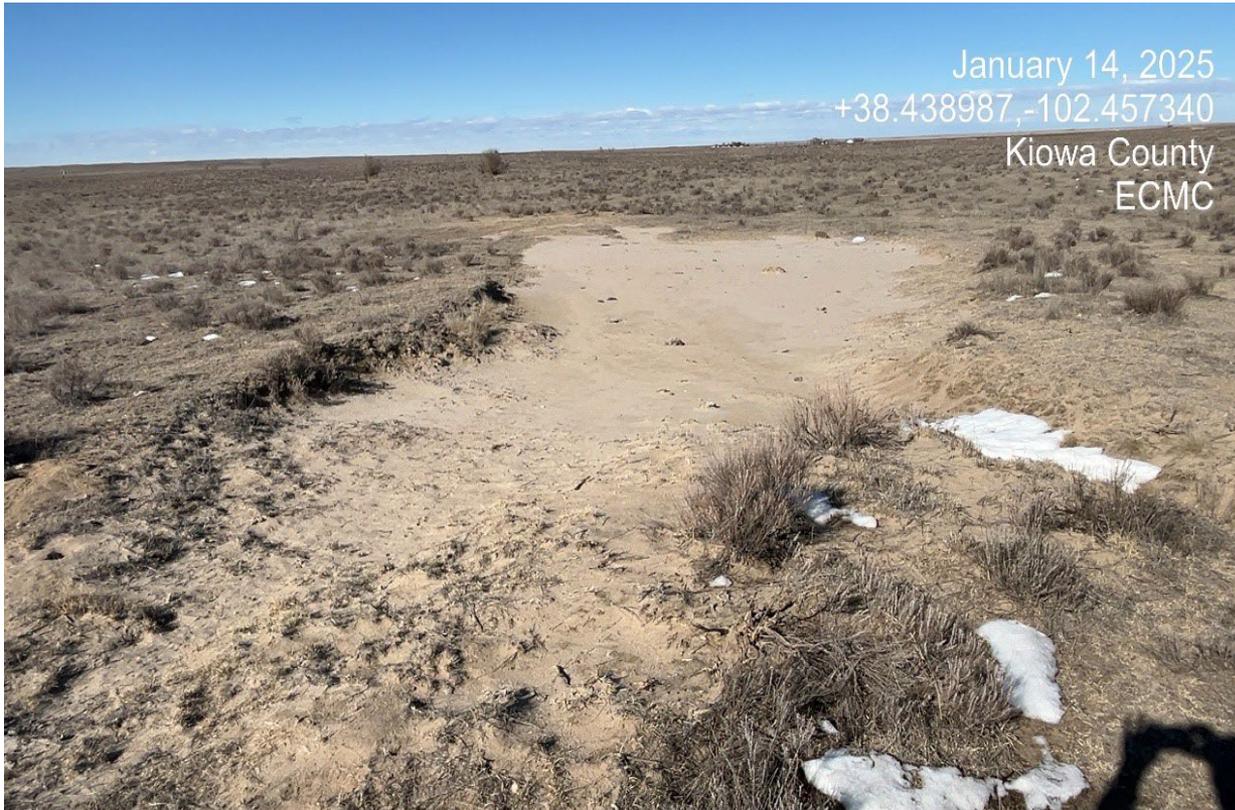
Photo 8. Just north of the wellsite (~500') is another impacted area with no vegetation establishment and erosion.
