Final Reclamation and Stormwater Inspection

Operator: KERR MCGEE OIL & GAS ONSHORE LP - 47120

Location ID: 459332

Well Name: AMATO-61N66W TANK/1SEW

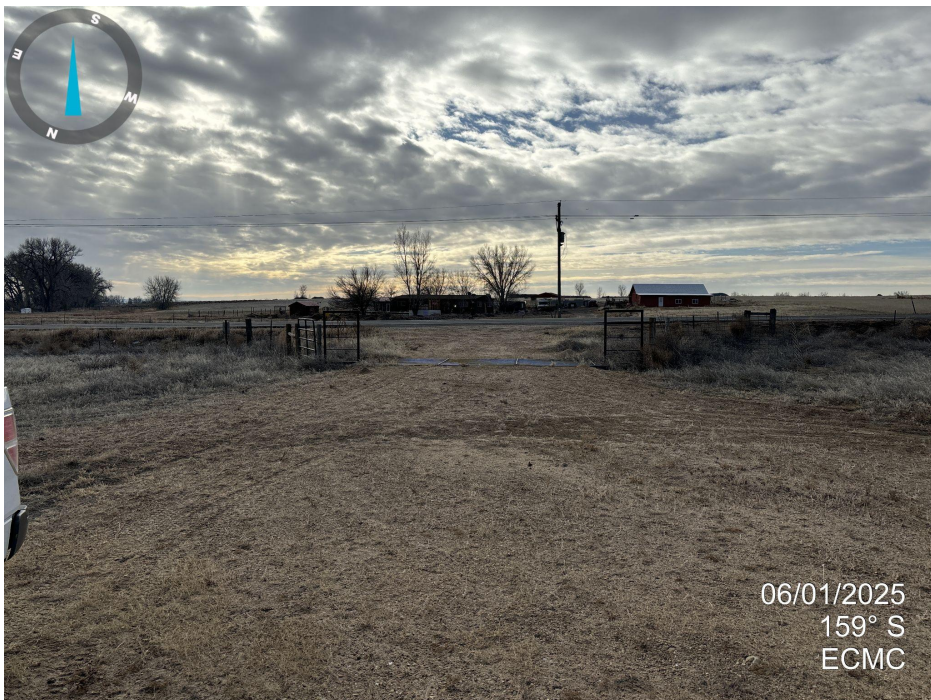
Photo 1. Photo taken looking east at entrance of location. Cattle guard remains in place off of SH52. Gravel has not been removed from site.

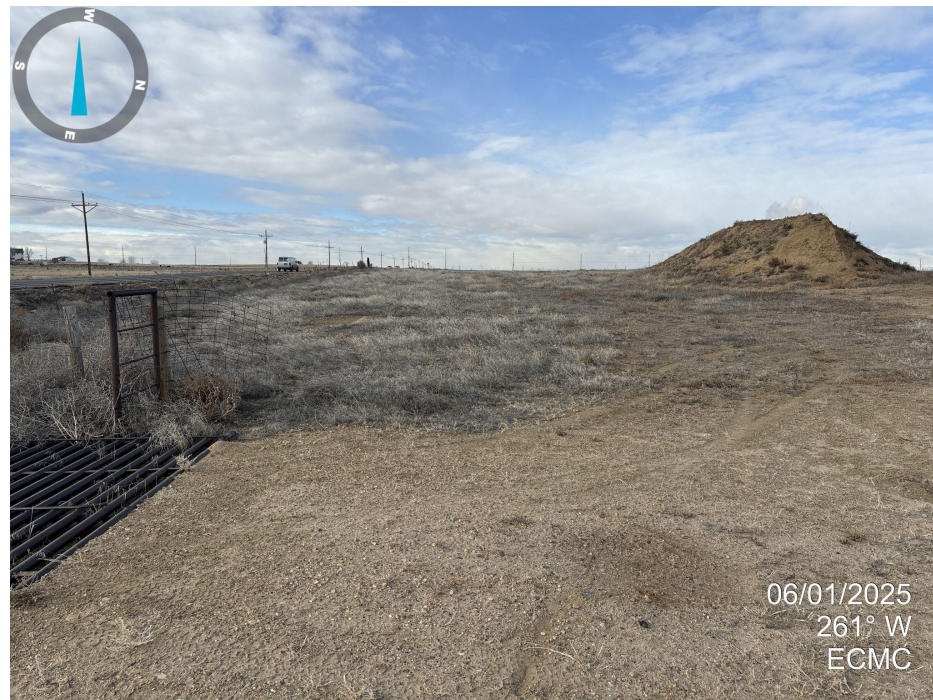
Photo 2. Looking west across tank battery. Desirable vegetation has failed to establish. Undesirable plant species such as Russian thistle, Kochia, and noxious weeds such as Downy Brome and Scotch thistle are dominant.

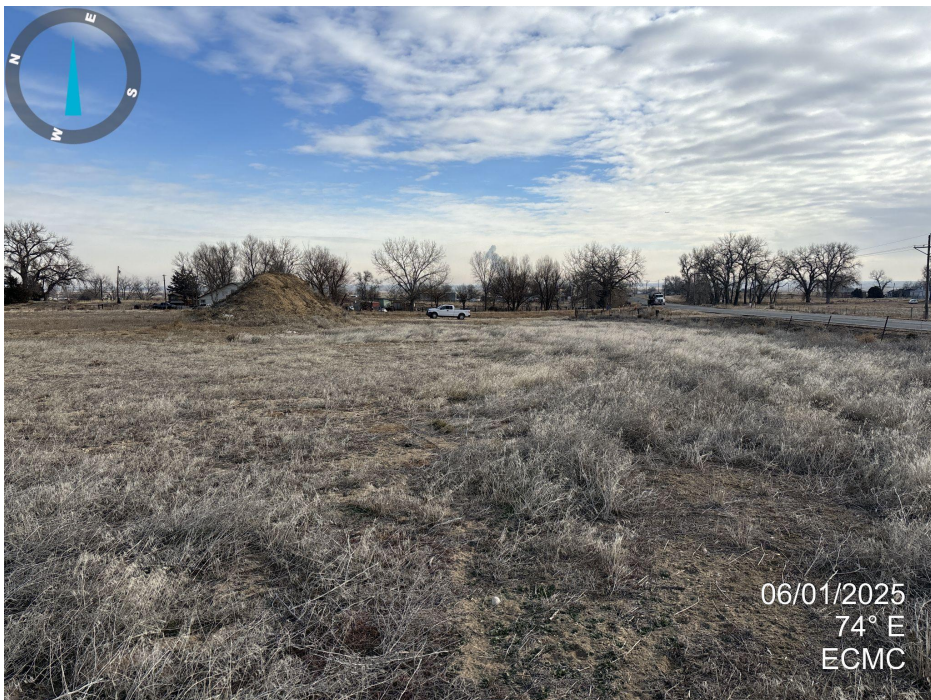
Photo 3. Picture taken looking east across tank battery location. See Photo 2 comments.

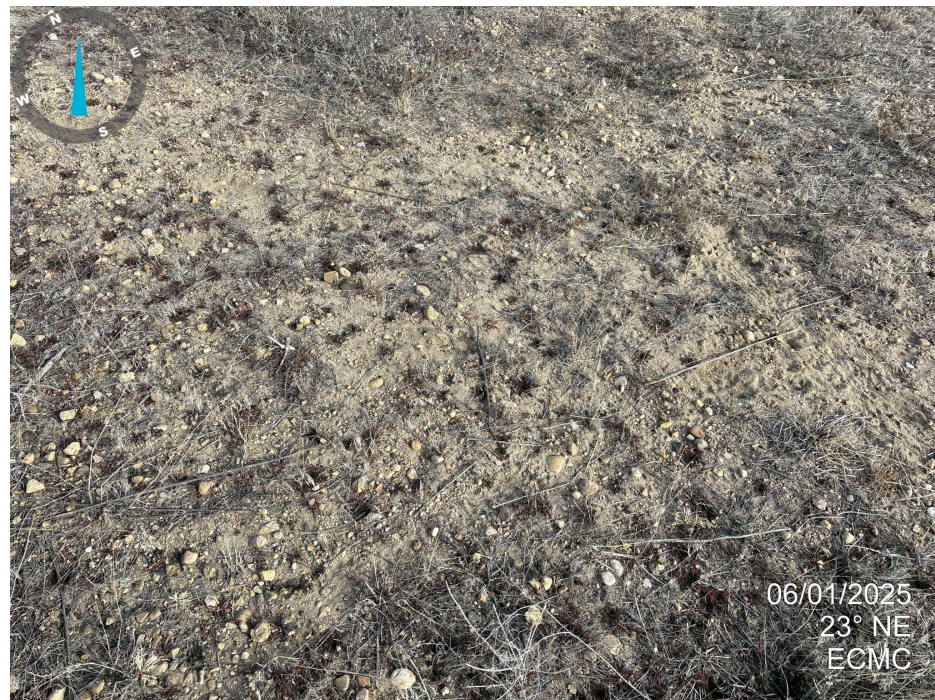
Photo 4. Looking at north side of tank battery. Gravel remains on location.
