Inspection Photos
Location Name: QB Energy ALP 19-10 (K19NE) Pad
Location #: 335338

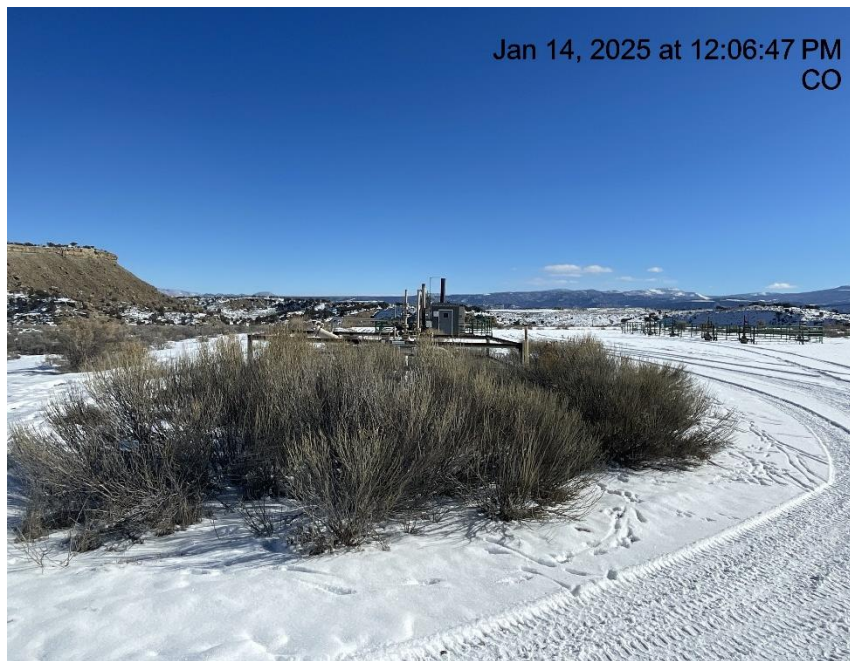
Photo # 8572 From entrance to location

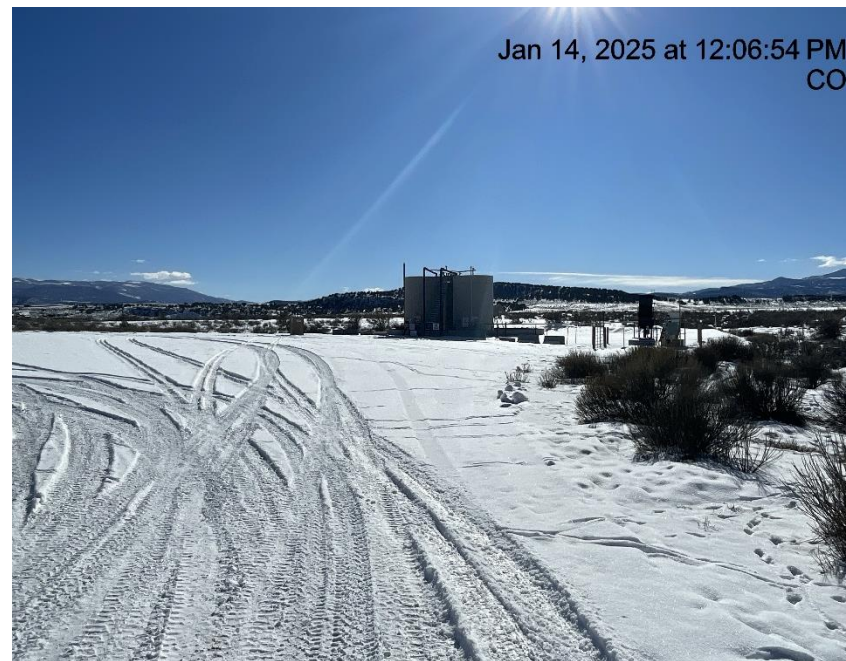
Photo # 8573 From entrance to location

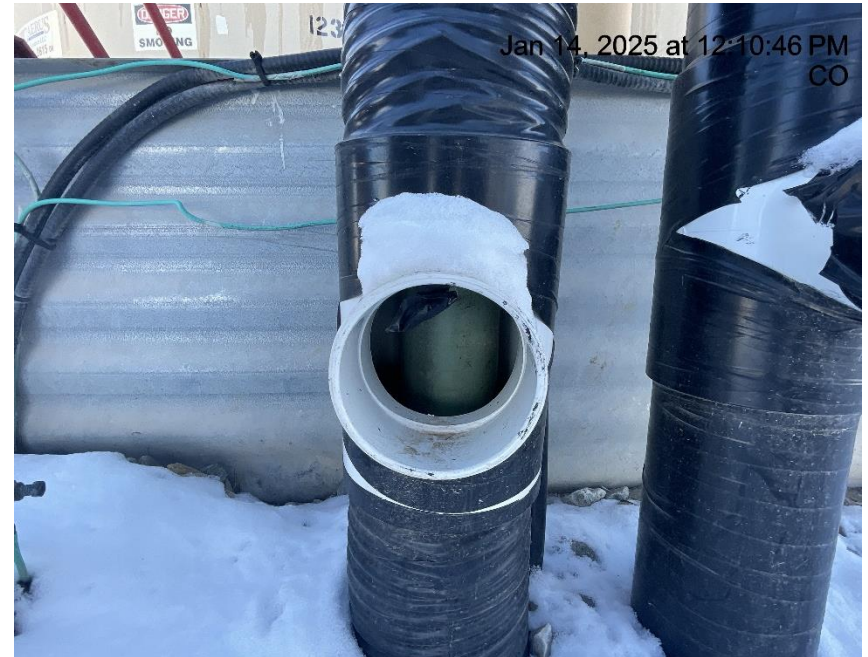
**Photo # 8583 Flowline heating insulation open ended
/wildlife hazard/available for entry by wildlife**

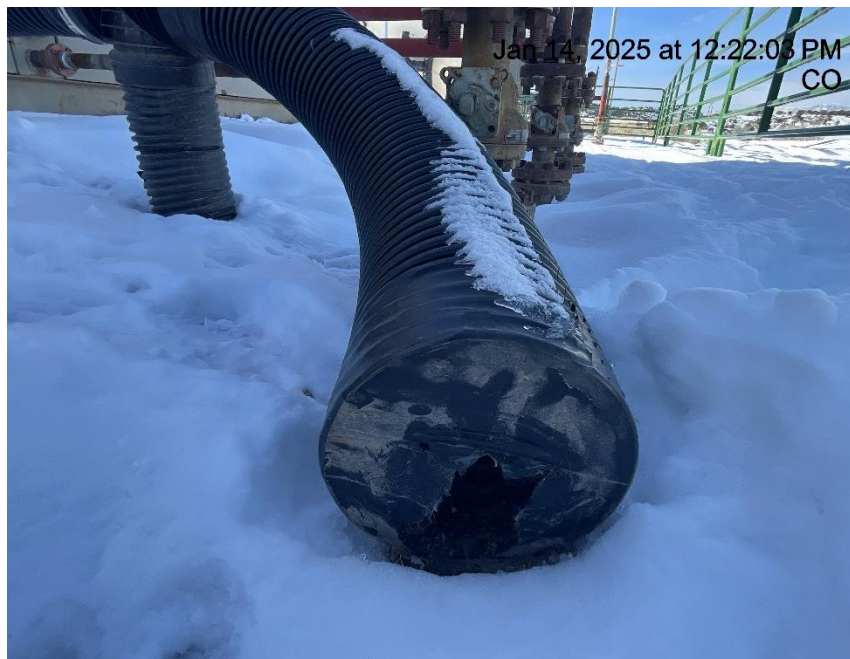
**Photo # 8584 Flowline heating insulation open ended
/wildlife hazard/available for entry by wildlife**

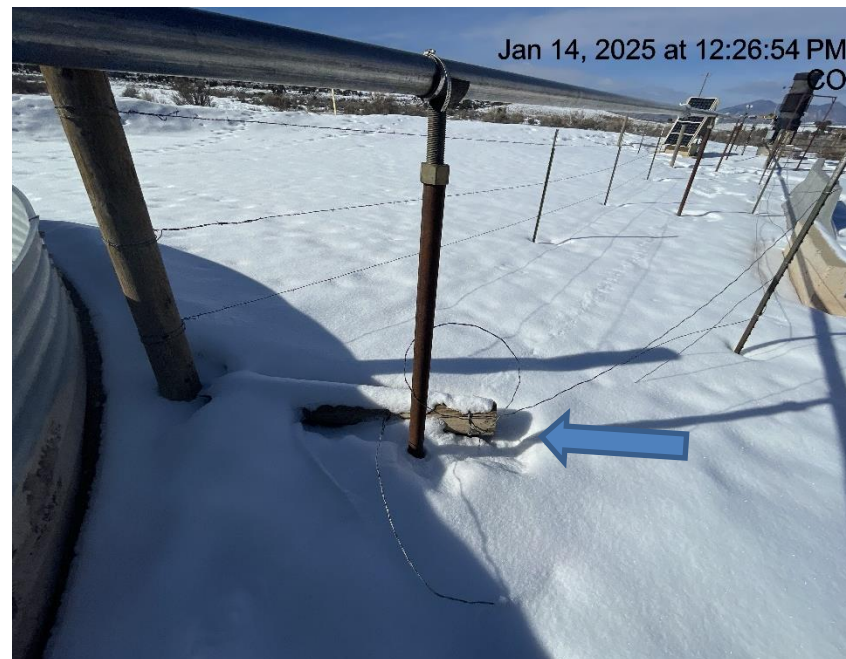
Photo # 8585 Wire fence needs maintenance

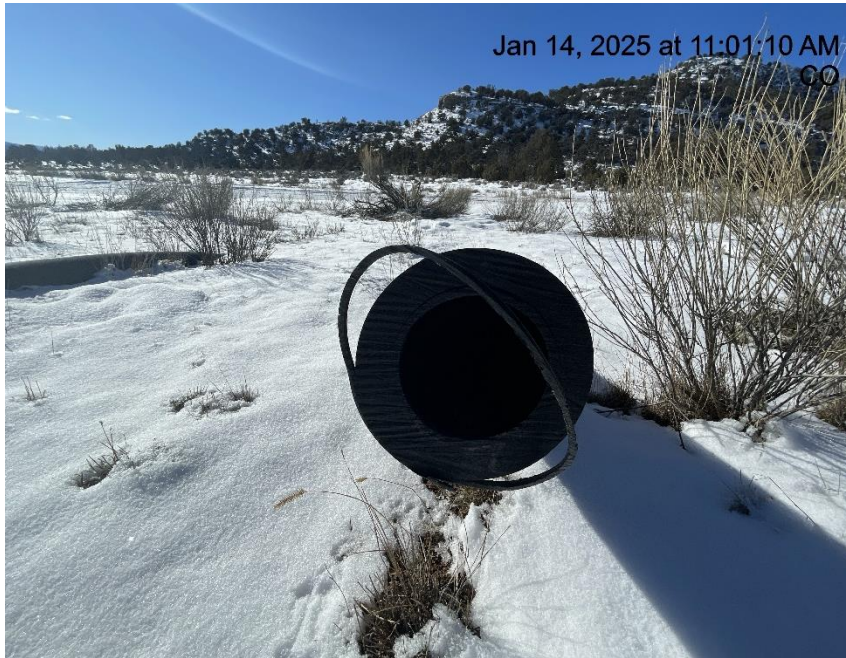
**Photo # 8586 Poly pipe along lease road open ended
/wildlife hazard/available for entry by wildlife**

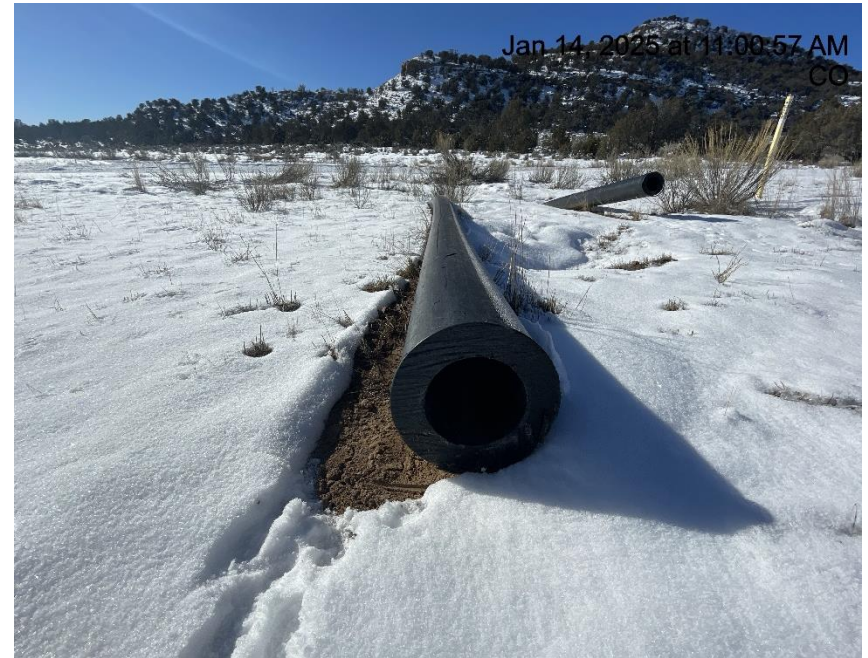
**Photo # 8587 Poly pipe along lease road open ended
/wildlife hazard/available for entry by wildlife**

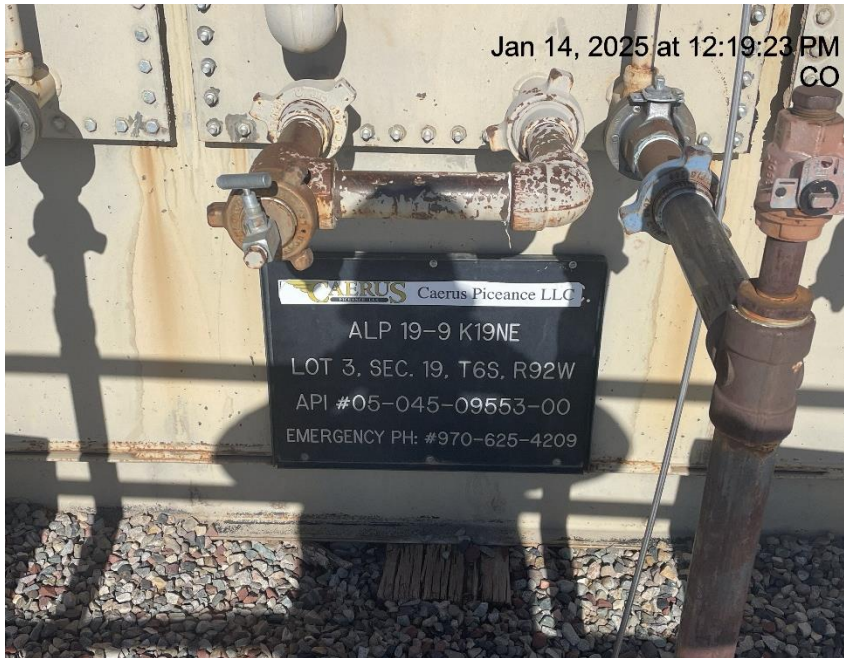
Photo # 8588 API # on ALP 19-9 wellhead sign incorrect

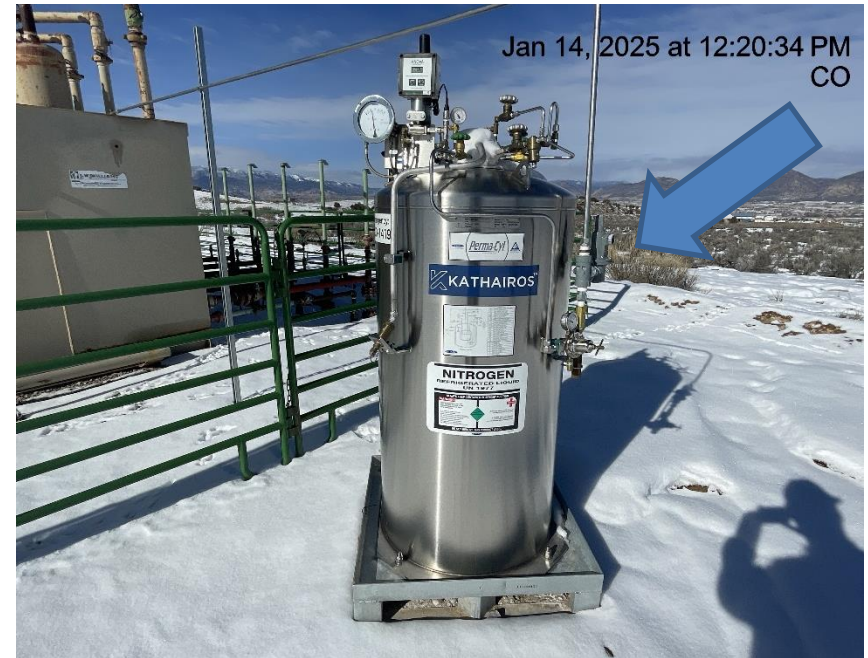
Photo # 8589 No FORM 4 SUNDRY for equipment/not in compliance with CECMC rules

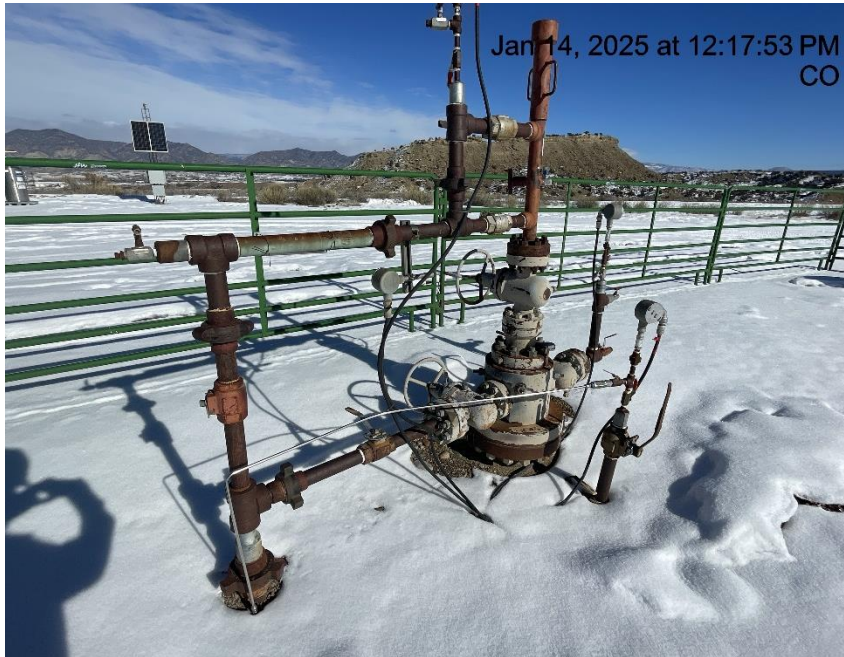
**Photo # 8590 ALP 19-9 bradenhead line tied into separator
/failure to comply with COA's**

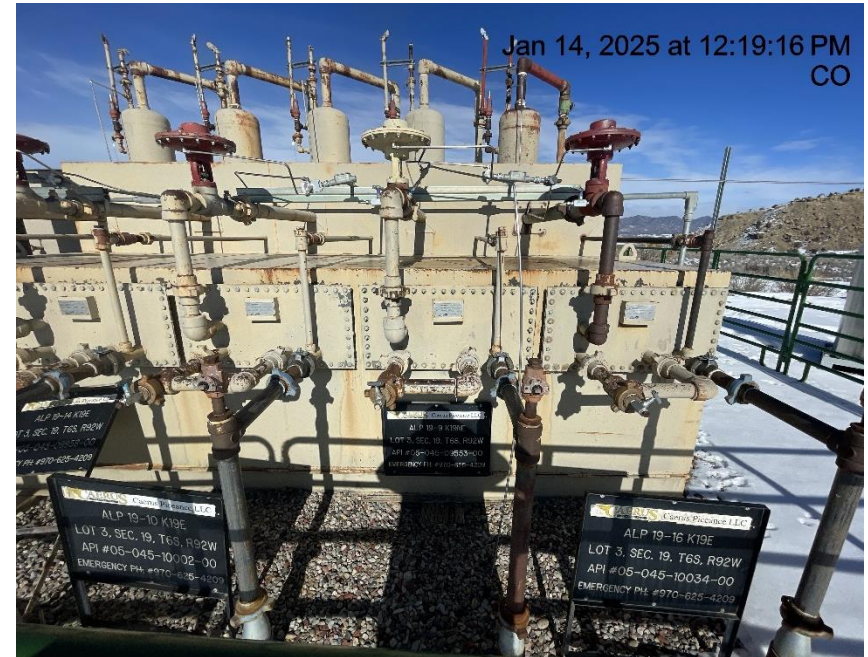
**Photo # 8591 ALP 19-9 bradenhead line tied into separator
/failure to comply with COA's**

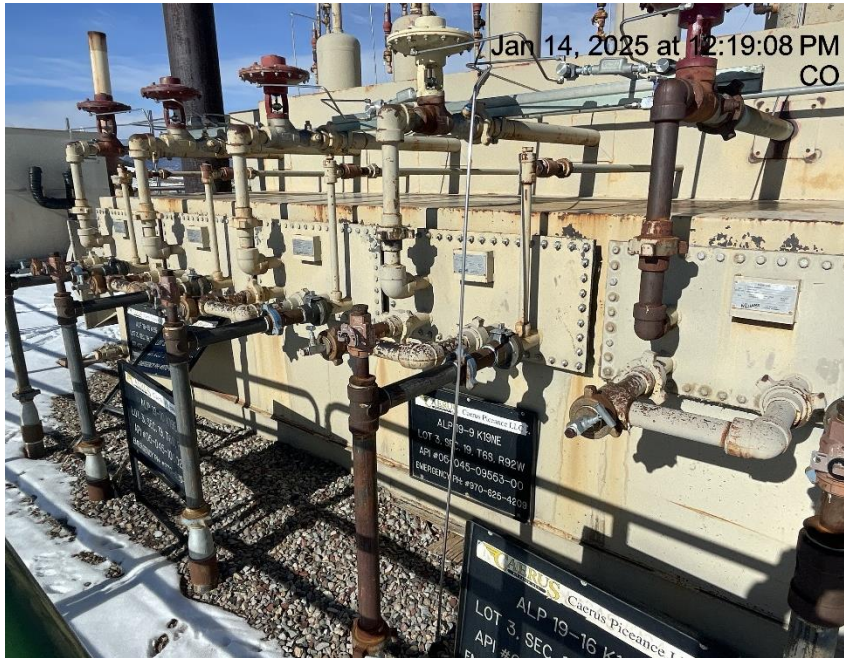
**Photo # 8592 ALP 19-9 bradenhead line tied into separator
/failure to comply with COA's**

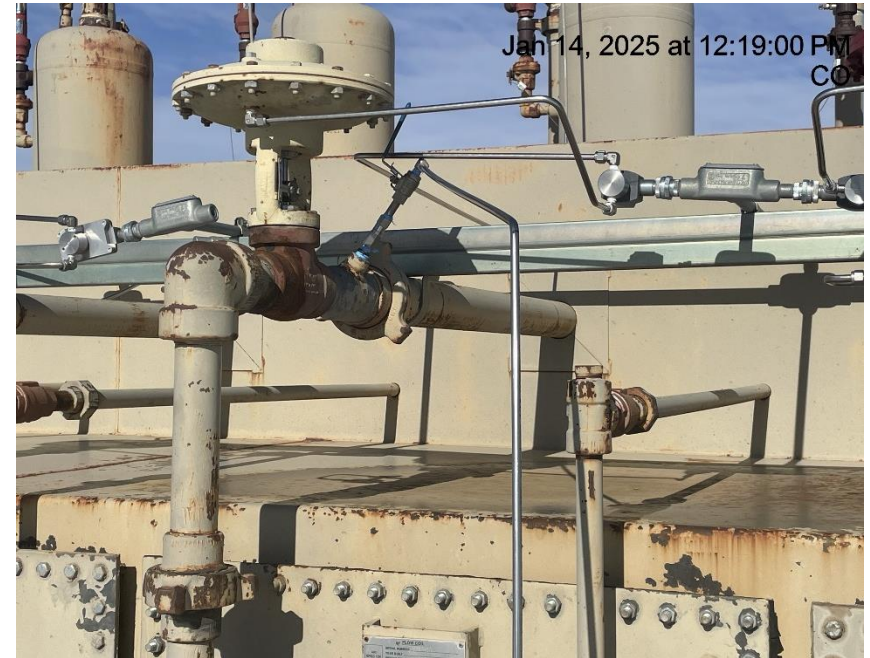
**Photo # 8593 ALP 19-9 bradenhead line tied into separator
/failure to comply with COA's**
