**Inspection Photos**  
**Location Name: Champlin HER 2-8 OWP**  
**Location ID: 320245**

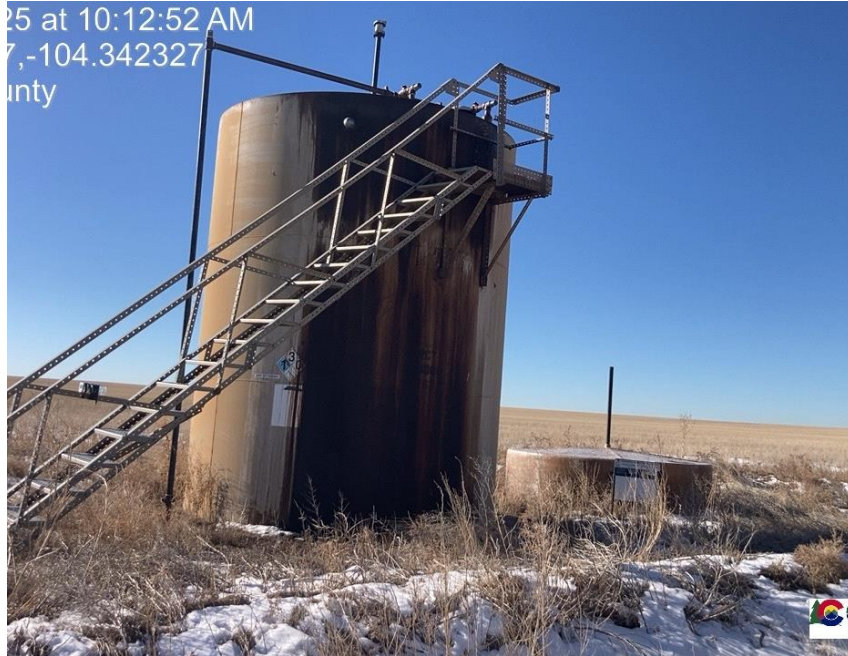
**Pic 3 Oil tank overflowed**
