Inspection Photos

Loc: 324795

Operator: WESTERN OPERATING COMPANY

Inspection Date: 1/14/2025

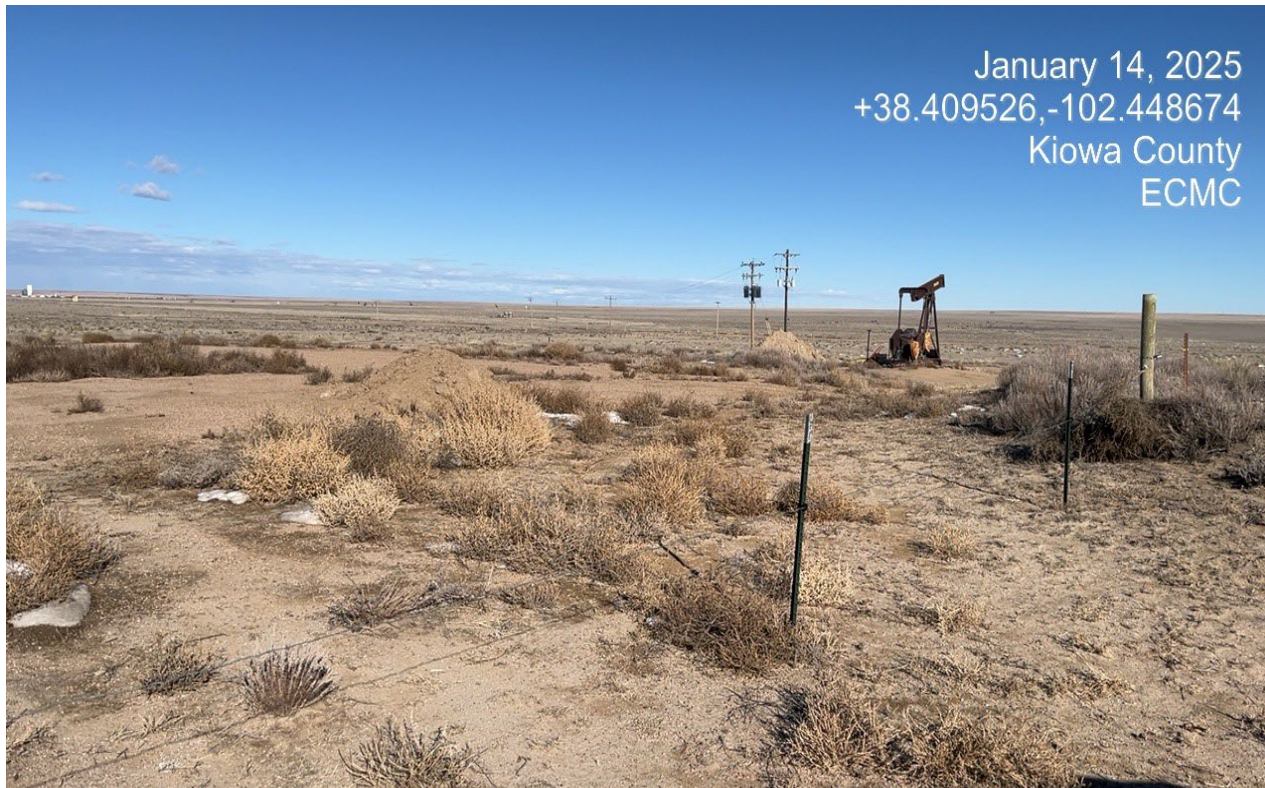
Photo 1. Facing northeast at the location.

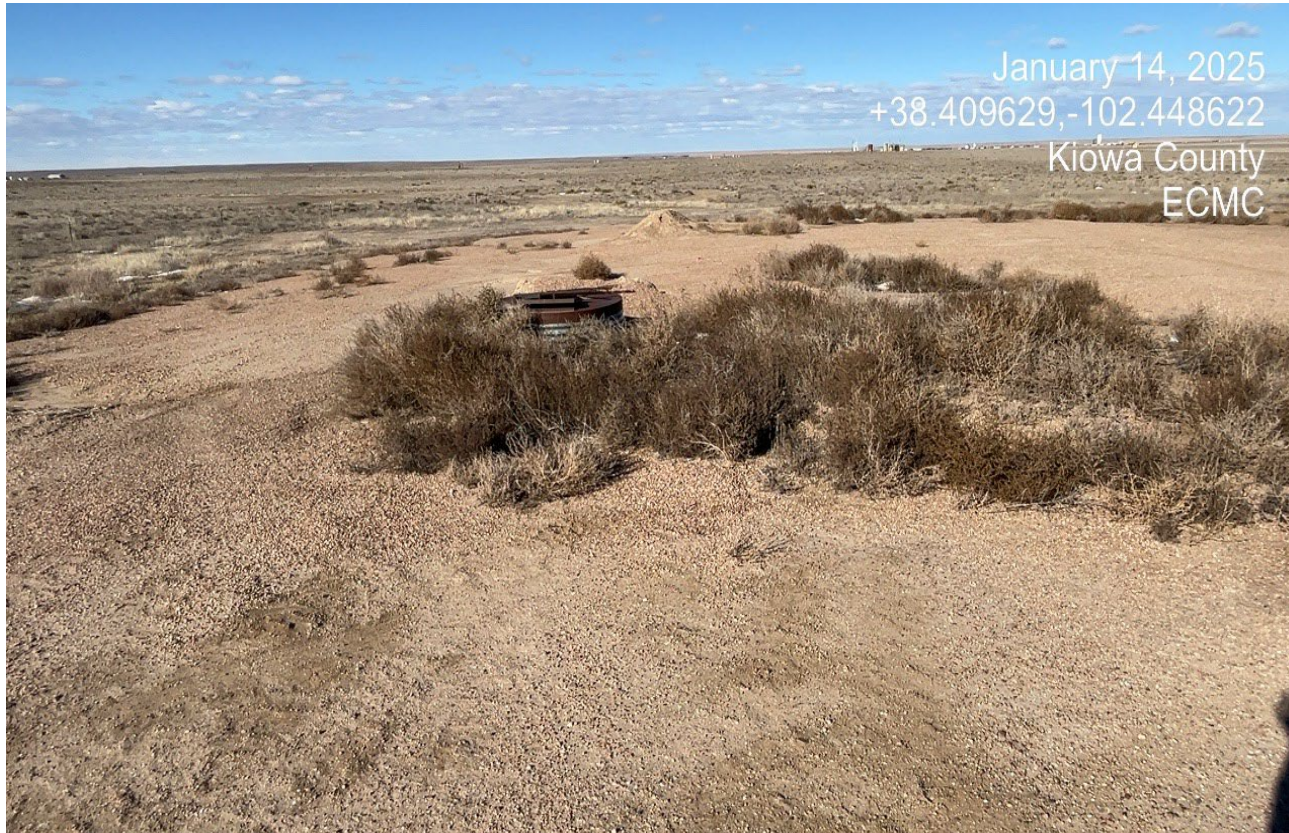
Photo 2. Facing north where the tank battery was location. The reclamation has not commenced at this location.

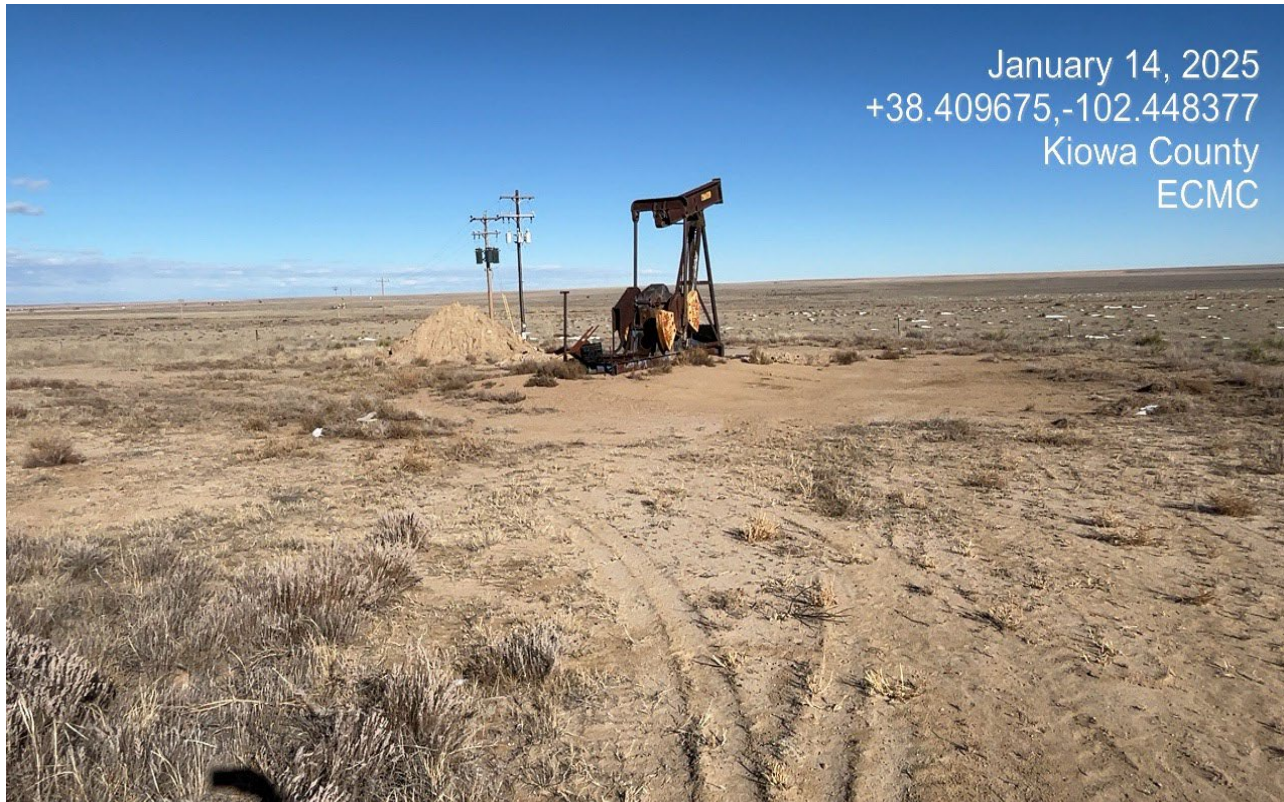
Photo 3. Facing northeast toward the wellsite. The well has been plugged and abandoned. The pumpjack and electric utilities must be removed.

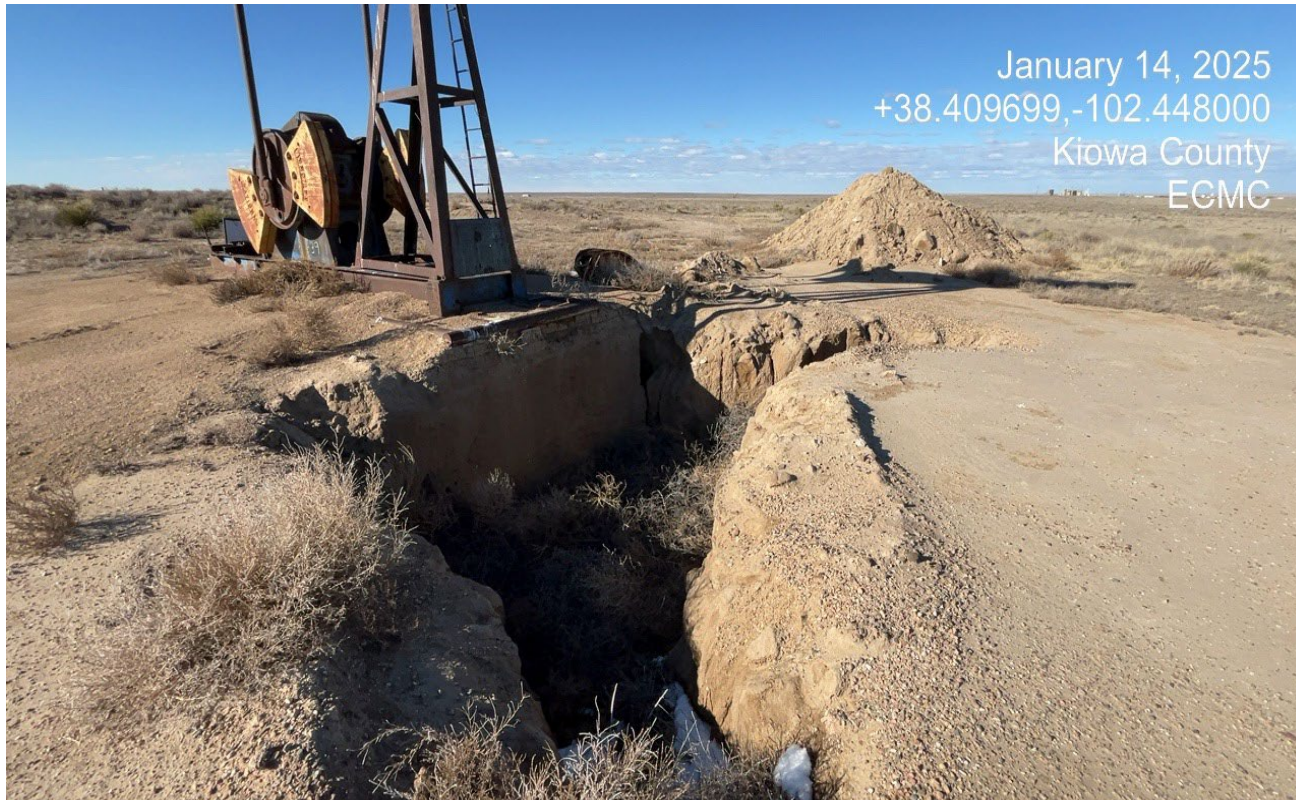
Photo 4. There is an open excavation at the wellhead from remediation. This area needs to be protected to prevent wildlife or livestock from falling in.

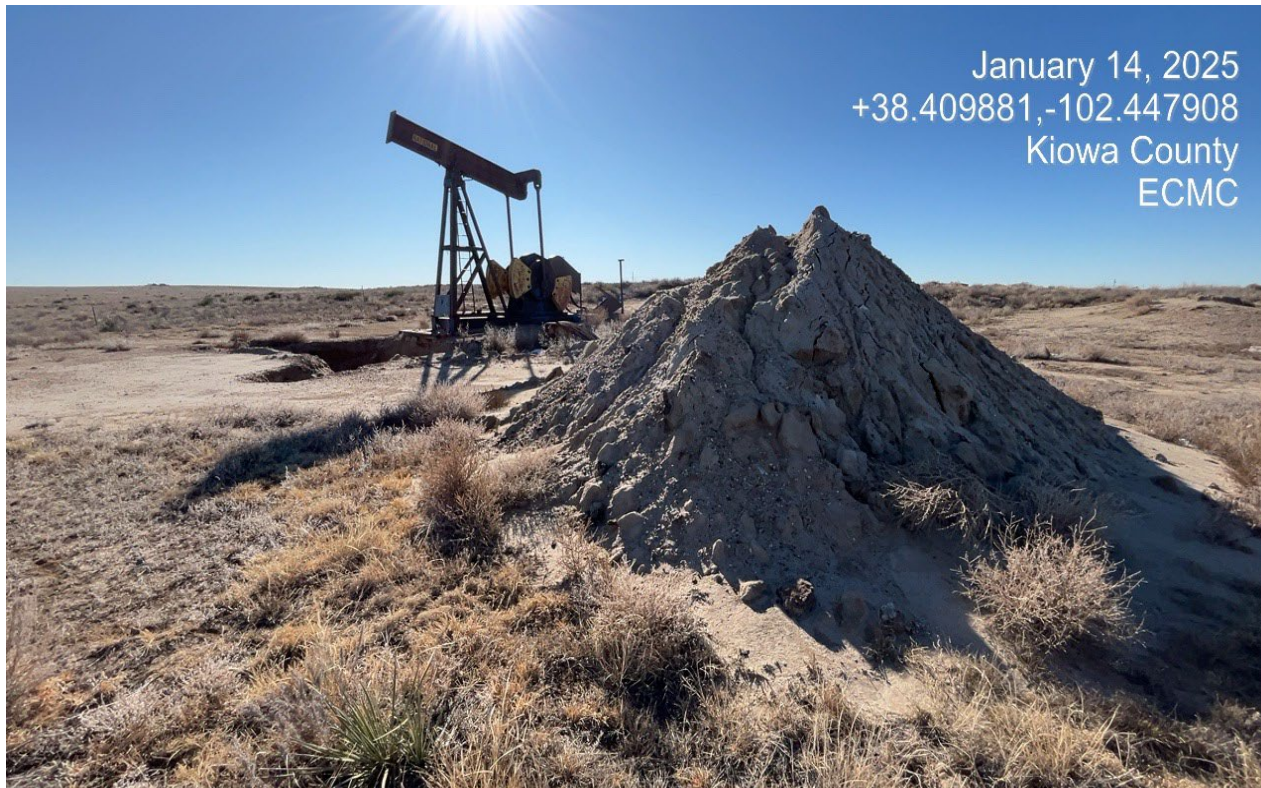
Photo 5. It appears this pile is impacted soils from the excavation. This pile is not stored with liner or berm to prevent contamination. Impacted soils need to be removed.

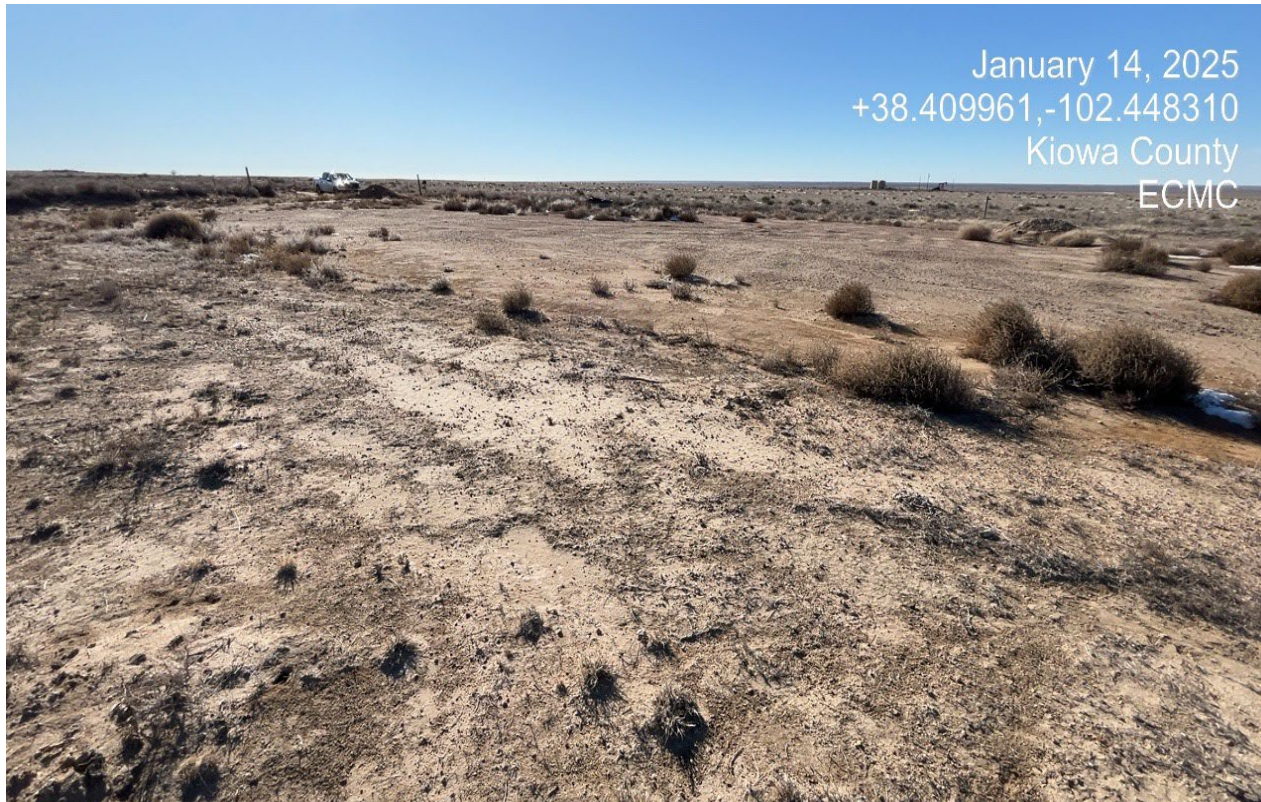
Photo 6. Facing southwest toward the disturbance area of the tank battery. It appears there may be impacted soils that will need to be remediated and reclaimed.

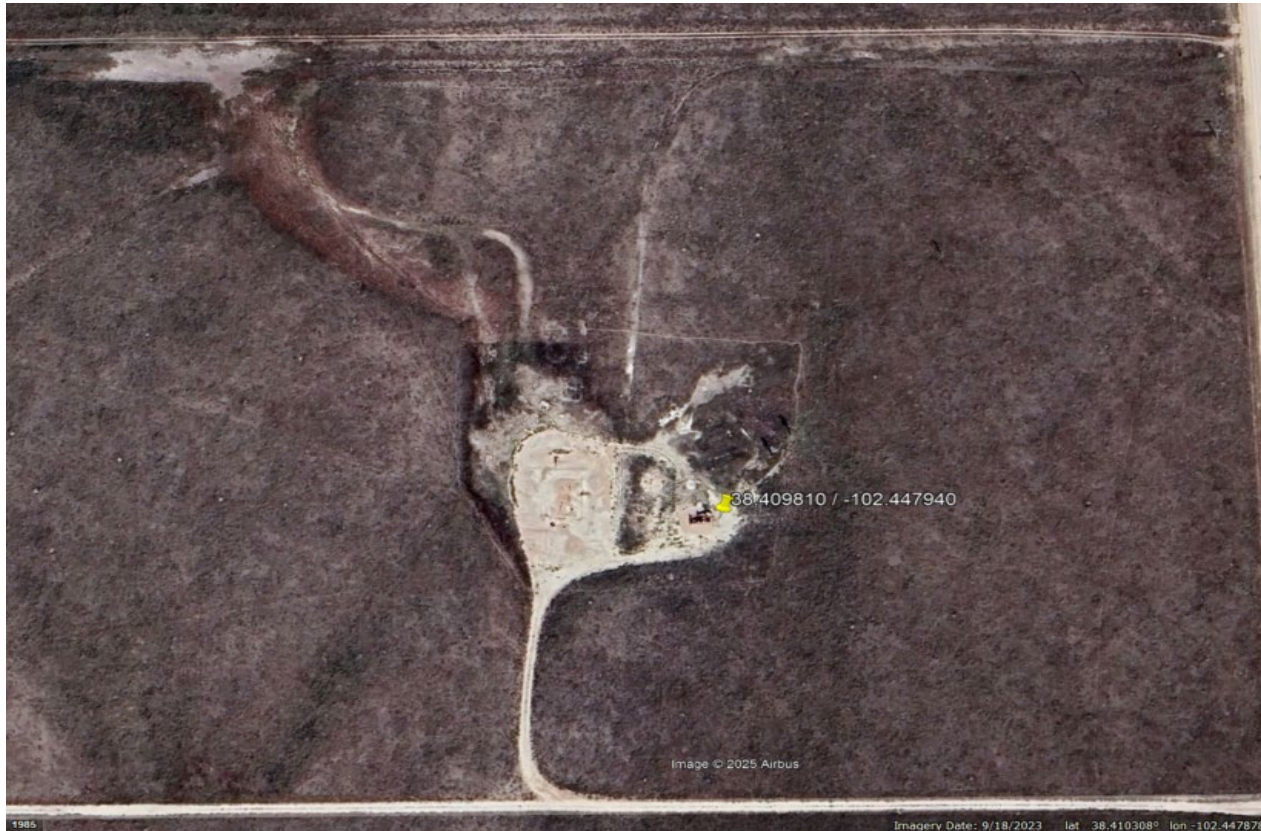
Photo 7. 2023 Aerial image of the Foster #1 location. There are impacts from historic spills that will need to be remediated.
