Inspection Photos

Location Name: TEP ROCKY MOUNTAIN LLC CIRCLE B LAND 24B-35-692 Pad

Location ID: 334695

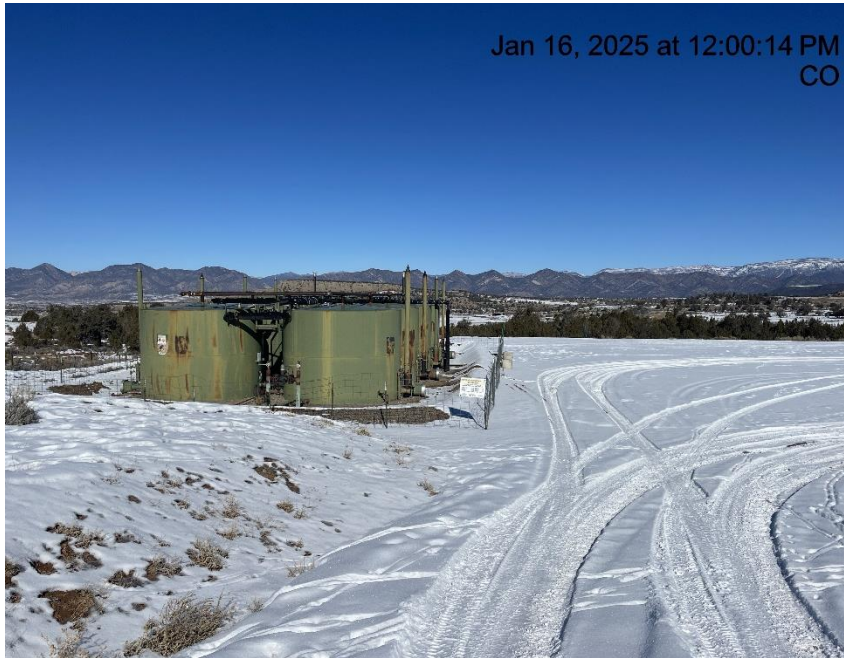
Photo # 9520 From entrance to location

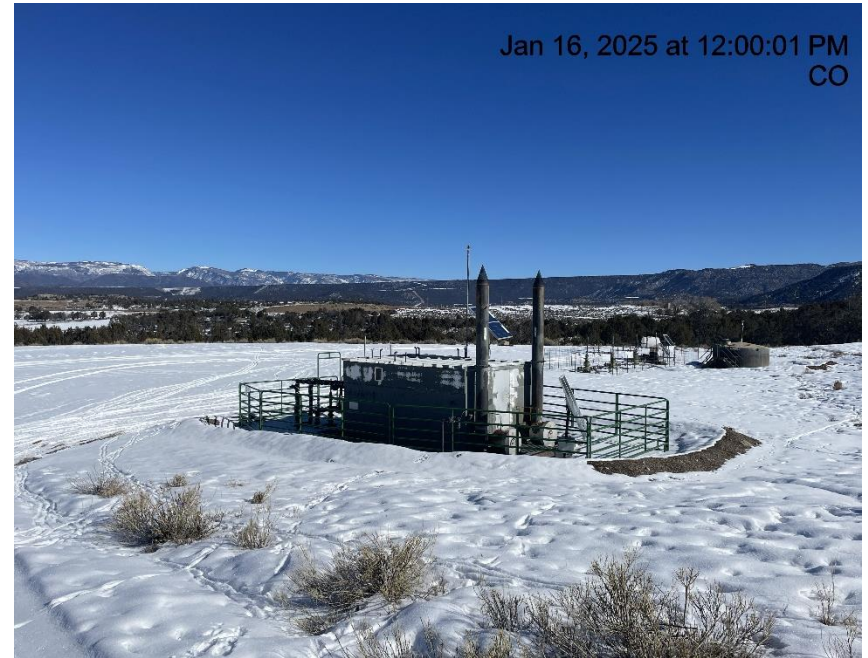
Photo # 9521 From entrance to location

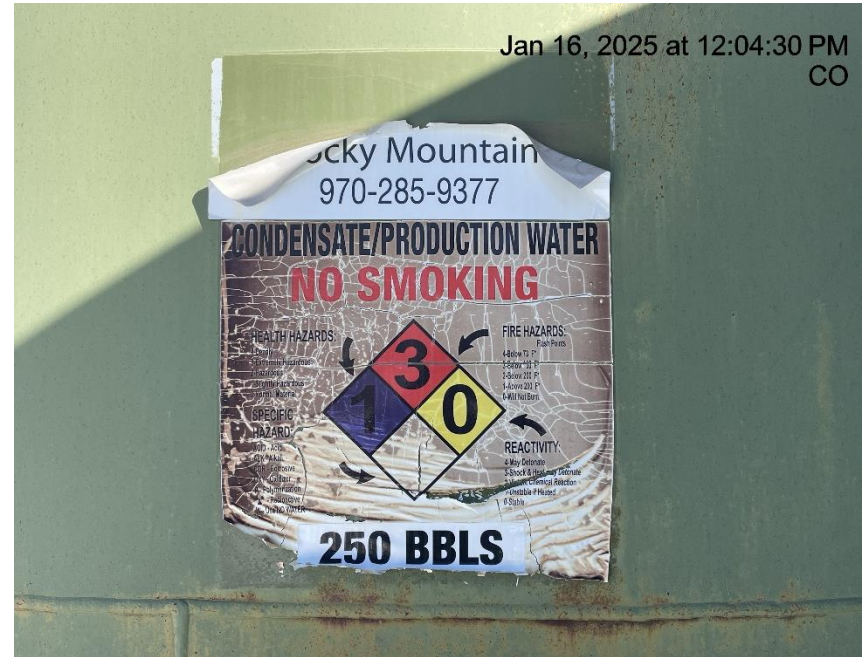
Photo # 9529 Tank label damaged & some required info is becoming illegible

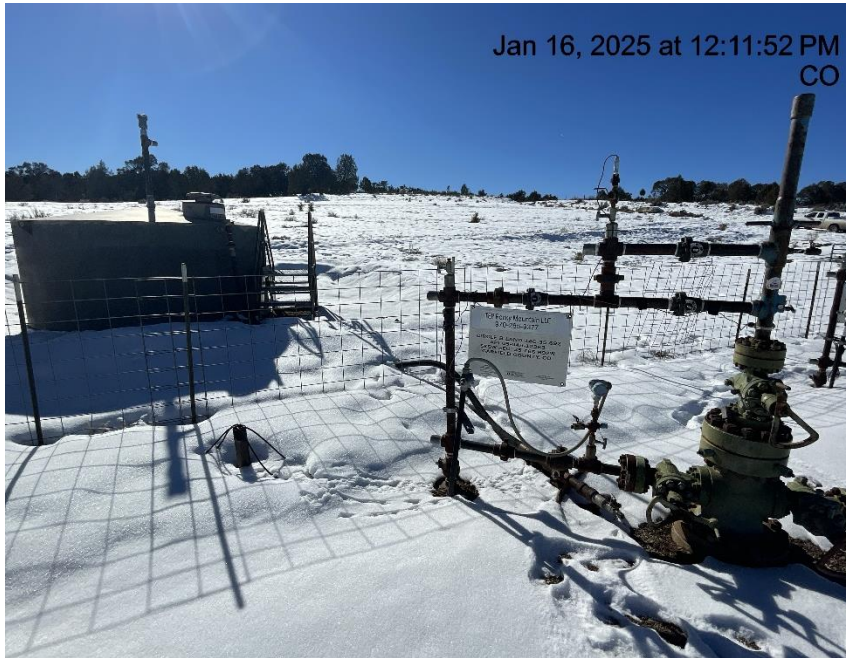
Photo # 9530 CIRCLE B LAND 14C-35-692 well bradenhead line connected to blowdown tank

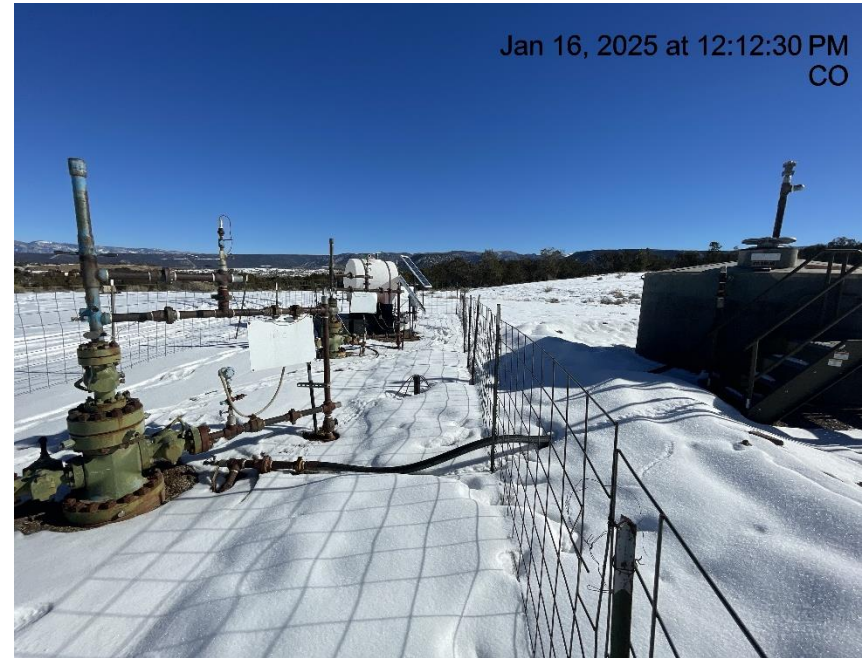
Photo # 9531 CIRCLE B LAND 14C-35-692 well bradenhead line connected to blowdown tank

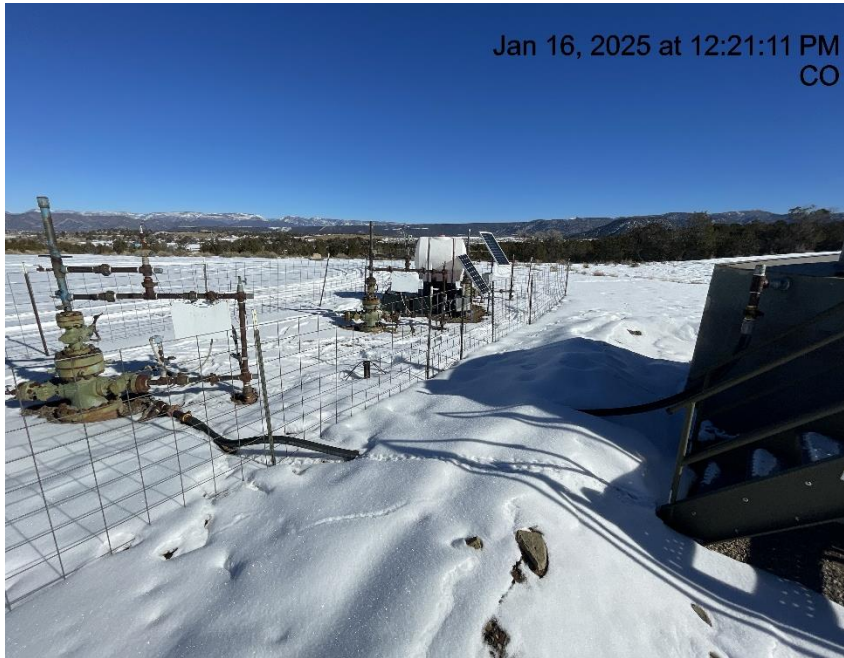
Photo # 9532 CIRCLE B LAND 14C-35-692 well bradenhead line connected to blowdown tank

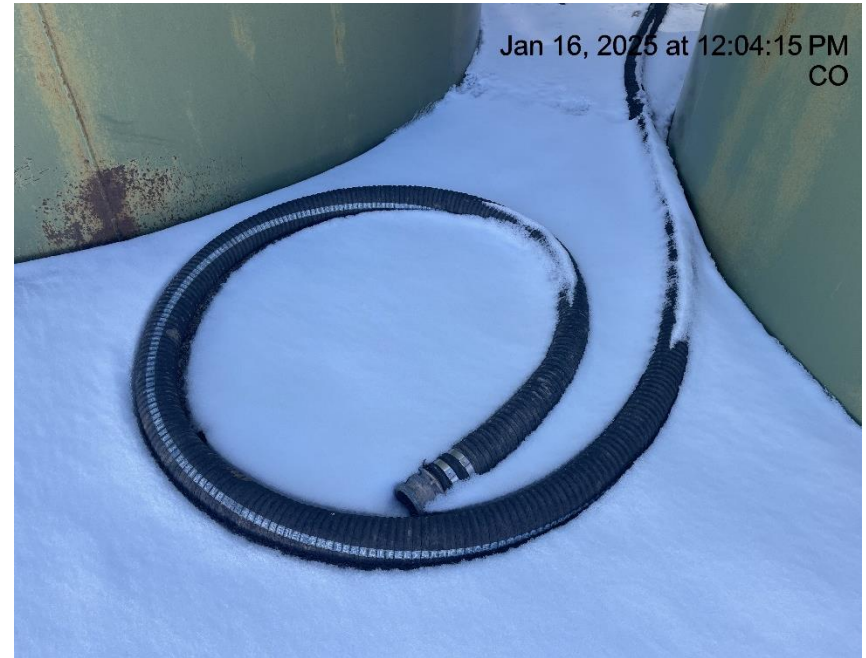
Photo # 9533 Unused hose in secondary containment

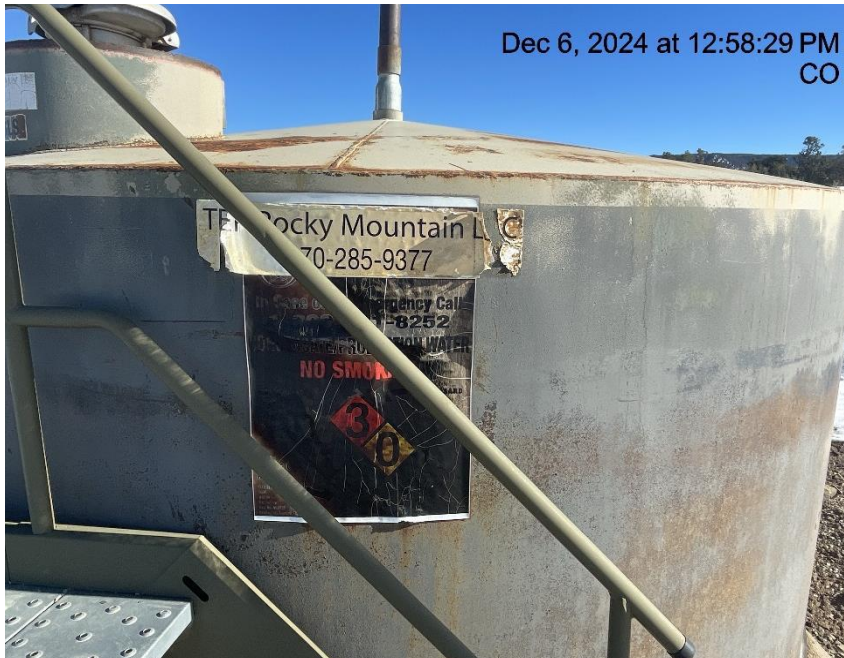
Photo # 2573 From inspection 708905205 conducted on 12/06/2024 Blowdown tank label weathered & illegible /does not comply with CECMC rules. Additionally capacity on tank label is also incorrect

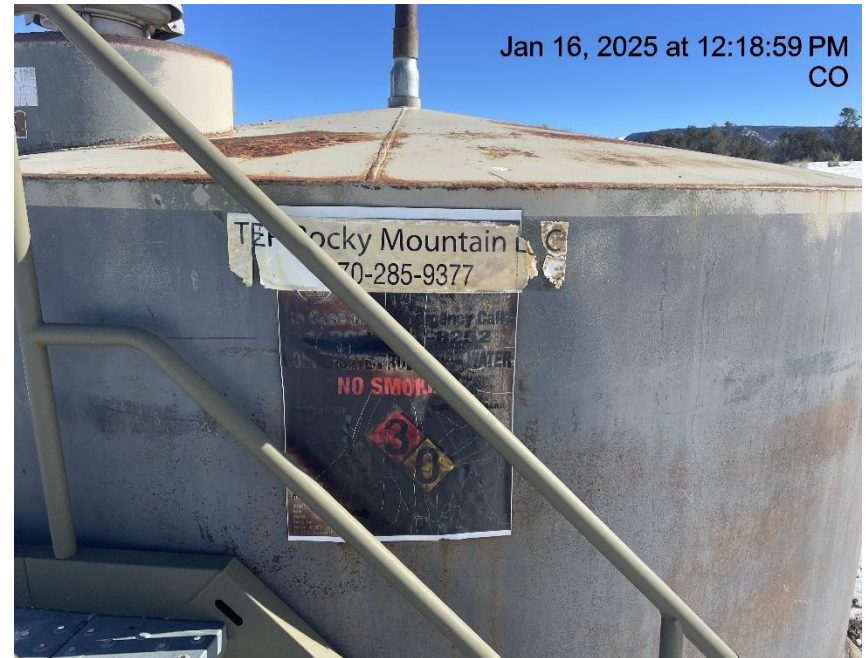
Photo # 9534 Blowdown tank label weathered & illegible /does not comply with CECMC rules. Additionally capacity on tank label is also incorrect

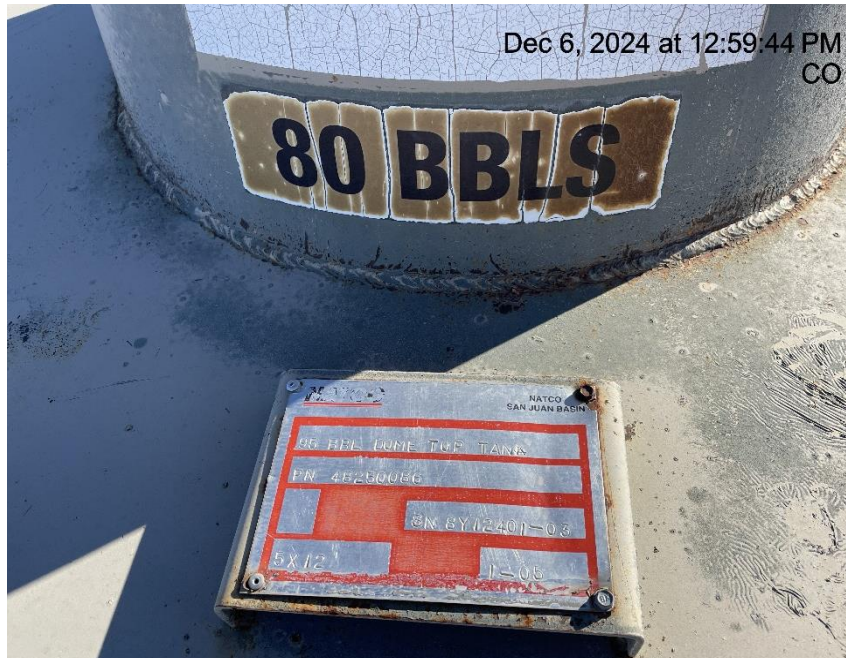
Photo # 2574 From inspection 708905205 conducted on 12/06/2024 Capacity on tank label for blowdown tank is incorrect/does not comply with CECMC rules

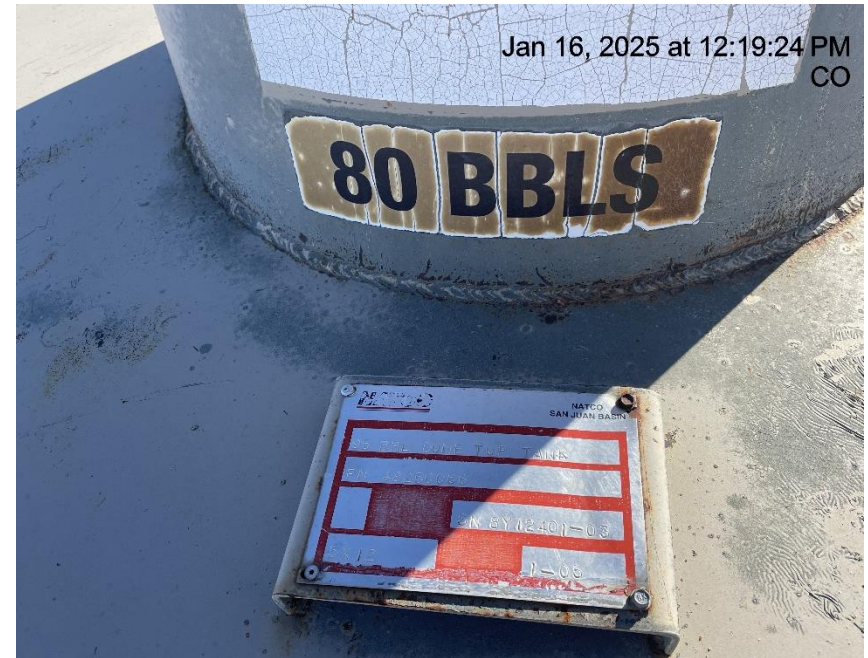
Photo # 9535 Capacity on tank label for blowdown tank is incorrect/does not comply with CECMC rules

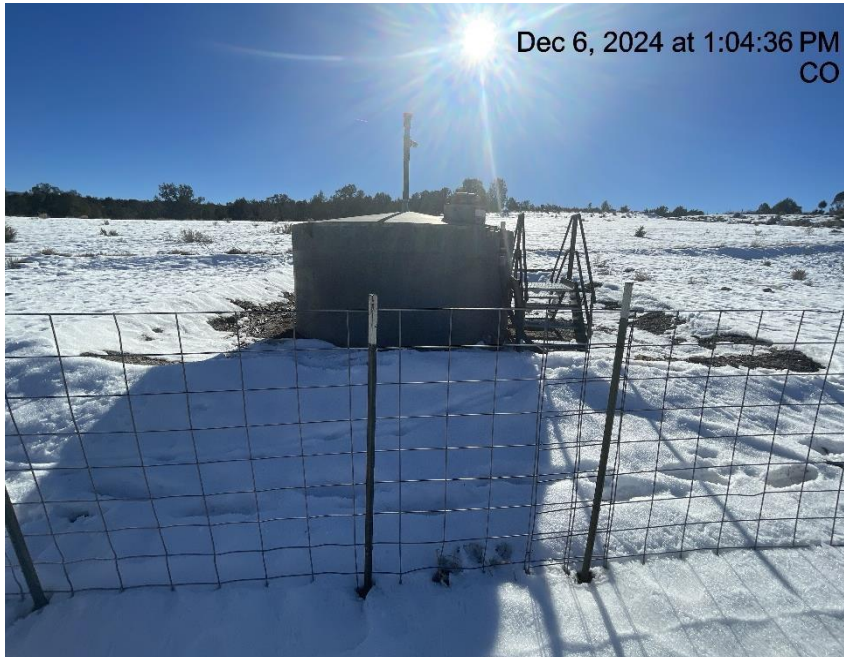
Photo # 2576 From inspection 708905205 conducted on 12/06/2024 Secondary containment insufficient/does not comply with CECMC rules

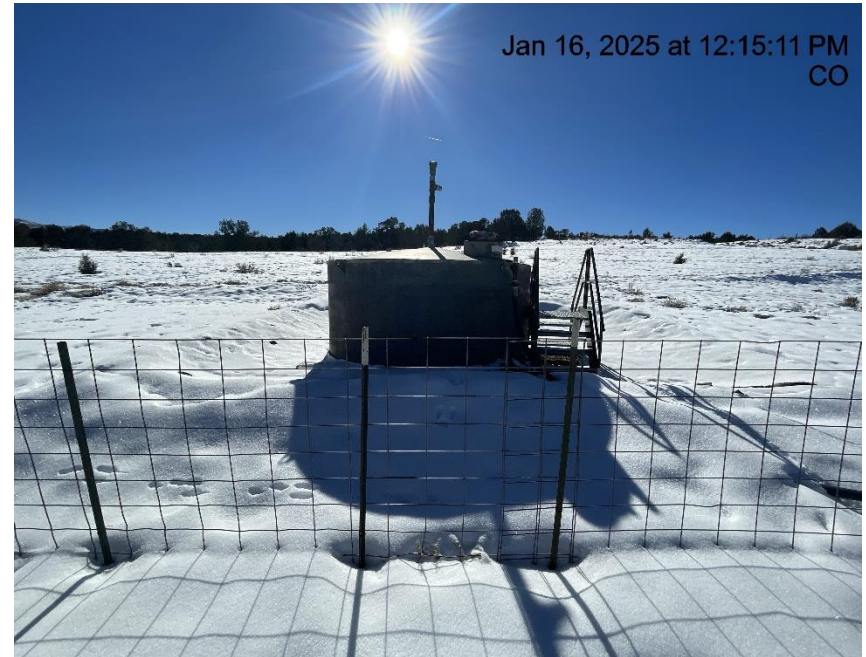
Photo # 9536 Secondary containment insufficient/does not comply with CECMC rules
