Final Reclamation Complete Notice – Cropland Drone Imagery

PERMIT CLOSURE REPORT – CROPLAND

Location ID 302243

Location Name LARSON-67N66W/20NWNW

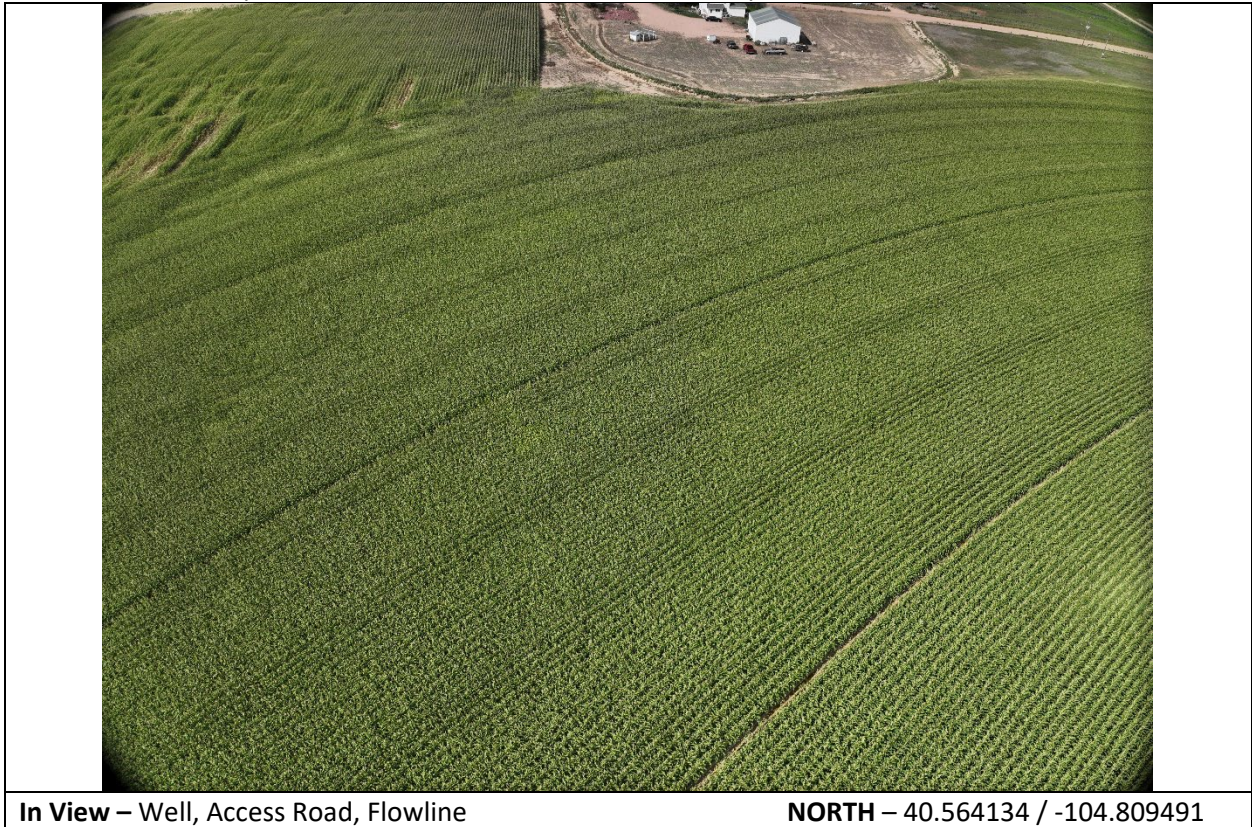
NORTH – 40.564134 / -104.809491

In View – Well, Access Road, Flowline

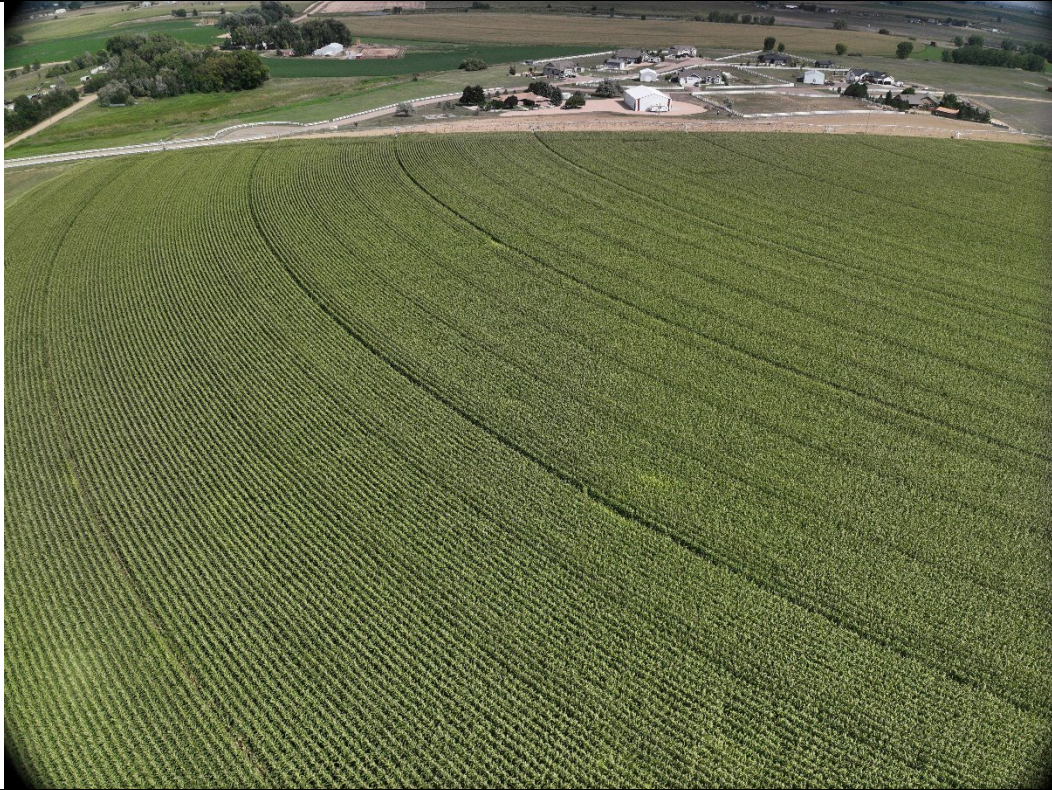
EAST – 40.565807 / -104.810388

In View – Well, Access Road, Flowline

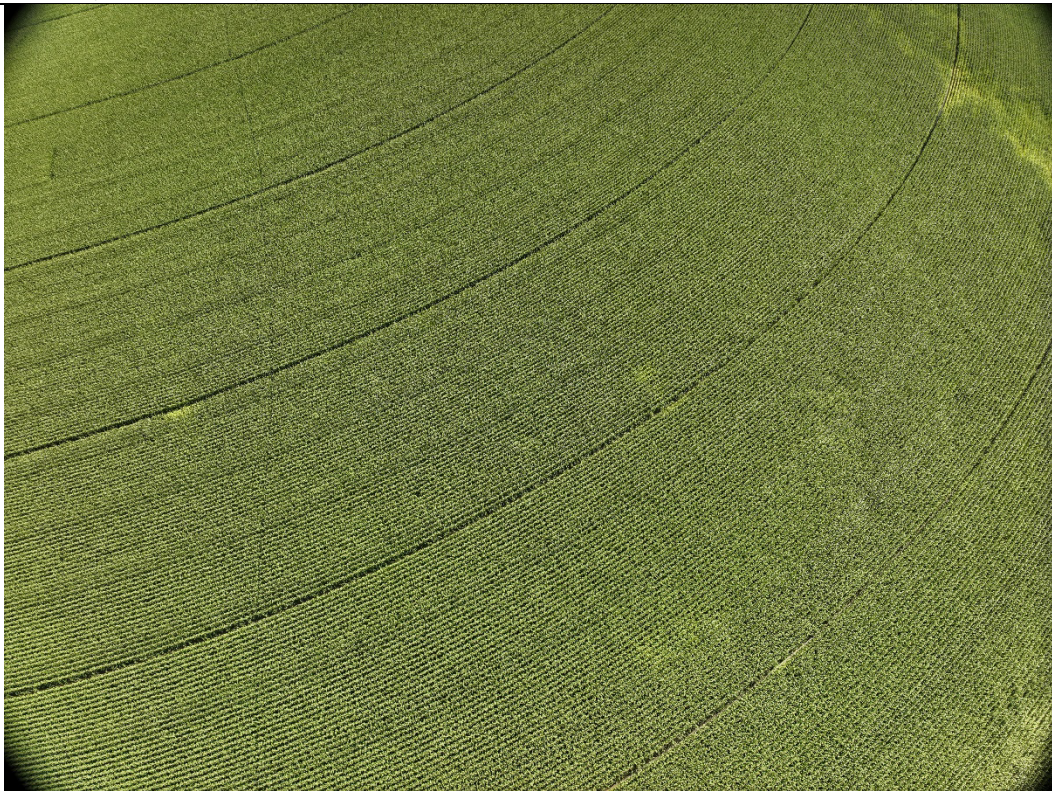
SOUTH – 40.566298 / -104.809441

In View – Well, Access Road, Flowline

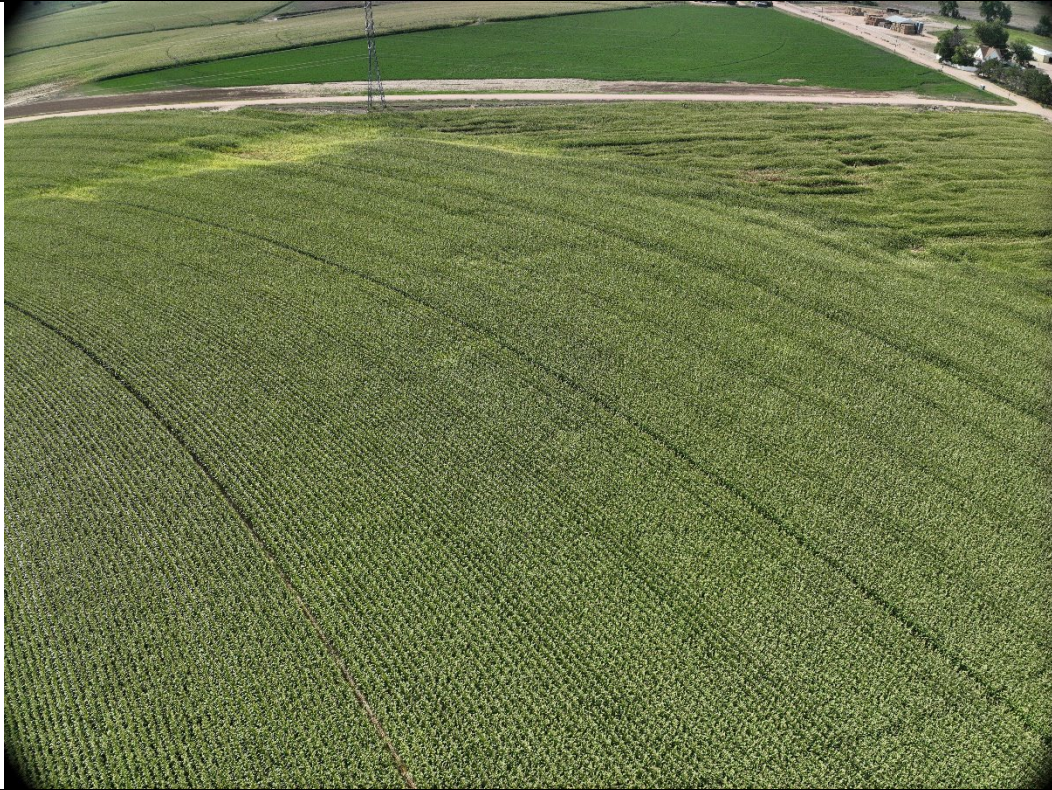
WEST – 40.565699 / -104.808567

In View – Well, Access Road, Flowline

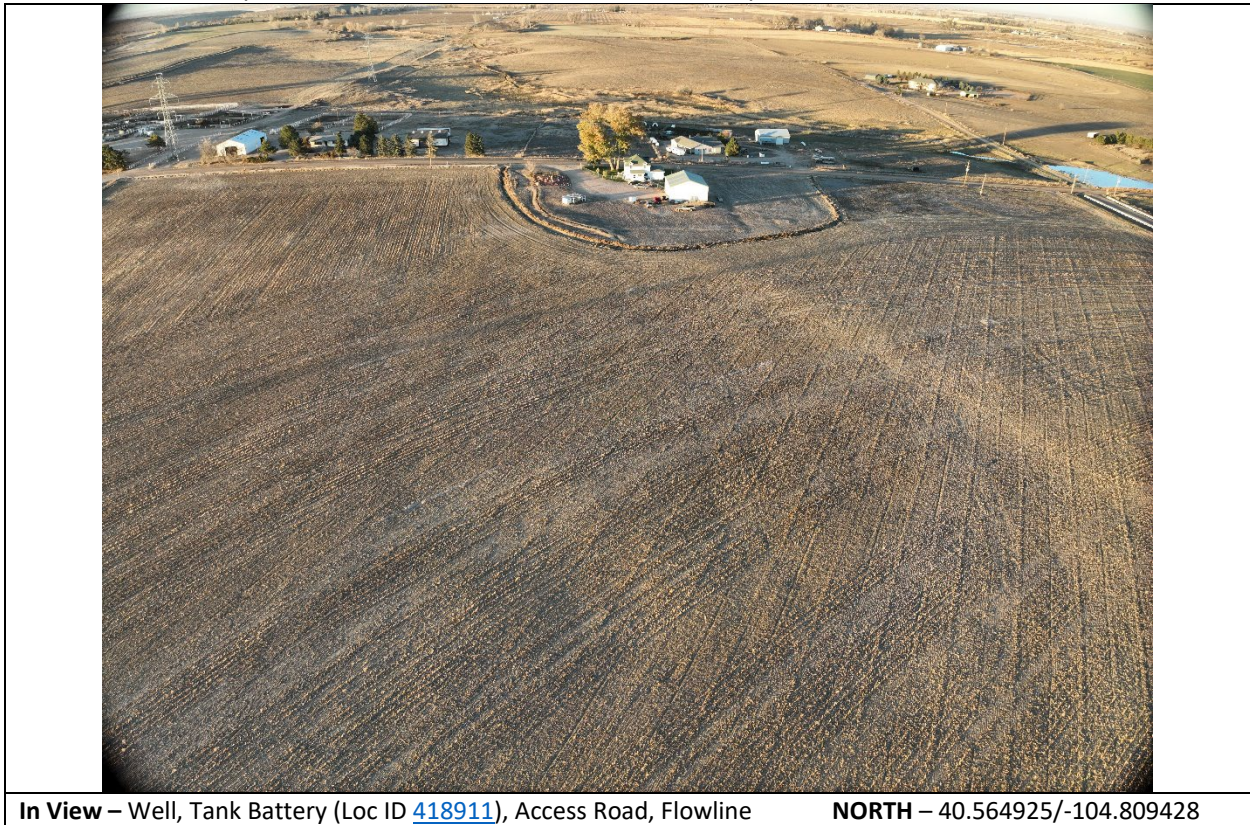
NORTH – 40.564925/-104.809428

In View – Well, Tank Battery (Loc ID [418911](#)), Access Road, Flowline

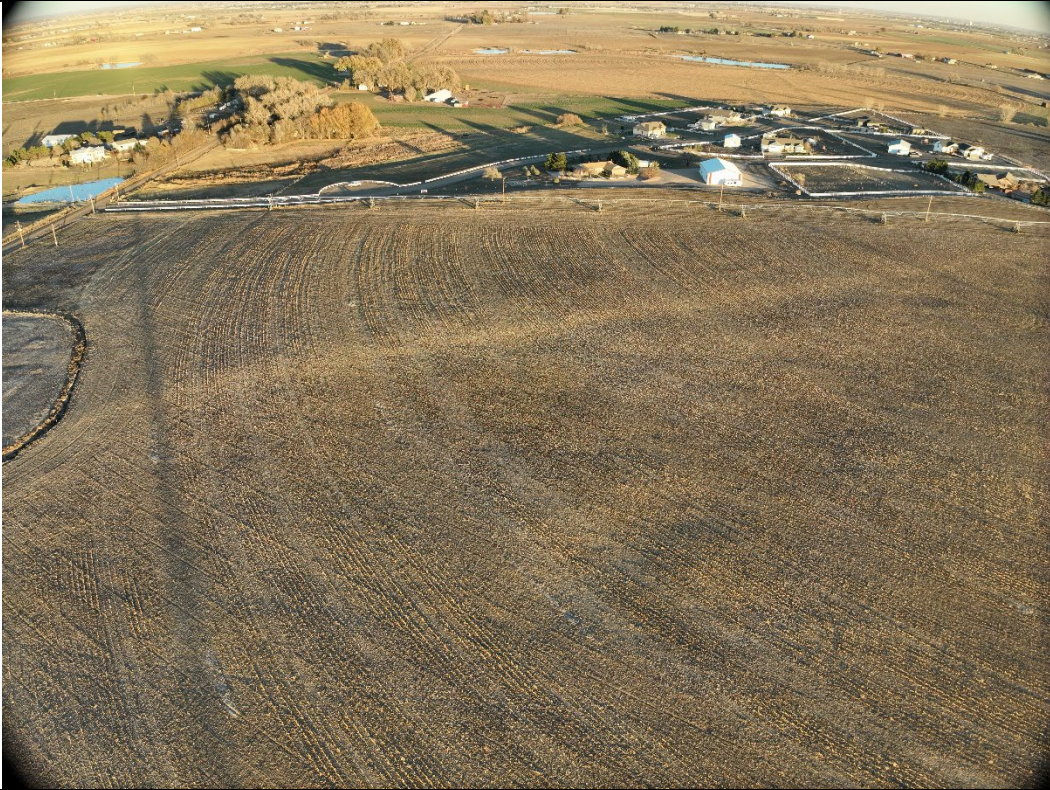
EAST – 40.565667 / -104.810575

In View – Well, Tank Battery, Access Road, Flowline

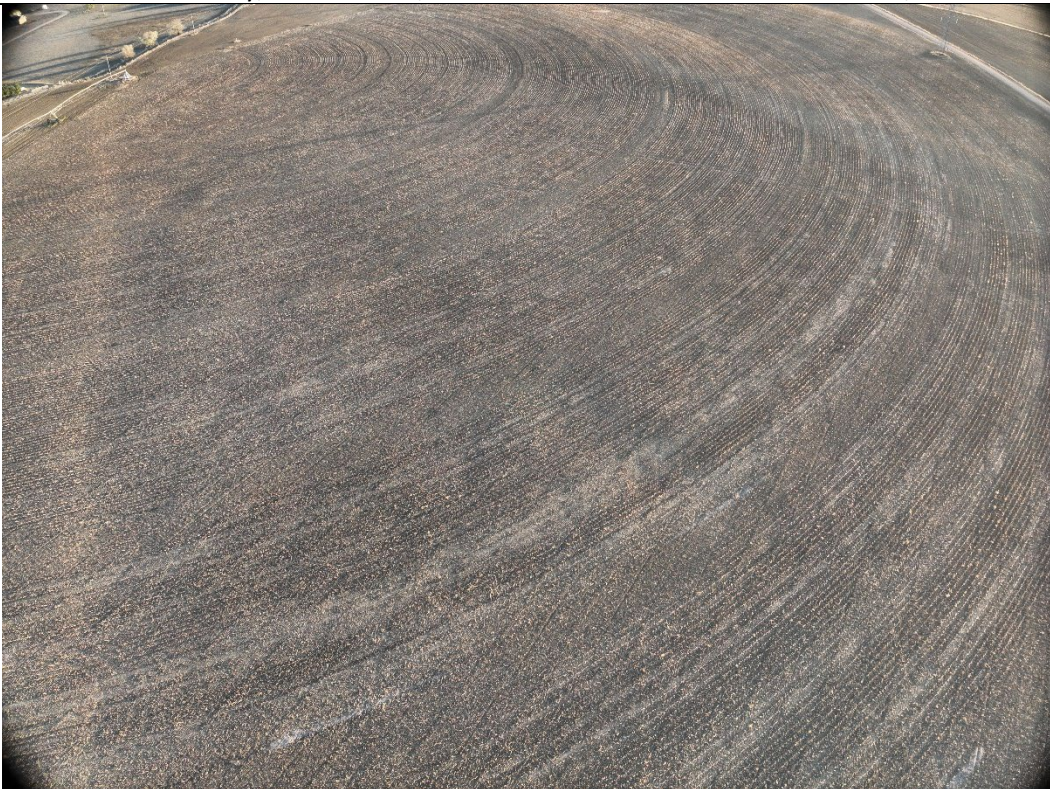
SOUTH – 40.566324 / -104.809364

In View – Well, Access Road, Flowline

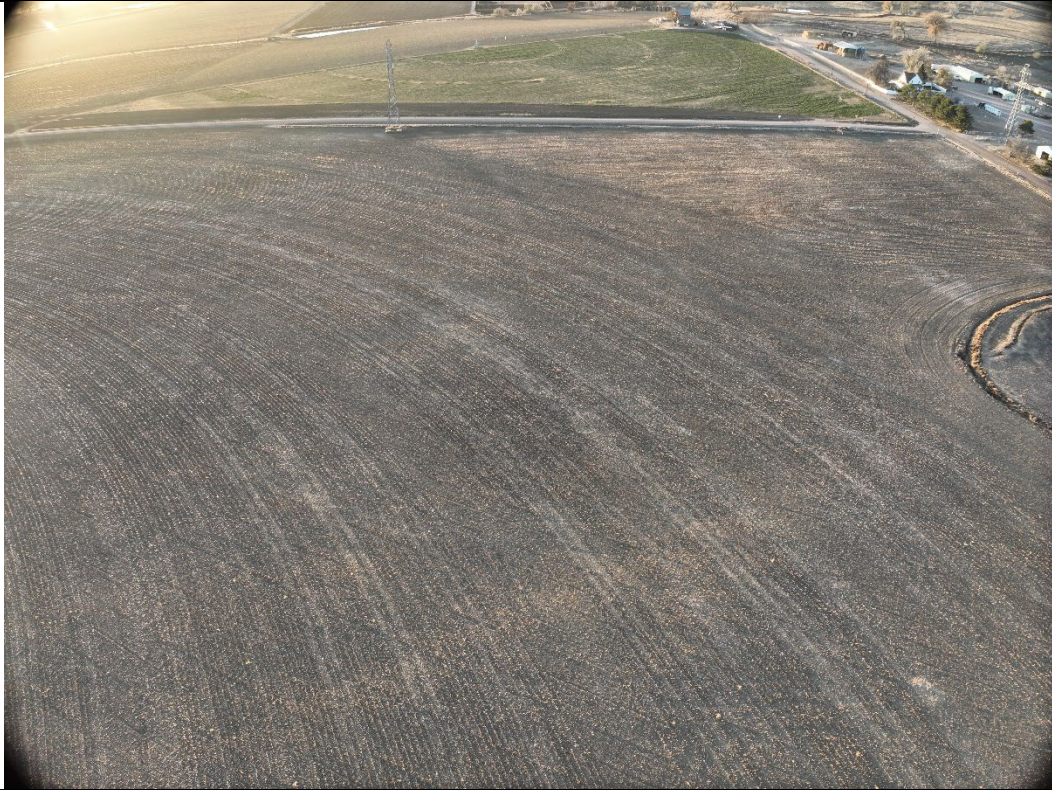
WEST – 40.565721 / -104.807836

In View – Well, Access Road, Flowline

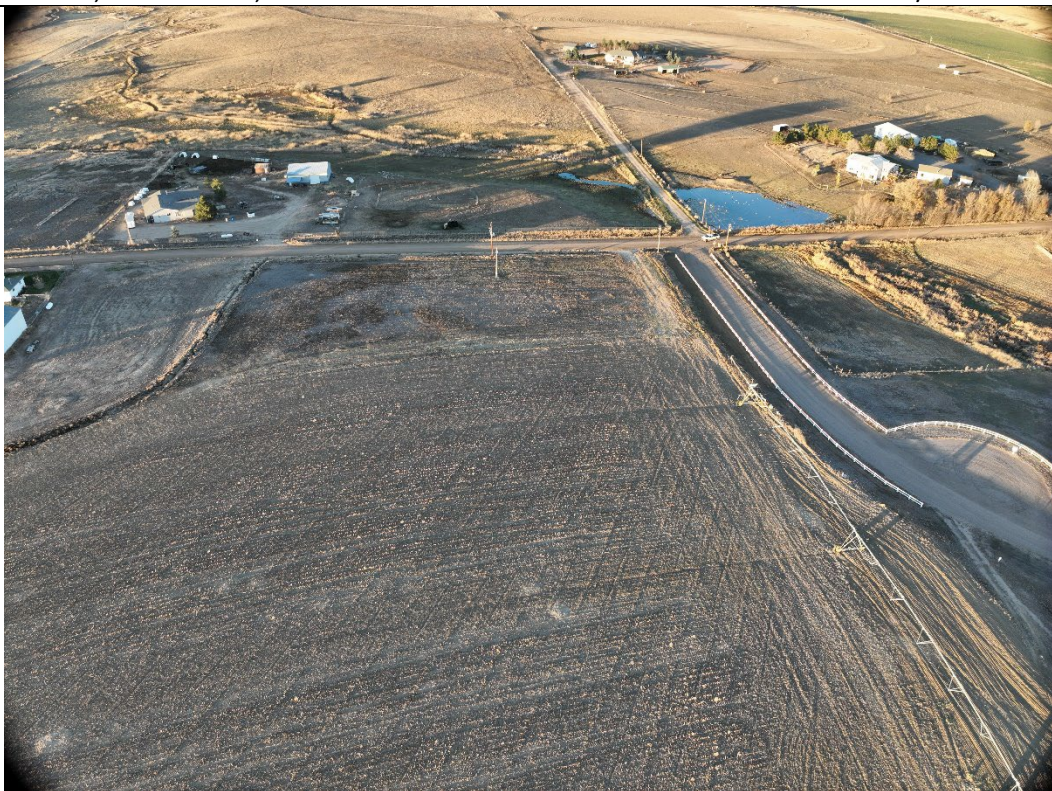
NORTH – 40.565715 / -104.807834

In View – Tank Battery (Loc ID [418911](#)), Access Road, Flowline
