Inspection/Audit Photos

Location: LARAMIE ENERGY LLC WHF/D17 998

Location ID: 429734

Date: 01/23/2025

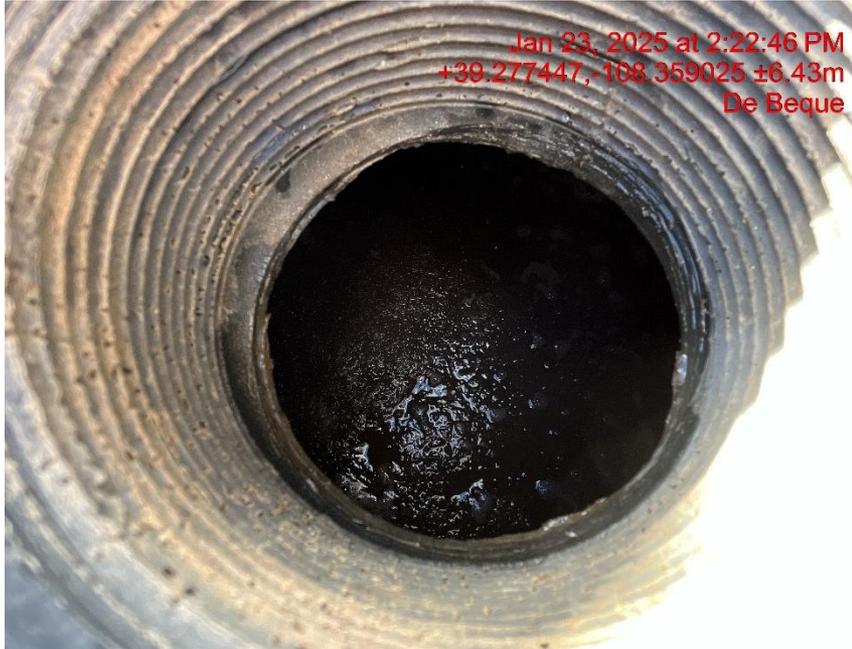
Photo # 3324 Failure to maintain chemical BMP/chemical containment approximately 3/4th full of fluid/not sufficient to contain possible spill

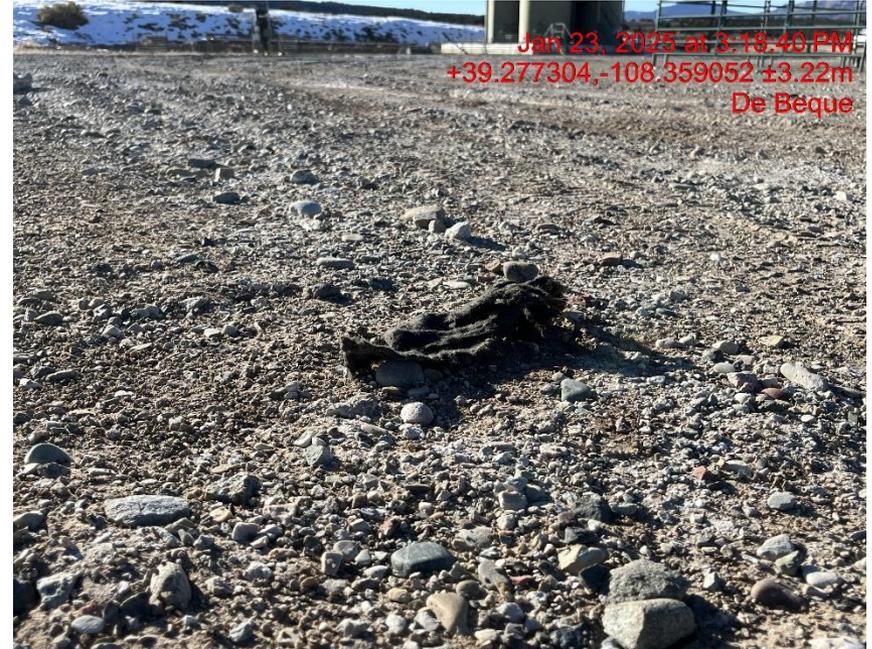
Photo # 3366 Debris

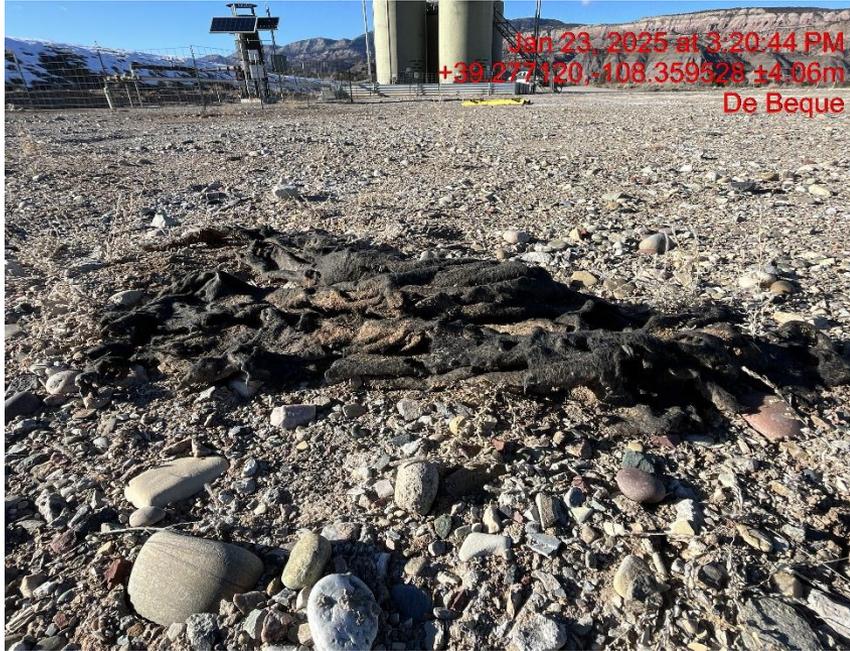
Photo # 3367 Debris

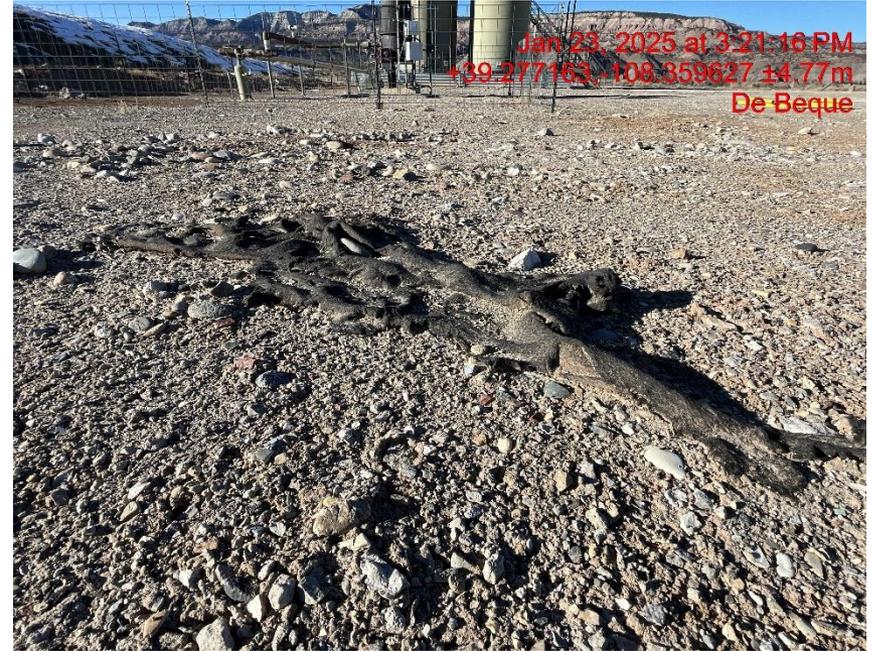
Photo # 3368 Debris

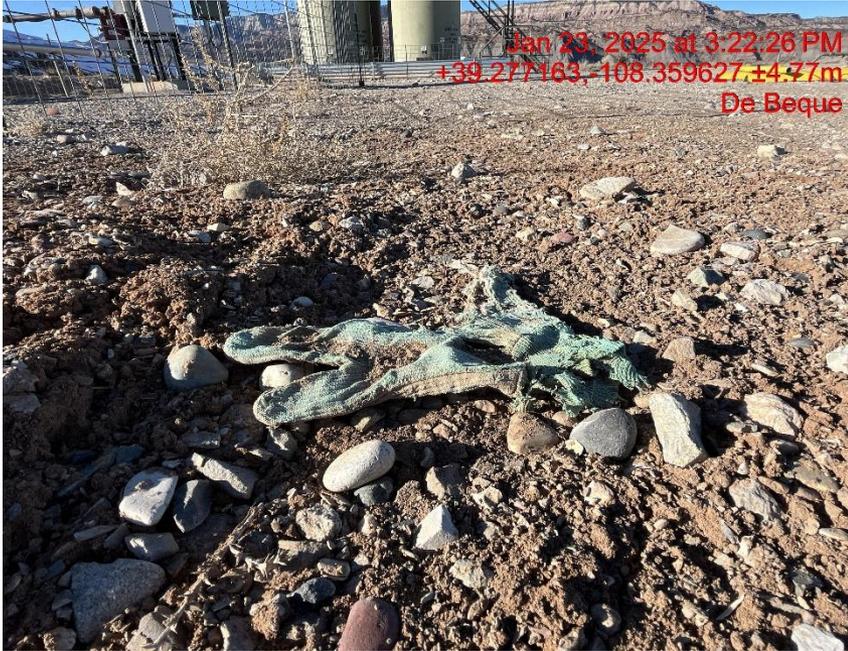
Photo # 3370 Debris

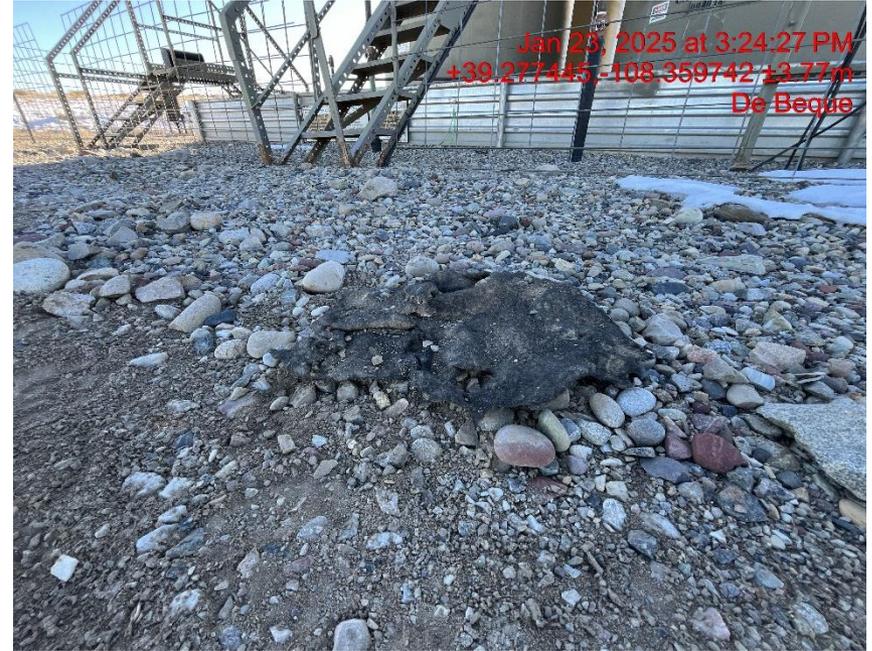
Photo # 3374 Debris

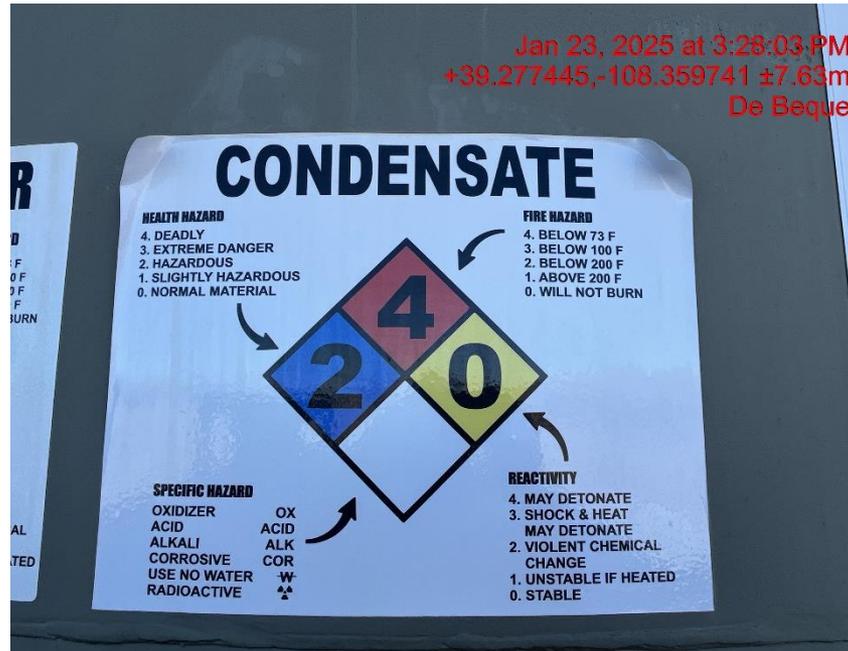
Photo # 3379 Label is showing signs of disrepair
