# Inspection/Audit Photos

Location: TEP ROCKY MOUNTAIN LLC STRAIT BOTTOM RANCH/SG 23-22 PAD

Location ID: 435460

Date: 01/21/2025

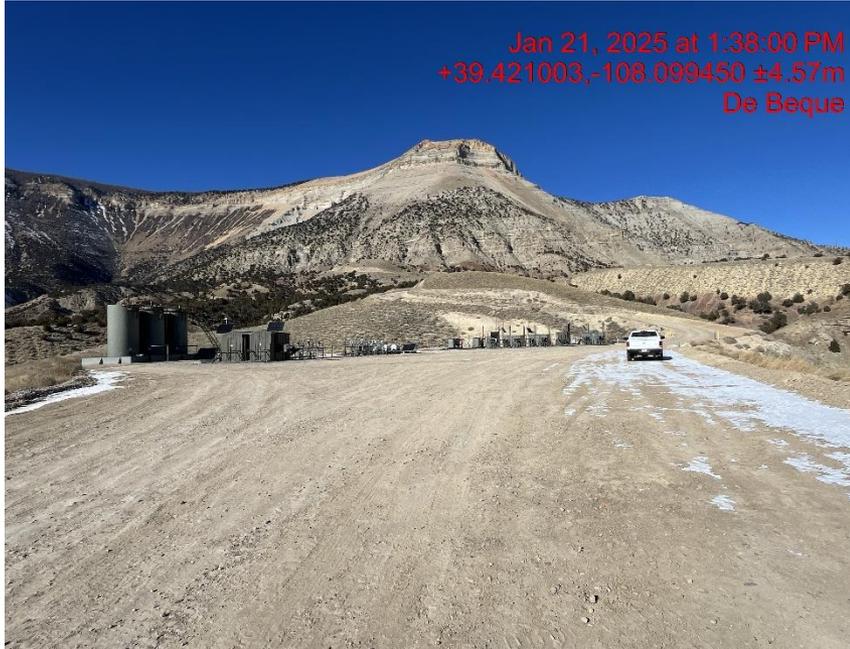
Photo # 3019 Entrance to location

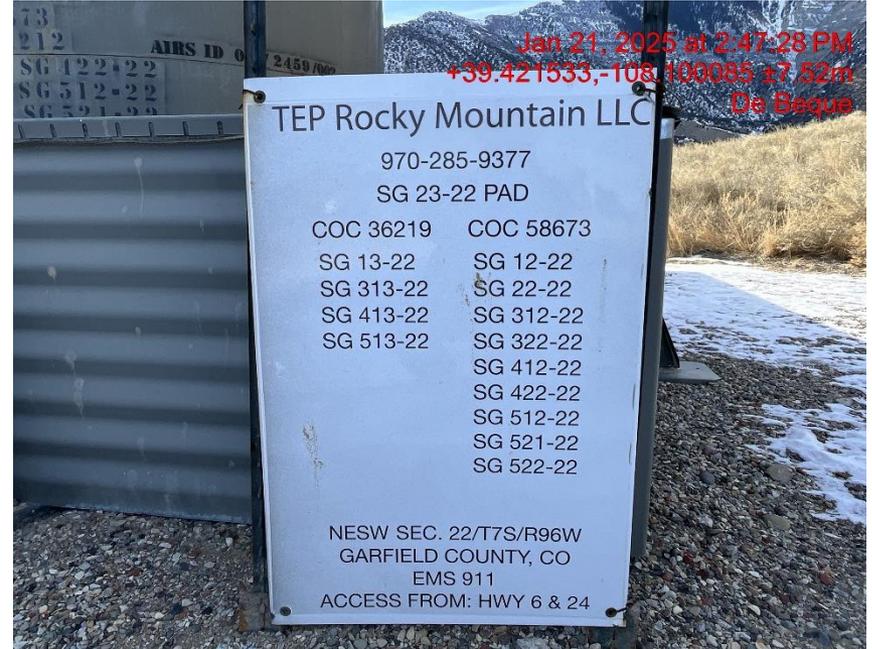
Photo # 3085 Location

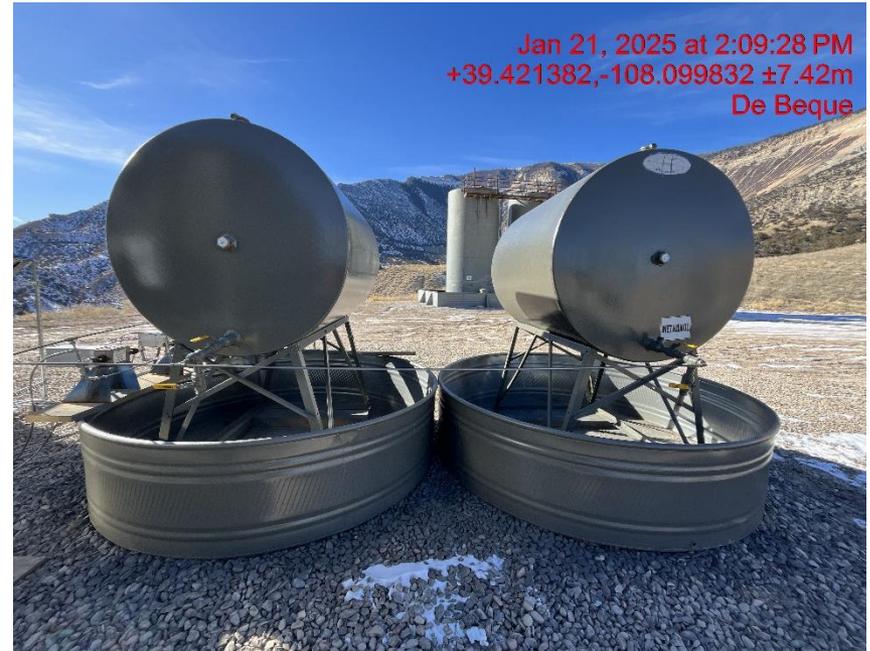
Photo # 3039 Chemical tanks lack required labeling/do not comply with CECMC rules

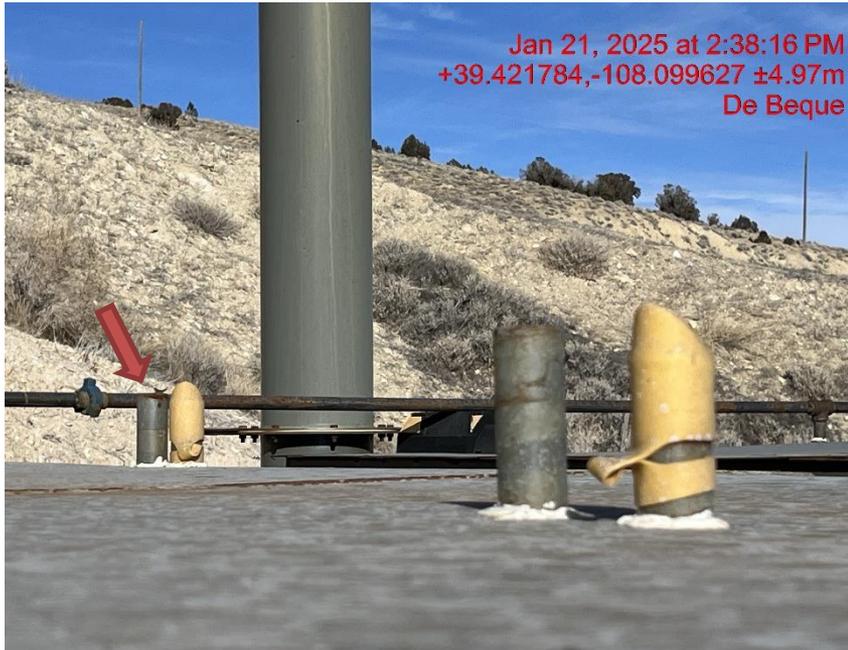
**Photo # 3074 PRV vent lines do not comply with CECMC pressure safety device rules**

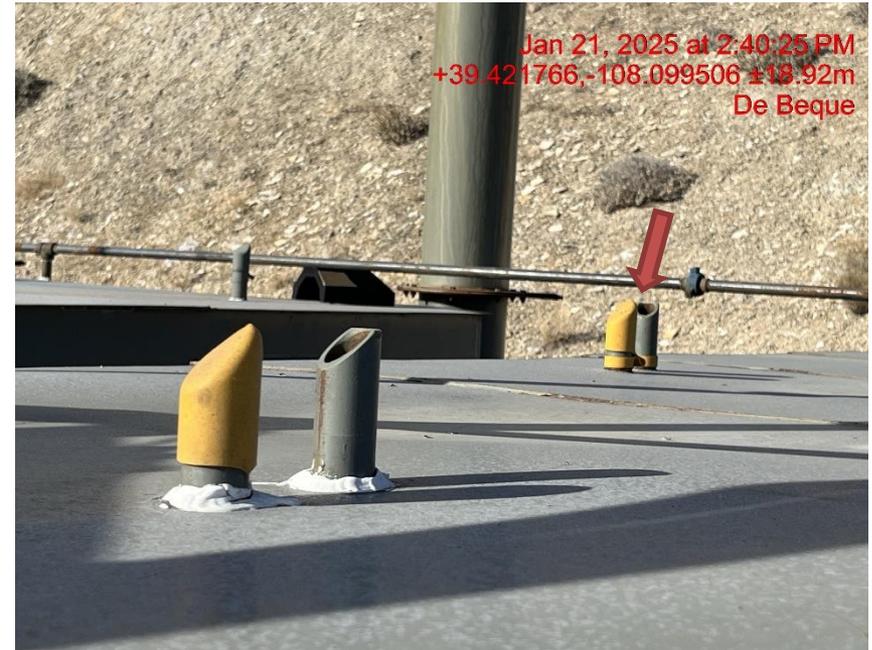
**Photo # 3076 PRV vent lines do not comply with CECMC pressure safety device rules**

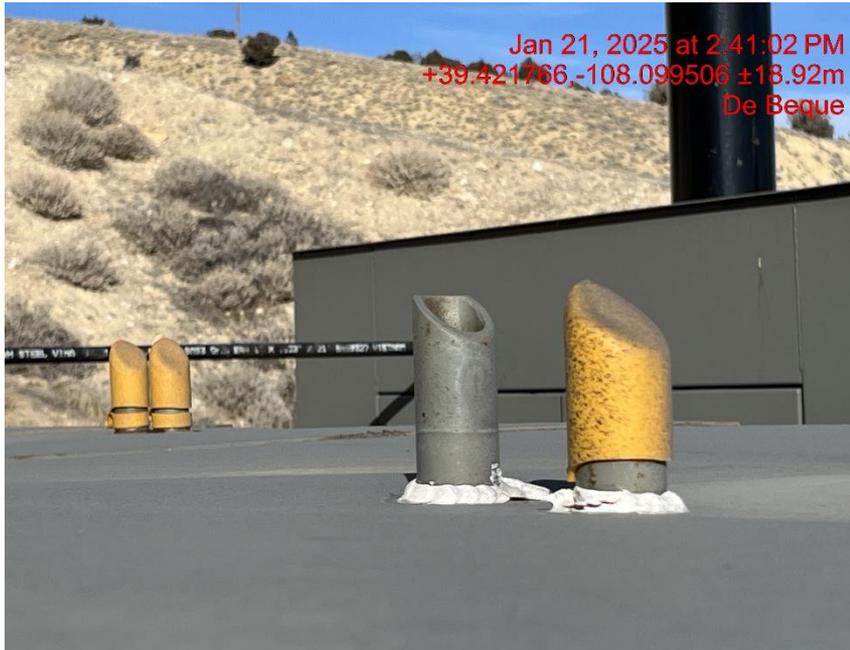
Photo # 3077 PRV vent line does not comply with CECMC pressure safety device rules

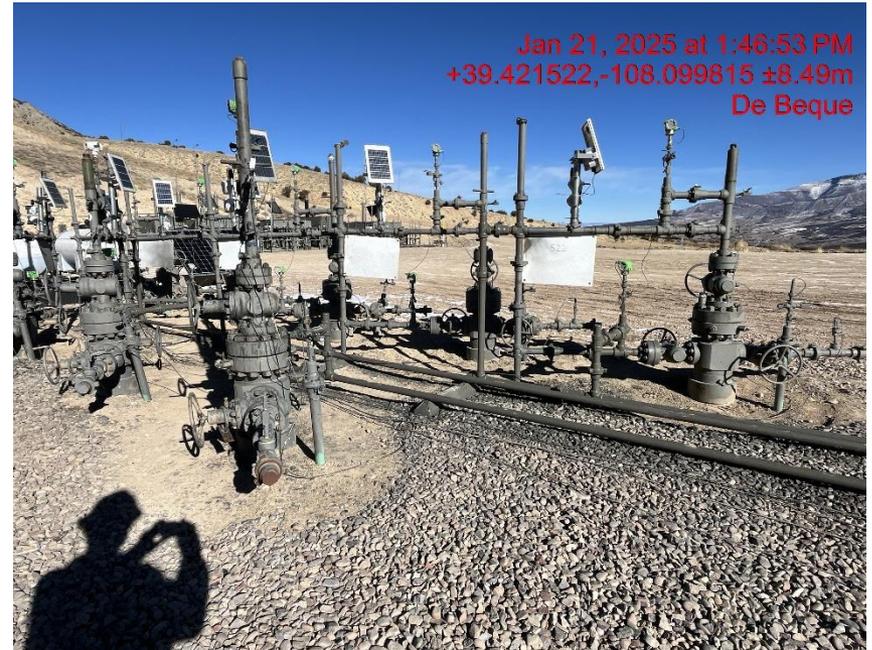
Photo # 3023 Paint staining the ground around equipment & flowlines in multiple areas on location

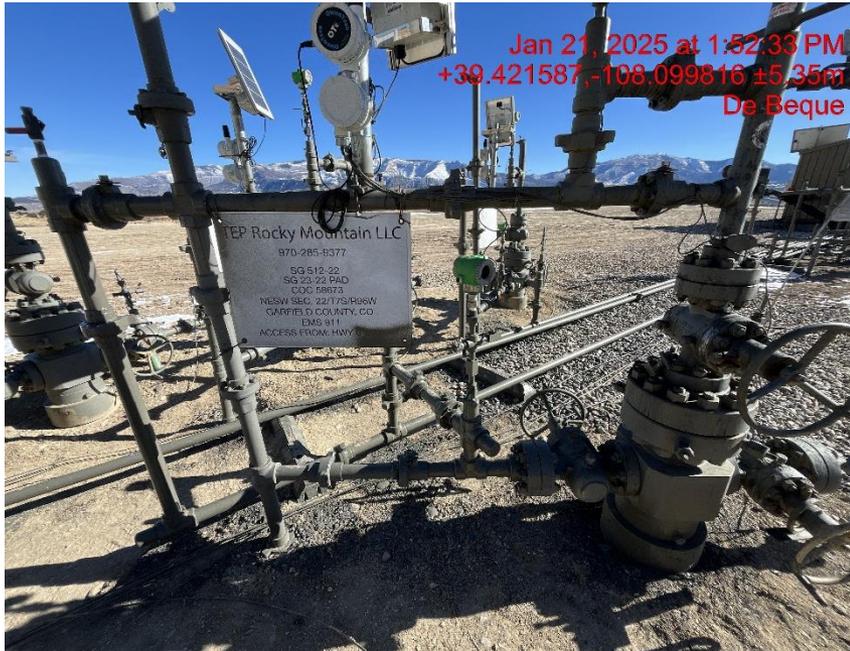
Photo # 3027 Paint staining the ground around equipment & flowlines in multiple areas on location

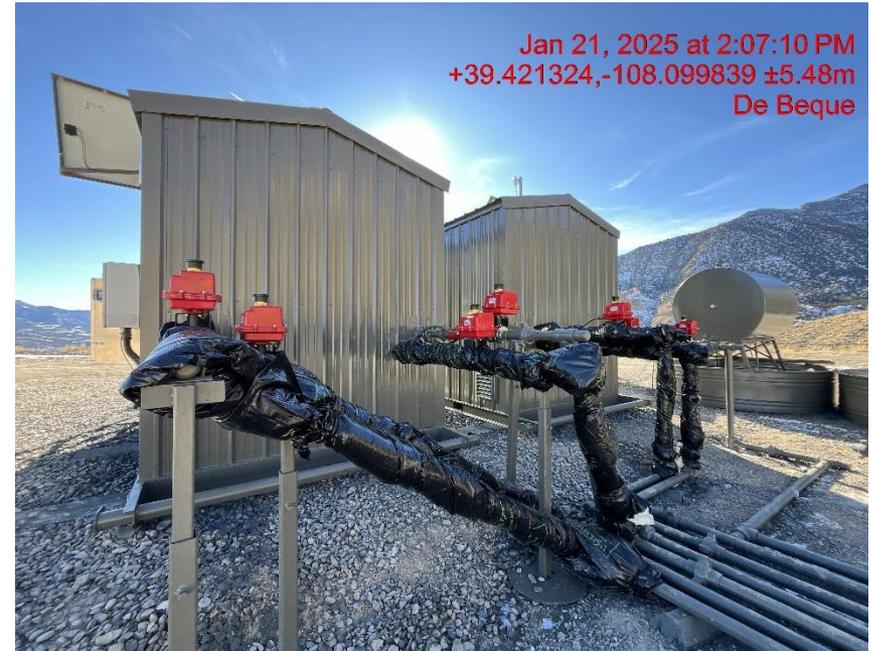
Photo # 3035 Paint staining the ground around equipment & flowlines in multiple areas on location

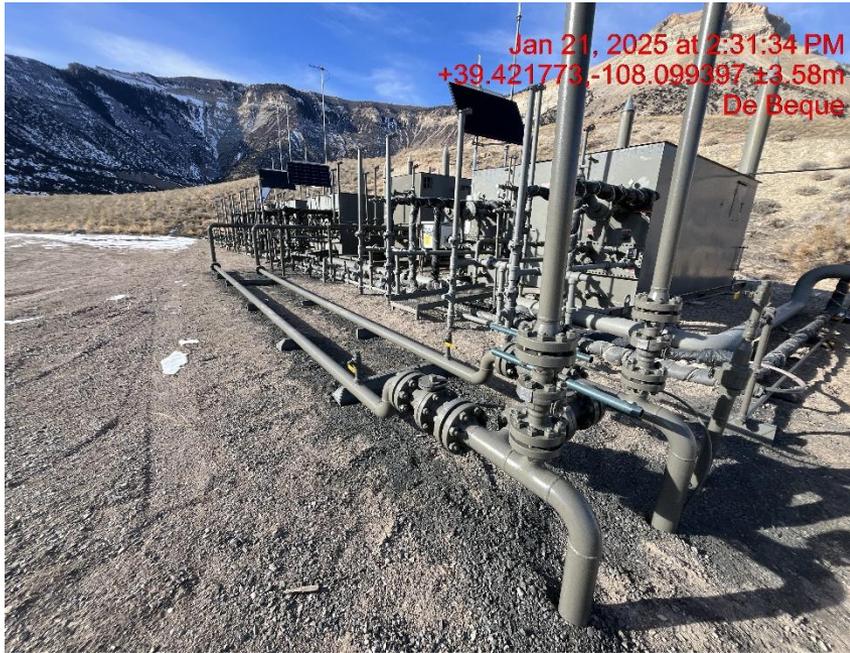
**Photo # 3065 Paint staining the ground around equipment & flowlines in multiple areas on location**

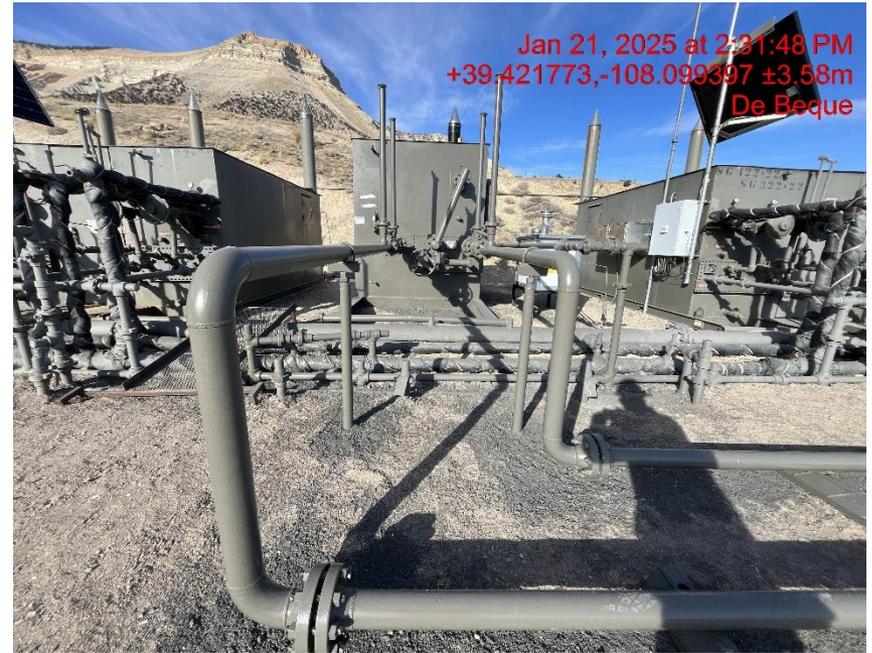
**Photo # 3066 Paint staining the ground around equipment & flowlines in multiple areas on location**
