Inspection Photos
Location Name: Miller 22-08 1N44W
API Number: 125-11680

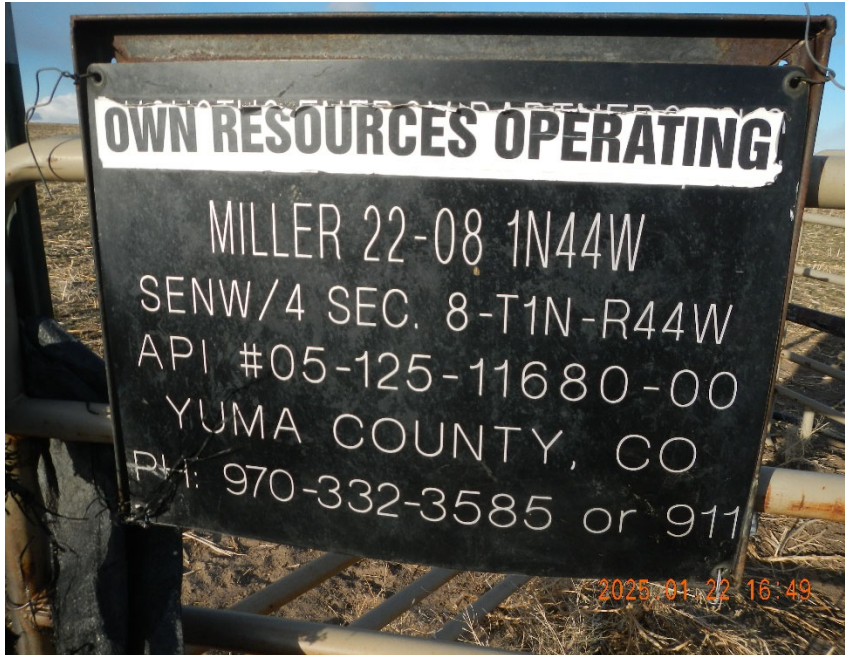
1. Lease sign at well location.

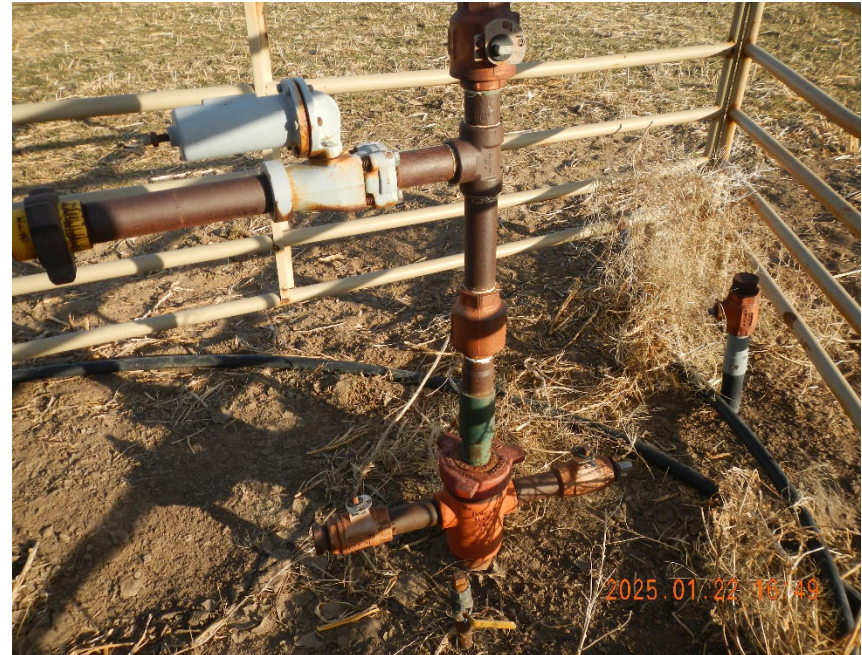
2. View of wellhead. Note dried vegetation inside fencing.

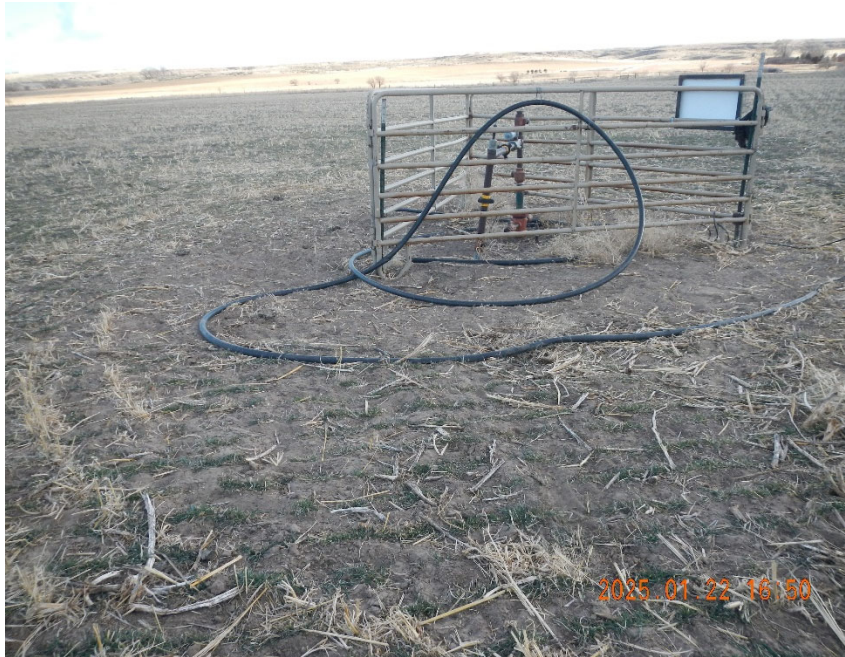
3. Black poly line outside well fencing.

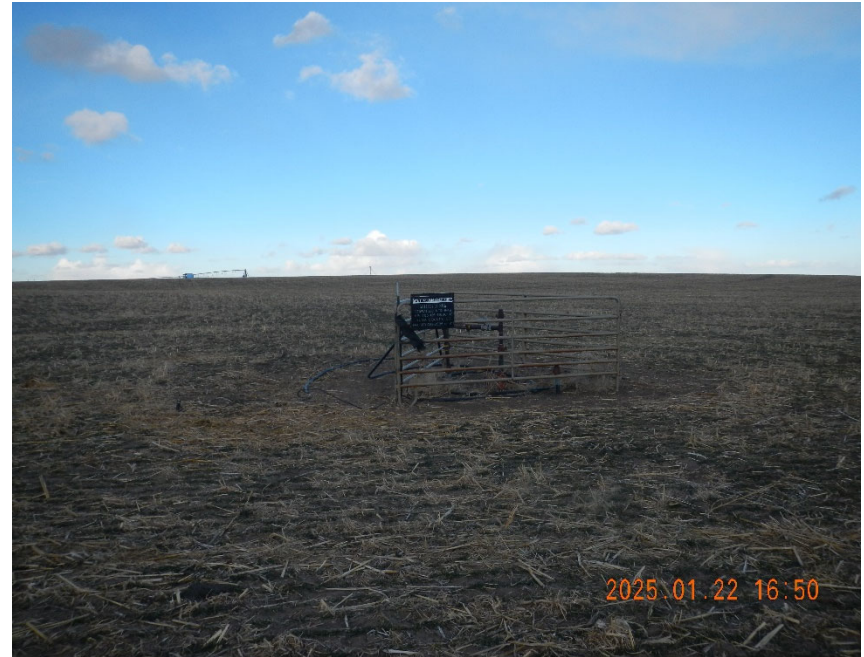
4. Well location overview.

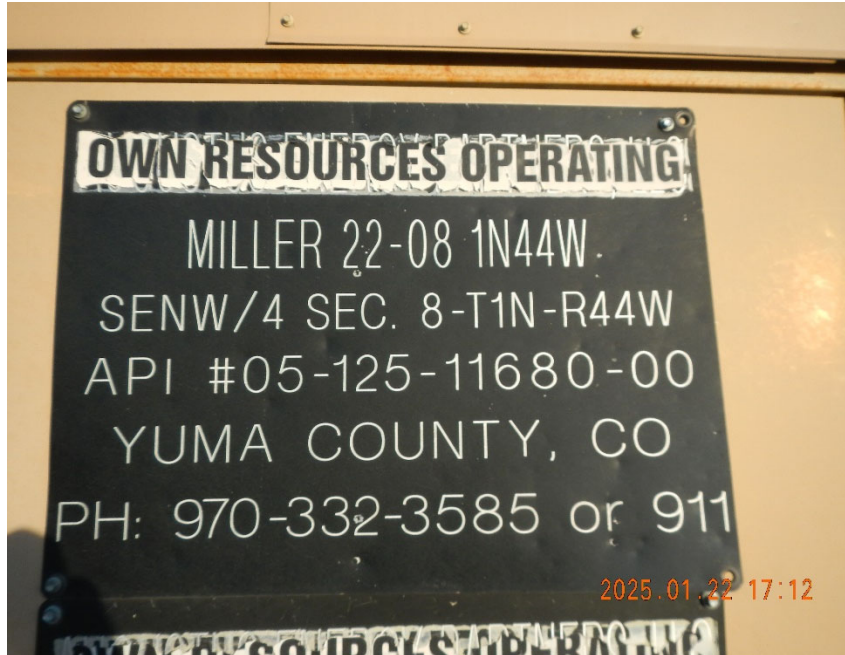
5. Lease sign at remote tank/gathering location.

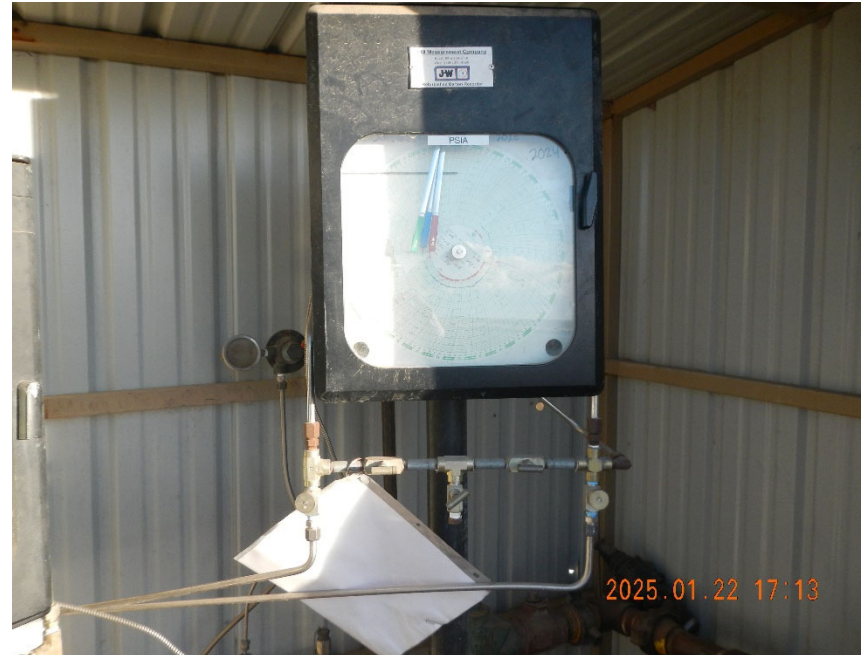
6. Gas meter inside meter shed.

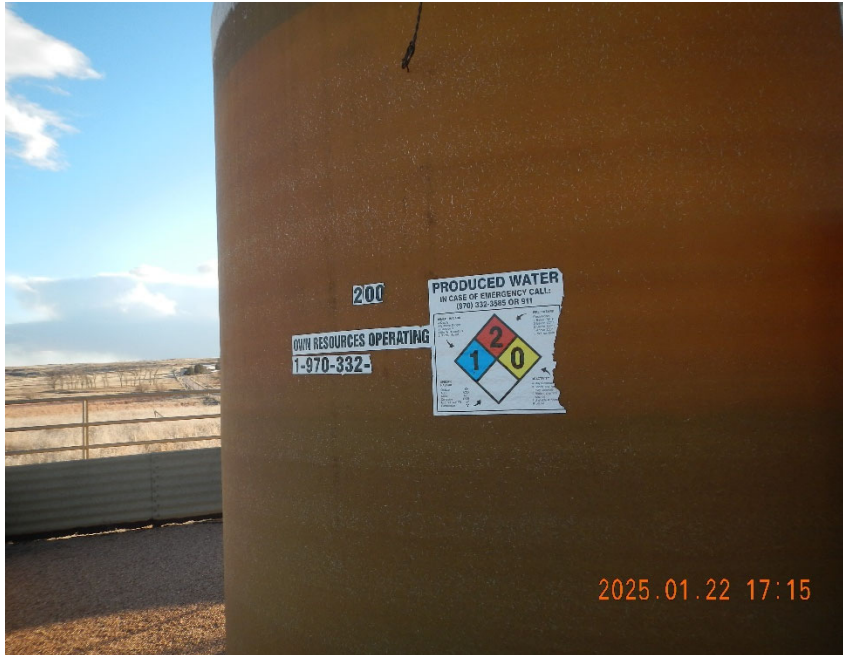
7. Produced water tank at remote battery. Note labels/stickers are peeling and require replacement.

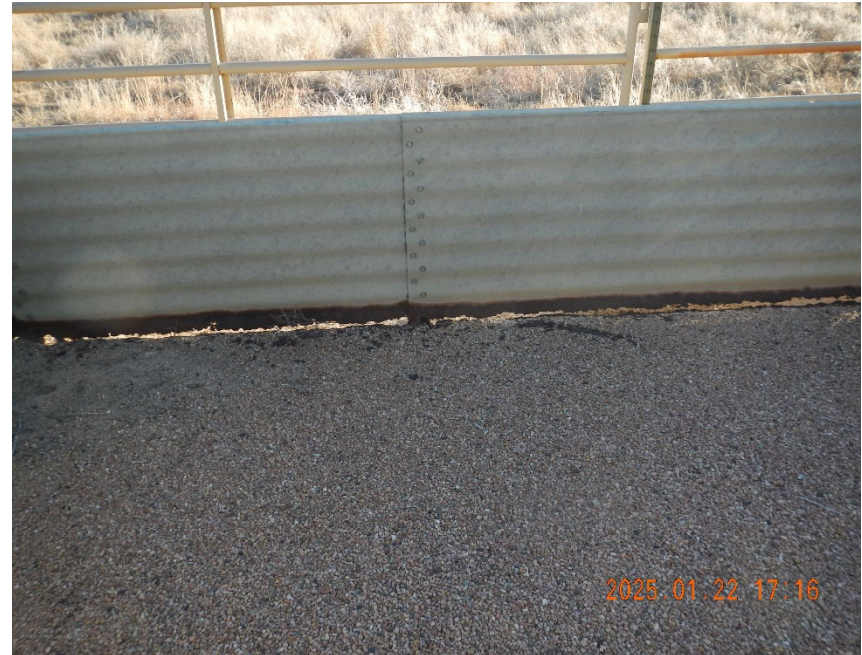
8. View of metal containment wall around tank that has rusted through at grade level.
