Inspection Photos
Location Name: Miller 32-08 1N44W
API Number: 125-11681

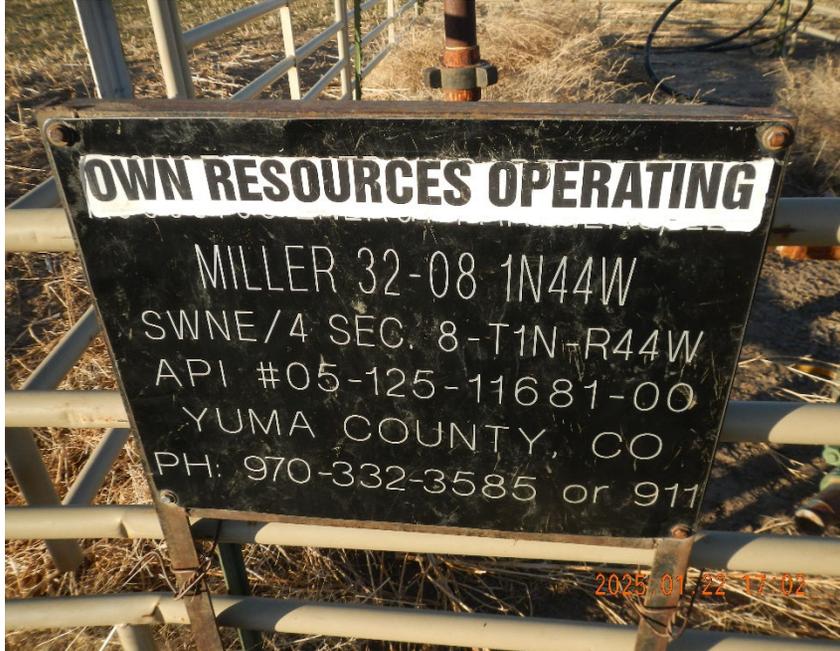
1. Lease sign at well location.

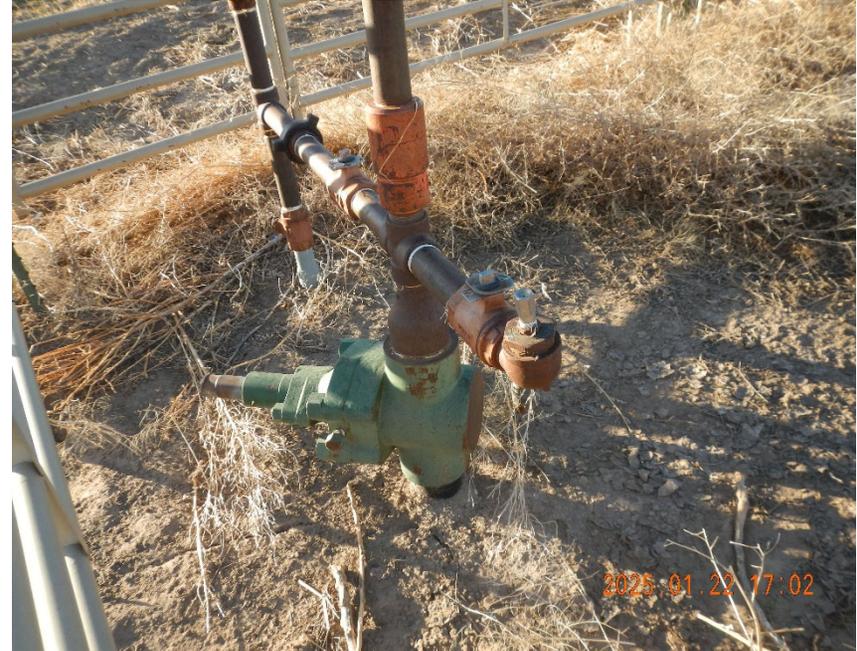
2. View of wellhead. Note dried vegetation inside fencing.

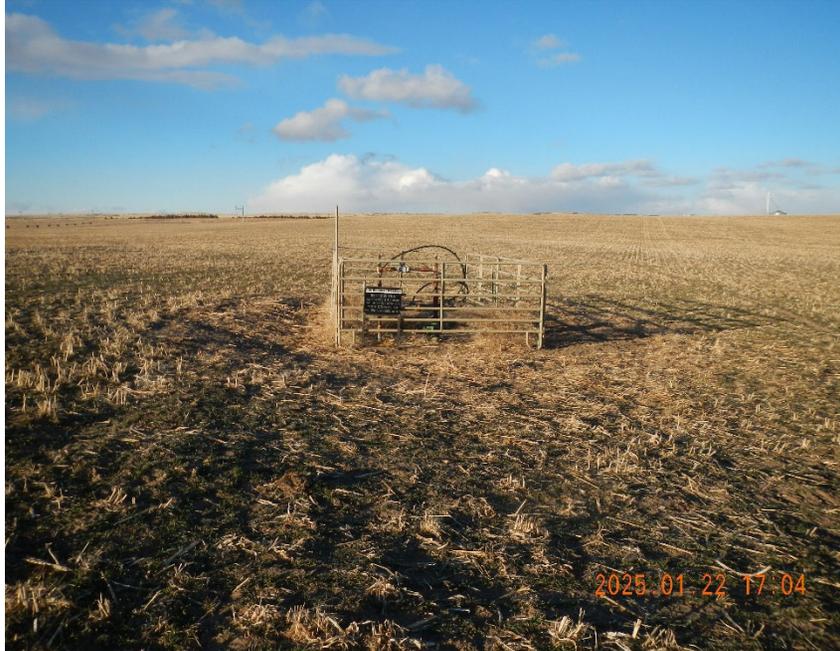
3. Well location overview. Note black poly visible against fencing.

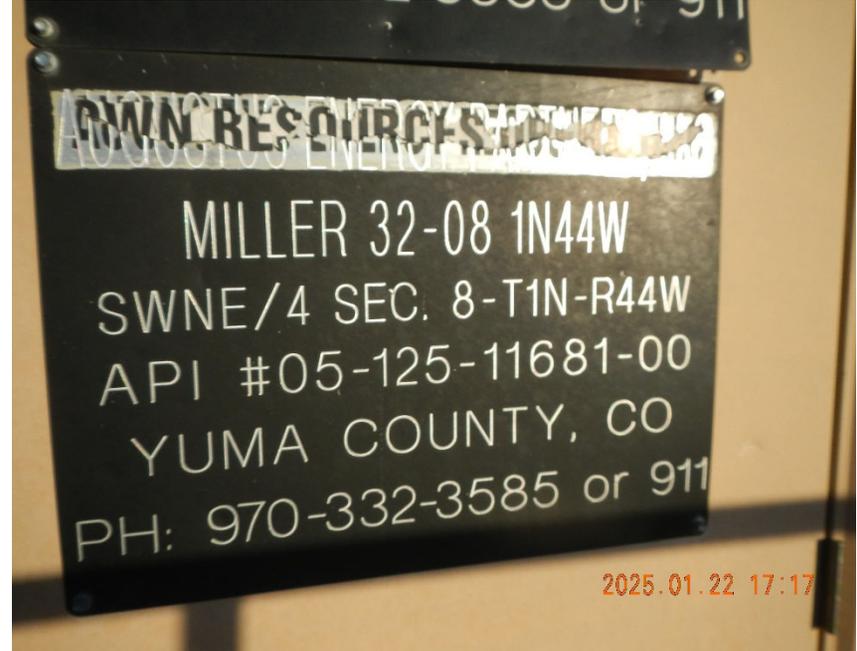
4. Lease sign at remote gathering location.

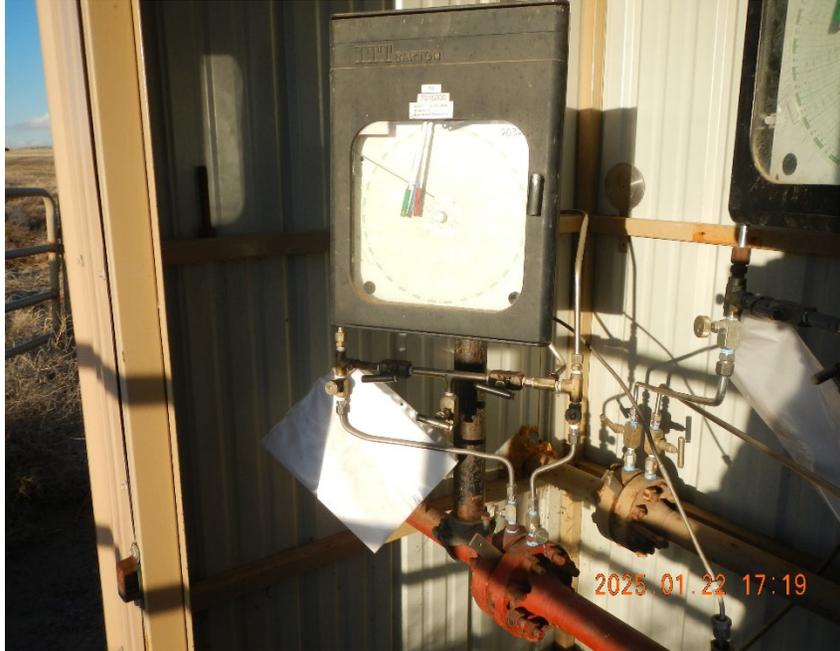
5. Gas meter inside meter shed.

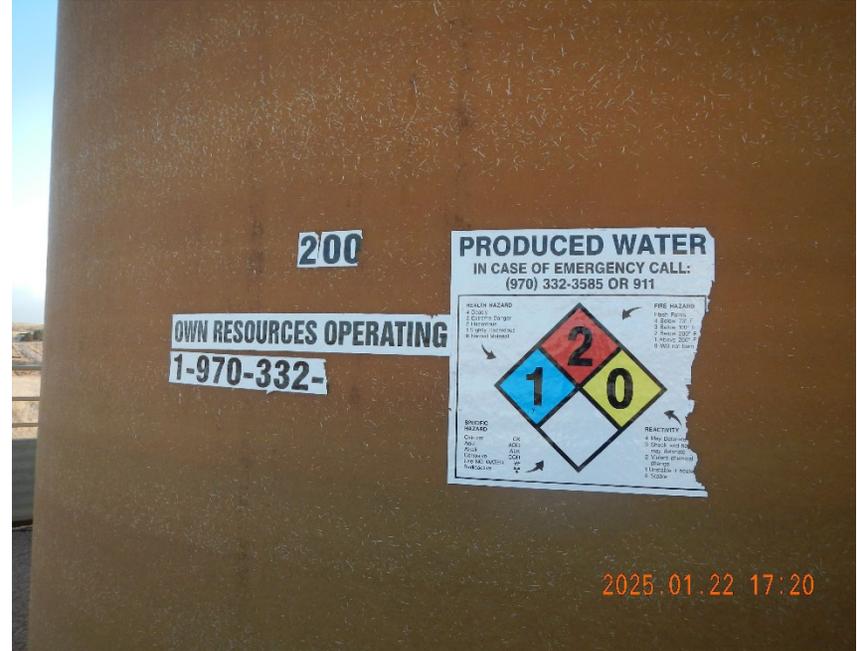
6. Produced water tank. Note labels/stickers peeling.

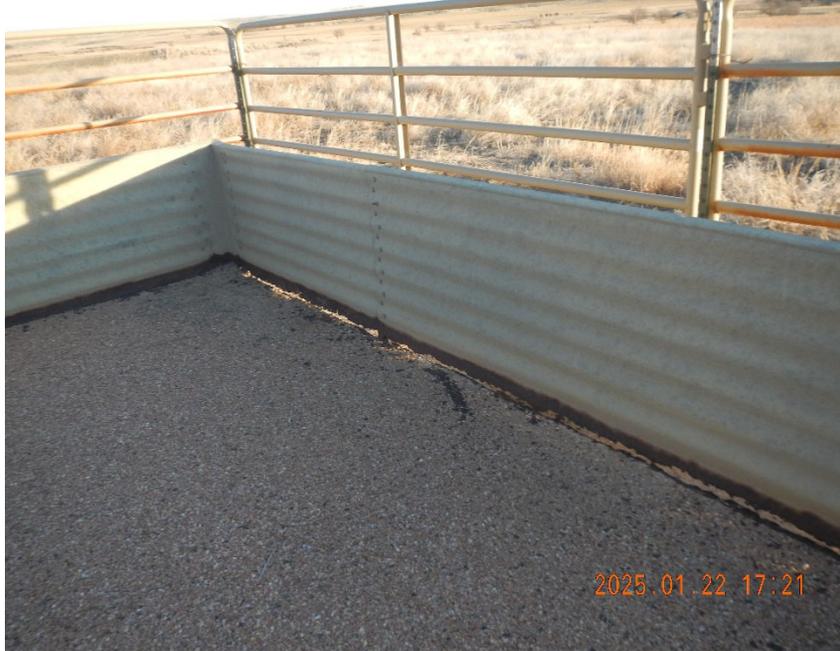
7. Metal containment is rusted through at grade. Note visible daylight along base of metal wall.

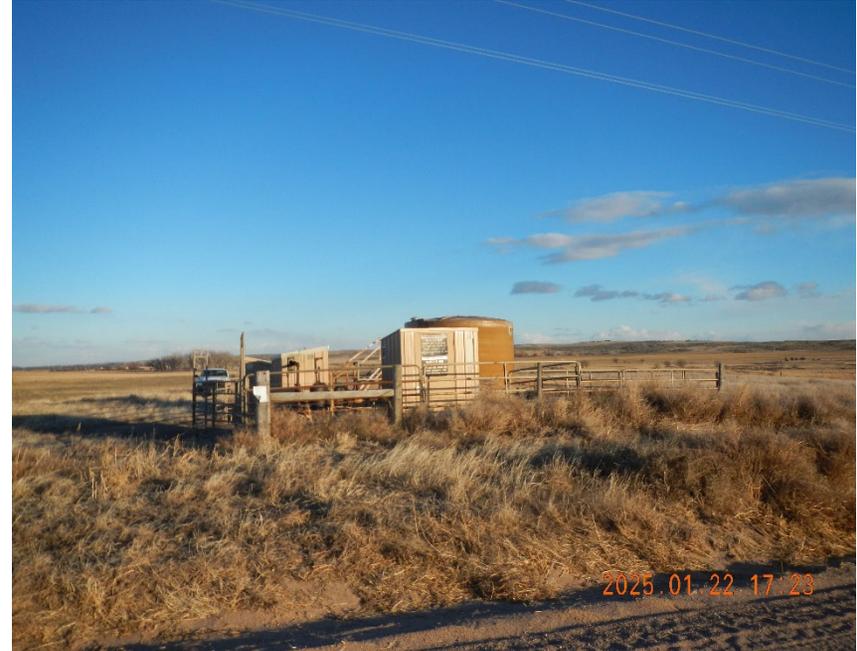
8. Remote tank/gathering location overview.
