Inspection Photos

ID: 412152

Operator: **MULL DRILLING COMPANY INC**

Inspection Date: 1/28/2025

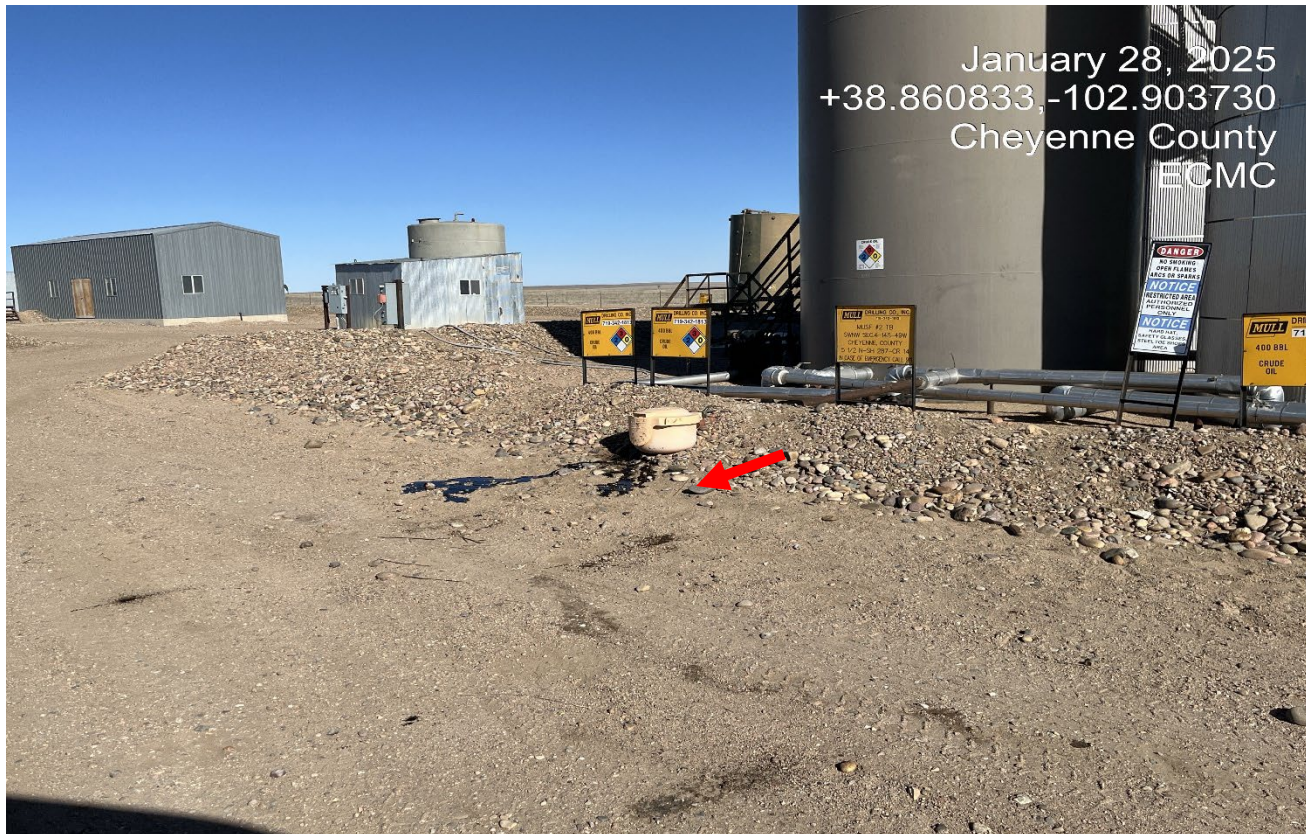
Photo 1. There is oil leaking out of the truck load out at the MUSF #2 TB.

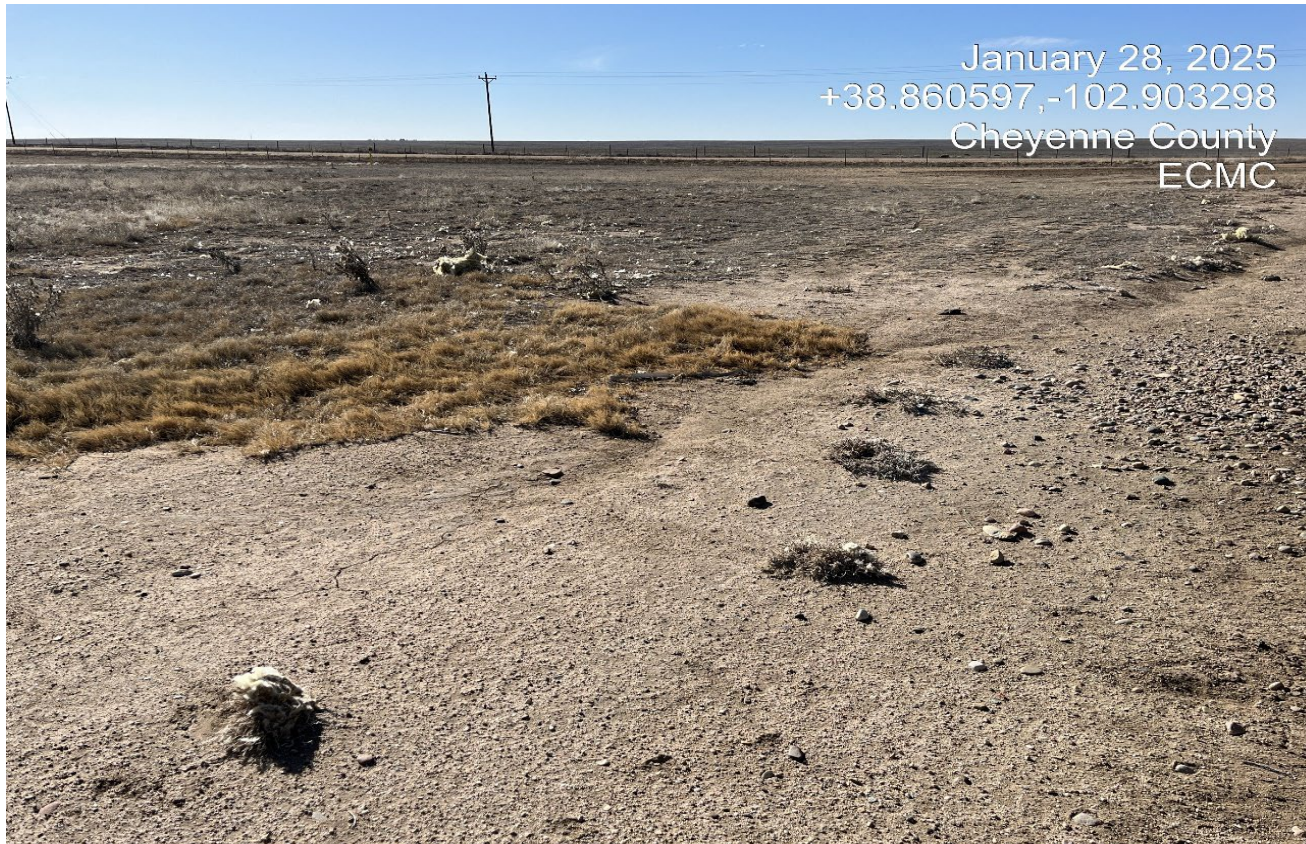
Photo 2. Facing toward the adjacent pasture south of the tank battery. There is insulation debris scattered in this pasture that needs to be cleaned up.

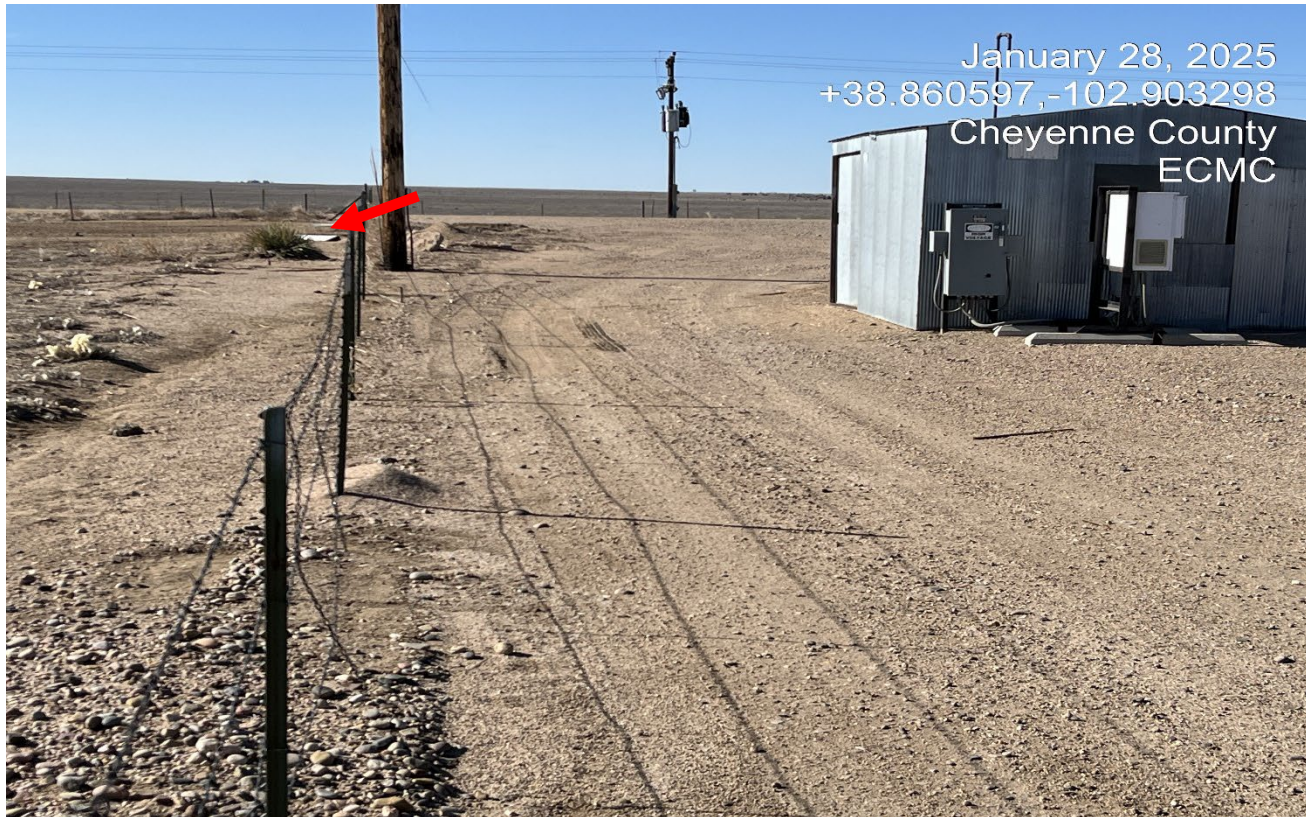
Photo 3. Facing east at the south side of the location. There is also a piece of tin shown at red arrow.

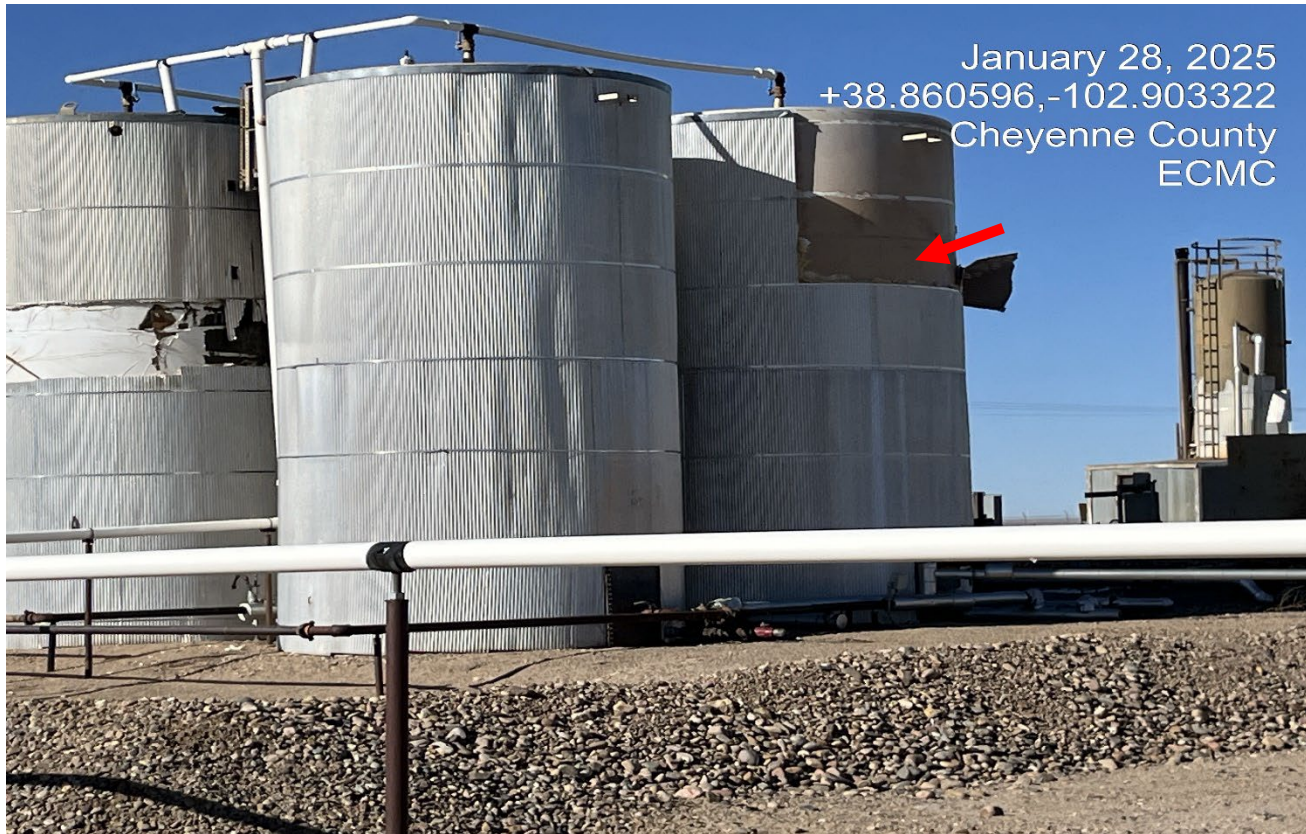
Photo 4. The observed tin and insulation have blown off this tank.
