# Inspection Photos

API: 017-06625

Operator: **WILLIFORD ENERGY COMPANY**

Inspection Date: 1/28/2025

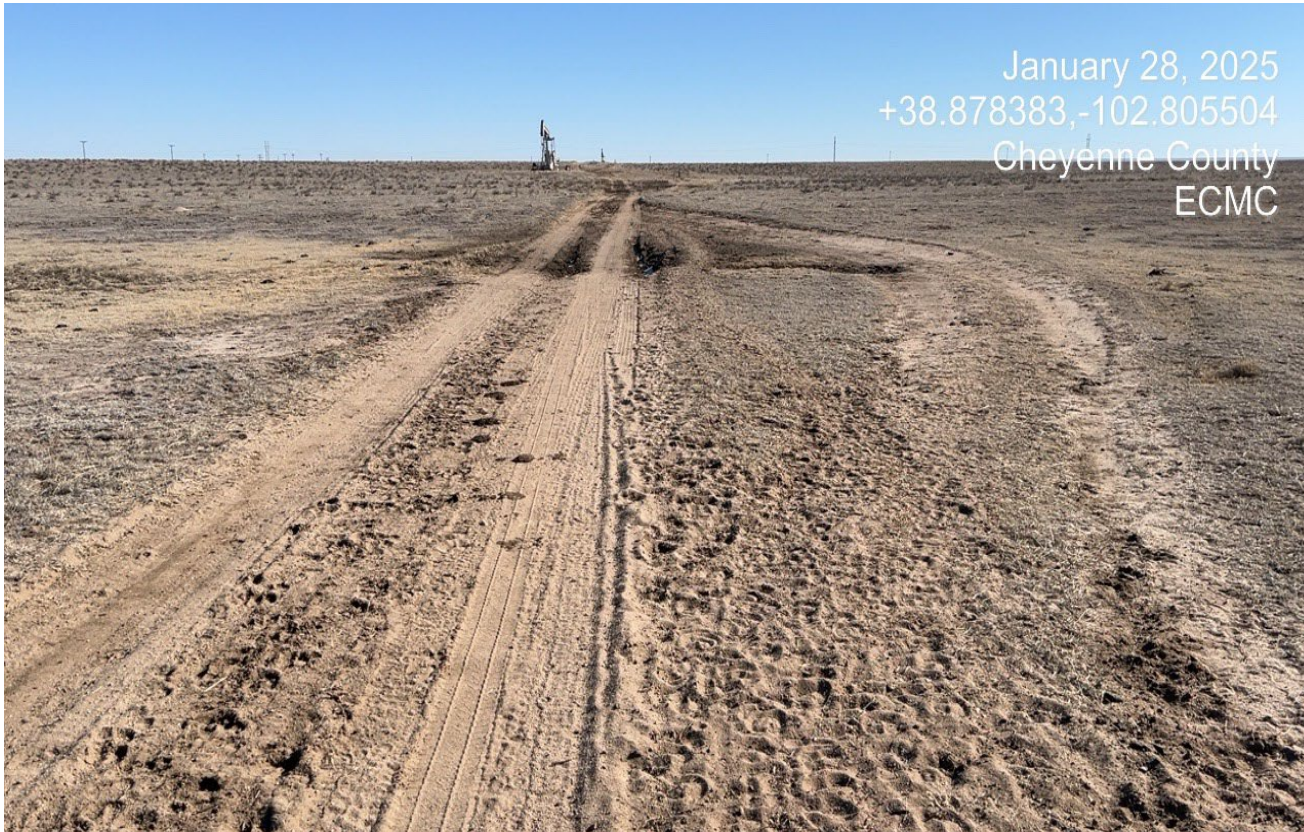
**Photo 1.** Facing east along the access road. Vehicles are causing unnecessary disturbance driving outside of the access road due to stormwater pooling on the road. The access road must be maintained and shall not drive outside of the access road boundary.

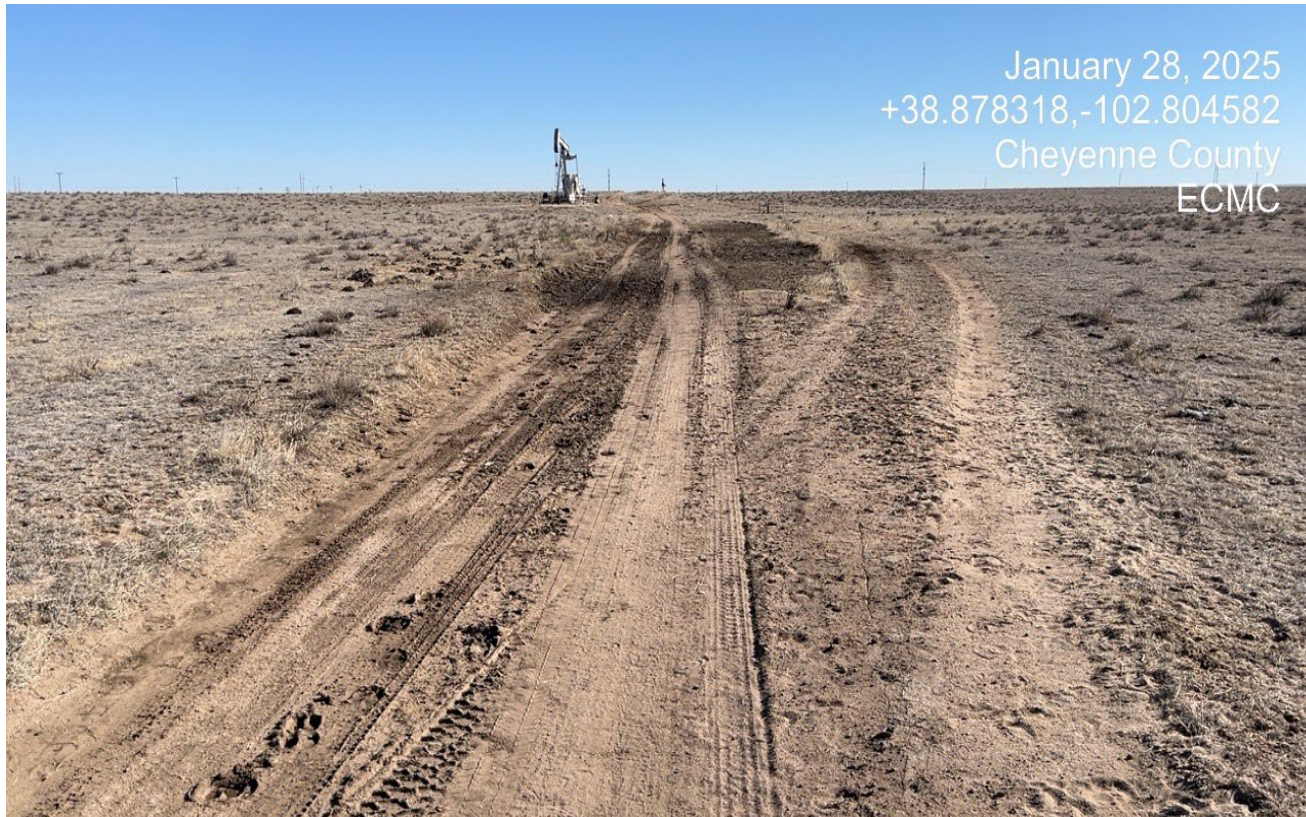
**Photo 2.** Facing east along the access road. Vehicles are causing unnecessary disturbance driving outside of the access road due to stormwater pooling on the road. The access road must be maintained and shall not drive outside of the access road boundary.

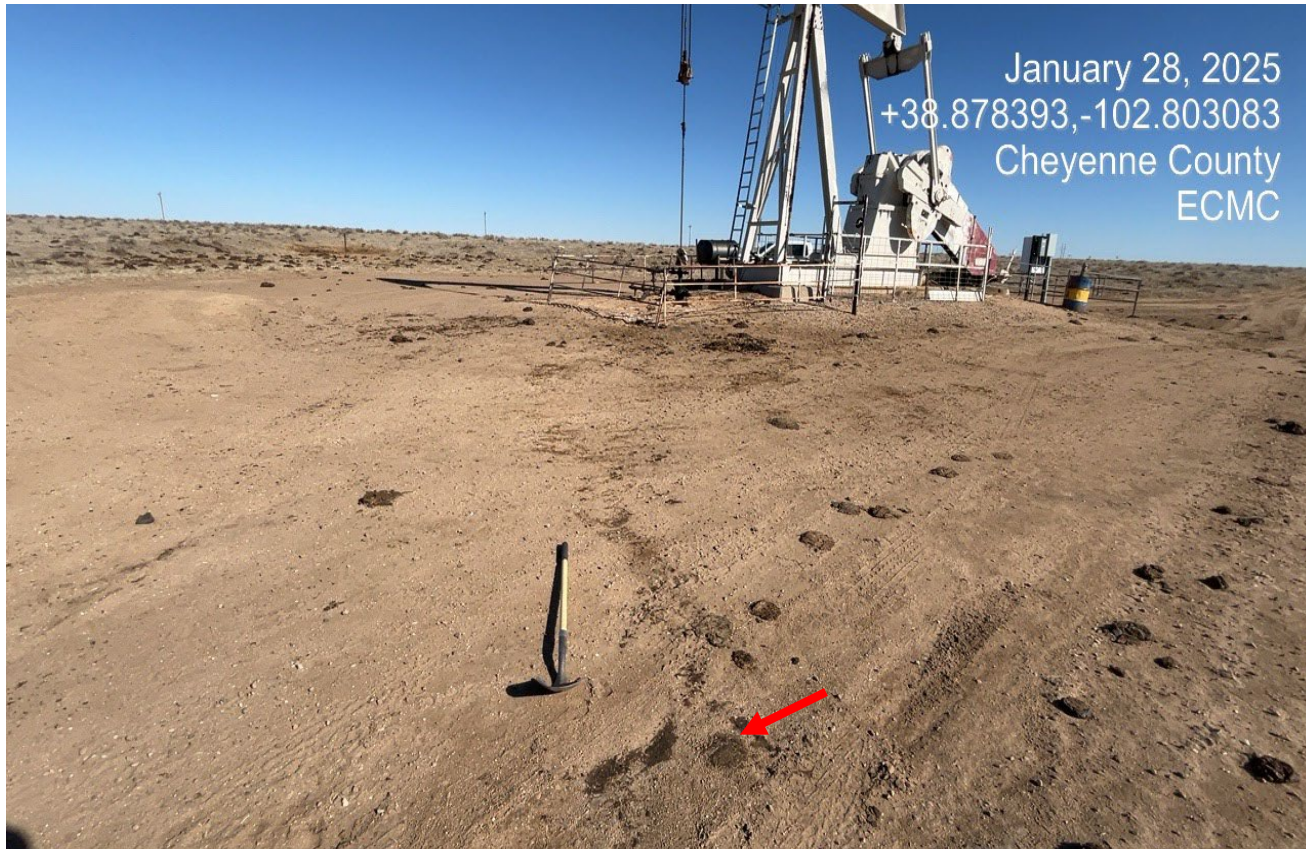
**Photo 3.** Facing northeast toward the wellsite. There are oil stained soil shown at red arrow along the 4.5' shovel. Additional stained soils were observed from this point to the wellhead.

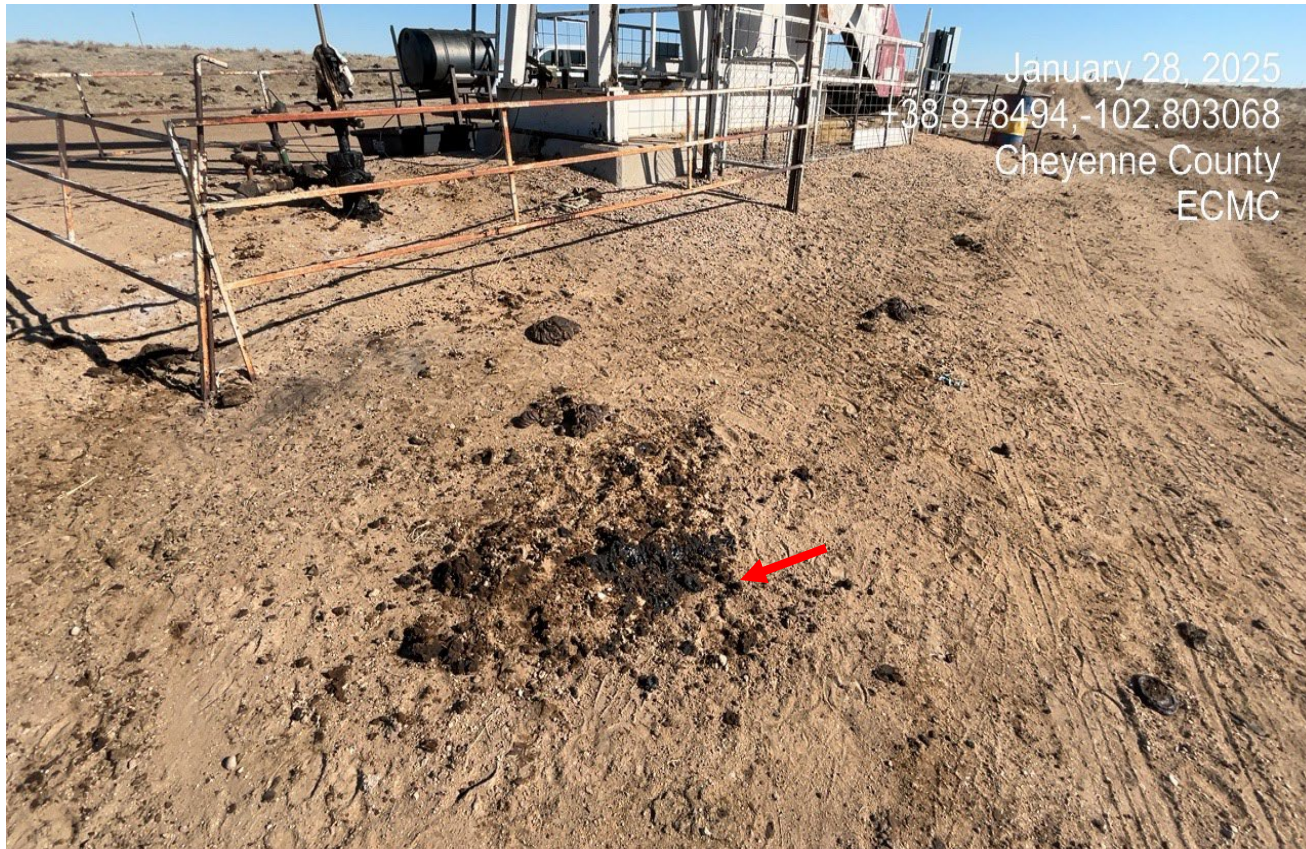
**Photo 4.** There are stained soils from a recent leak at the wellhead.

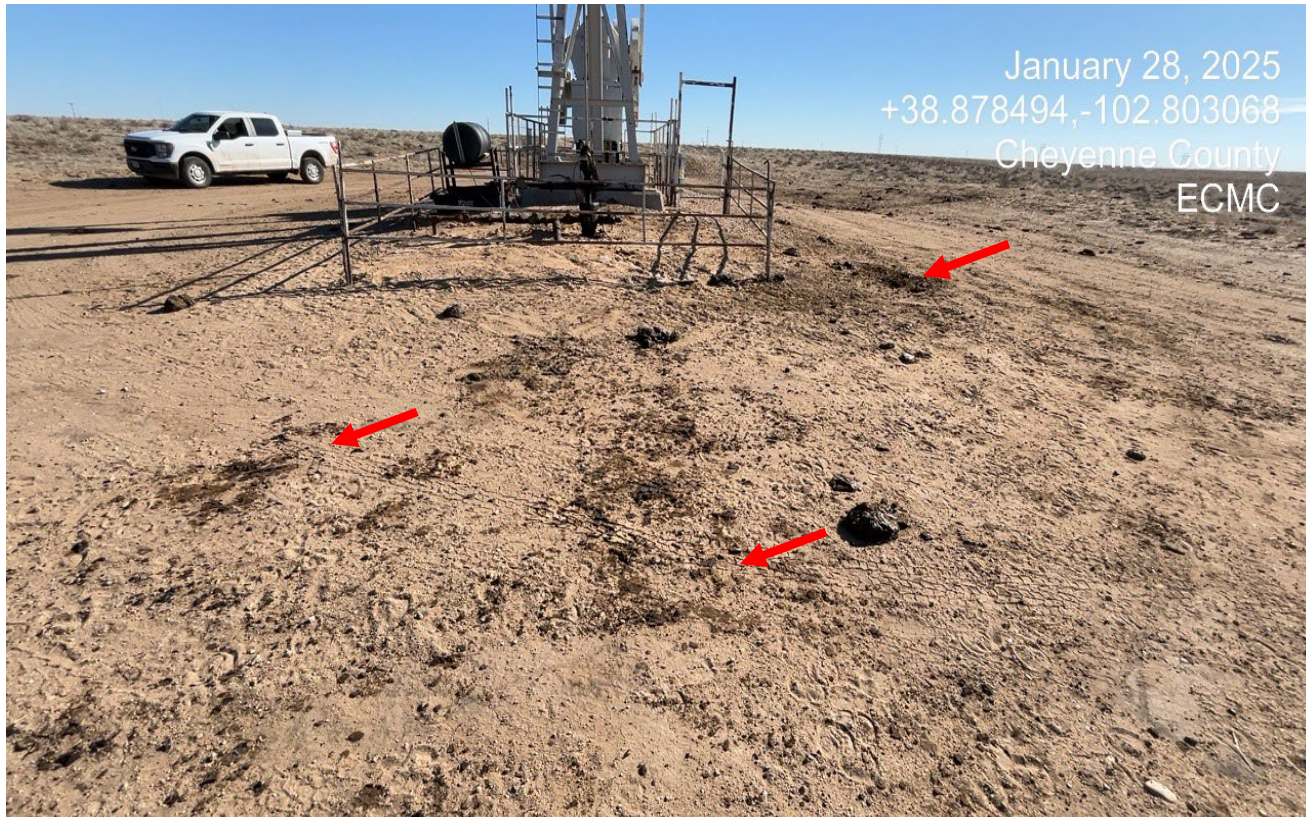
**Photo 5.** There are stained soils from a recent leak at the wellhead shown at red arrows.

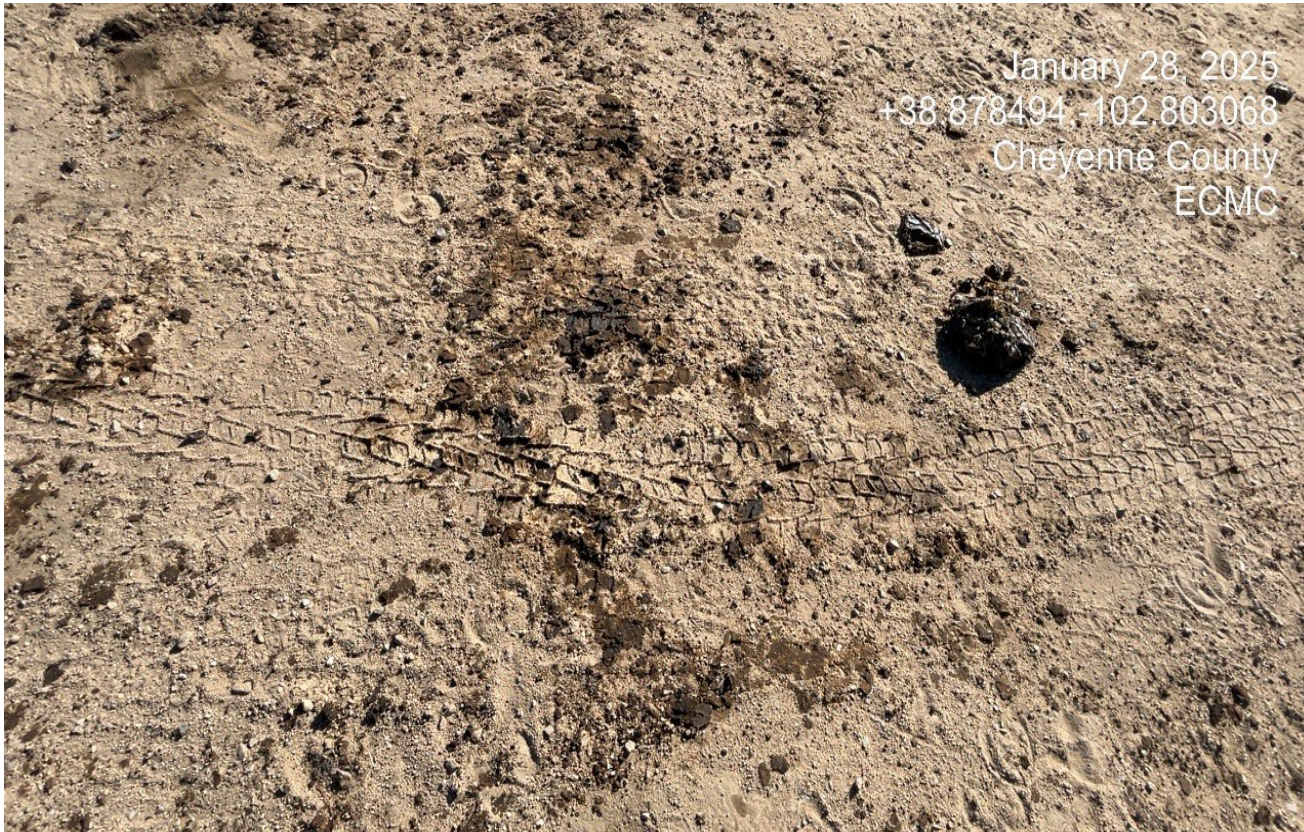
**Photo 6.** View of stained soils shows vehicle and cattle tracks on top of the stained soils.

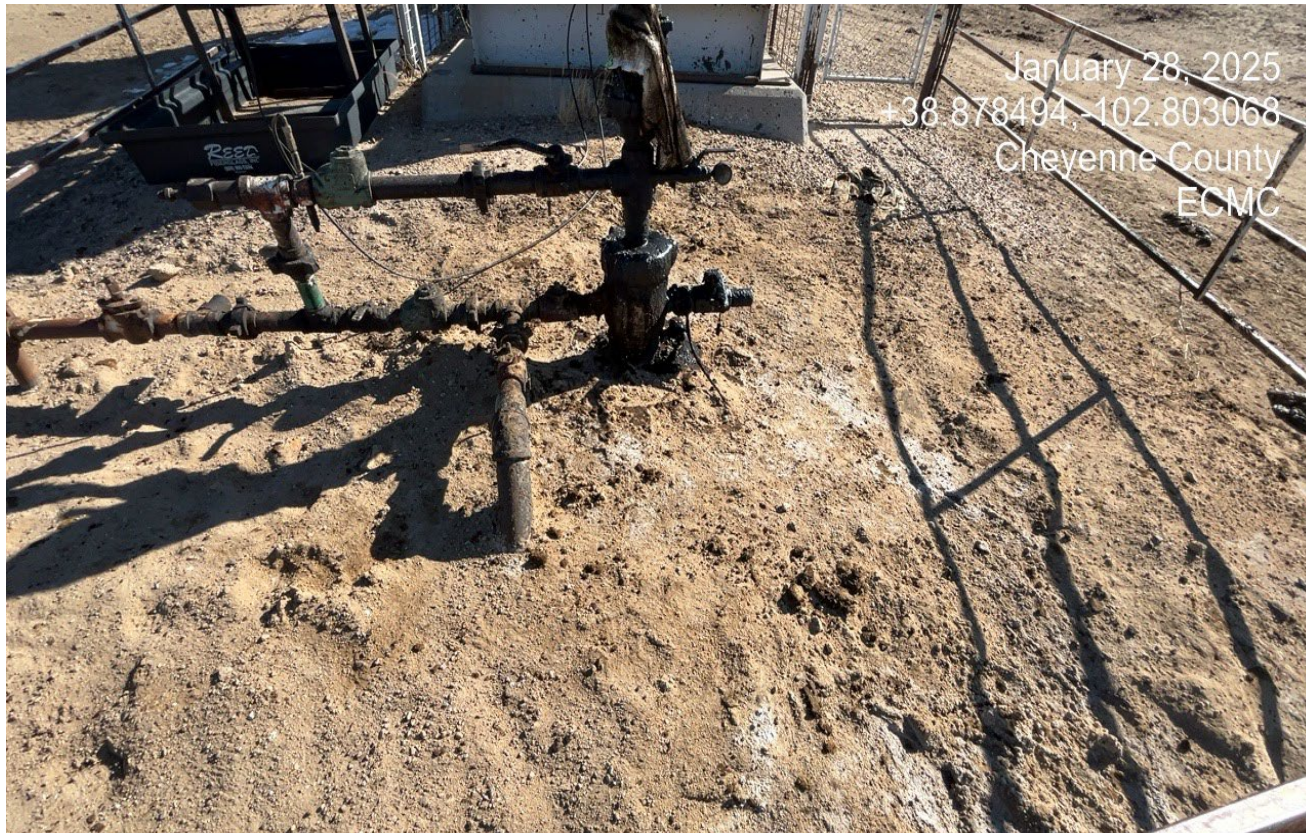
**Photo 7.** View of wellhead shows stained soils which appear to be covered up with sand.

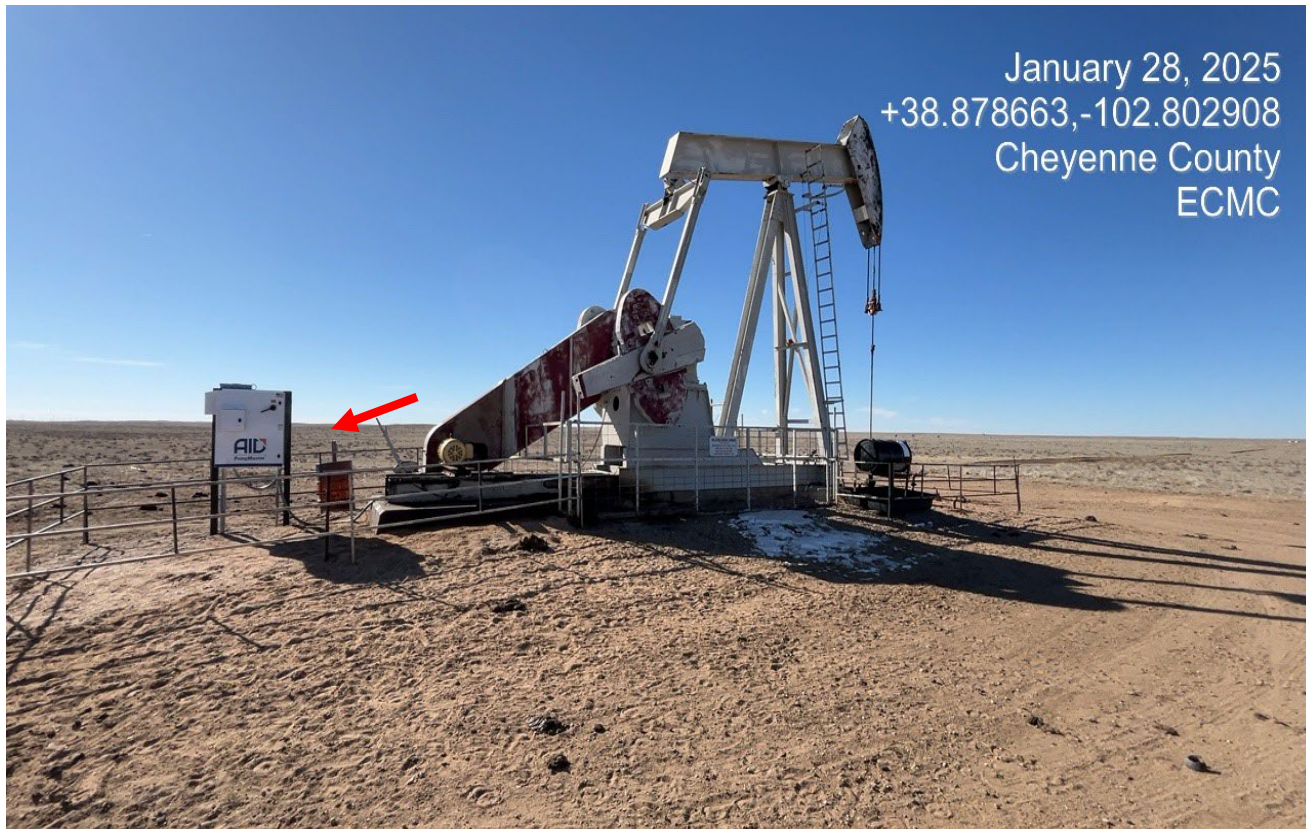
**Photo 8.** Facing southwest toward the wellsite. A new electric motor has been installed at the pumpjack.

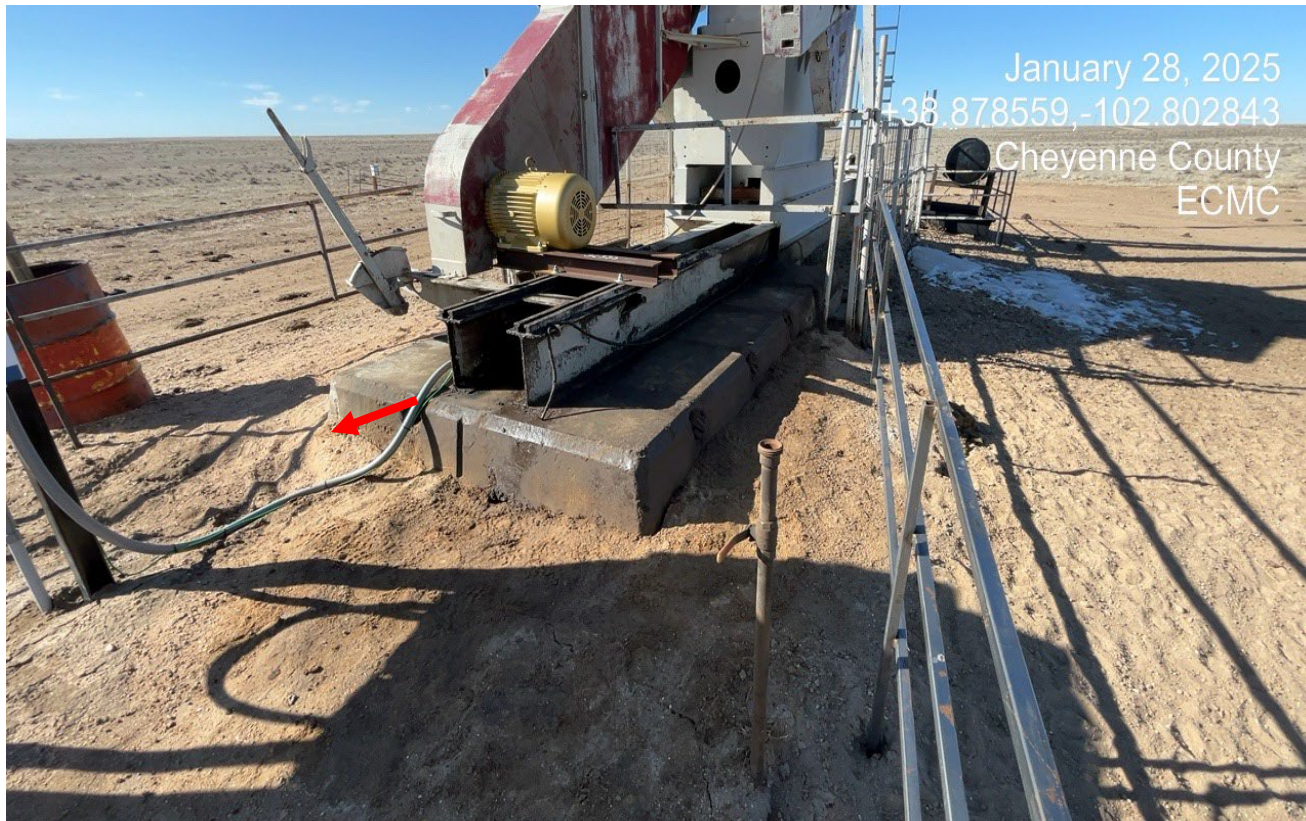
**Photo 9.** There are still oil stained soils at the pumpjack that have not been cleaned up.

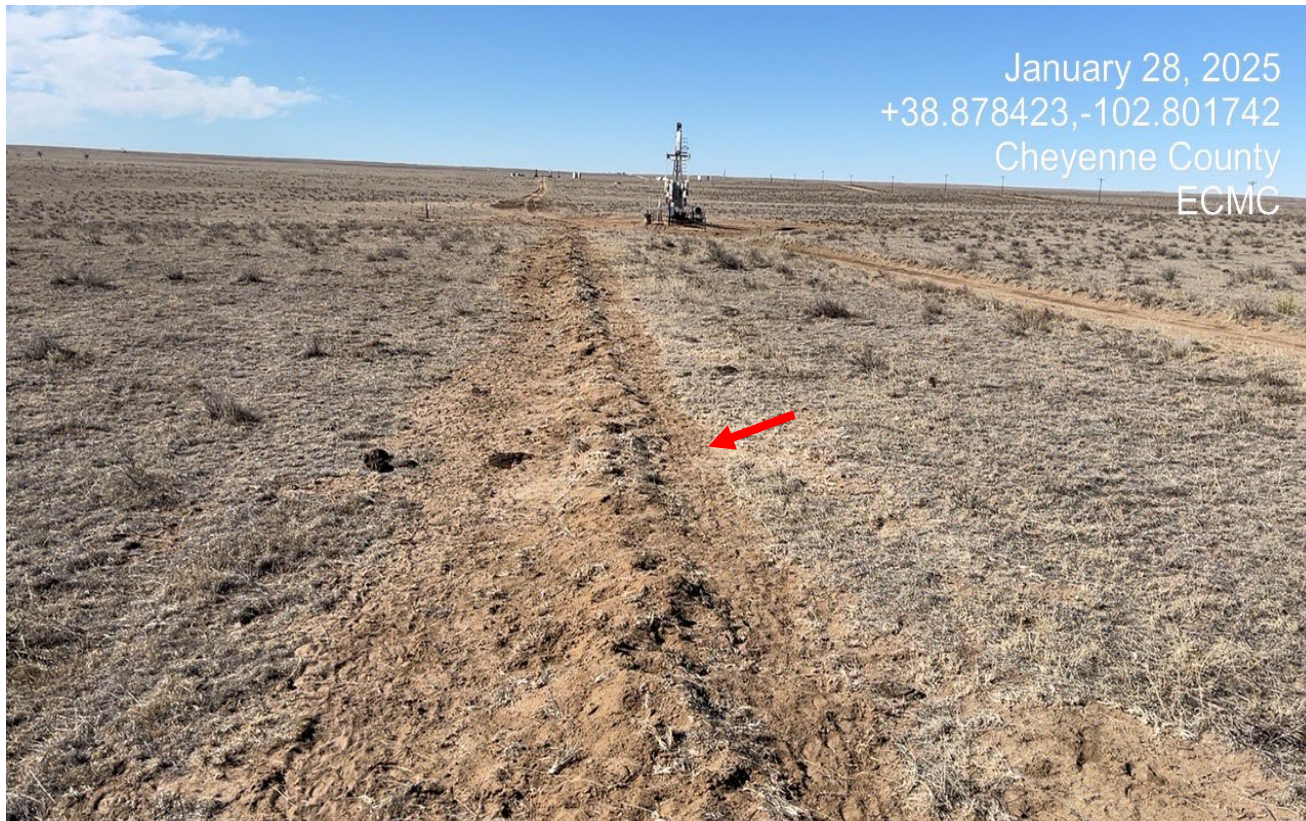
**Photo 10.** There has been new disturbance from a buried electric line to service the new electric motor at the pumpjack. The disturbed area will need to be reclaimed.
