**Inspection/Audit Photos**  
**Location Name: QB Energy DUNN 9-4 (C9E) Pad**  
**Location ID: 334841**

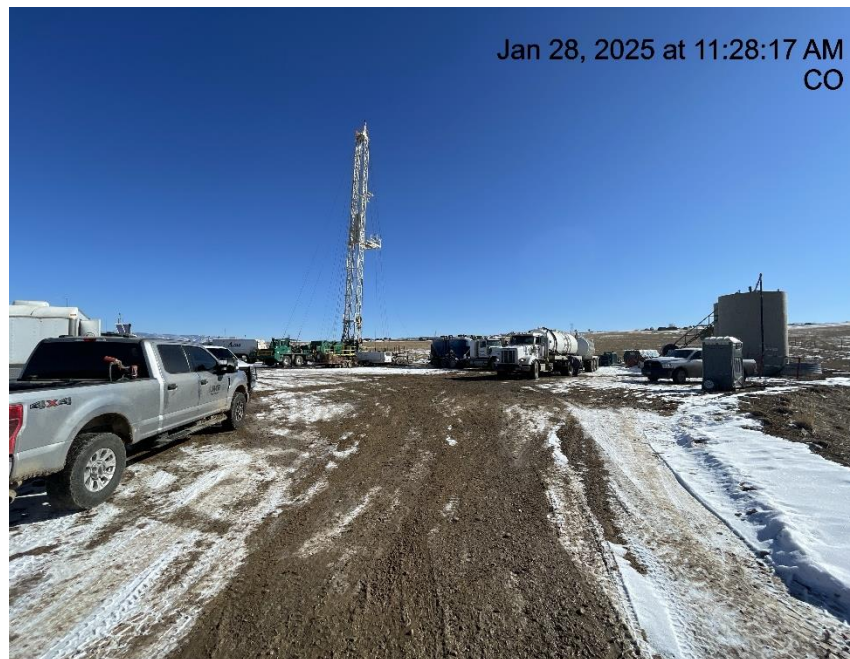
**Photo # 1709 From entrance to location**

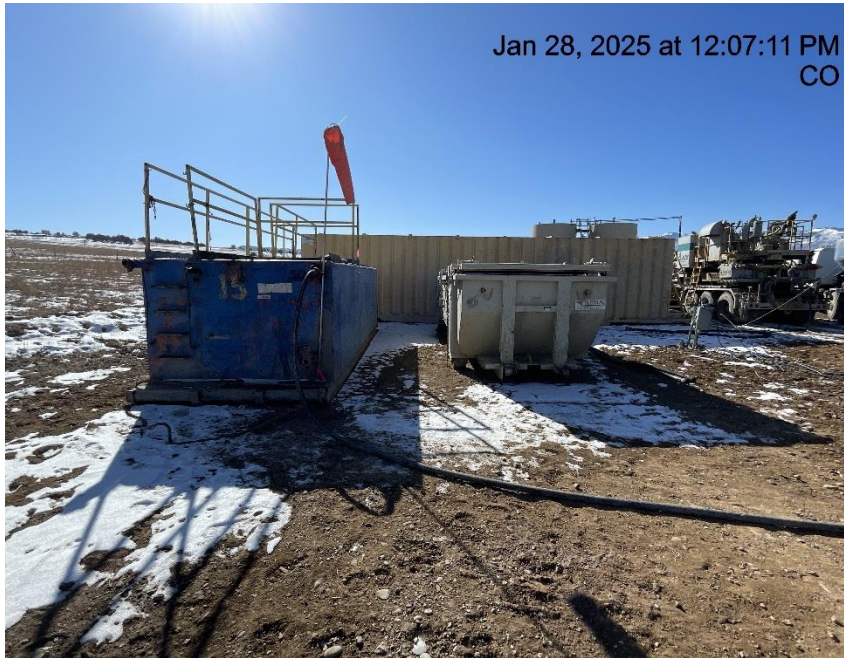
**Photo # 1723 Tanks lack secondary containment/failure to comply with COA**

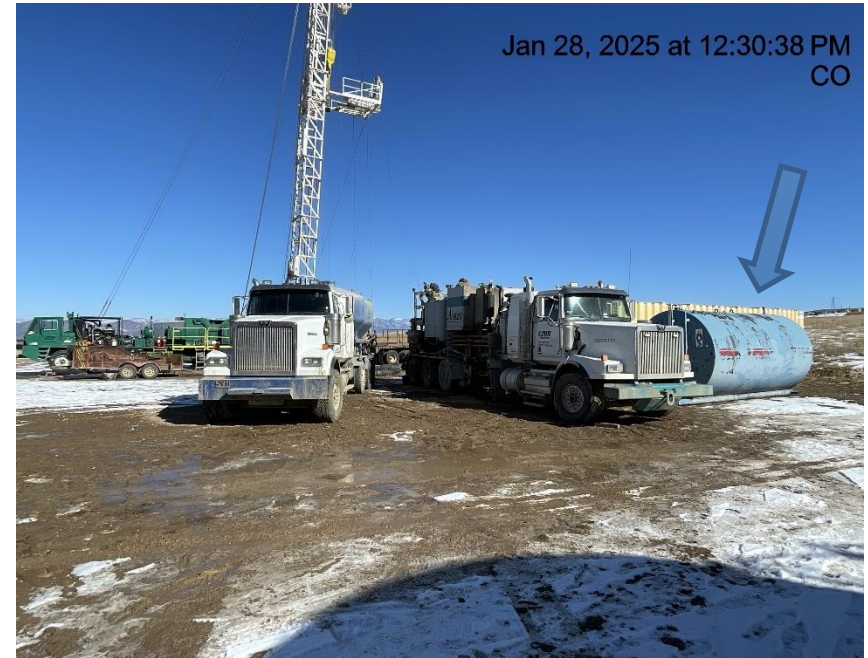
**Photo # 1724 Tanks lack secondary containment/failure to comply with COA**

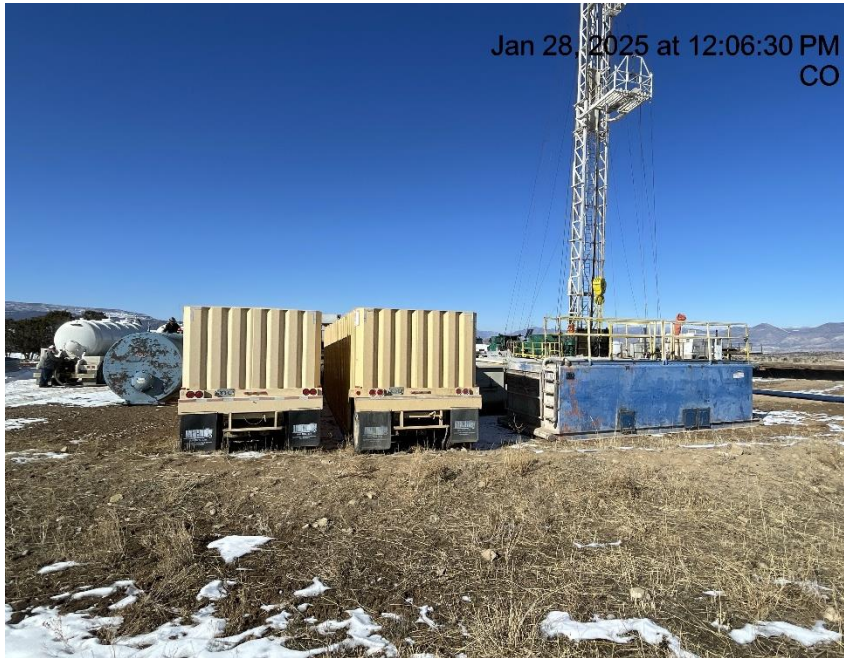
**Photo # 1725 Tanks lack secondary containment/failure to comply with COA**
