Inspection Photos

API: 017-06410

Operator: **WILLIFORD ENERGY COMPANY**

Inspection Date: 1/28/2025

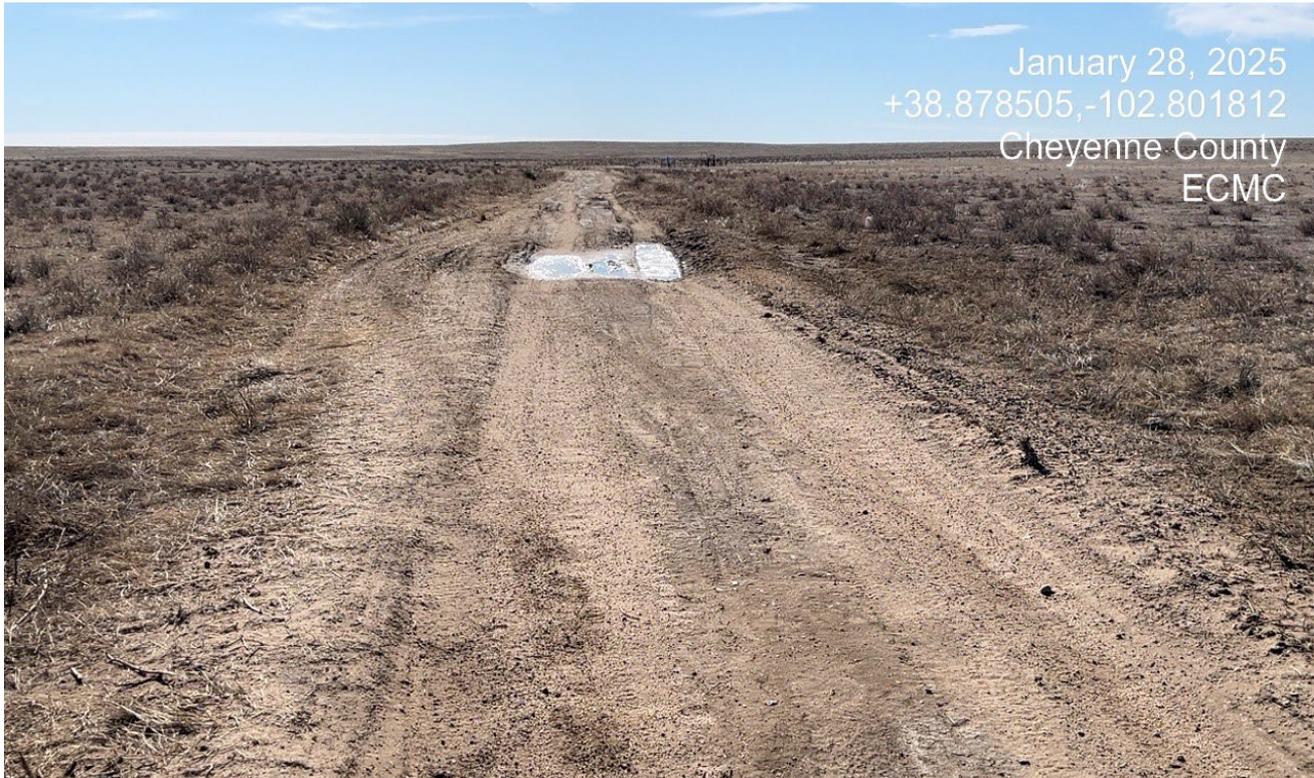
Photo 1. Facing south along the access road. Vehicles are causing unnecessary disturbance driving outside of the access road due to stormwater pooling on the road. The access road must be maintained and vehicles shall not drive outside of the access road boundary. Previous corrective action was not completed.

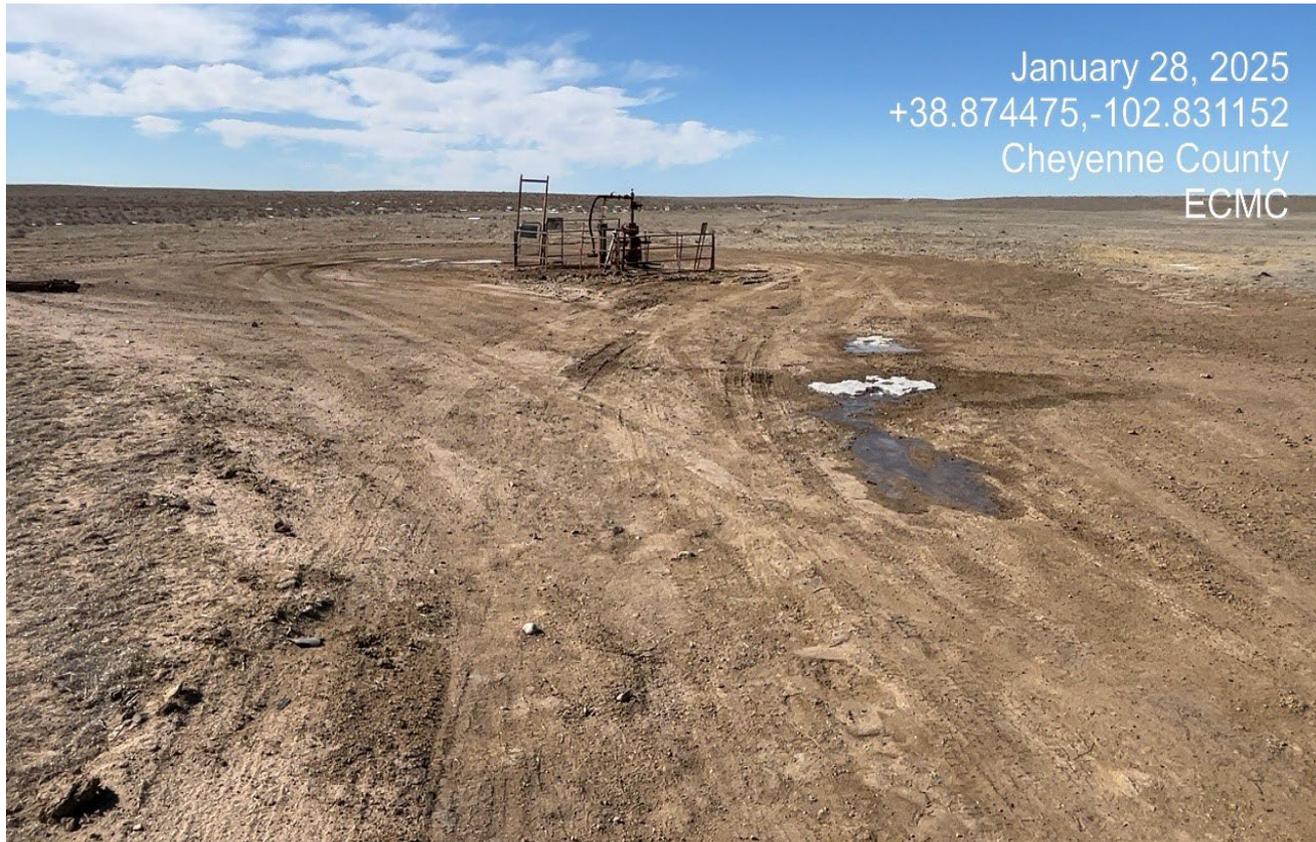
Photo 2. Facing southwest toward the wellsite.

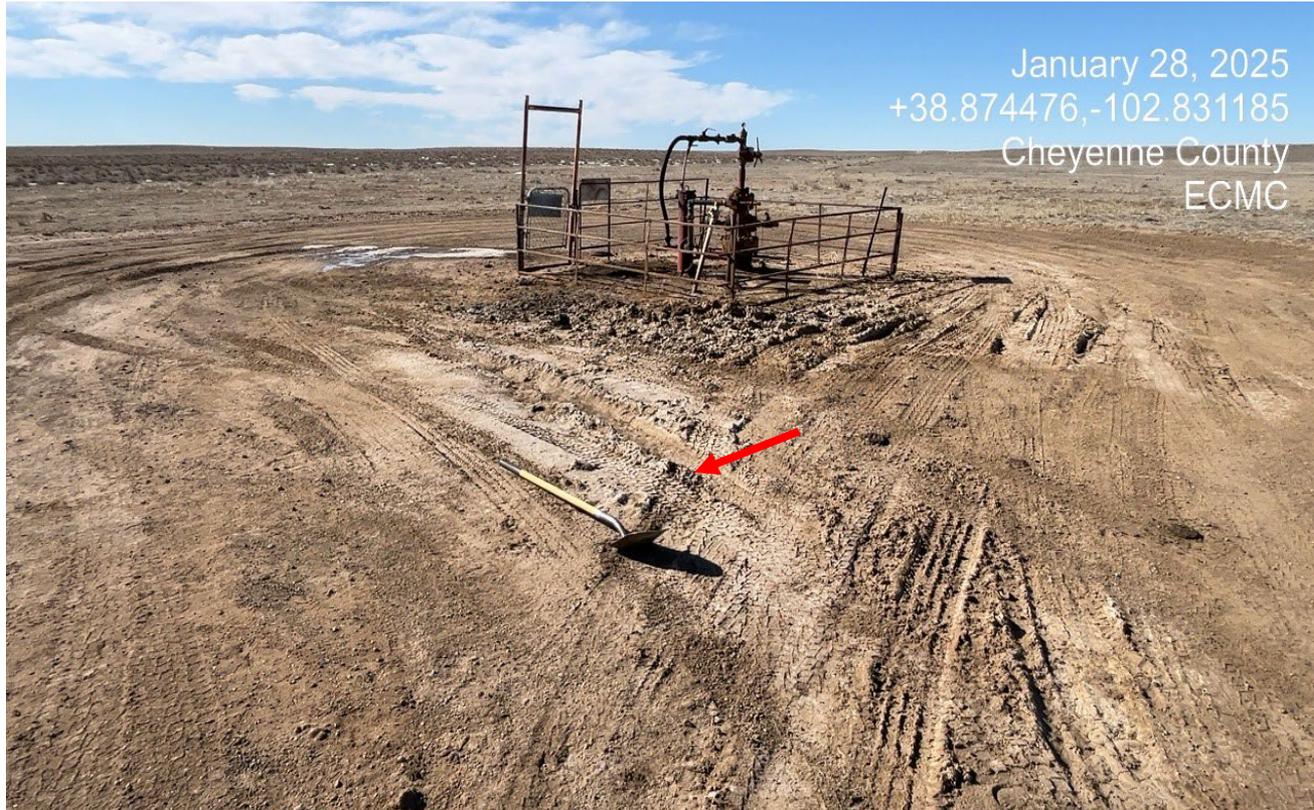
Photo 3. Facing west toward the wellsite. There was a leak at the wellhead which appears to have flowed to the east side of the location. There is white and blackened soils which appears to be condensate from the well.

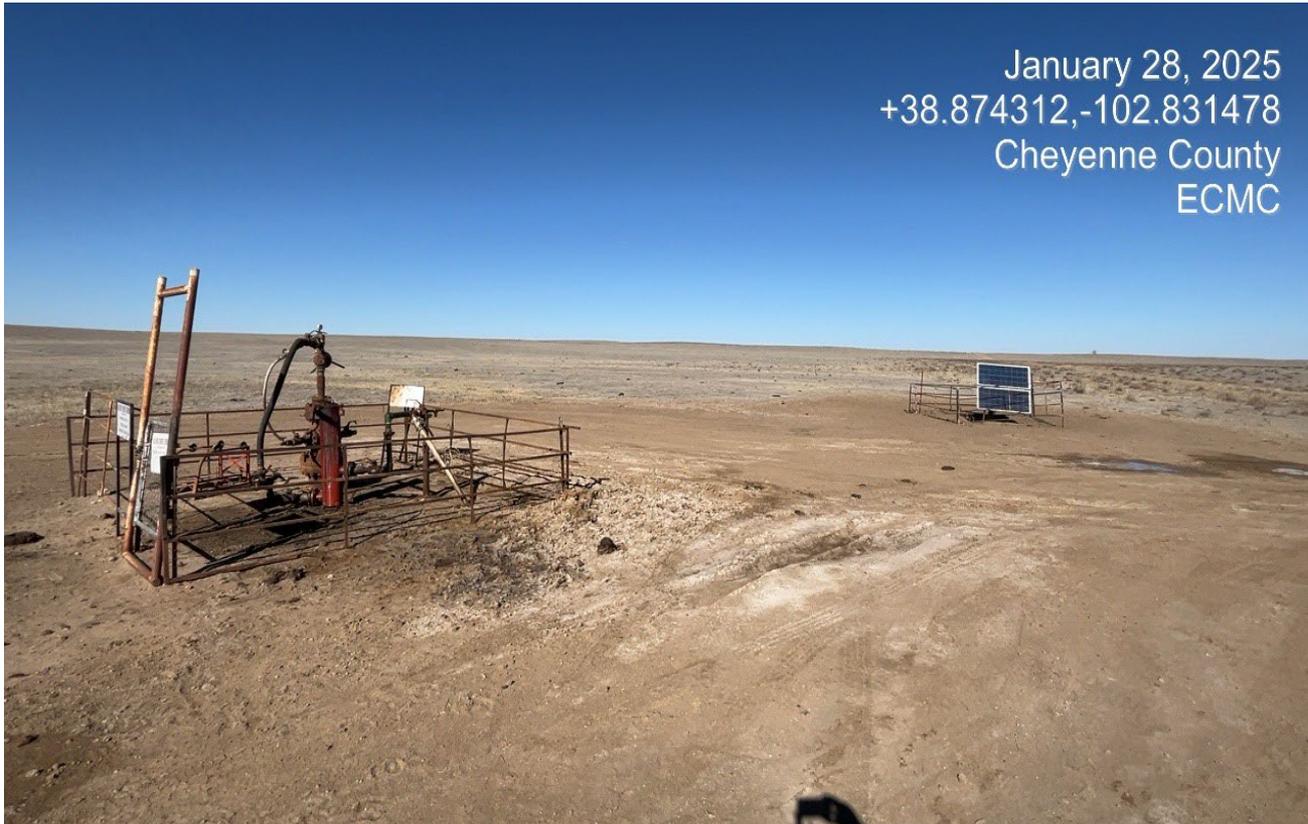
Photo 4. Facing northwest toward the wellsite. There was a leak at the wellhead which appears to have flowed to the east side of the location. There is white and blackened soils which appears to be condensate from the well.

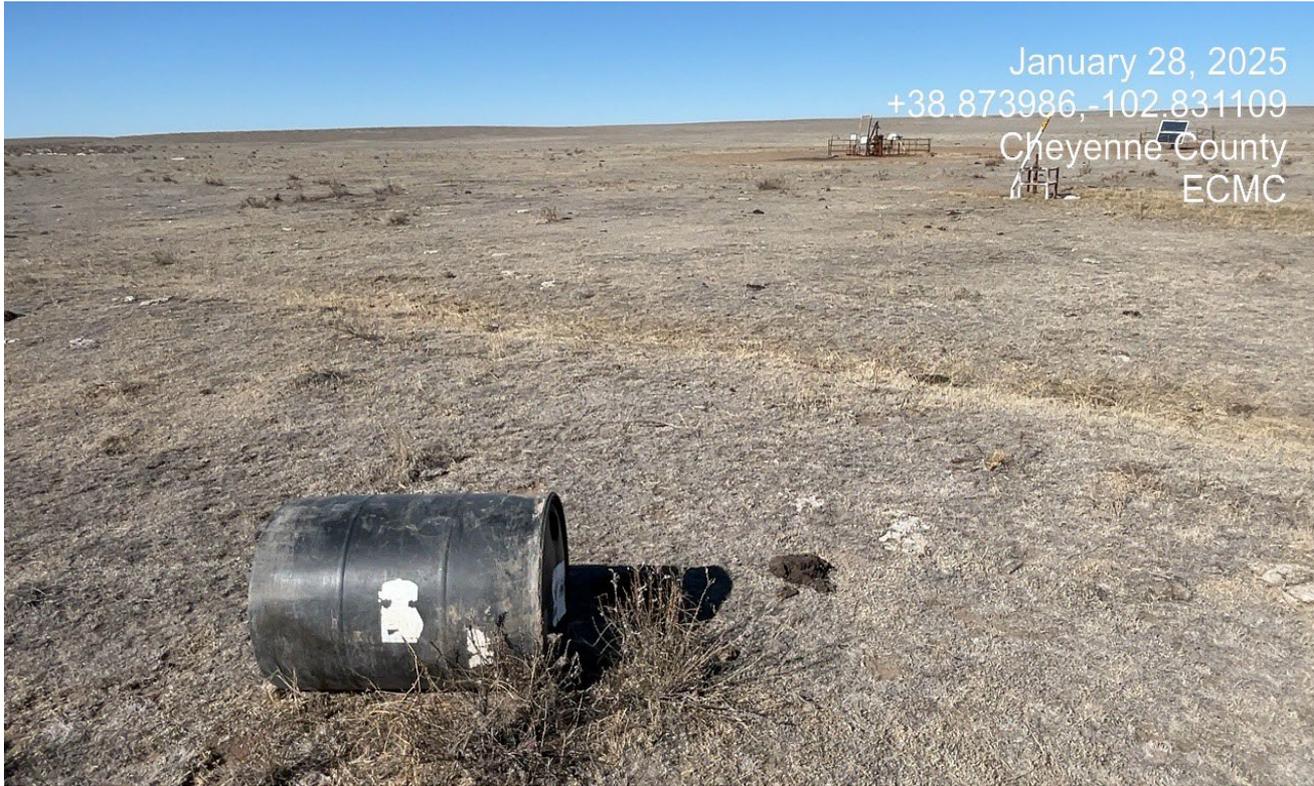
Photo 5. There is a black barrel that blew off the location.
