SITE-SPECIFIC QUALITY ASSURANCE & QUALITY CONTROL AUDIT

PERMIT CLOSURE REPORT – RANGELAND

Location ID 330783

Location Name COLORADO ENERGY FEDERAL-610N64W/14NWSW

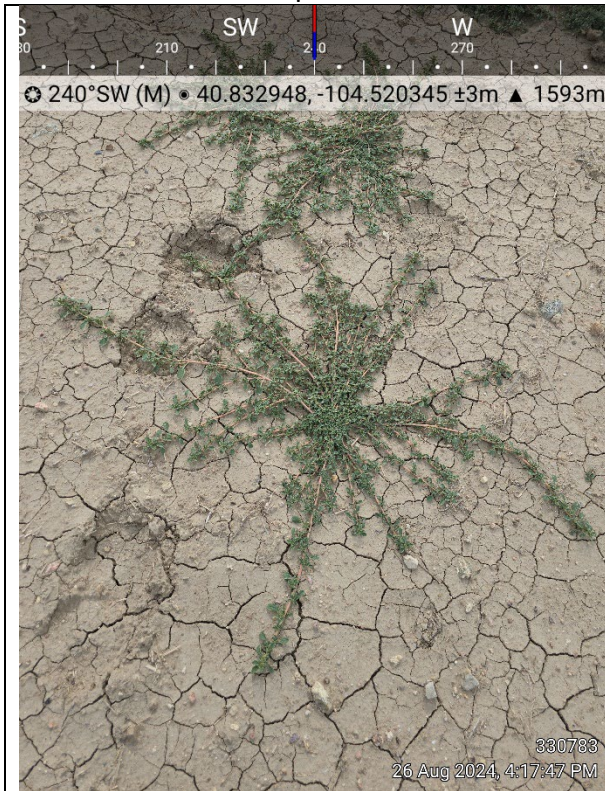
Amaranth (*Genus Amaranthus*)

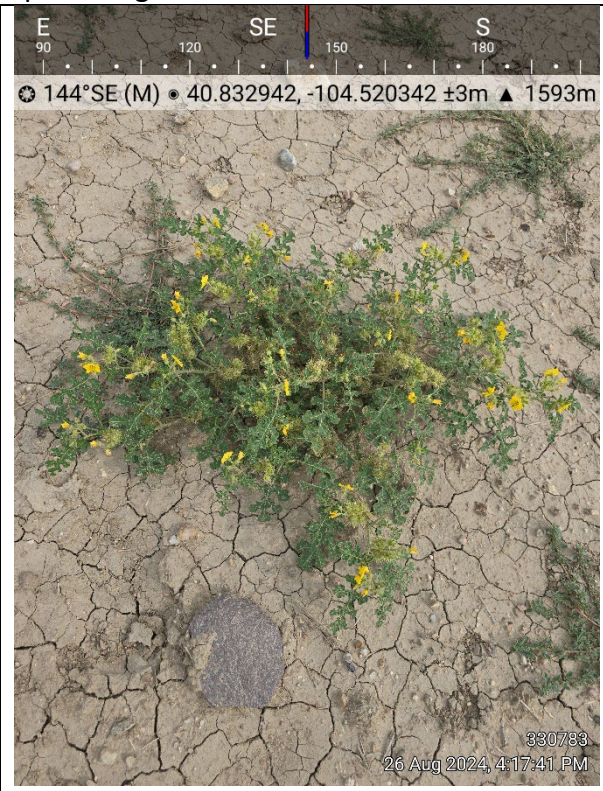
Buffalo-bur (*Solanum rostratum*)

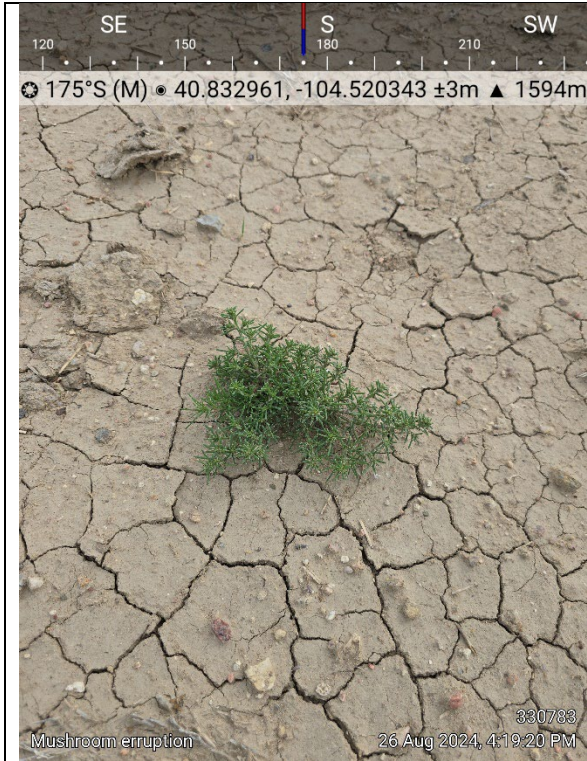
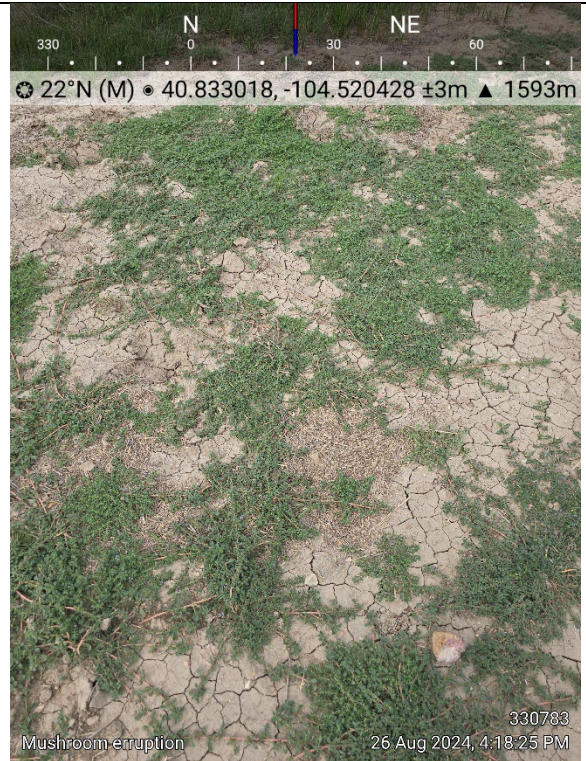
Russian Thistle (*Salsola tragus*)

Puncturevine (*Tribulus terrestris*) List C

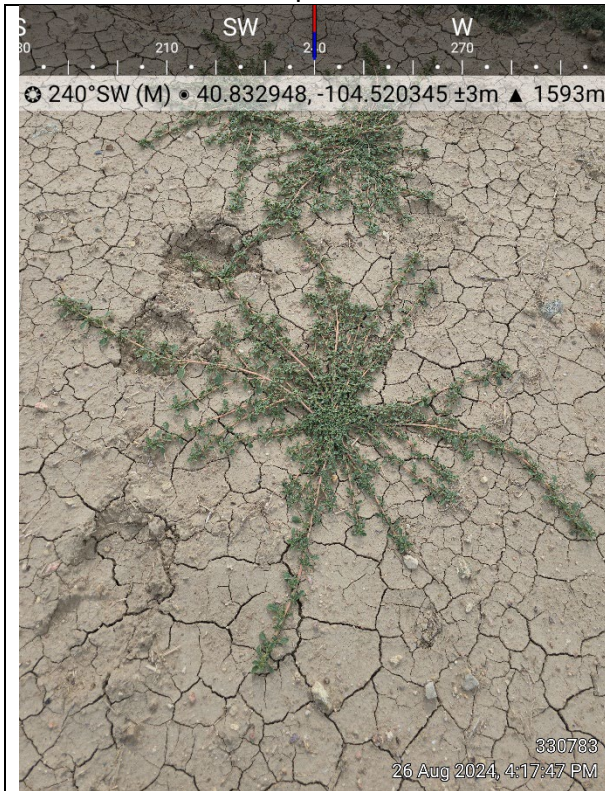
Amaranth (*Genus Amaranthus*)

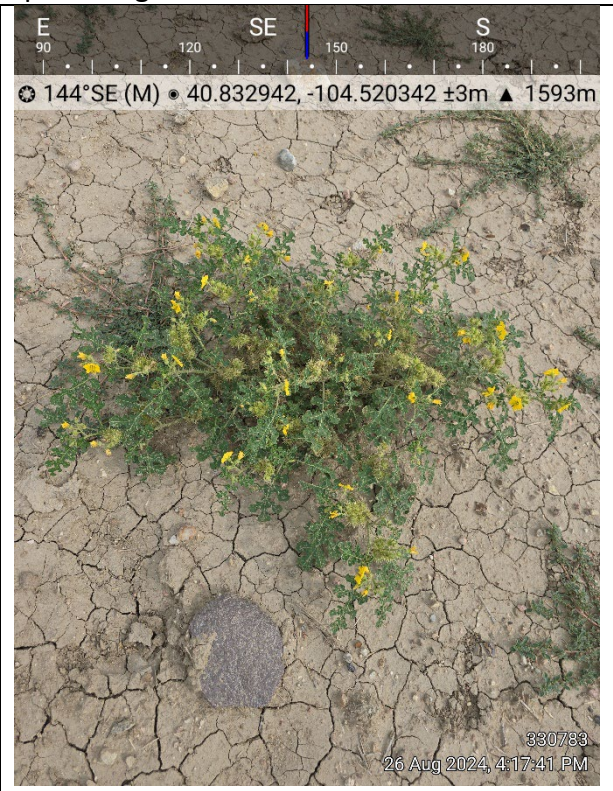
Buffalo-bur (*Solanum rostratum*)

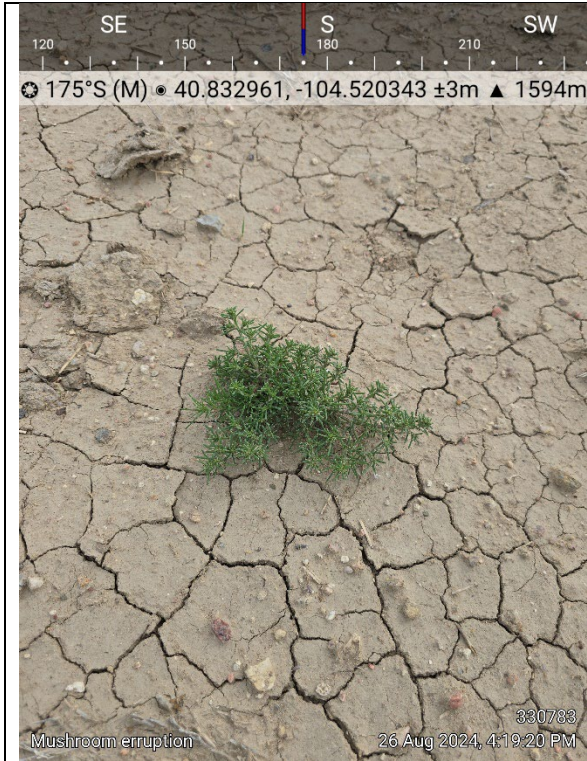
Mushroom eruption

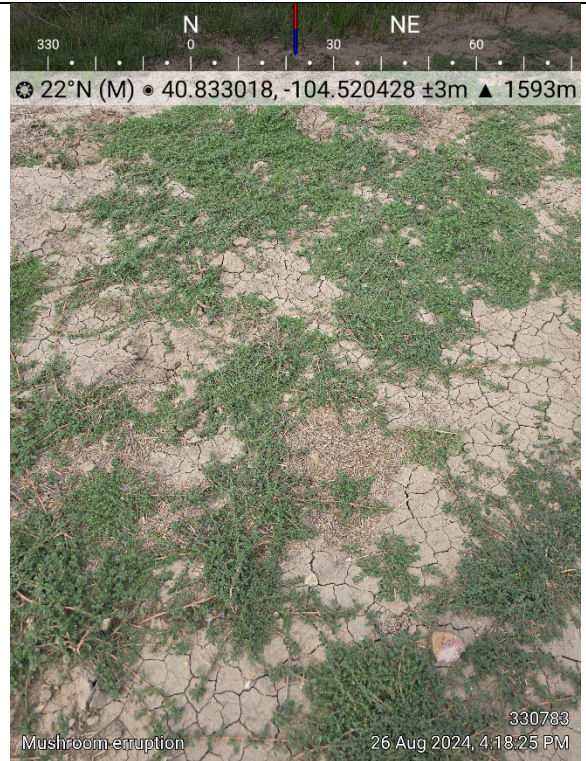
Mushroom eruption

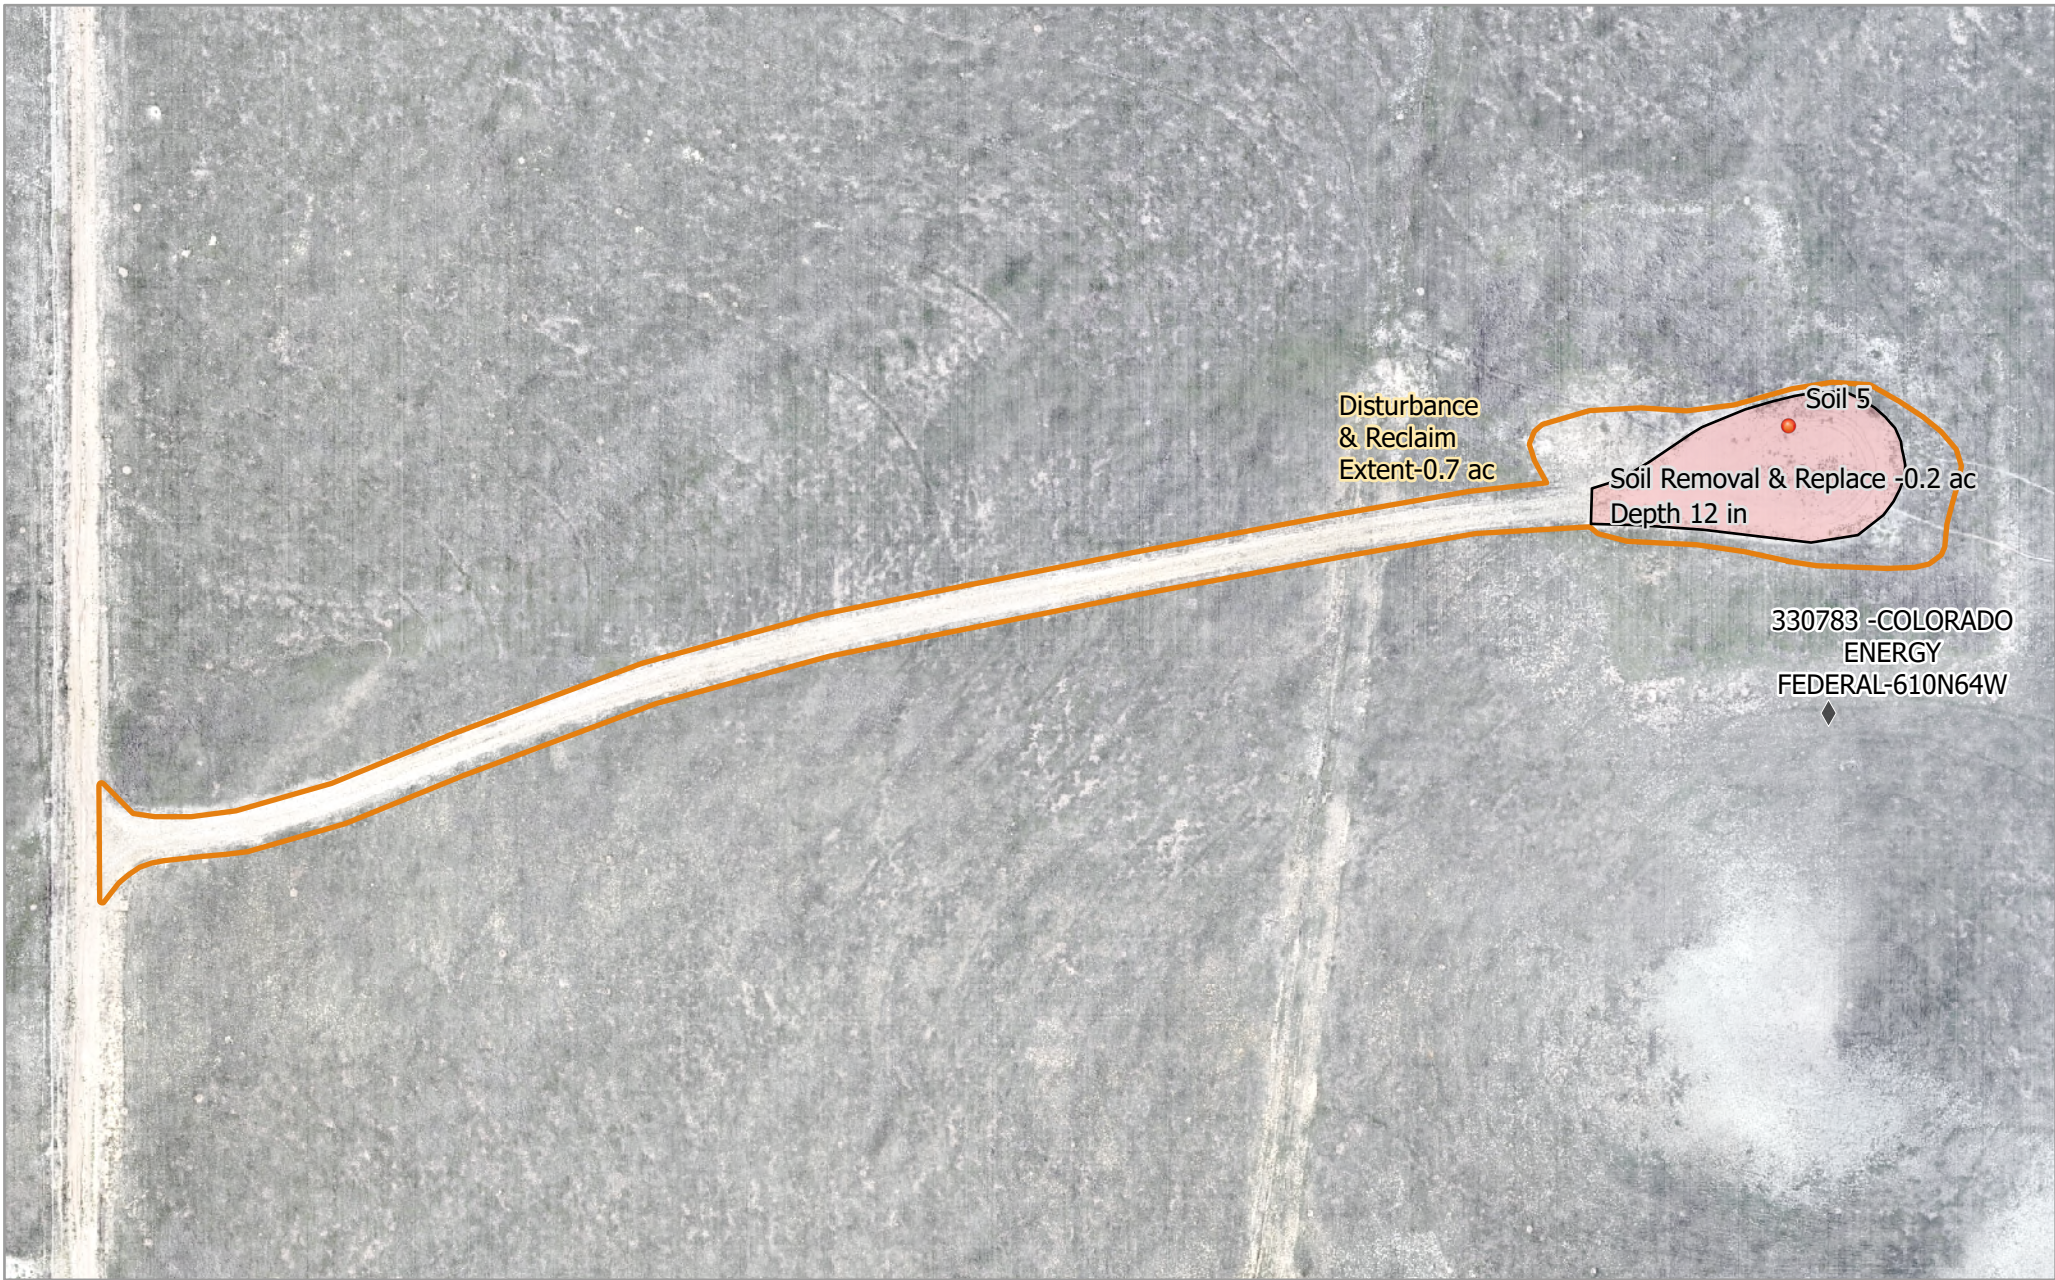
**CIV - 330783 - Colorado Energy Federal
610N64W/14NWSW
Map Extent - Reclaim Extent**

- Continuous bare ground on road and pad
- Weed impact primarily broadleaf weeds
- Bermuda grass found in the area between the pad and the boundary of the disturbance extent
- Recommendations
 - Remove, replace, decompact, disc, seed, and crimp straw with USFS seed mix that is adjusted to work with the entire site

Step	Description	Complete Date
1 – Soil Samples	Collection of soil samples from the site	26 Aug 2024
2 – Remove Exclusion Fence	Removal of fences as per reclamation plan	Week of April 1, 2025
3 – Soil Removal to Mapped Extent 0.2 acres	Removal of non-compliant soil 12 inches within the reclaim extent.	Week of April 1, 2025
4 – Soil Removal Inspection	In-person inspection and confirmation with soil sampling	Week of April 1, 2025
5 – Imported Soil Sample Test Results Review*	Verification of imported soil with current lab test results	Week of April 7, 2025
6 – Soil Import	Import soil as specified in the plan	Week of April 14, 2025
7 – Seeding	Planting appropriate seed mix for reclamation 20 PLS/sq ft	Week of April 28, 2025
8 – Straw Spread and Crimp	Spreading and crimping straw to stabilize soil apply 2 tons/acre	Week of May 5, 2025
9 – Monitor	Continuous monitoring post reclamation	2025 - 2027
10 – Weed Management	Monthly monitoring is recommended with appropriate herbicide control	Jun 9 – Oct 6
