Inspection/Audit Photos
Location: QB Energy Puckett/697-26A
Location ID: 416157
Date: 01/27/2025

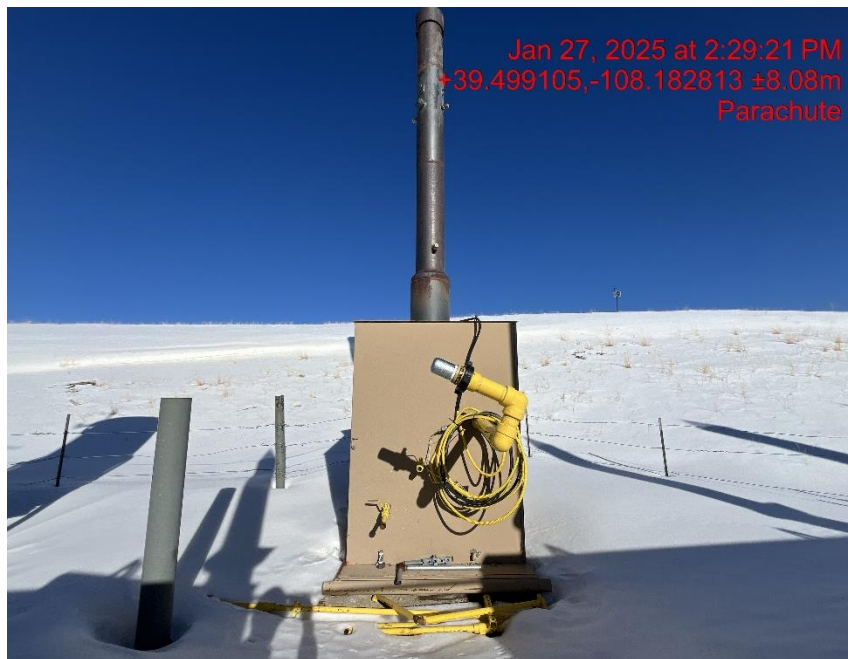
Photo # 3549 Unused equipment

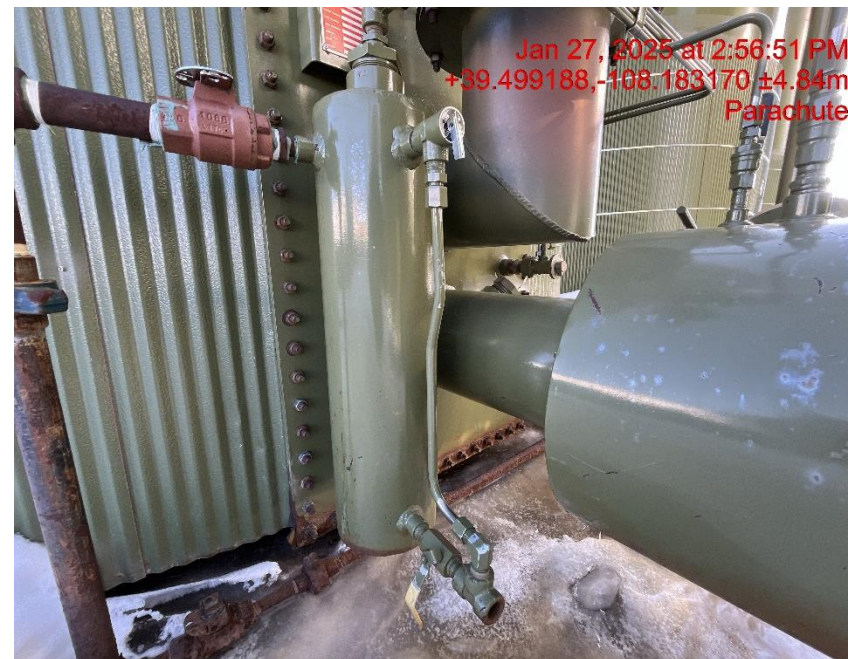
Photo # 3575 PRV vent line does not comply with CECMC pressure safety device rules

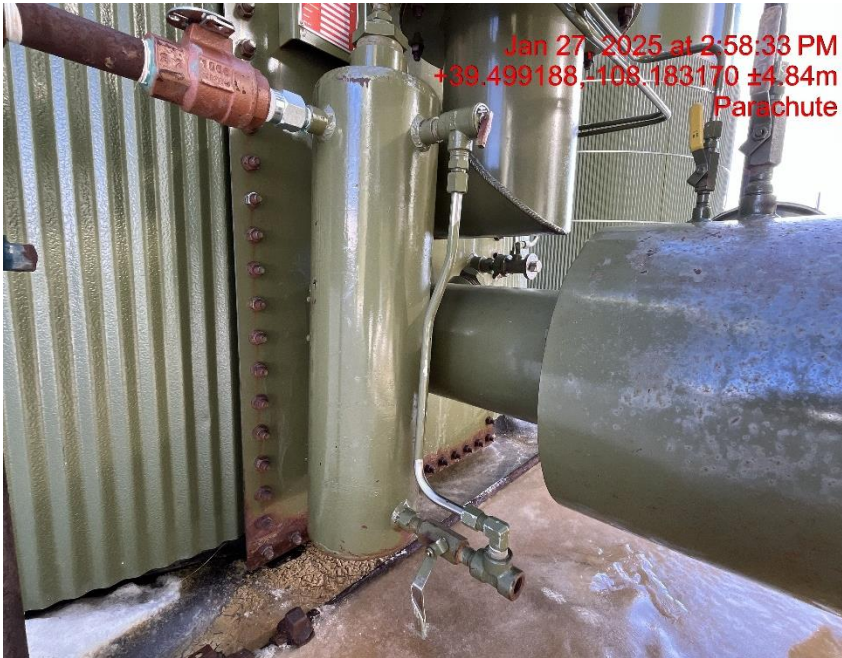
Photo # 3577 PRV vent line does not comply with CECMC pressure safety device rules

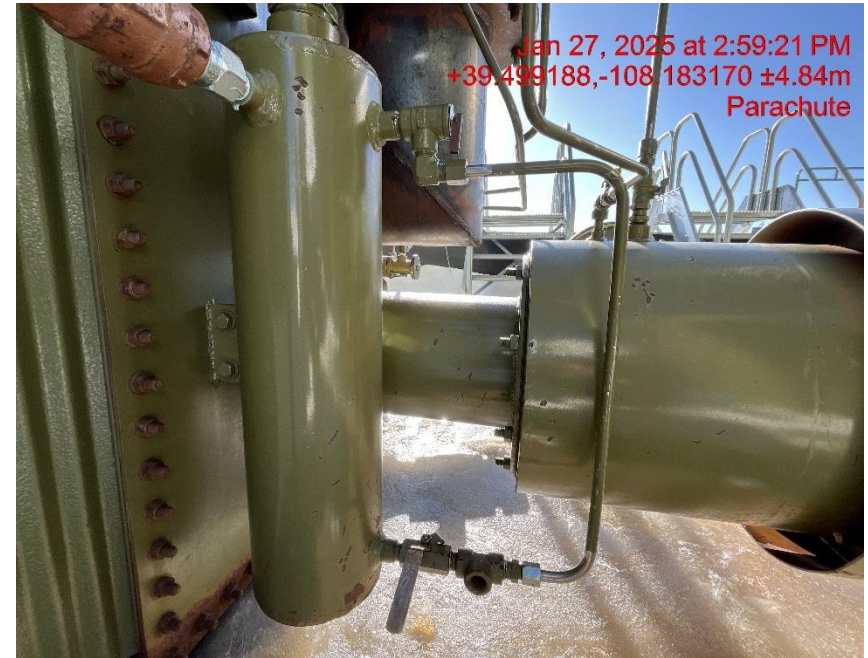
Photo # 3578 PRV vent line does not comply with CECMC pressure safety device rules

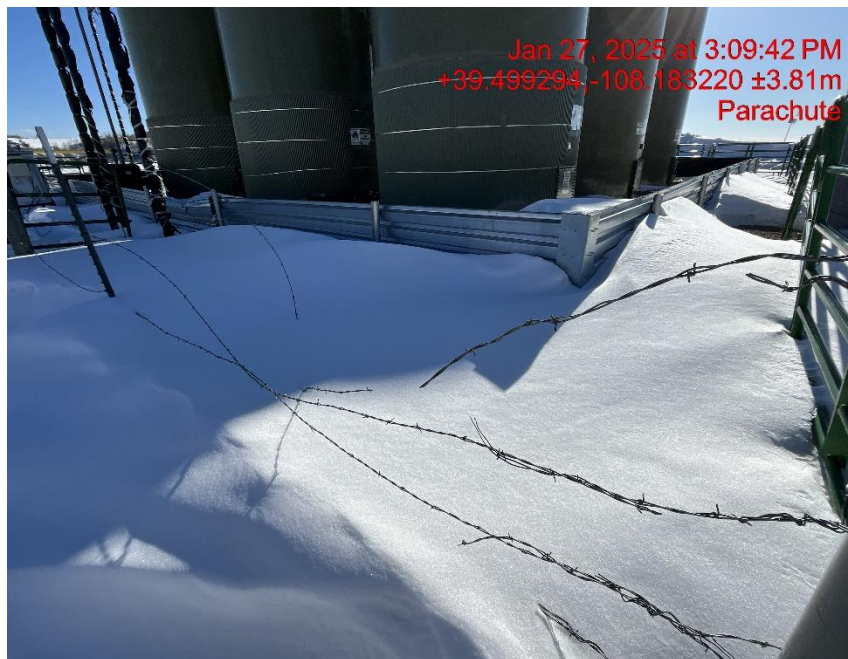
Photo # 3588 Wildlife hazard

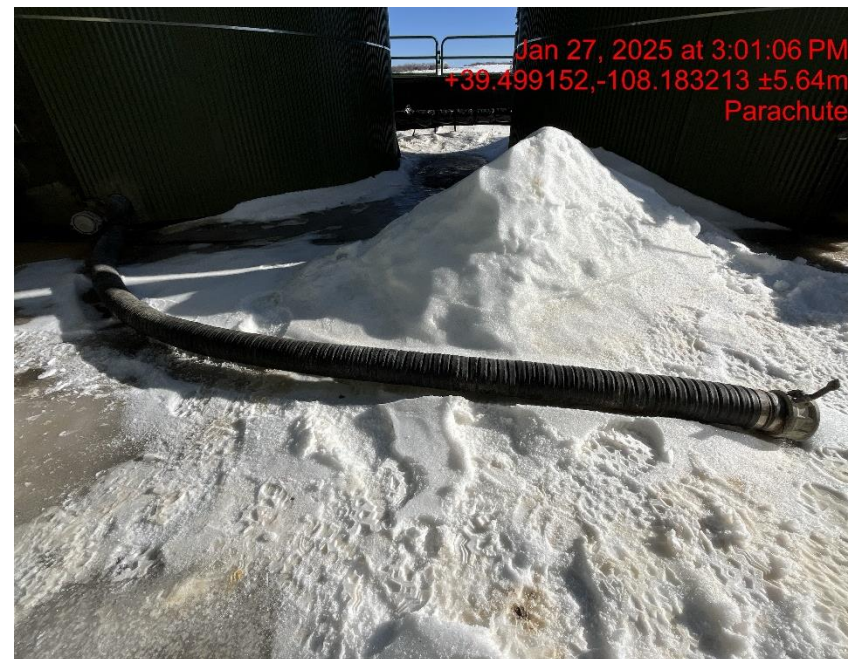
Photo # 3579 Unused hose

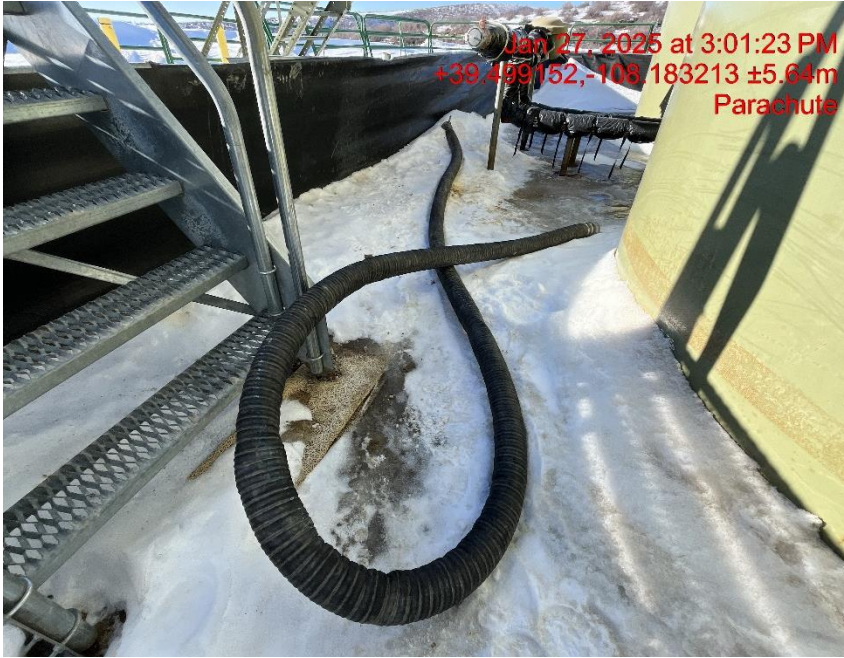
Photo # 3580 Unused hose

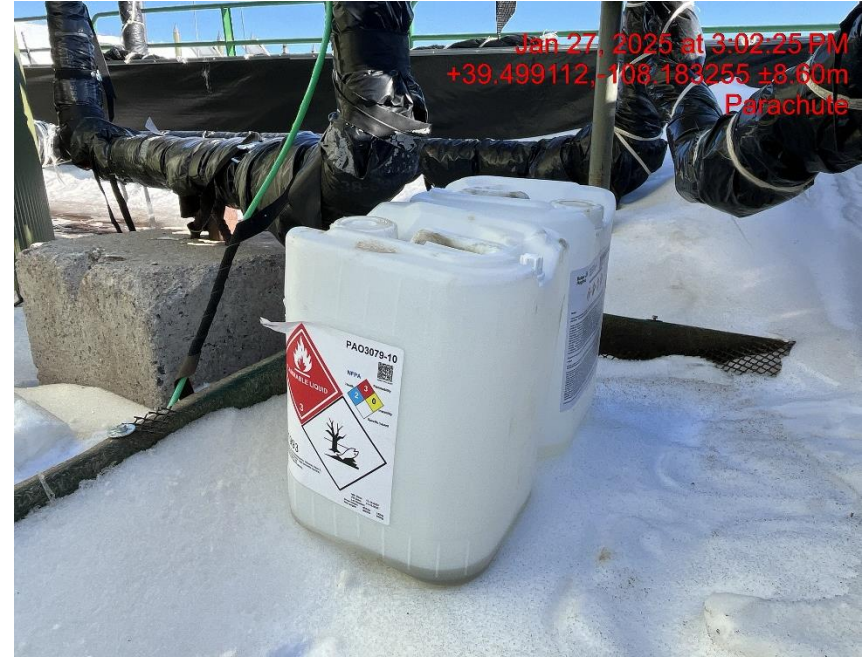
Photo # 3581 Empty chemical containers

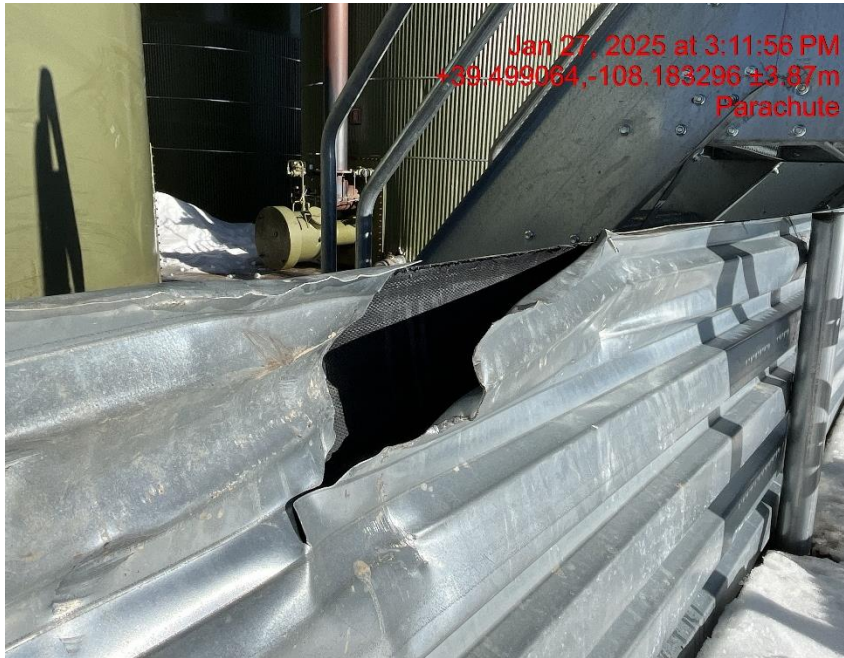
Photo # 3591 Containment showing signs of disrepair

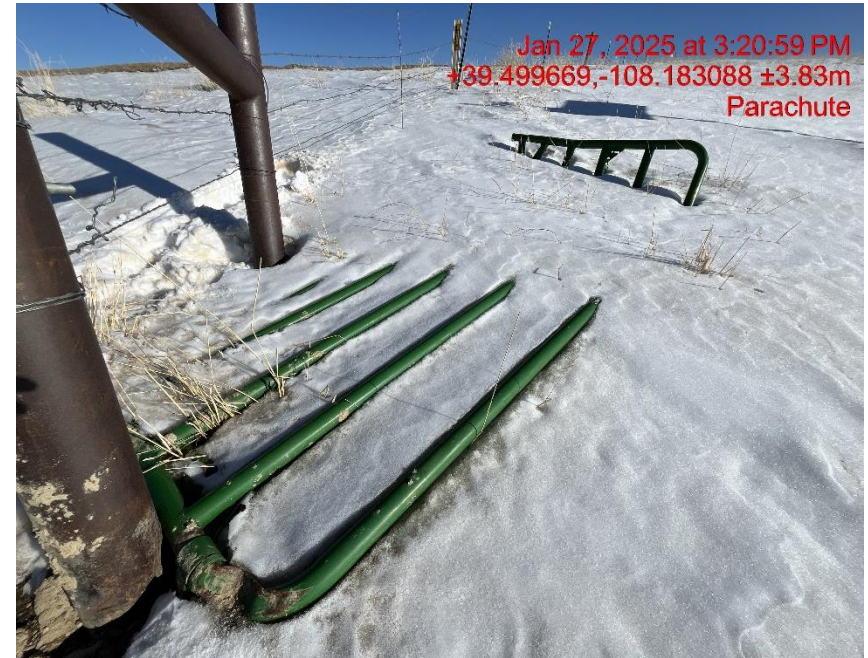
Photo # 3598 Debris
