Inspection/Audit Photos

Location Name: TEP ROCKY MOUNTAIN LLC RIVER RANCH A Pad

Location #: 336014

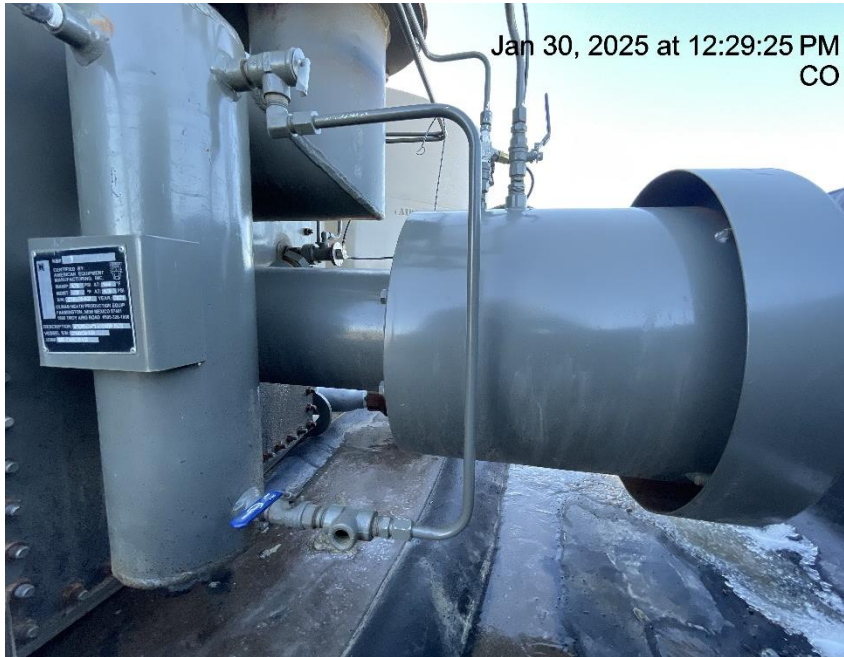
Photo # 2828 PRV vent line does not comply with CECMC pressure safety device rules

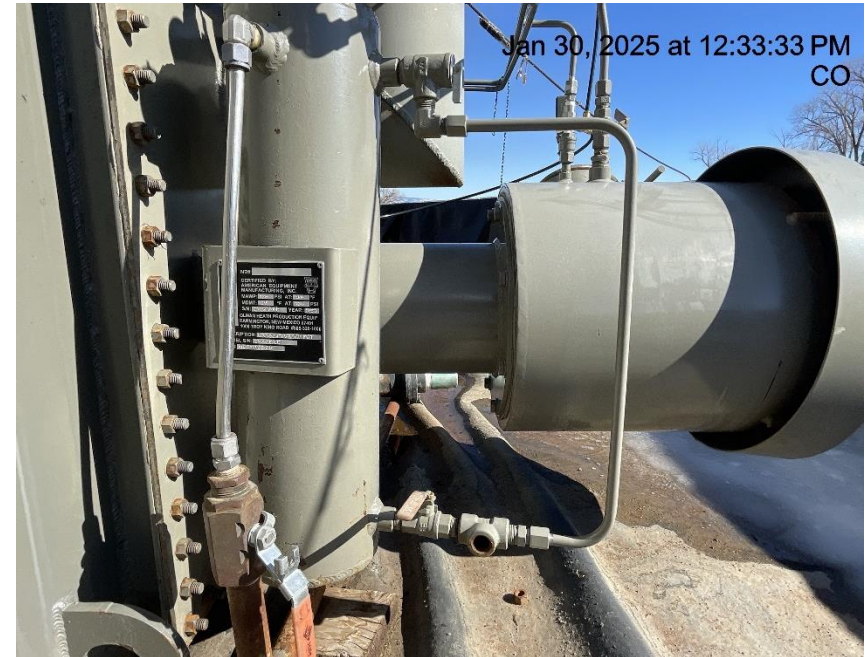
Photo # 2829 PRV vent line does not comply with CECMC pressure safety device rules

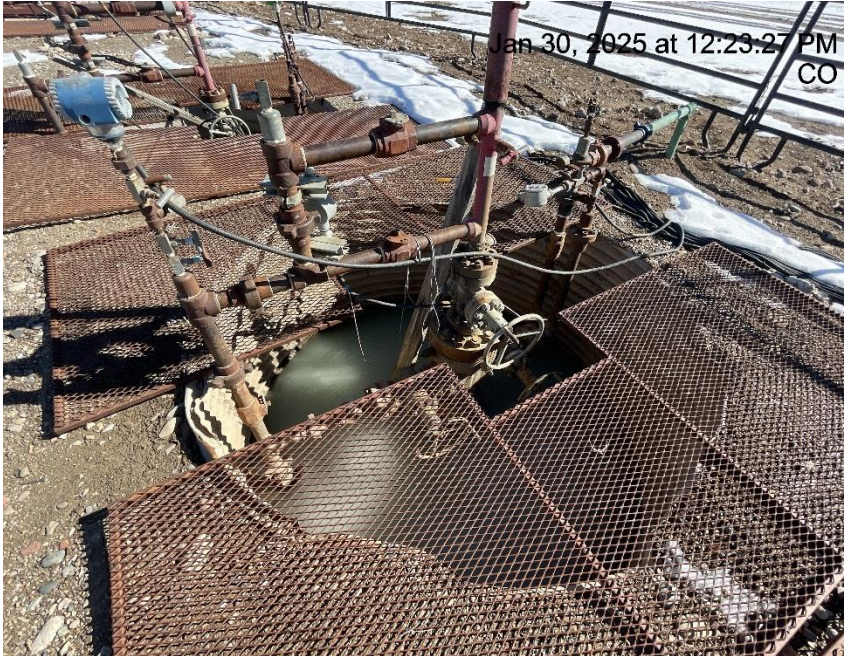
Photo # 2830 Cellar not properly covered/wildlife & personnel hazard

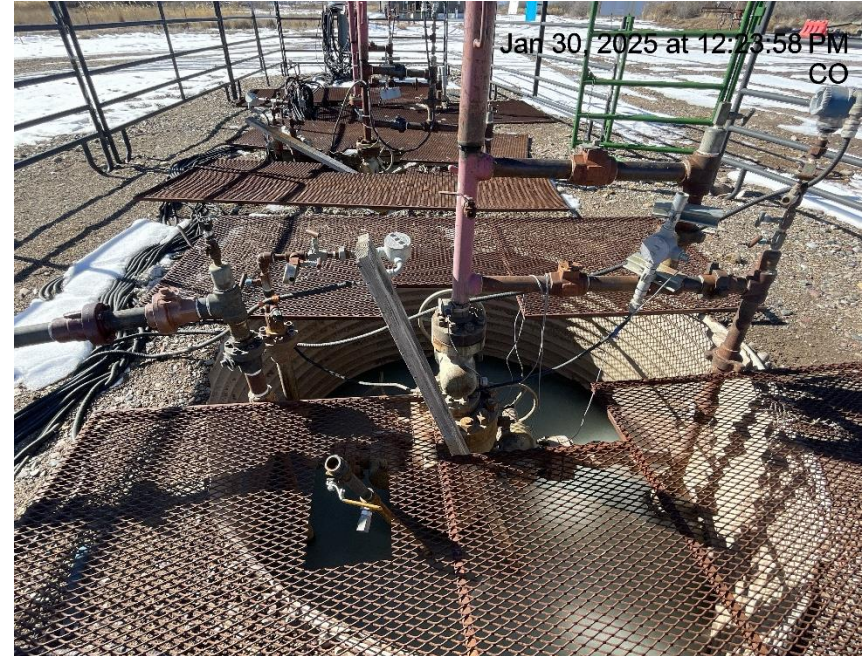
Photo # 2831 Wildlife egress board needs adjustment

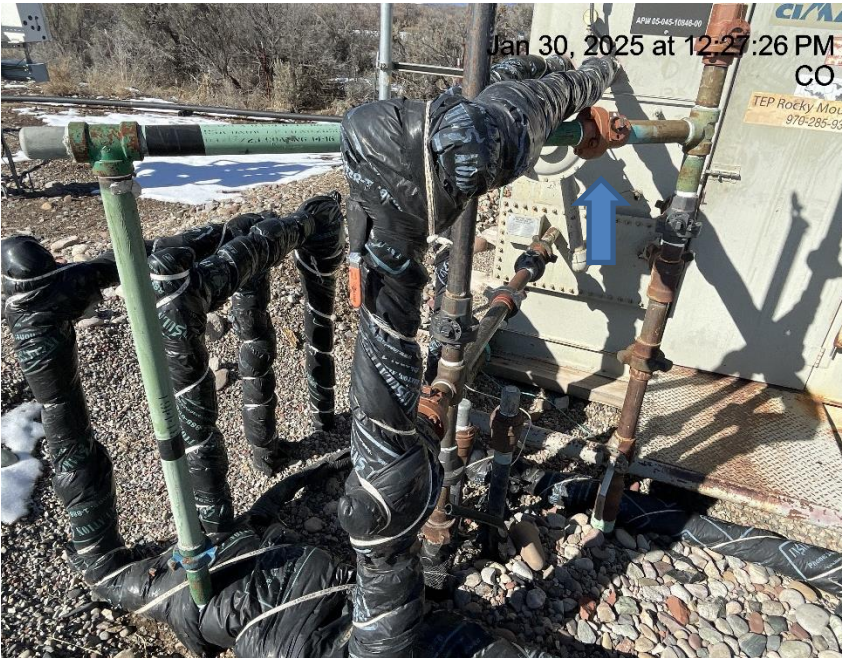
Photo # 2832 Valve on the 2 inch line connecting the RIVER RANCH A4 well BH line to the sales line appears to be shut

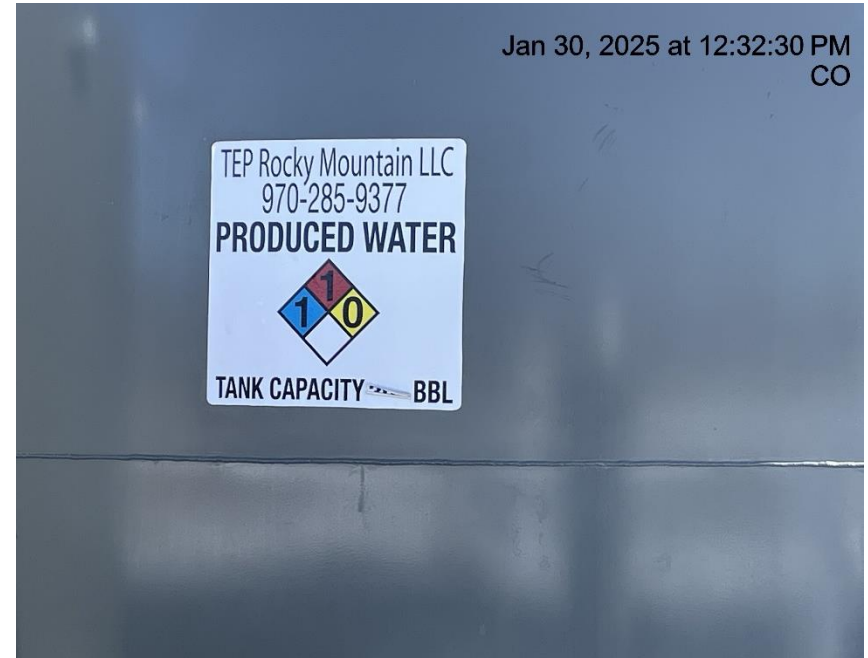
Photo # 2833 Capacity on tank label illegible/not in compliance with CECMC rules

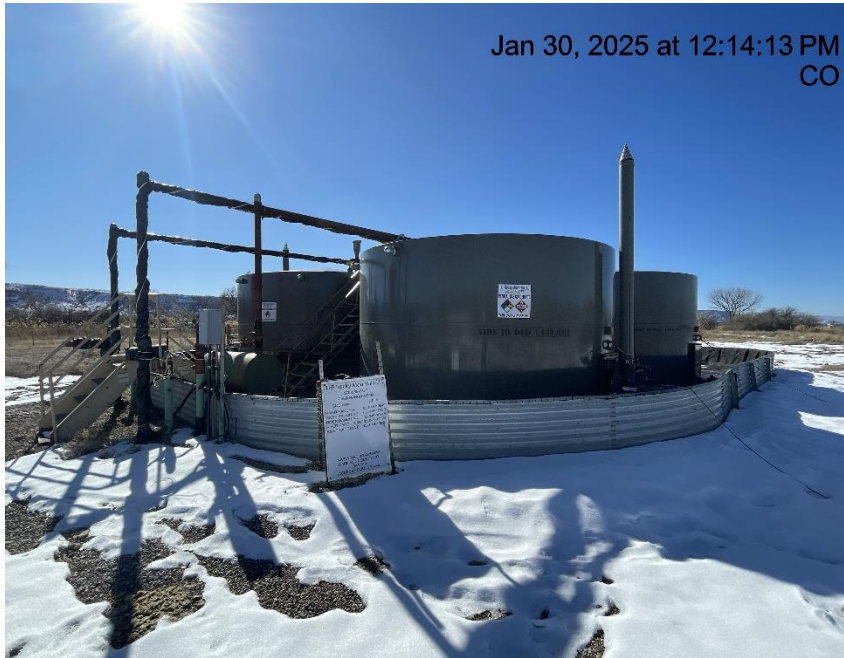
Photo # 2834 One 300 bbl tank added to location - Unable to locate FORM 4 SUNDRY for this equipment/not in compliance with CECMC rules

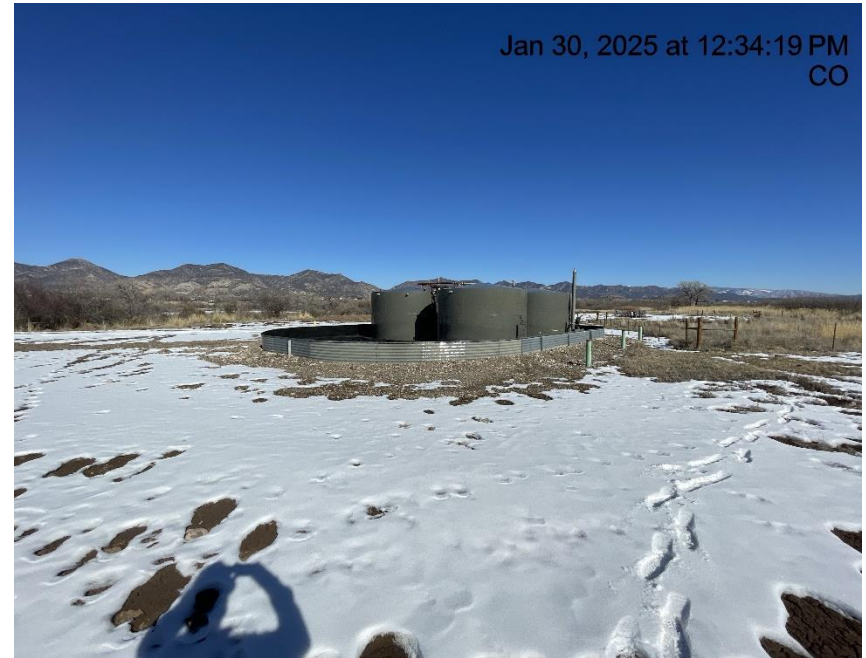
Photo # 2835 One 300 bbl tank added to location - Unable to locate FORM 4 SUNDRY for this equipment/not in compliance with CECMC rules
