## Inspection/Audit Photos

Location Name: TEP ROCKY MOUNTAIN LLC ROBINSON A Pad

Location #: 336015

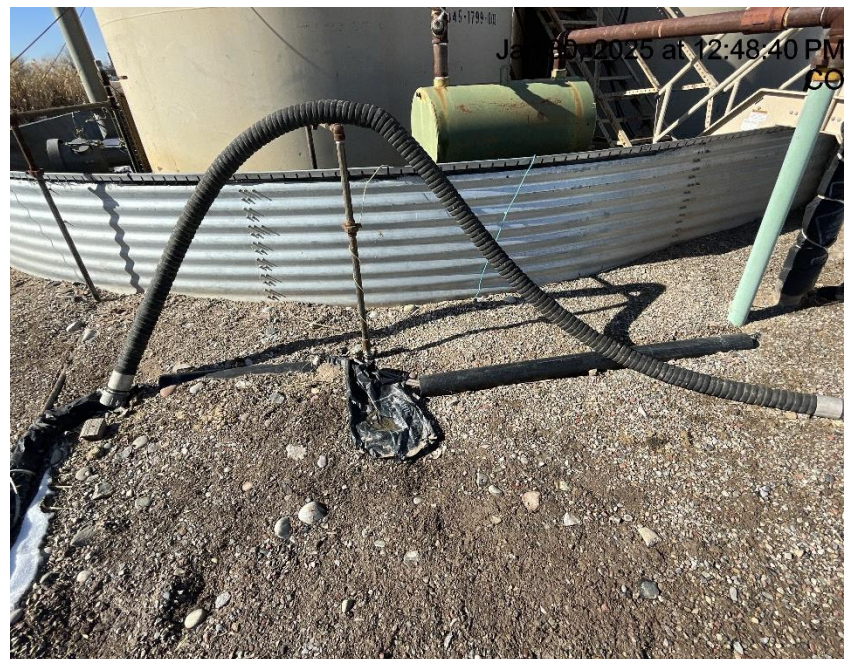
Photo # 2930 Damaged hose/debris

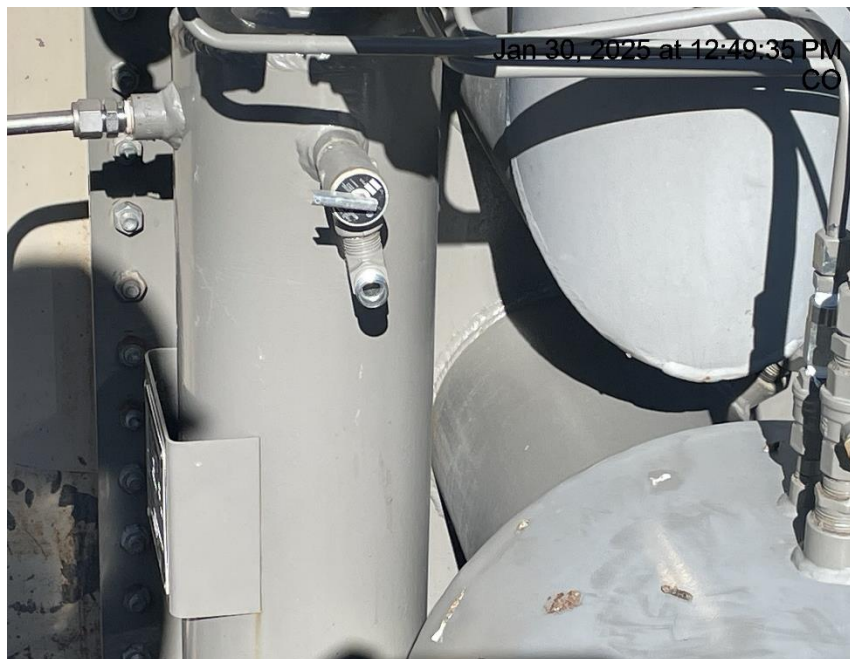
**Photo # 2931 PRV vent line does not comply with CECMC pressure safety device rules**

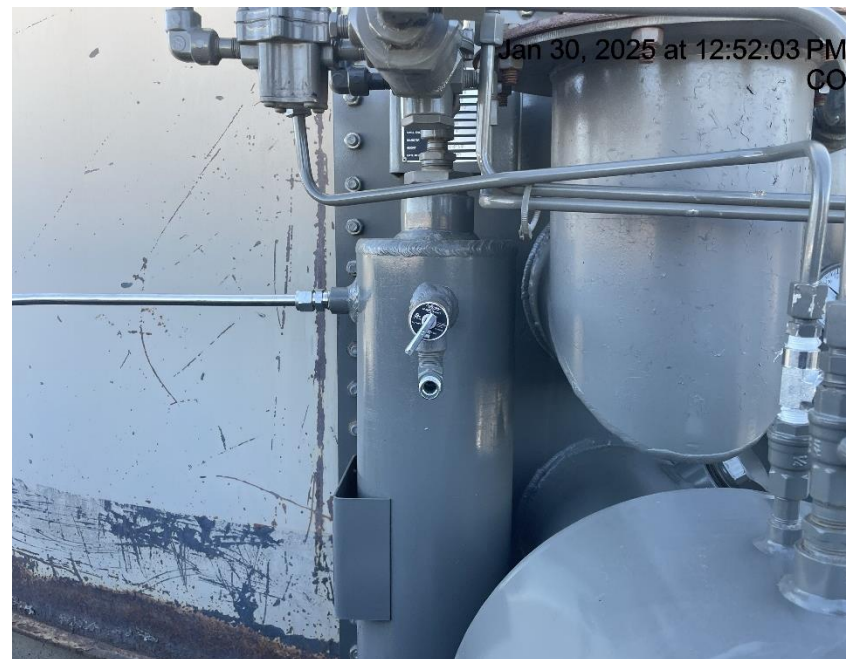
**Photo # 2932 PRV vent line does not comply with CECMC pressure safety device rules**

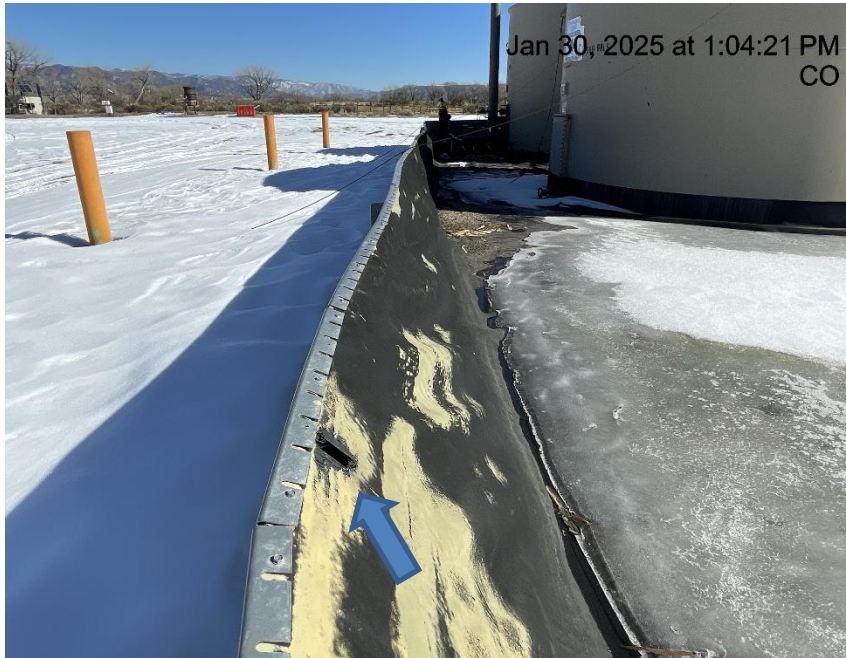
**Photo # 2933 Hole in secondary containment liner/liner needs maintenance**

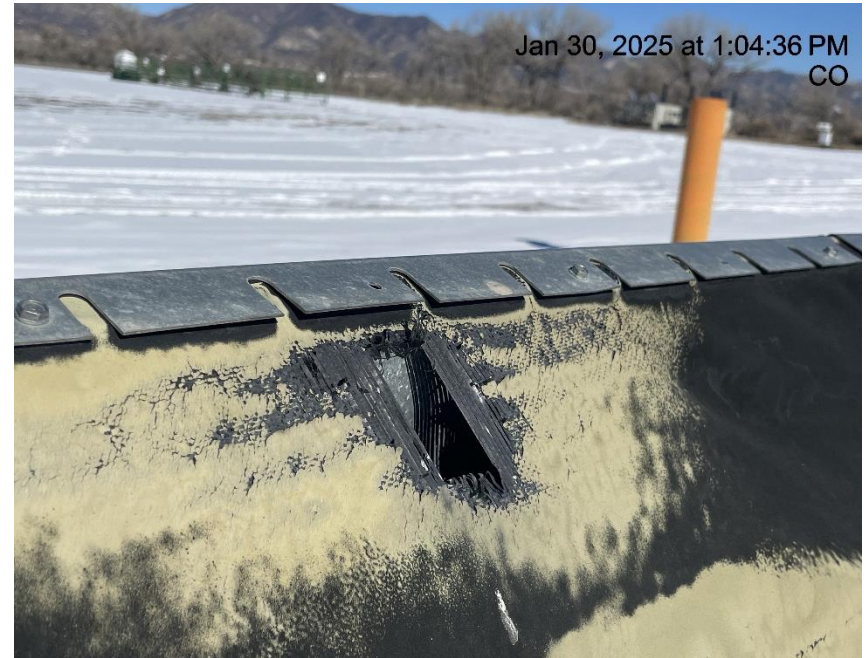
**Photo # 2934 Hole in secondary containment liner/liner needs maintenance**
