# Inspection Photos

API: 017-06629

Operator: **WILLIFORD ENERGY COMPANY**

Inspection Date: 1/28/2025

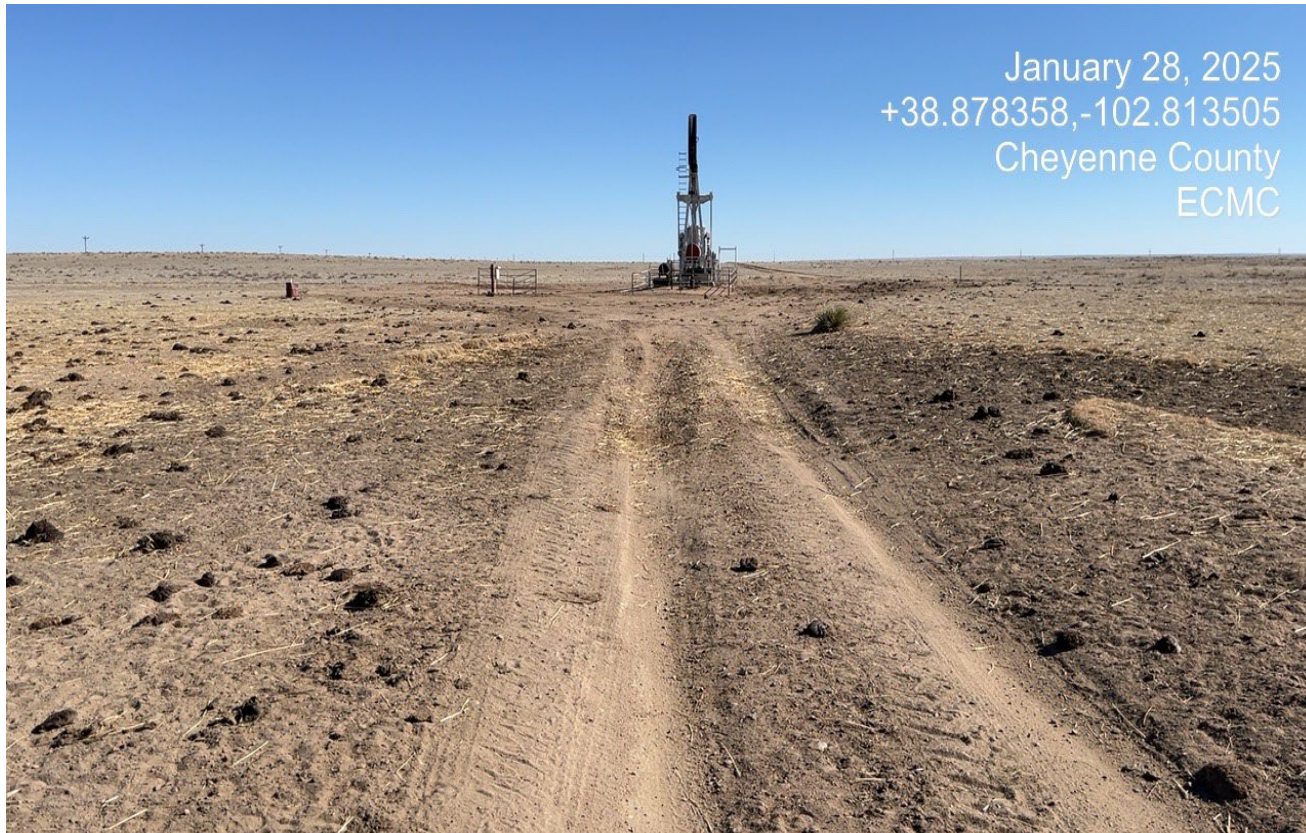
**Photo 1.** Facing east along the access road. Vehicles are causing unnecessary disturbance driving outside of the access road due to stormwater pooling on the road. The access road has not been repaired.

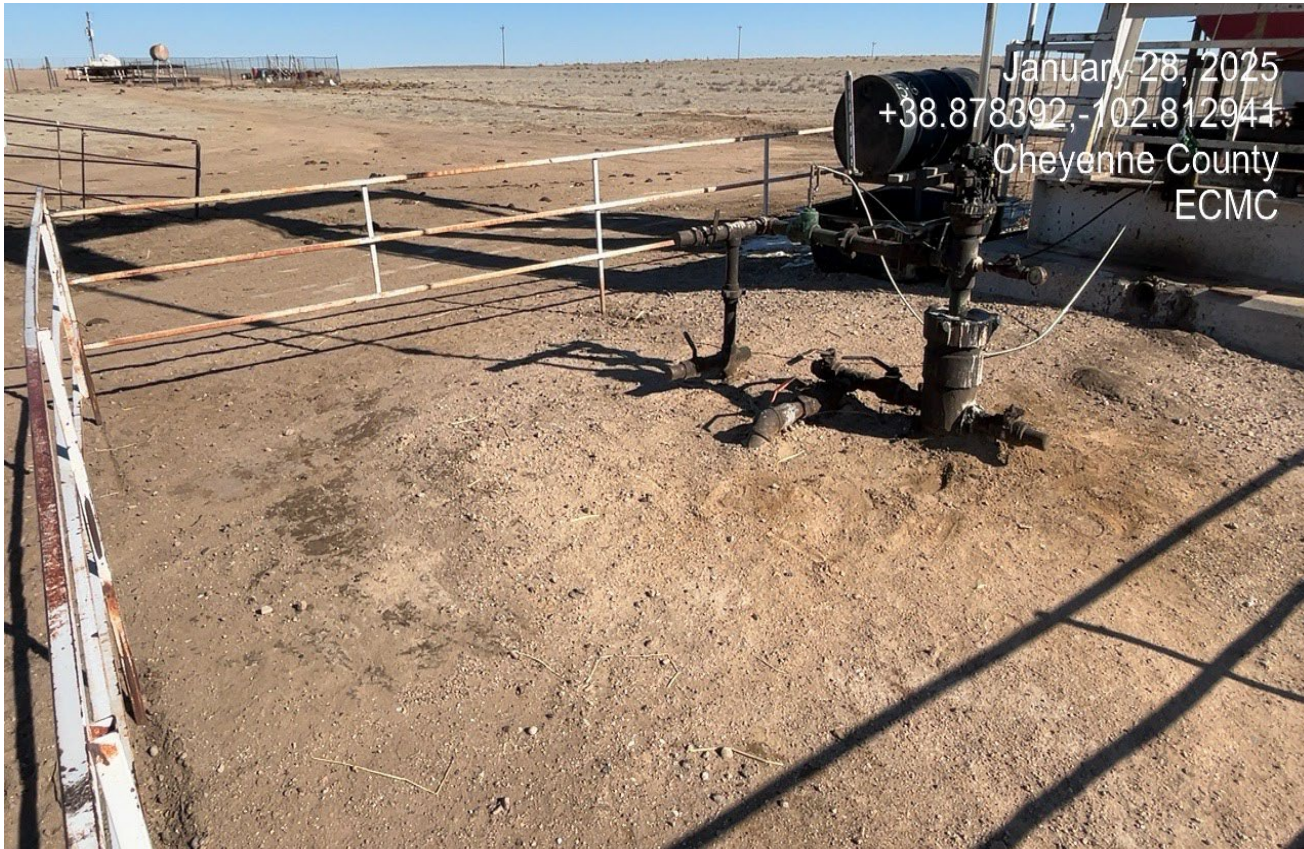
**Photo 2.** Facing toward the wellhead. There are stained soils by the wellhead. Previous CA was not completed.

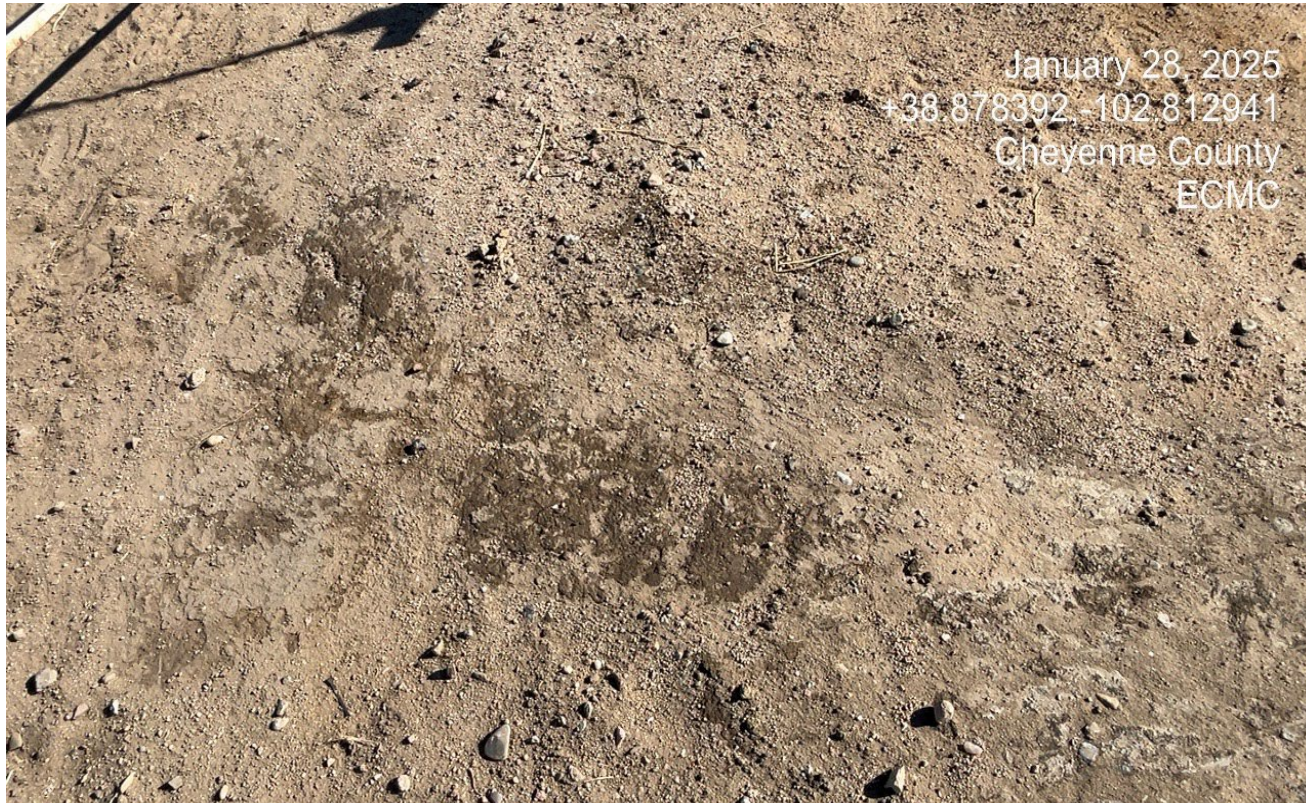
**Photo 3.** View of oil stained soils at the wellhead.

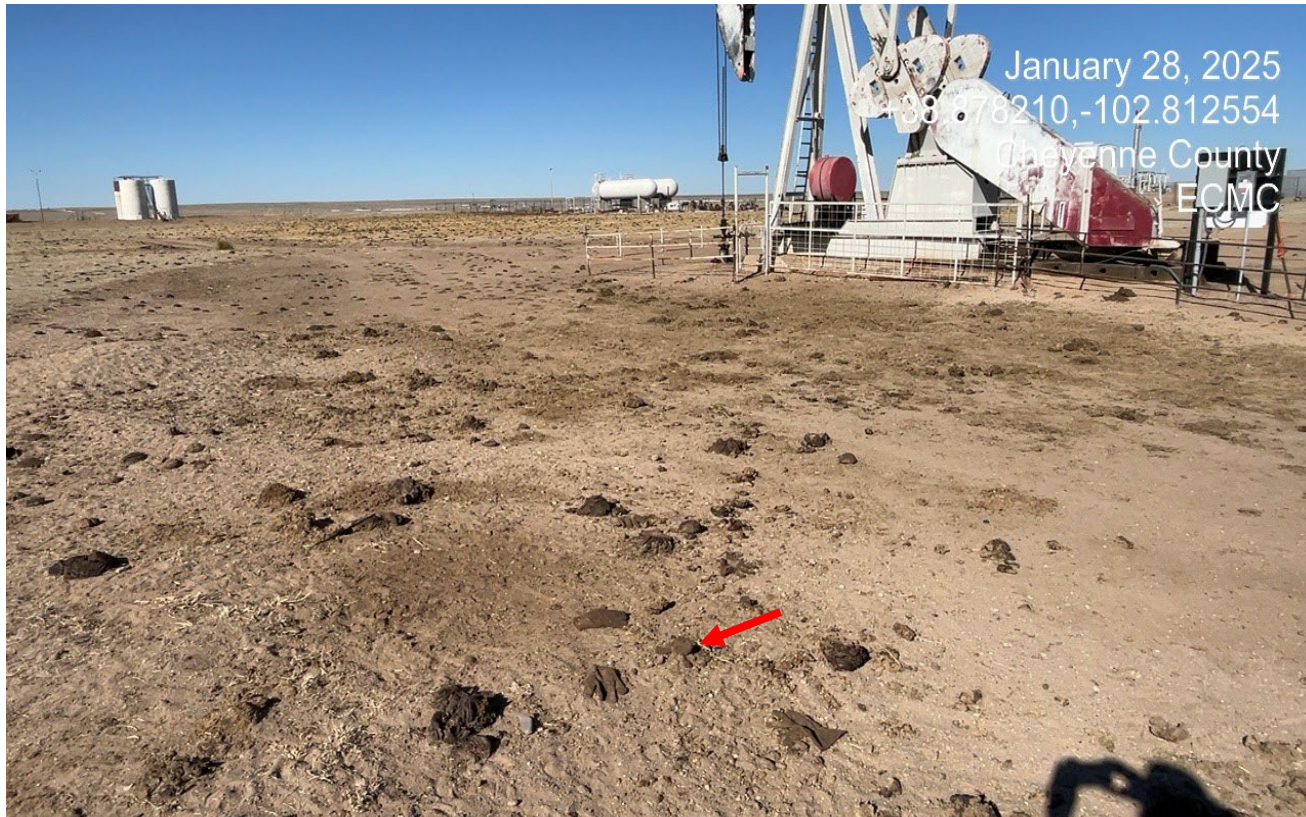
**Photo 4.** There is a pile of oily rags at the south side of the location. This must be removed and properly disposed. Previous CA was not completed.

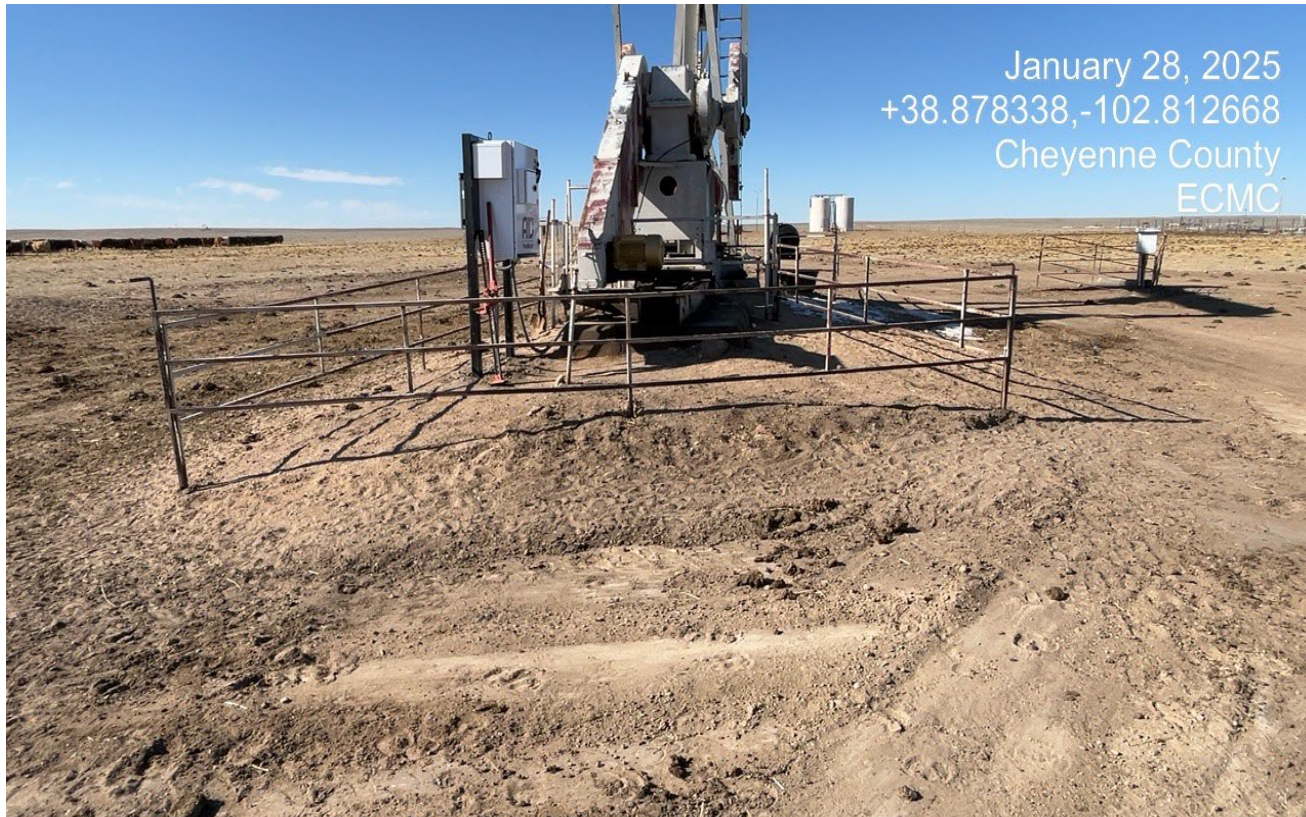
**Photo 5.** Facing toward the pumpjack. The engine has been replaced with an electric motor. It is unknown if oil saturated soils were cleaned up due to sand previously spread over this area.

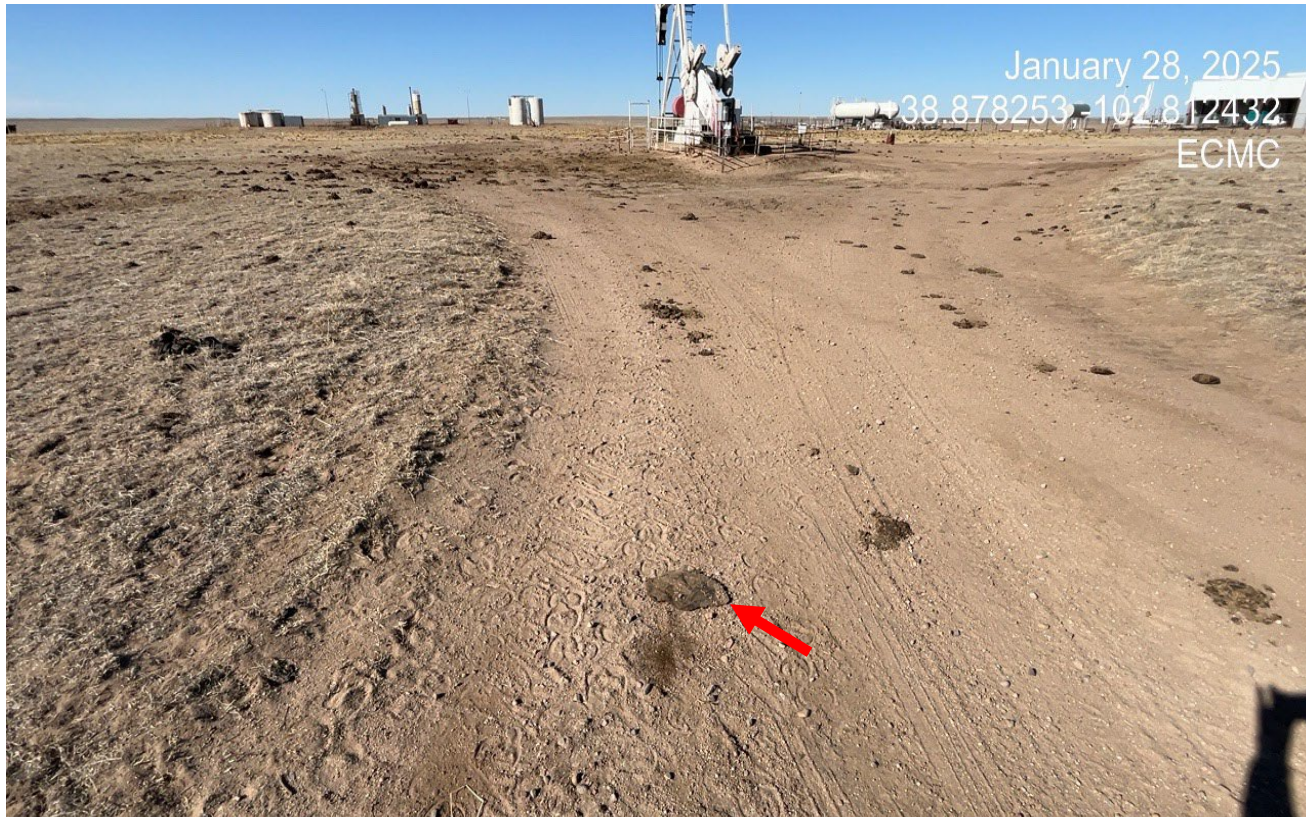
**Photo 6.** Facing northwest toward the wellsite. The red arrow points to an oily rag that still remains.

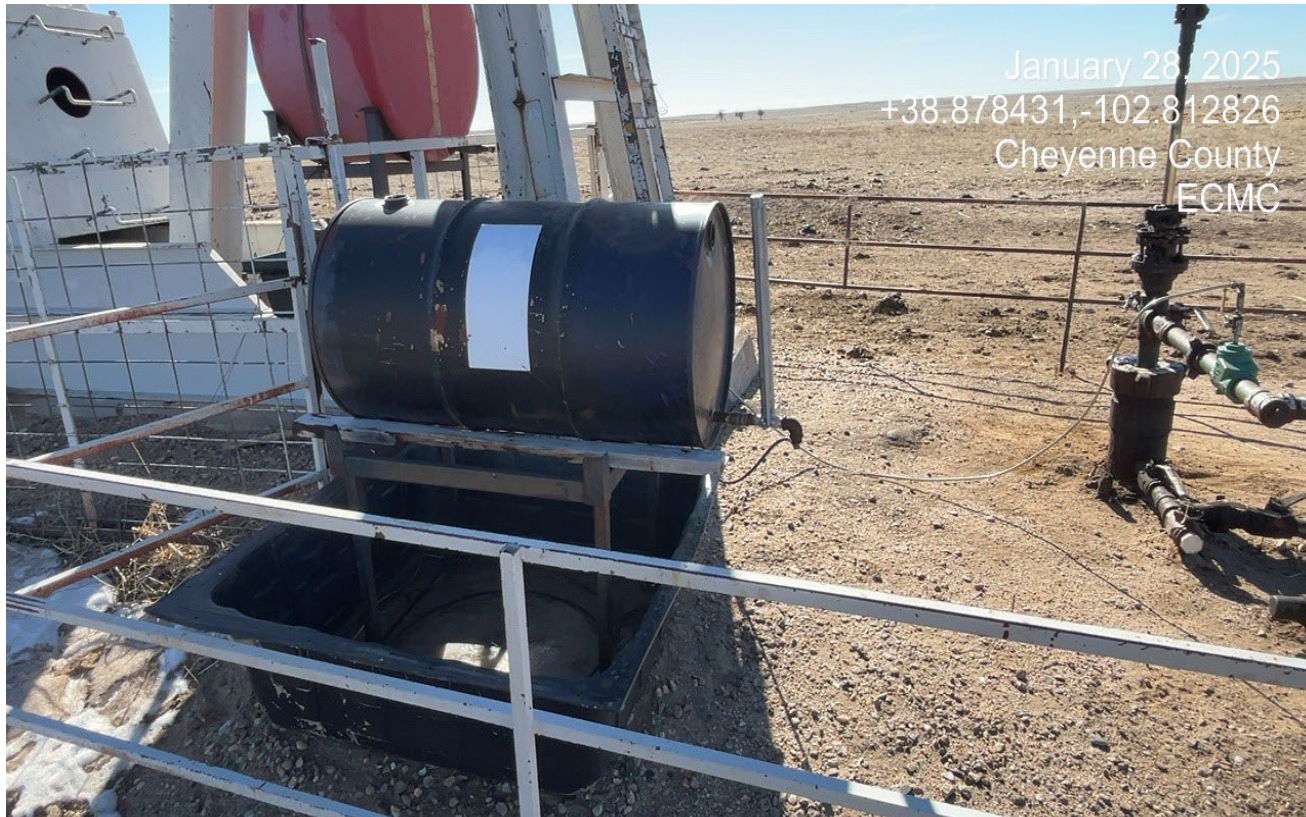
**Photo 7.** The labeling on the barrels is faded and needs to be updated.
