Final Reclamation and Stormwater Inspection

January 24, 2025

Location ID: 463813

Well Name: DADO #3-21

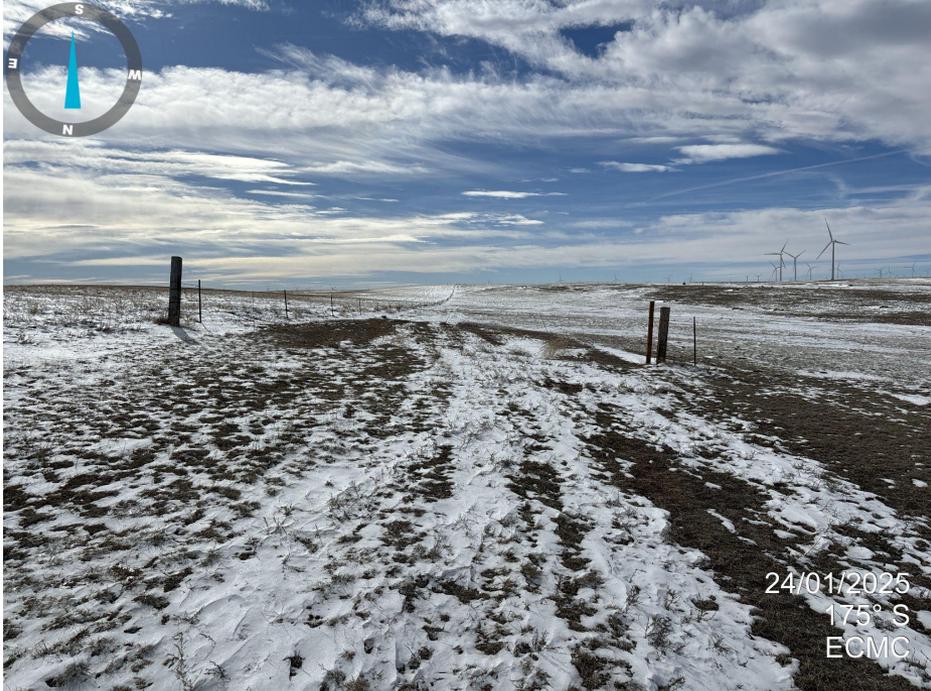
Photo 1. Looking south down access road. Due to snow cover a full vegetative assessment could not be completed.

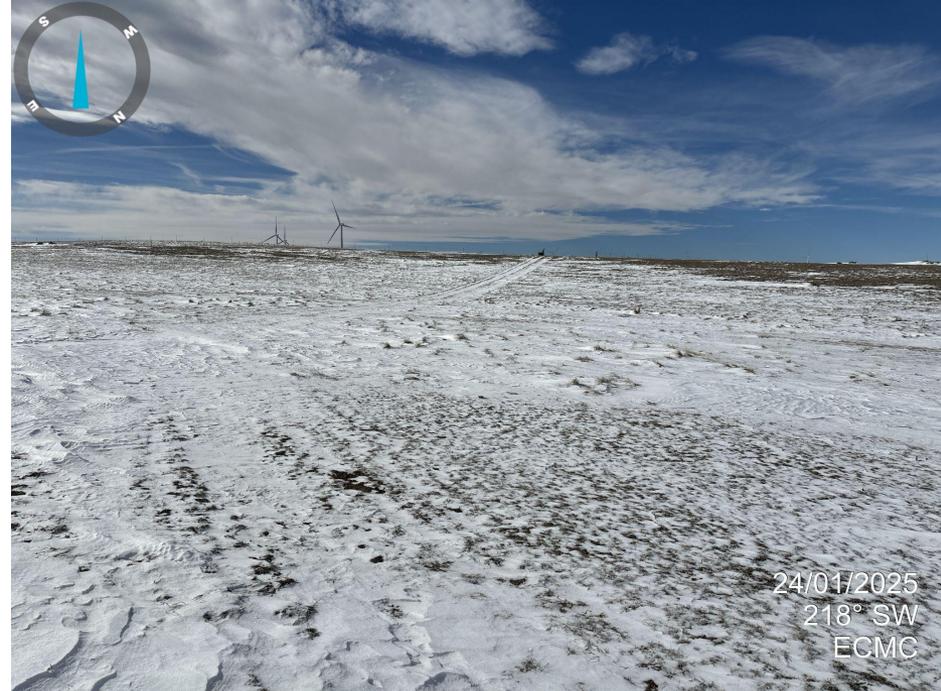
Photo 2. Looking southwest down access road toward well site.

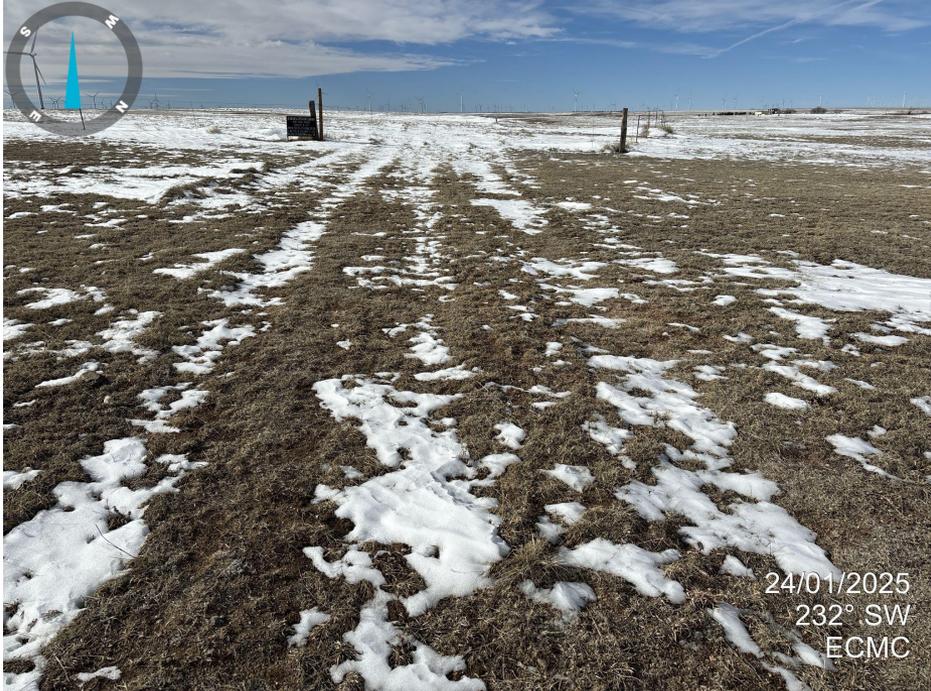
Photo 3. The access road in front of the gate appears to have perennial vegetation established.

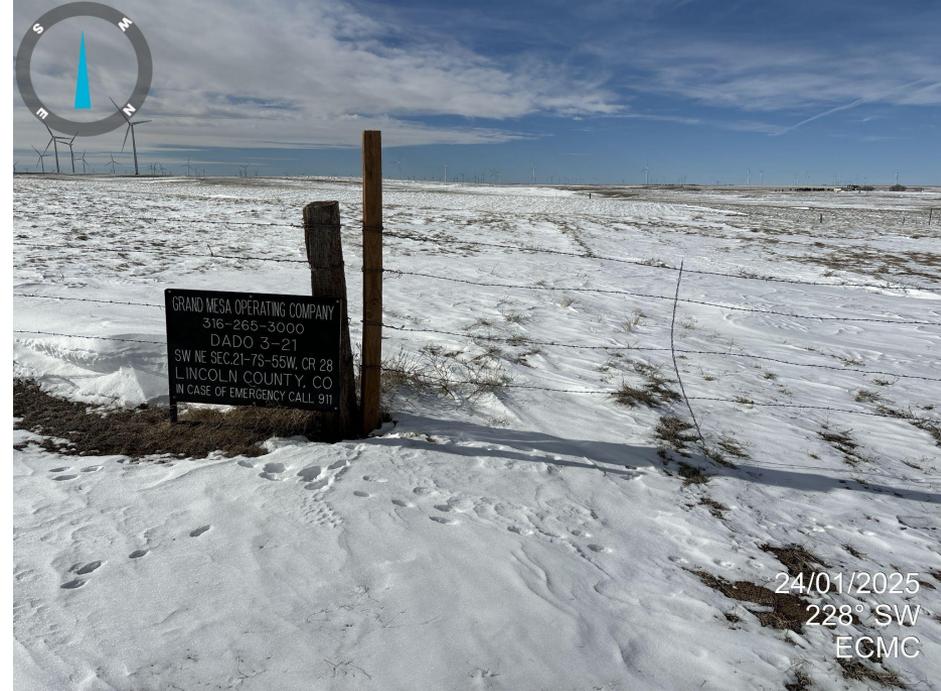
Photo 4. The location is fenced. Sign at entrance of location.

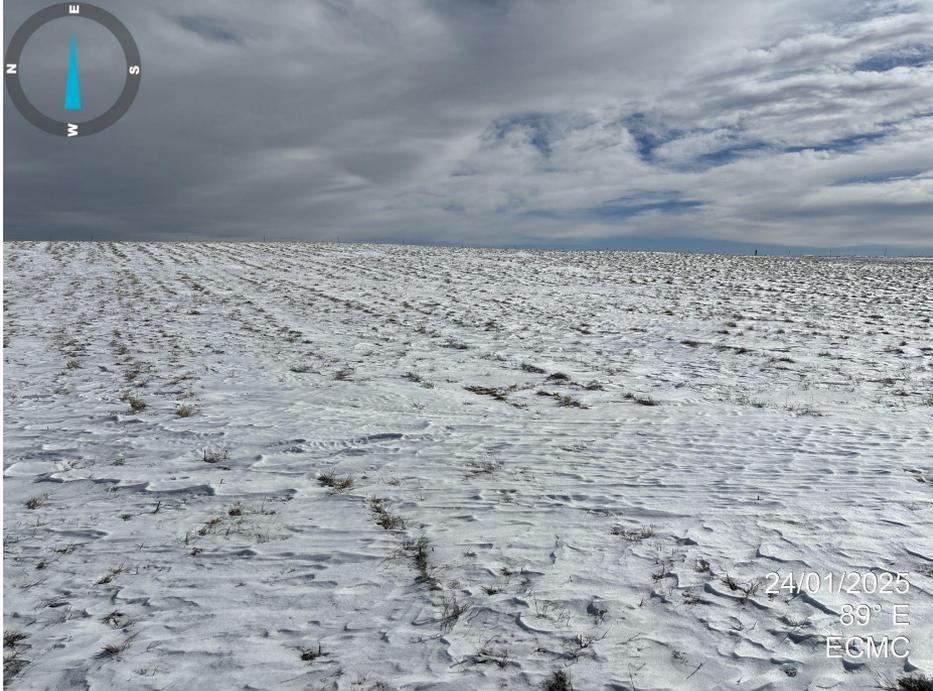
Photo 5. Looking east from well location. Due to snow cover a full vegetative assessment could not be completed.

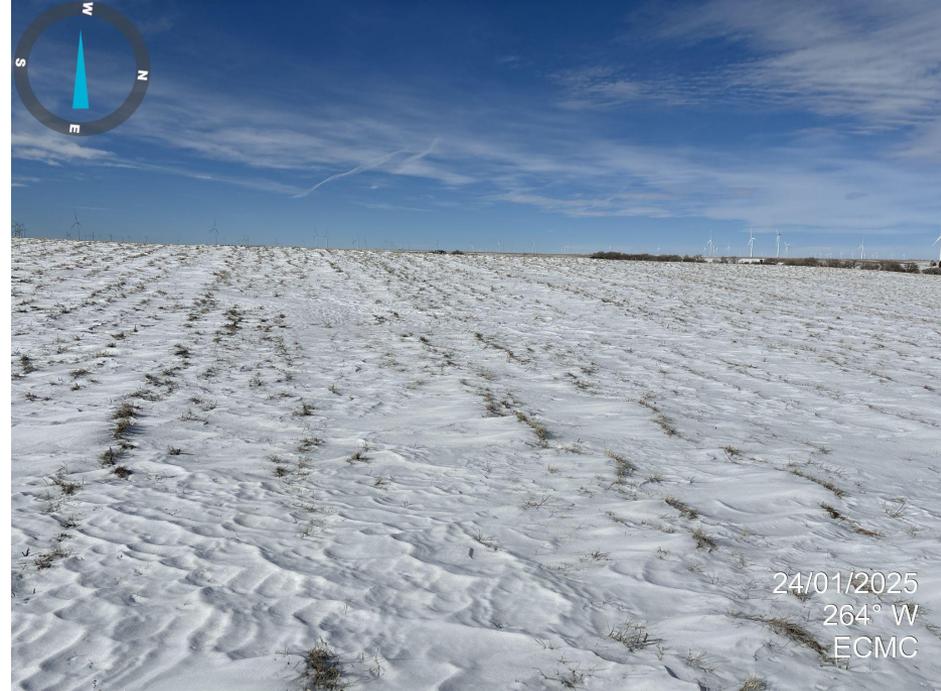
Photo 6. Looking west from well location. See Photo 5 comments.

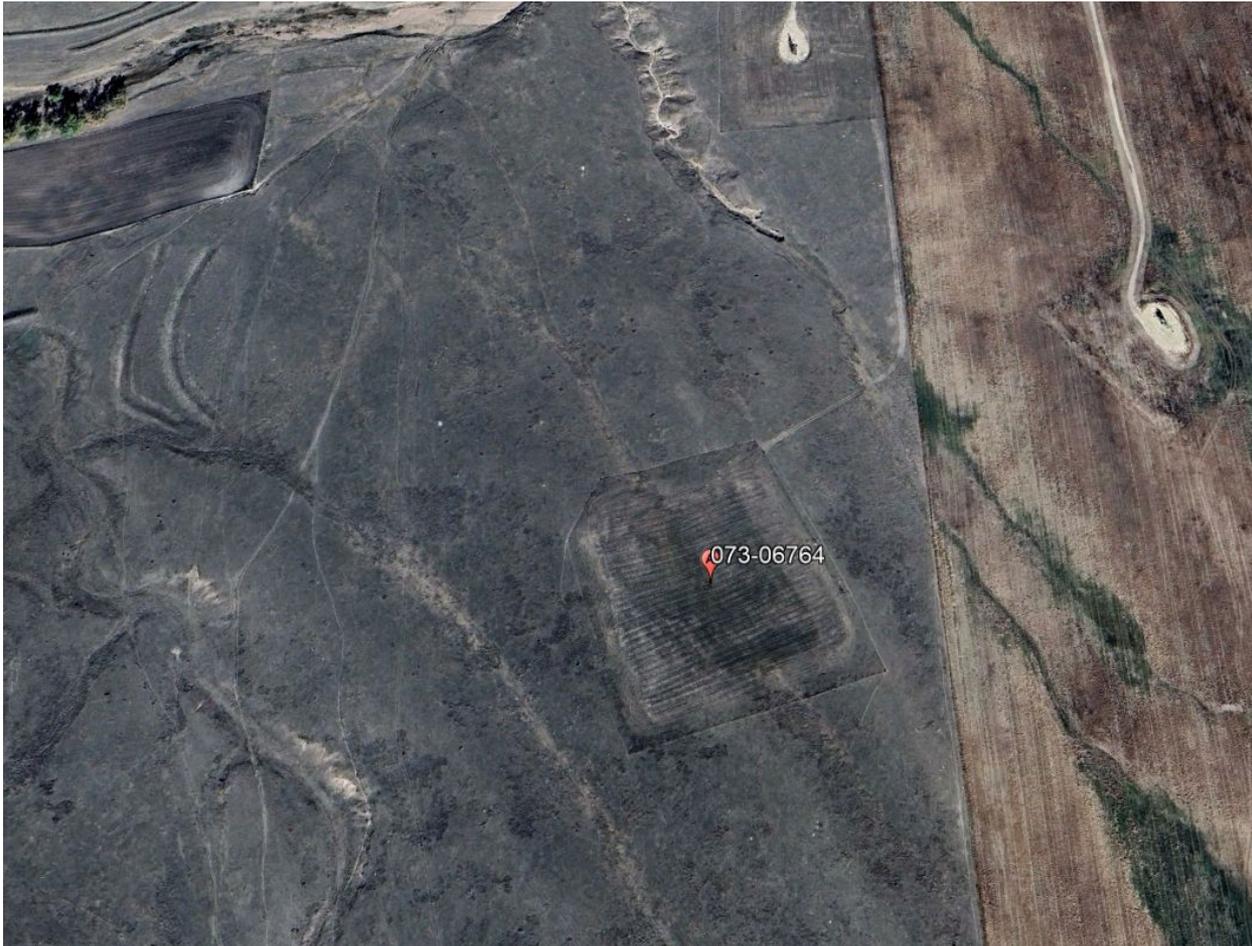
Photo 7. Google earth aerial image from 10/2024. Location appears to have reclamation work conducted.
