Interim Reclamation and Stormwater Inspection

Location ID: 456568

Well Name: BETTY PROD FACILITY/1

Inspection Document #: 718600224

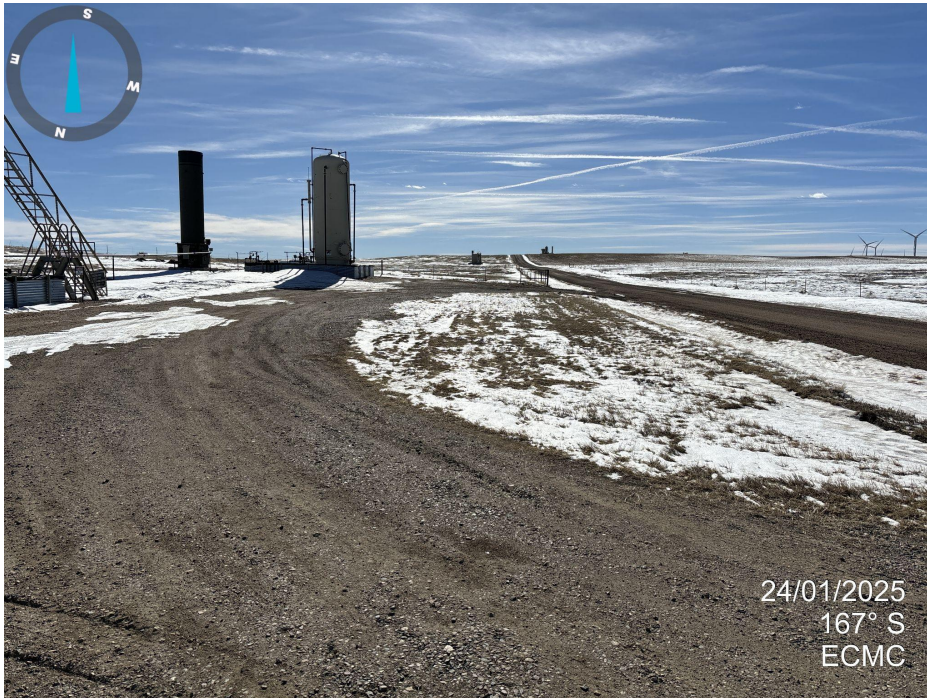
Photo 1. Photo taken looking south across the west side of location. Snow cover prevented a full vegetative assessment. At the time of inspection no noxious weeds were present.

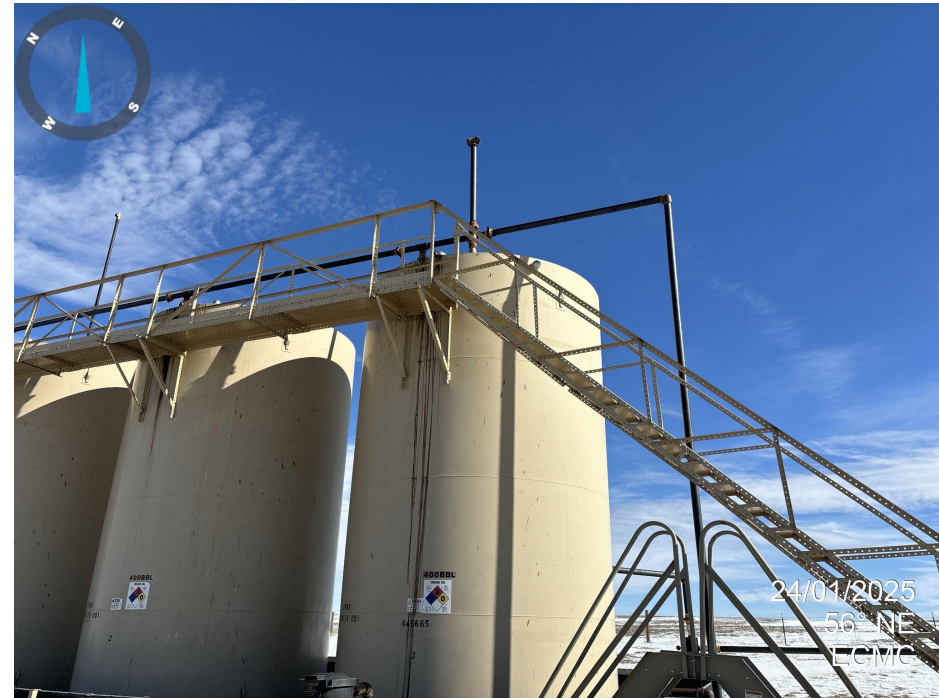
Photo 2. Looking east at tank battery. Spill from top hatch/valve.

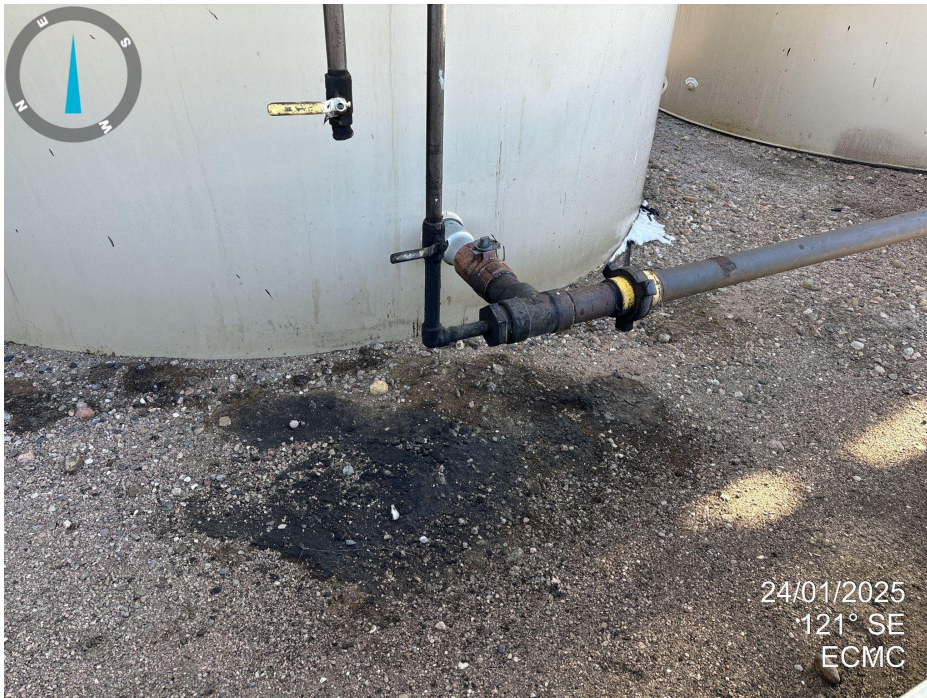
Photo 3. Looking at the west side of tank battery, northernmost crude oil tank. Stained soil beneath valves in secondary containment.

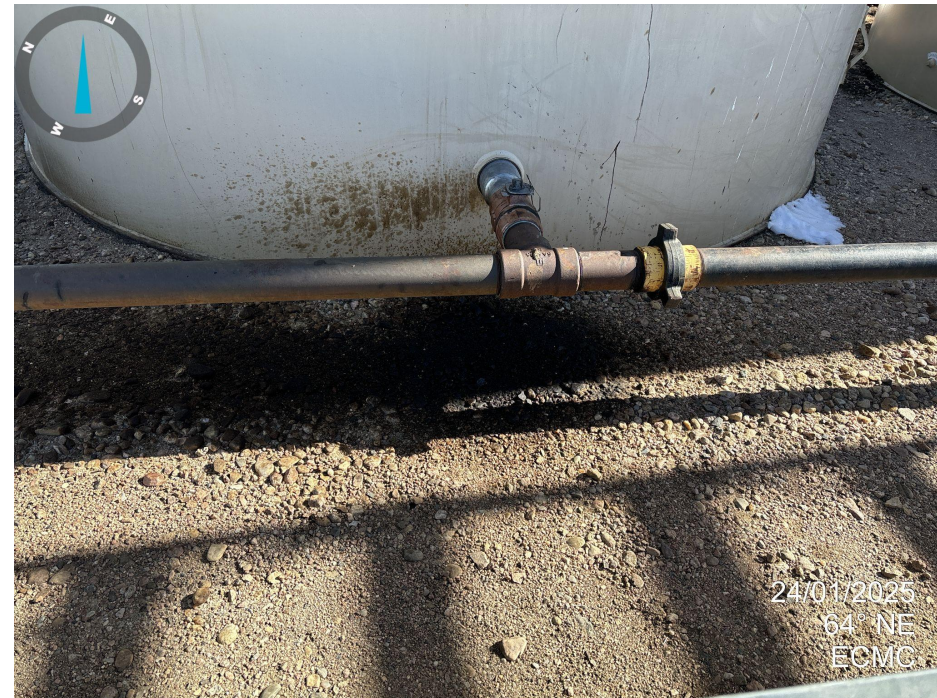
Photo 4. West side of tank battery middle crude oil tank. See photo 3 comments.

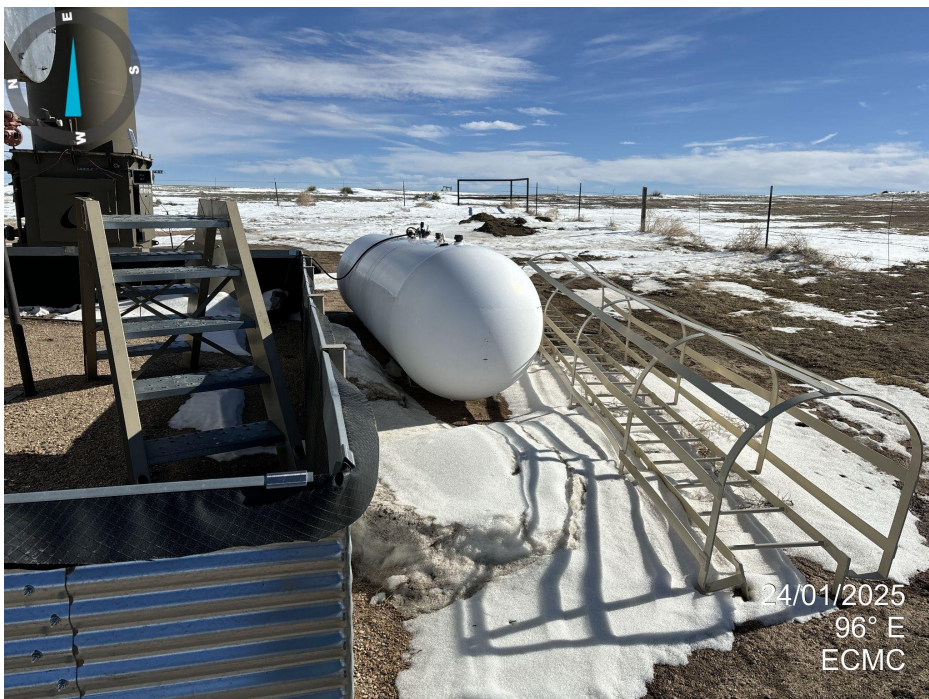
Photo 5. Picture on southern side of wellsite looking east near separator. Stairs and ladder are not installed.

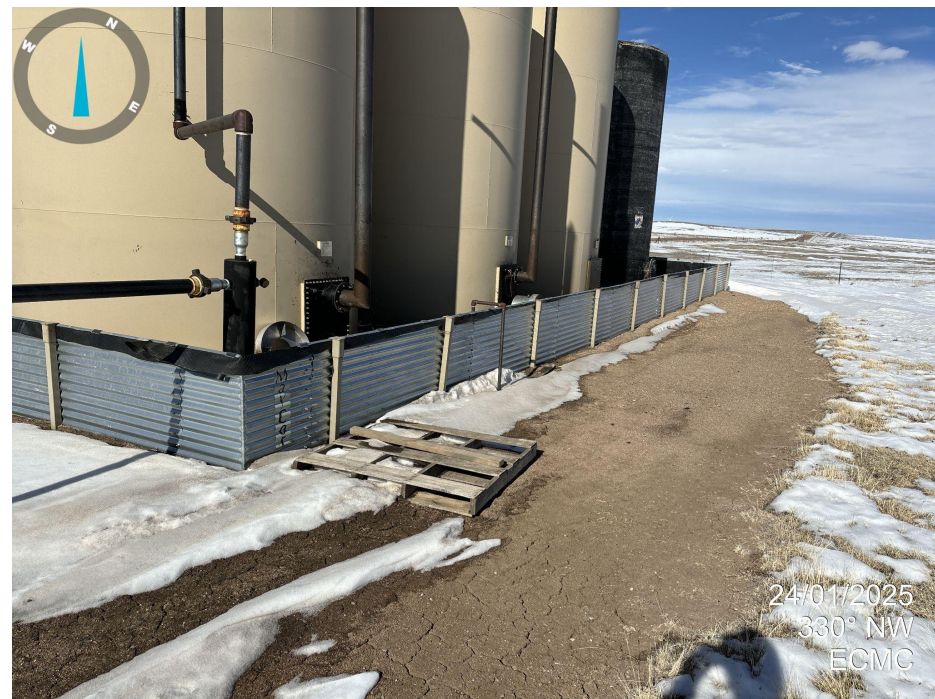
Photo 6. Pallet behind tank battery.

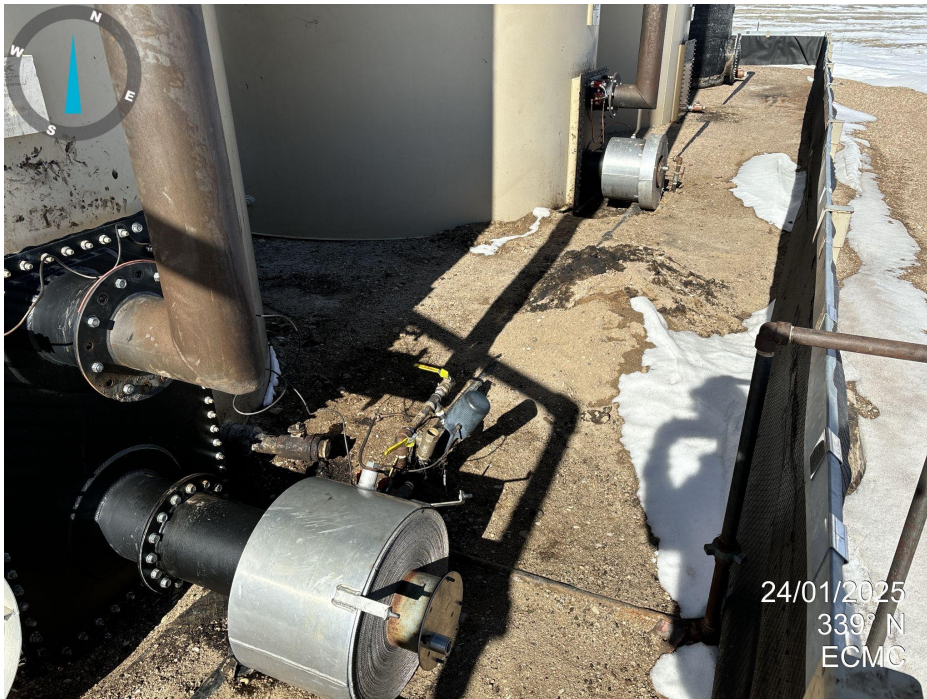
Photo 7. Picture taken on the east side of tank battery. Stained soil is present beneath each valve and in a pile between tanks.

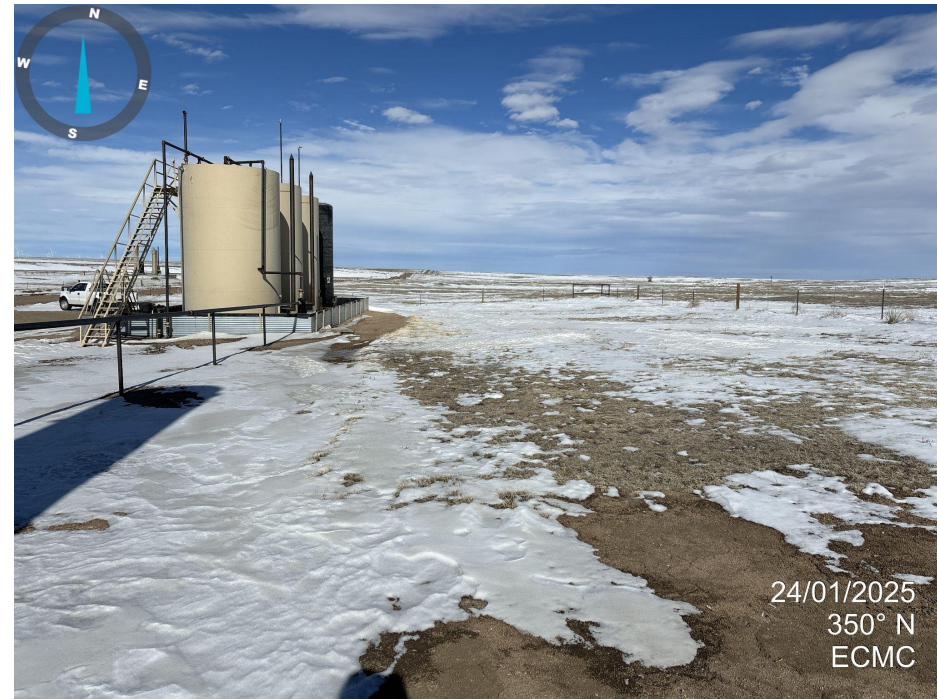
Photo 8. Looking north down the east side of the location. No noxious weeds were present at the time of inspection.
