Interim Reclamation and Stormwater Inspection

Date: 02/03/2025

Operator: WESTERN OPERATING COMPANY - 95620

Location ID: 312292

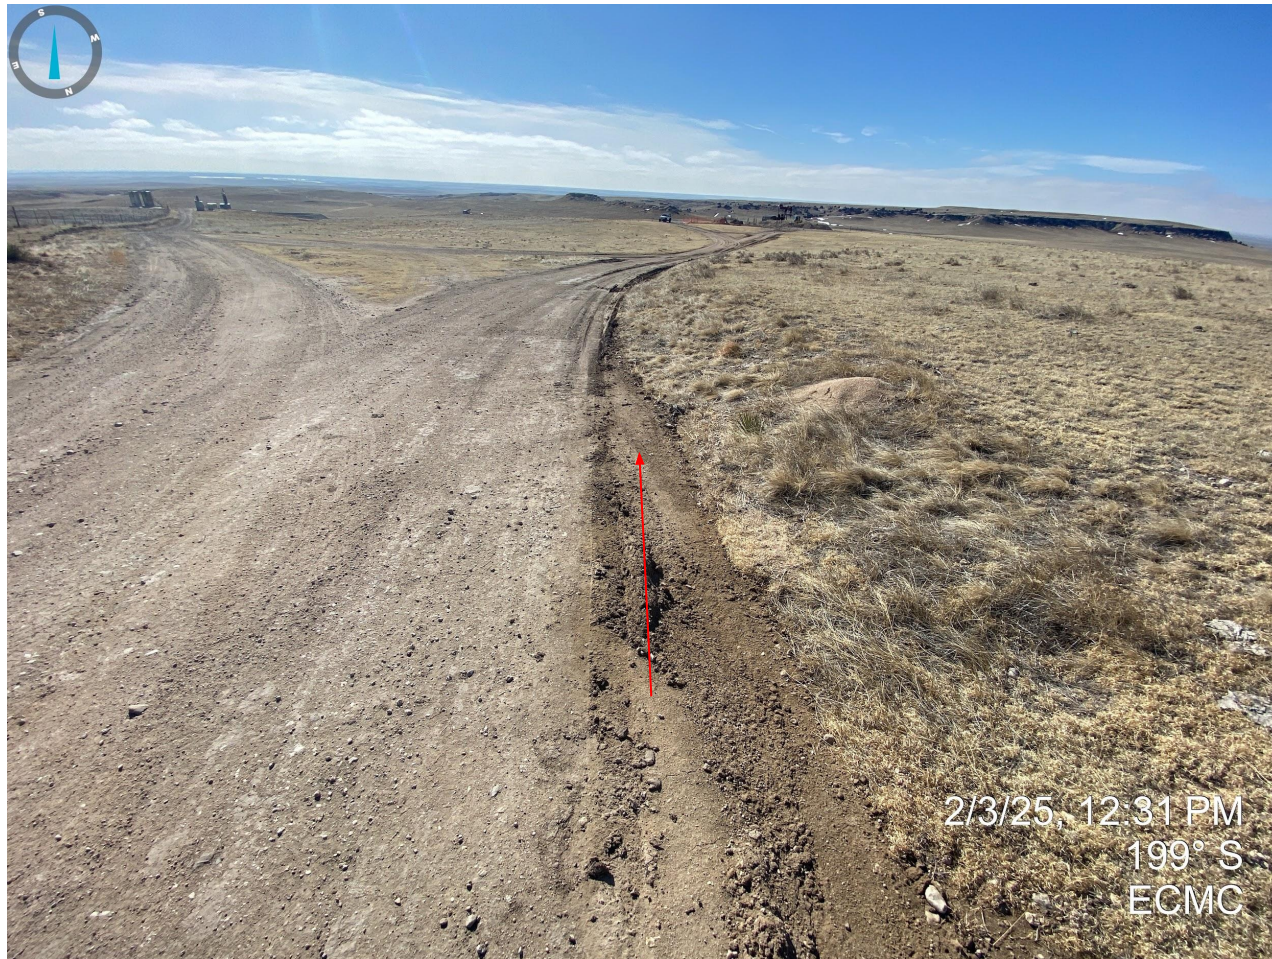
Photo 1. Erosion degradation near the location entrance appears to have been repaired.

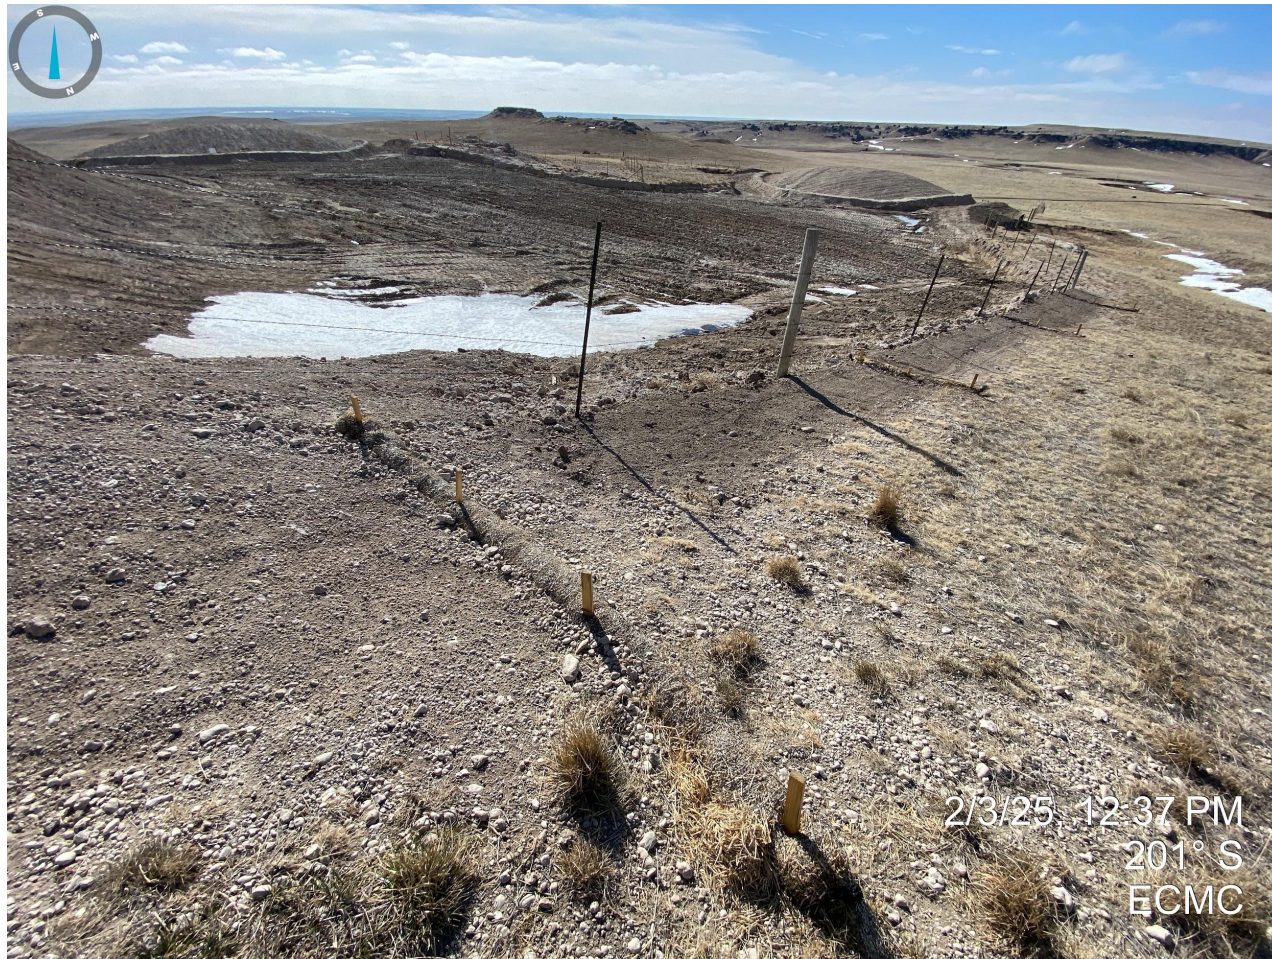
Photo 2. North side of pit. Straw wattles appear to have been installed per good engineering practices (trenched and backfilled). Additional reclamation activities are required to stabilize the bare/exposed soils.

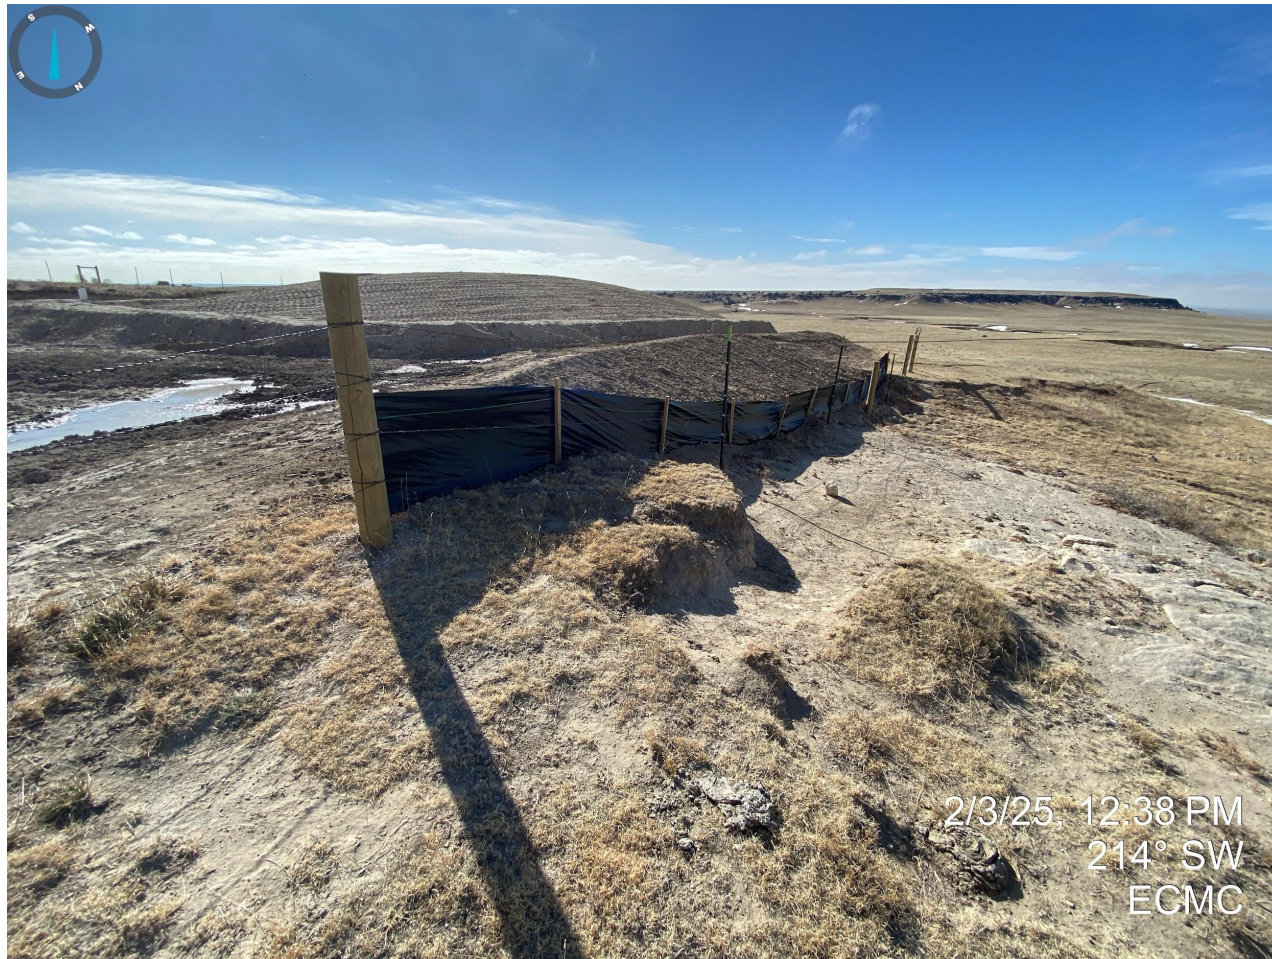
Photo 3. Additional stormwater and erosion control BMPs (silt fence) appear to have been implemented on the north/west side of the pit near the adjacent drainage.

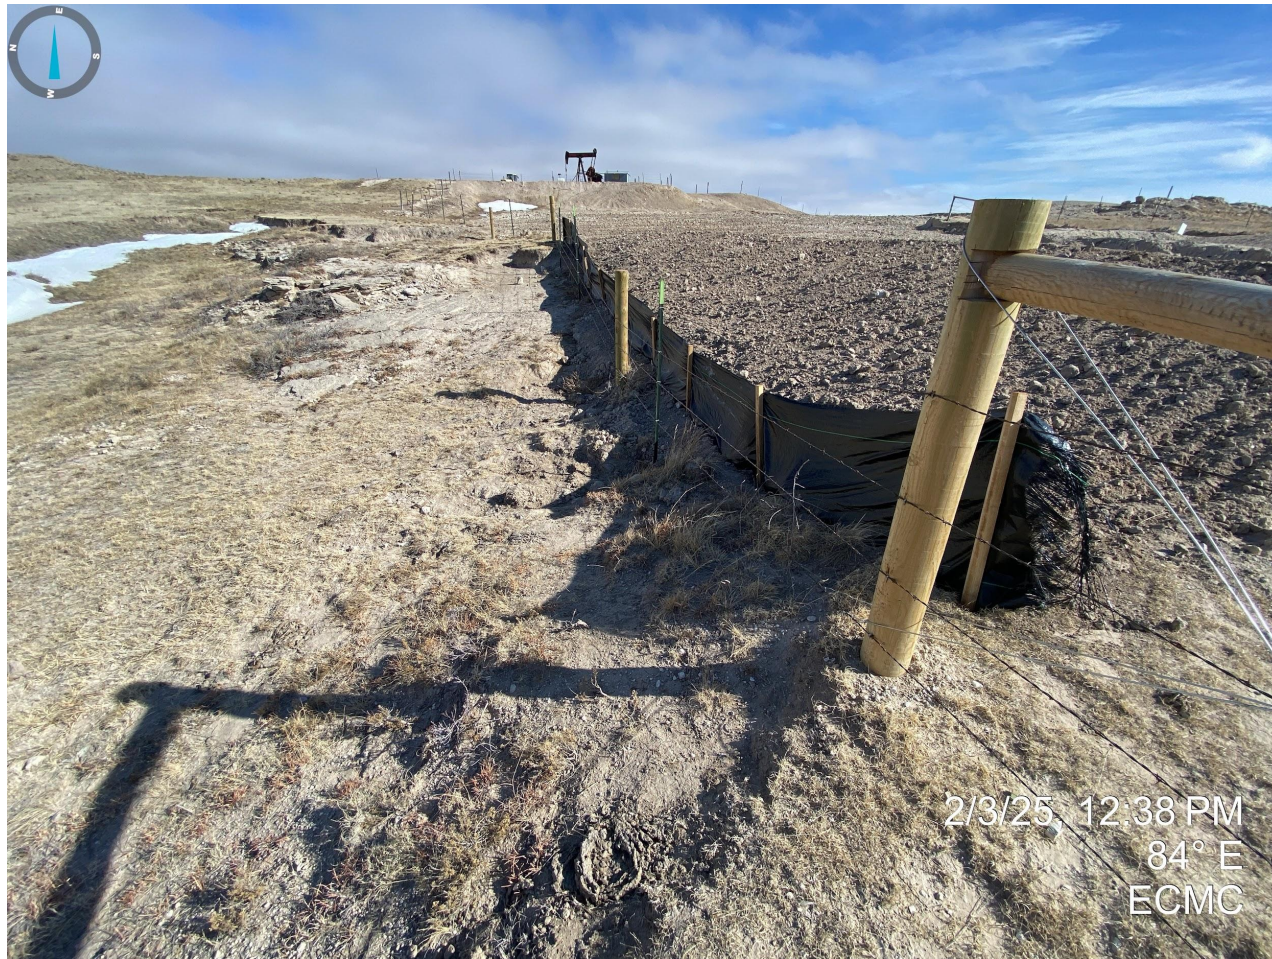
Photo 4. Continued from Photo 3; facing east.

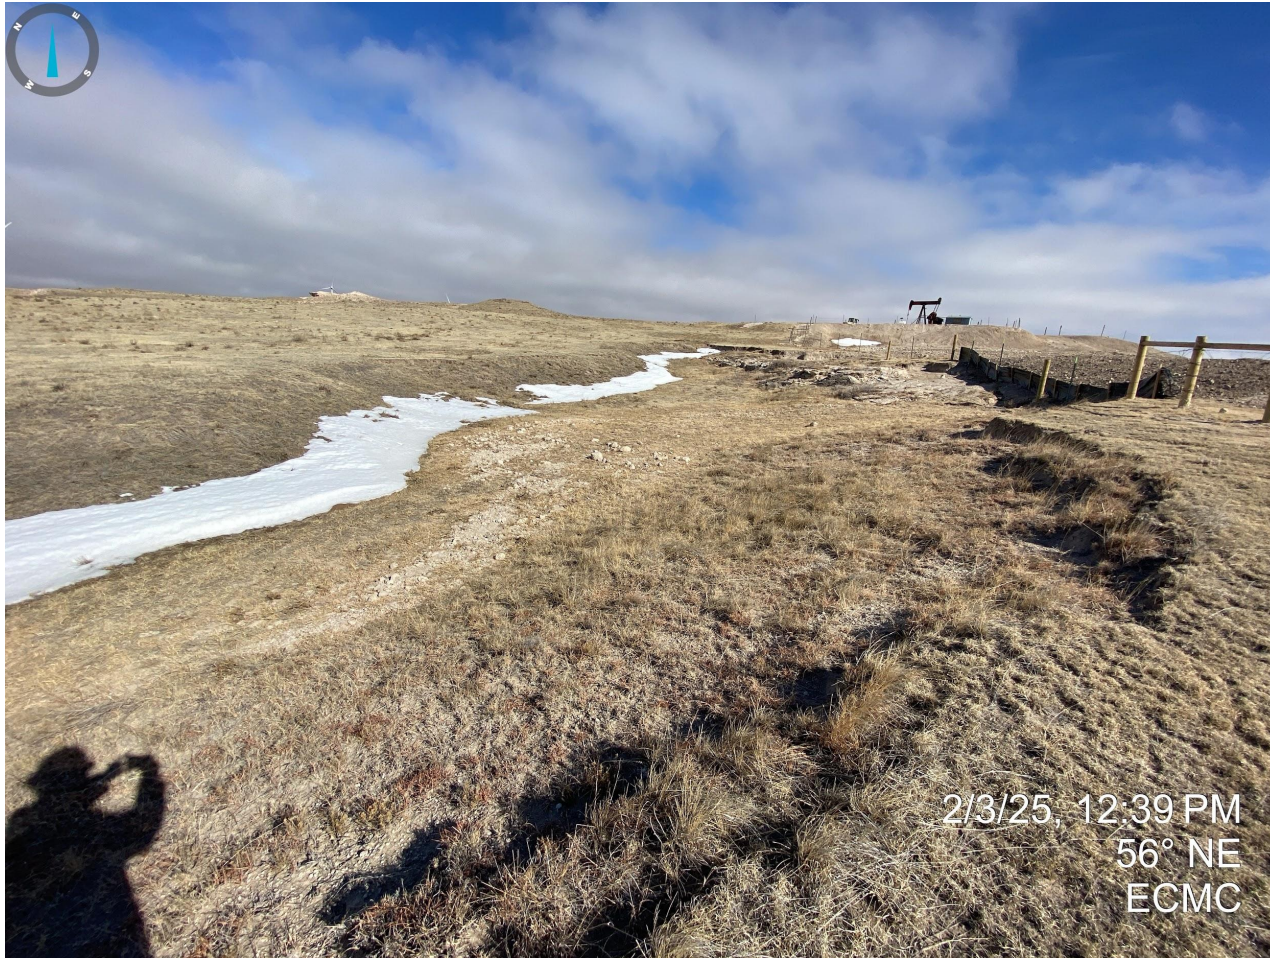
Photo 5. Overview of the adjacent drainage where off location sediment discharge from the pit excavation.

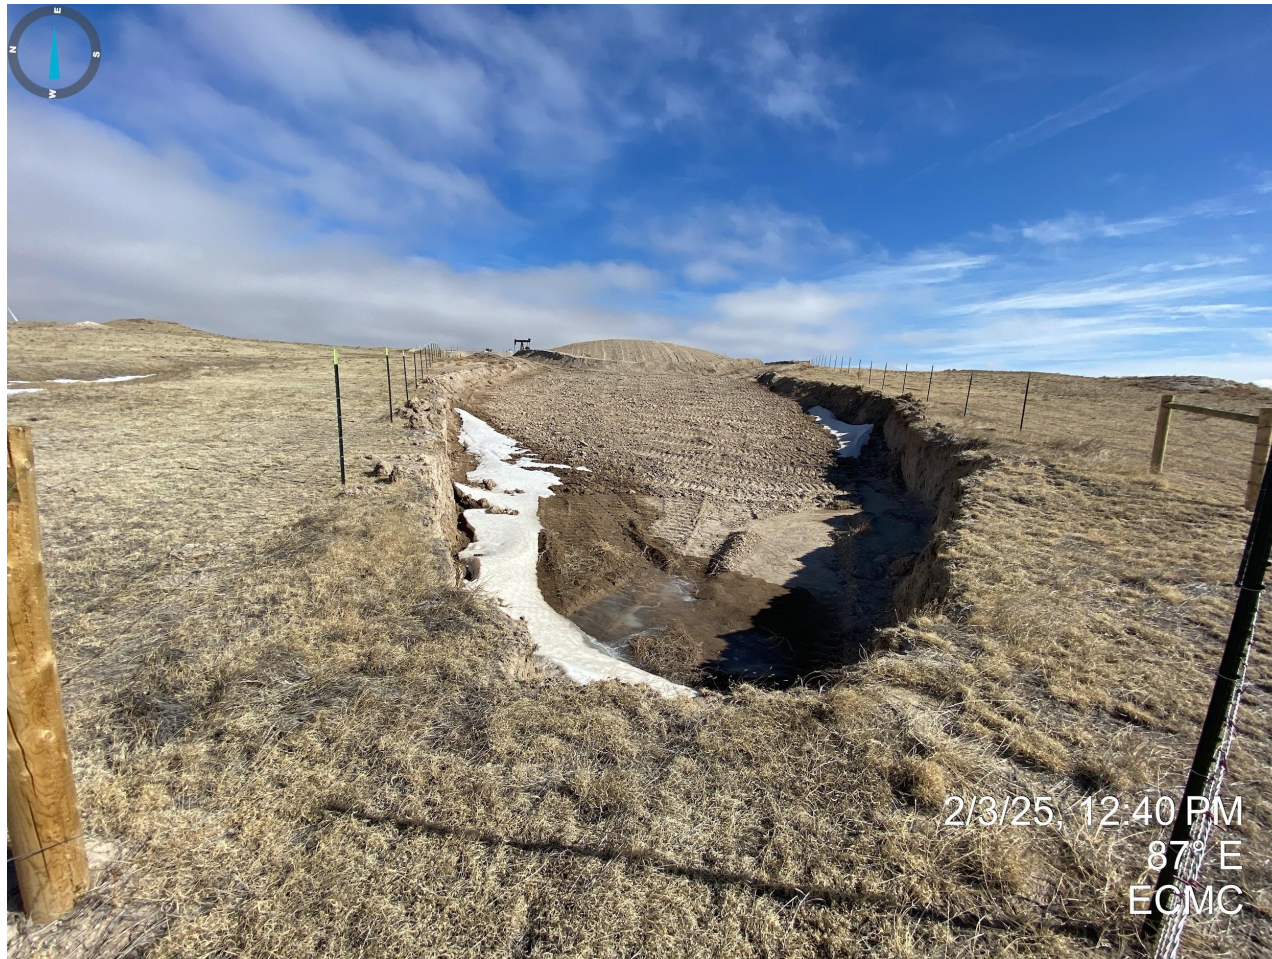
Photo 6. Western extent of excavation. It appears that stockpile (background) has been equipment tracked for short term stabilization and the excavation has been roughened. Undesirable vegetation previously documented appears to have been removed.

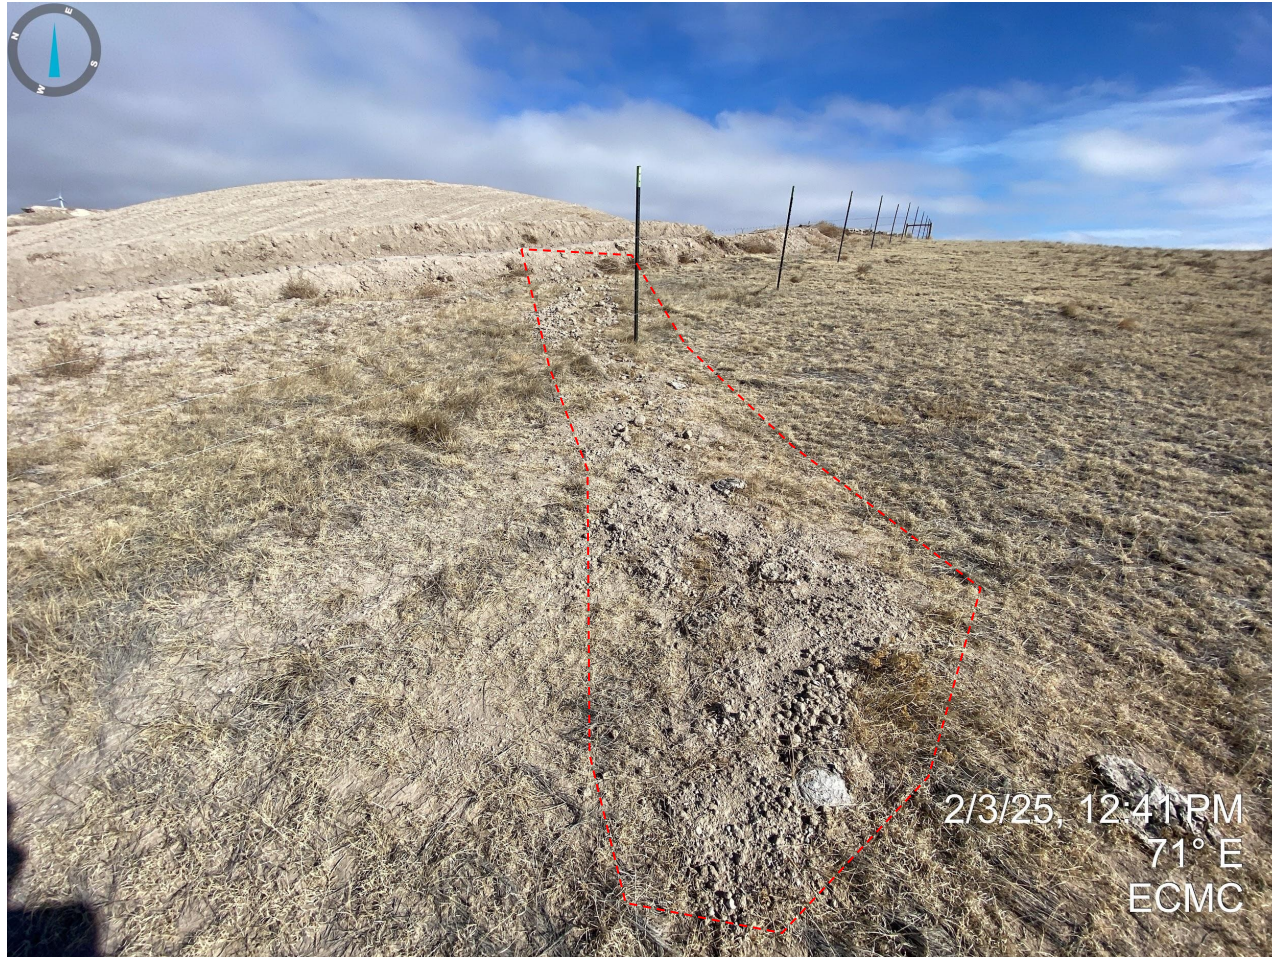
Photo 7. Southern portion of the western excavation/stockpile. Evidence of sediment discharge into the adjacent lands. Stormwater control measures do not appear to be adequate.

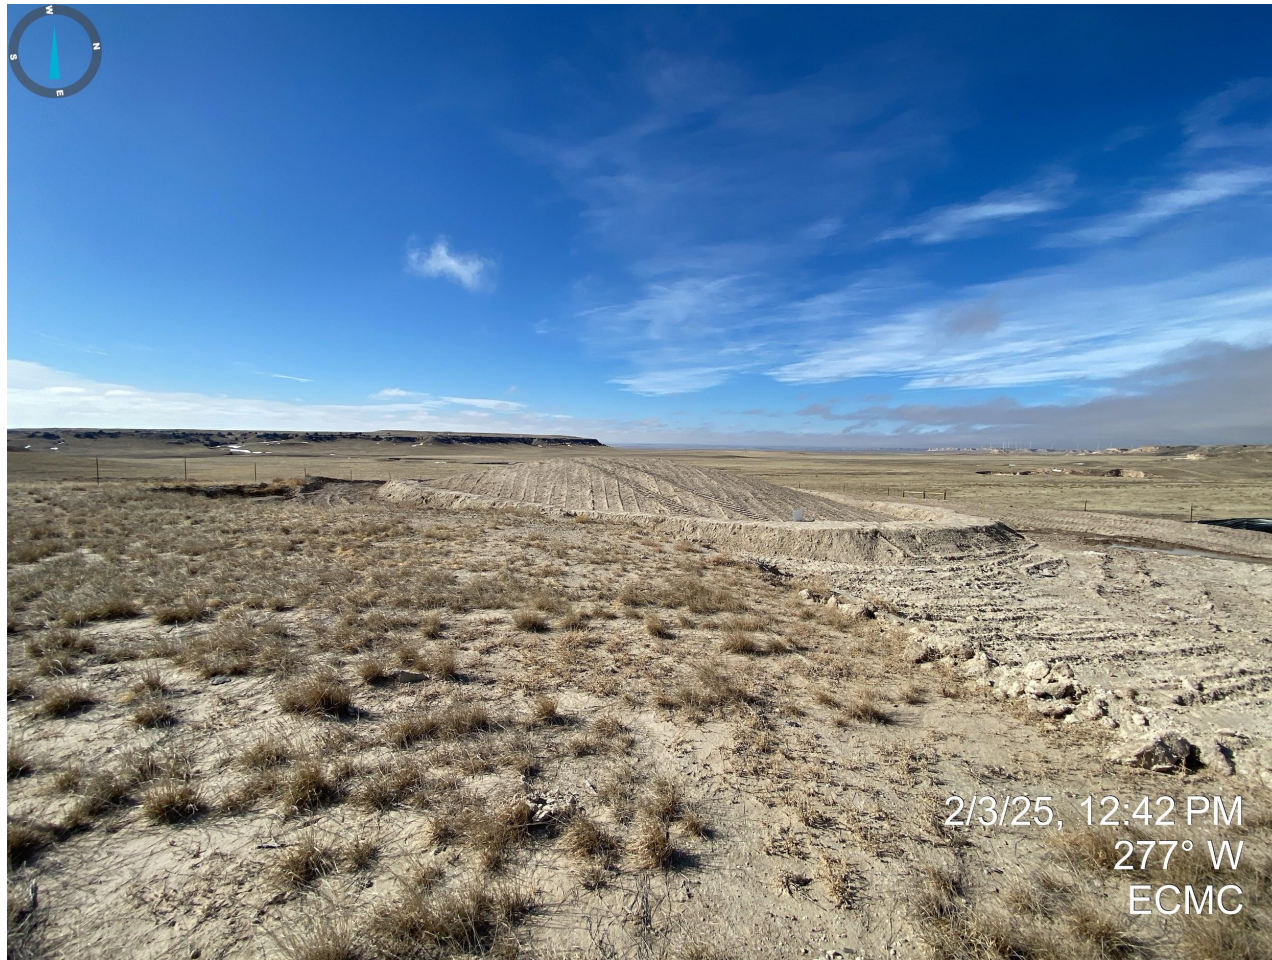
Photo 8. Photo taken between the two stockpiles, south side of pit excavation. Additional reclamation activities are required to stabilize areas experiencing bare soil and/or non-uniform vegetation cover.

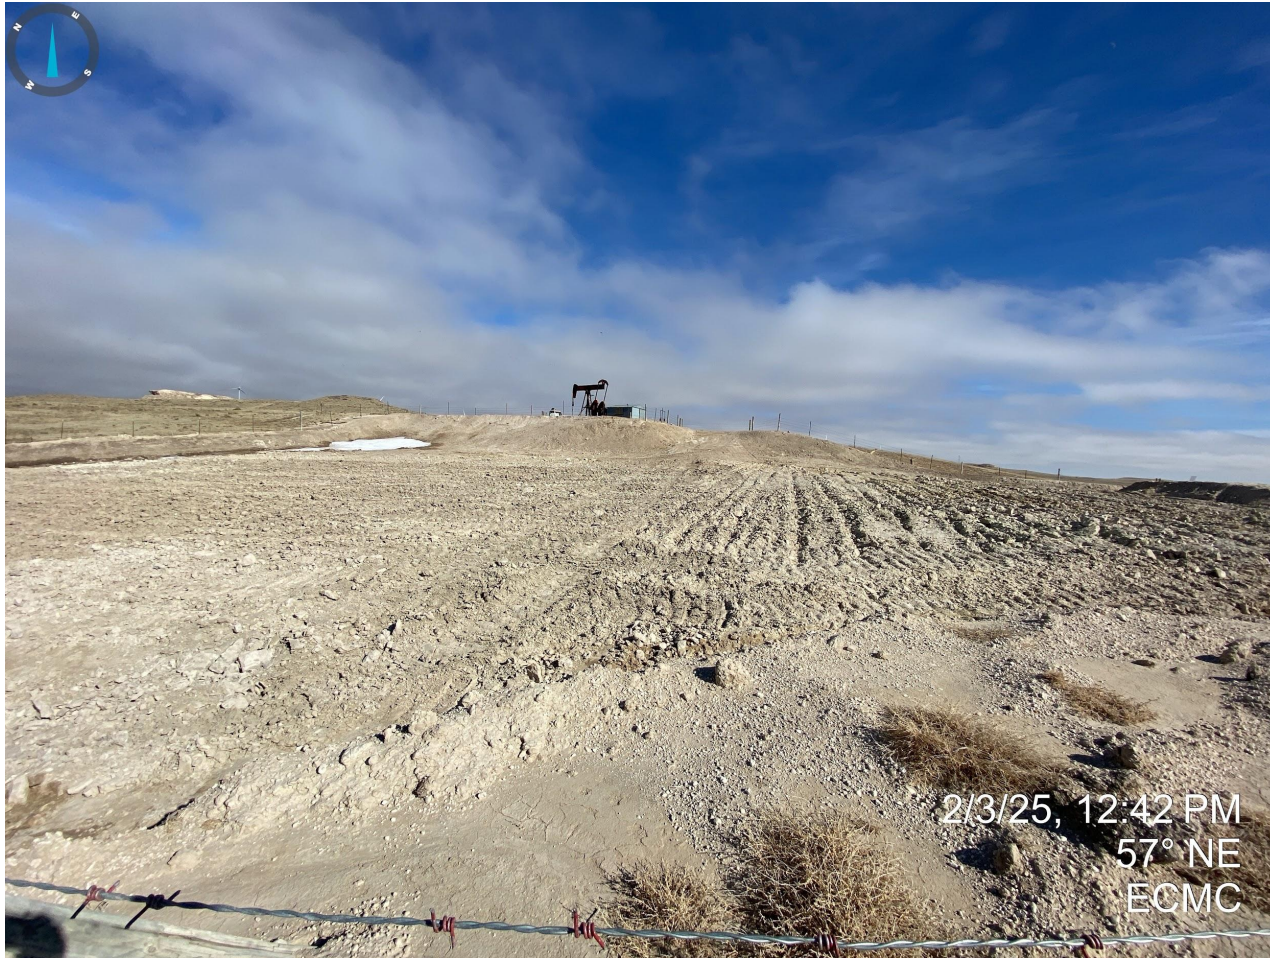
Photo 9. Overview of pit excavation/salt kill area.

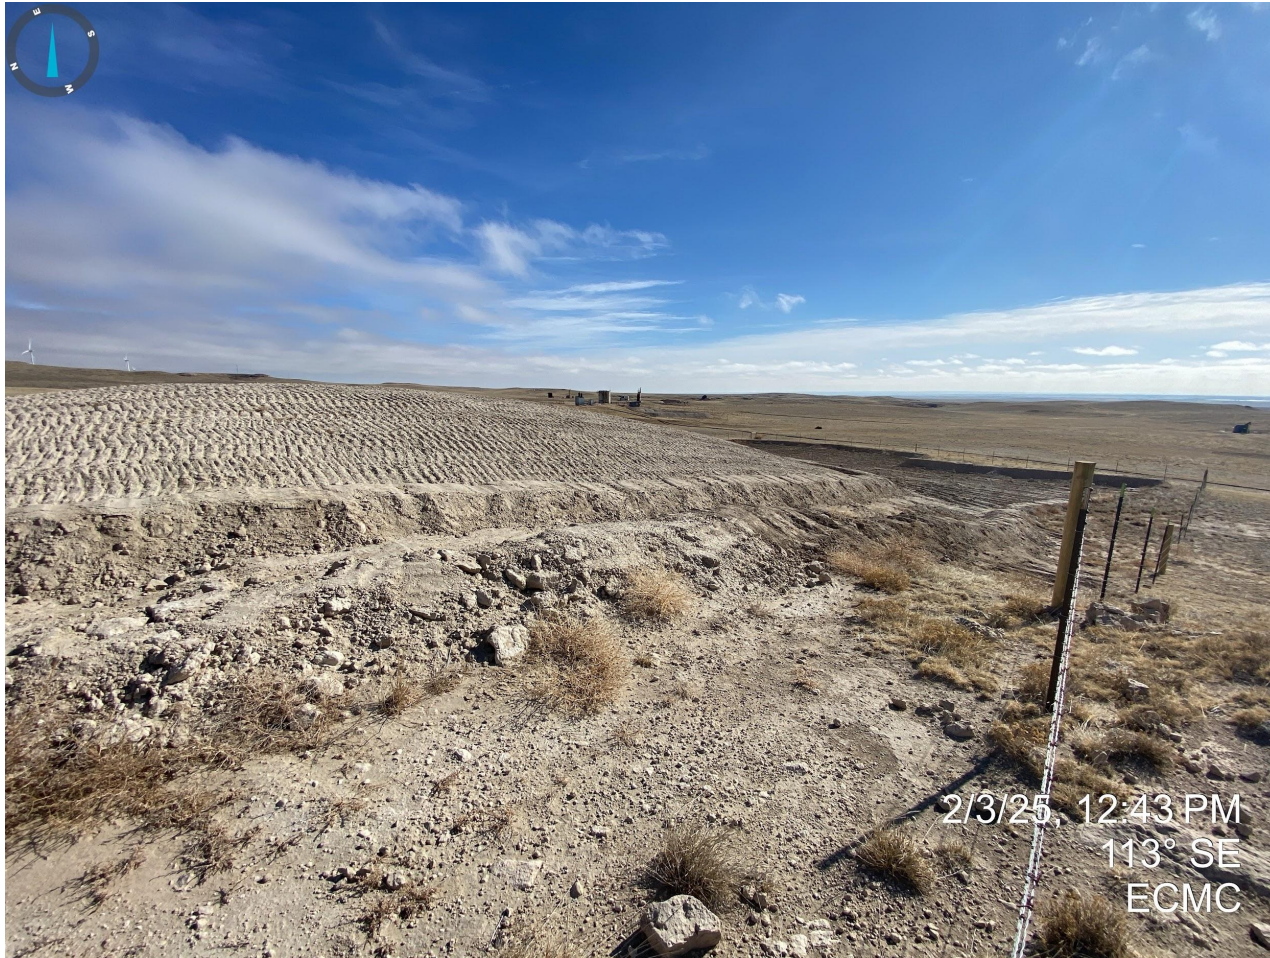
Photo 10. Southern/eastern salt kill excavation. It appears that a berm has been constructed around the stockpile, which has been equipment tracked for short term stabilization.

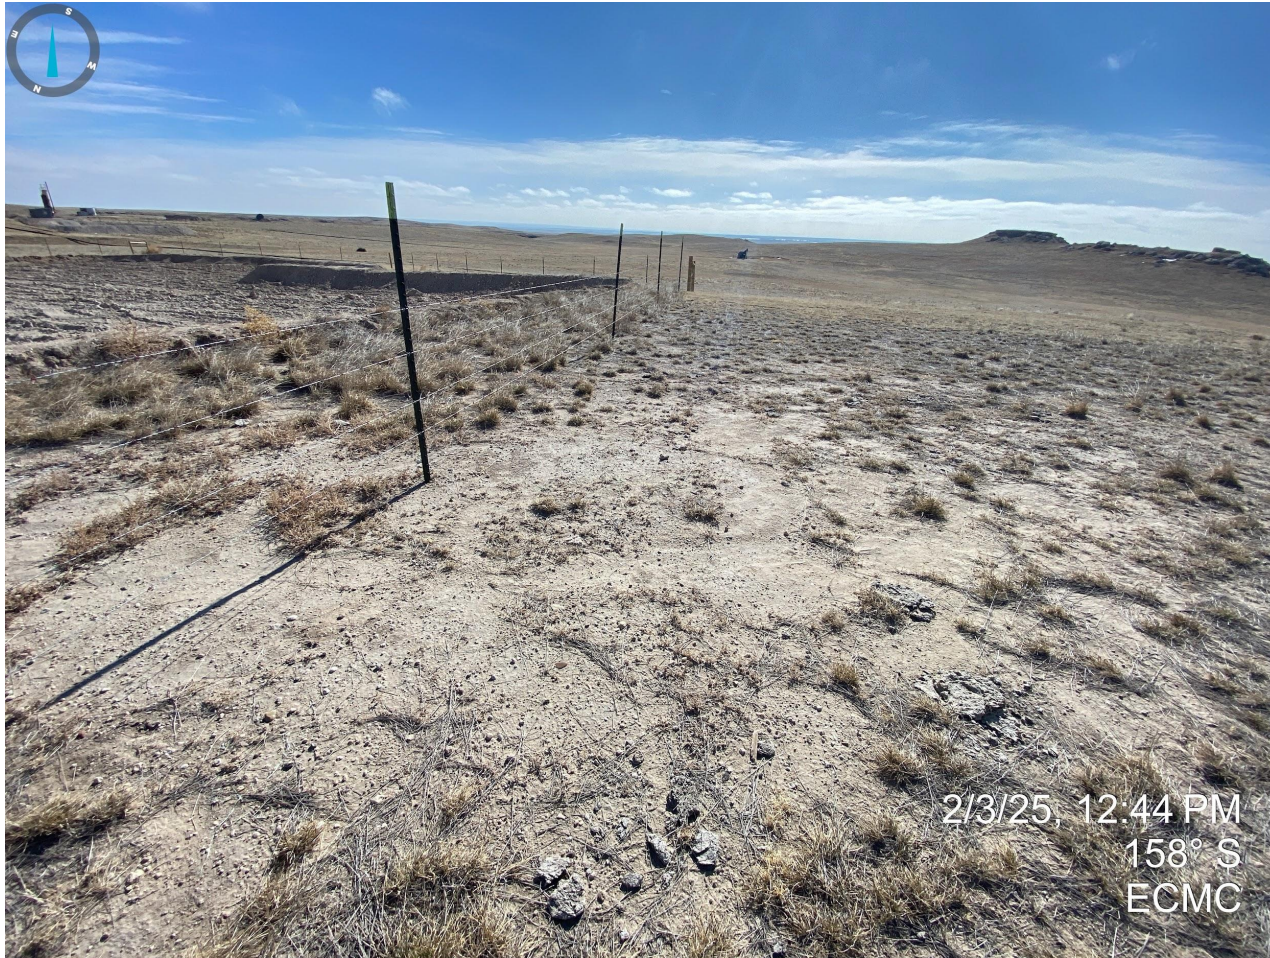
Photo 11. Southern/eastern salt kill excavation. Additional reclamation activities are required to stabilize areas experiencing bare soil and/or non-uniform vegetation cover.

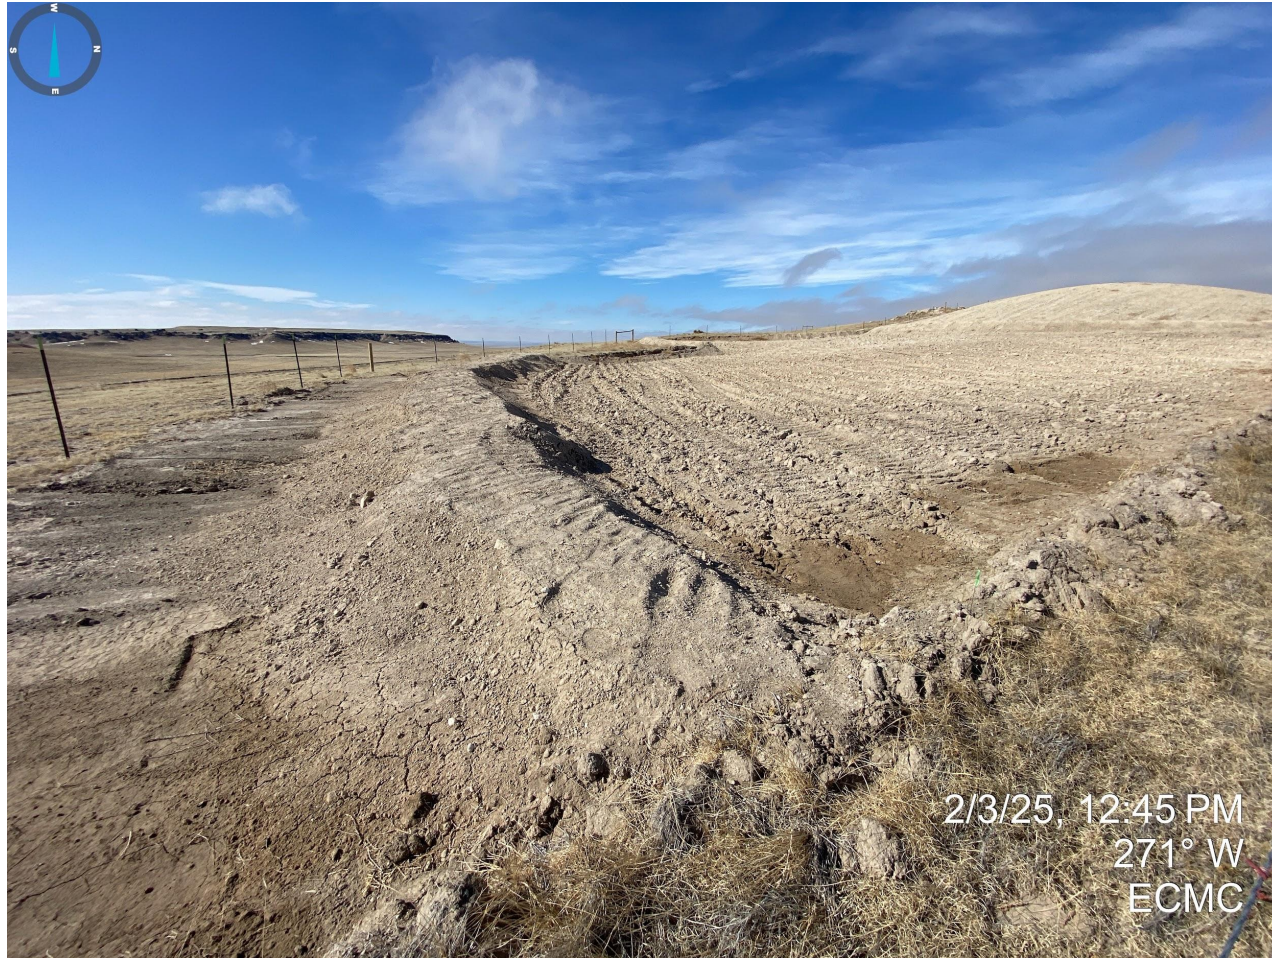
Photo 12. Southern/eastern salt kill excavation. A berm has been constructed at the southern portion of the excavation. Undesirable vegetation previously documented also appears to have been removed.

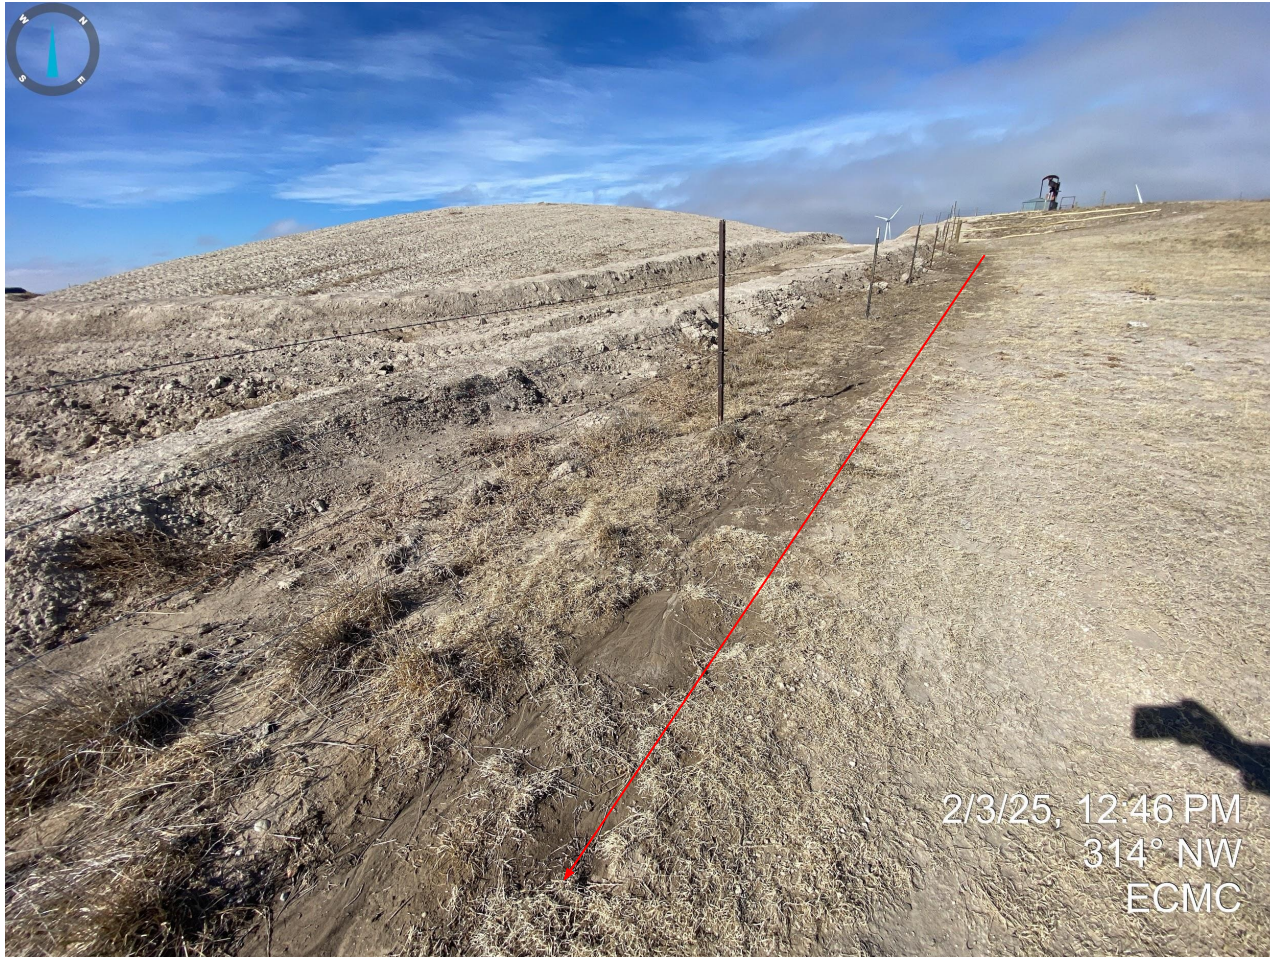
Photo 13. Southern/eastern salt kill excavation, east side. Erosion degradation from lack of proper stormwater control measures.

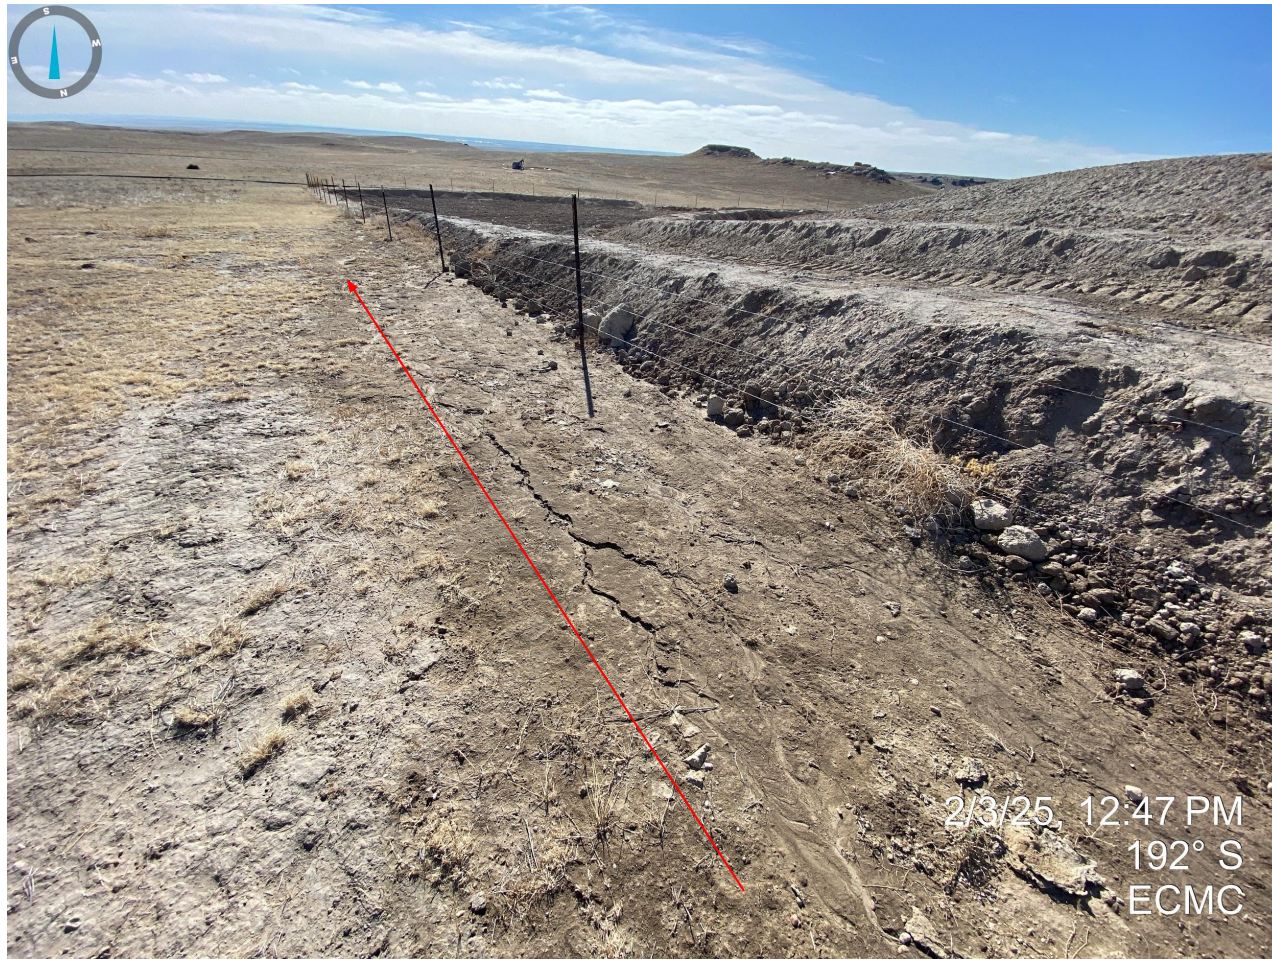
Photo 14. Continued from Photo 13, facing south.

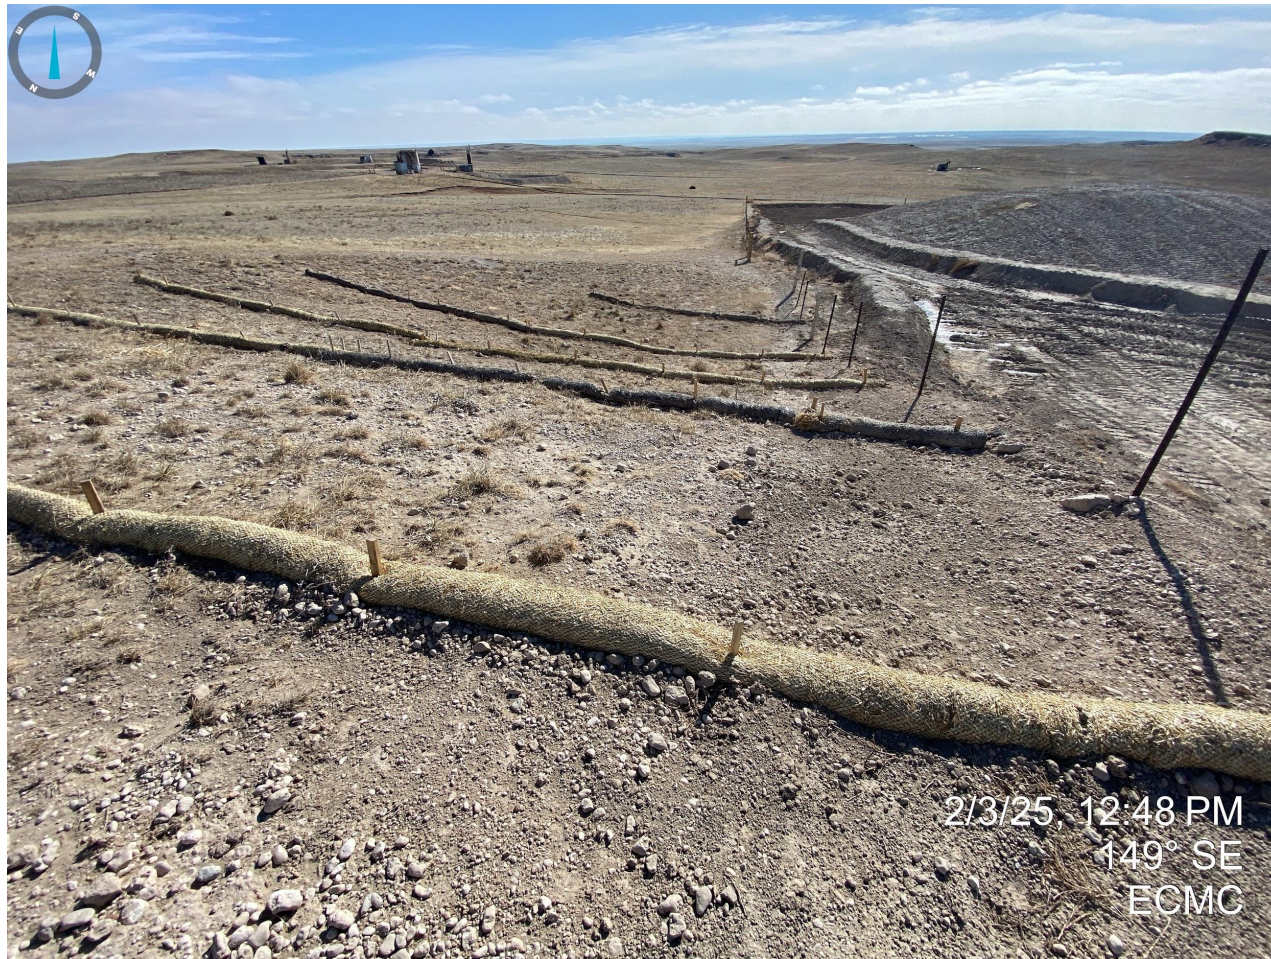
Photo 15. Eastern side of pit. It appears that erosion degradation has been repaired and stormwater control measures installed per good engineering practices. Additional reclamation activities are required to stabilize areas experiencing bare soil and/or non-uniform vegetation cover.

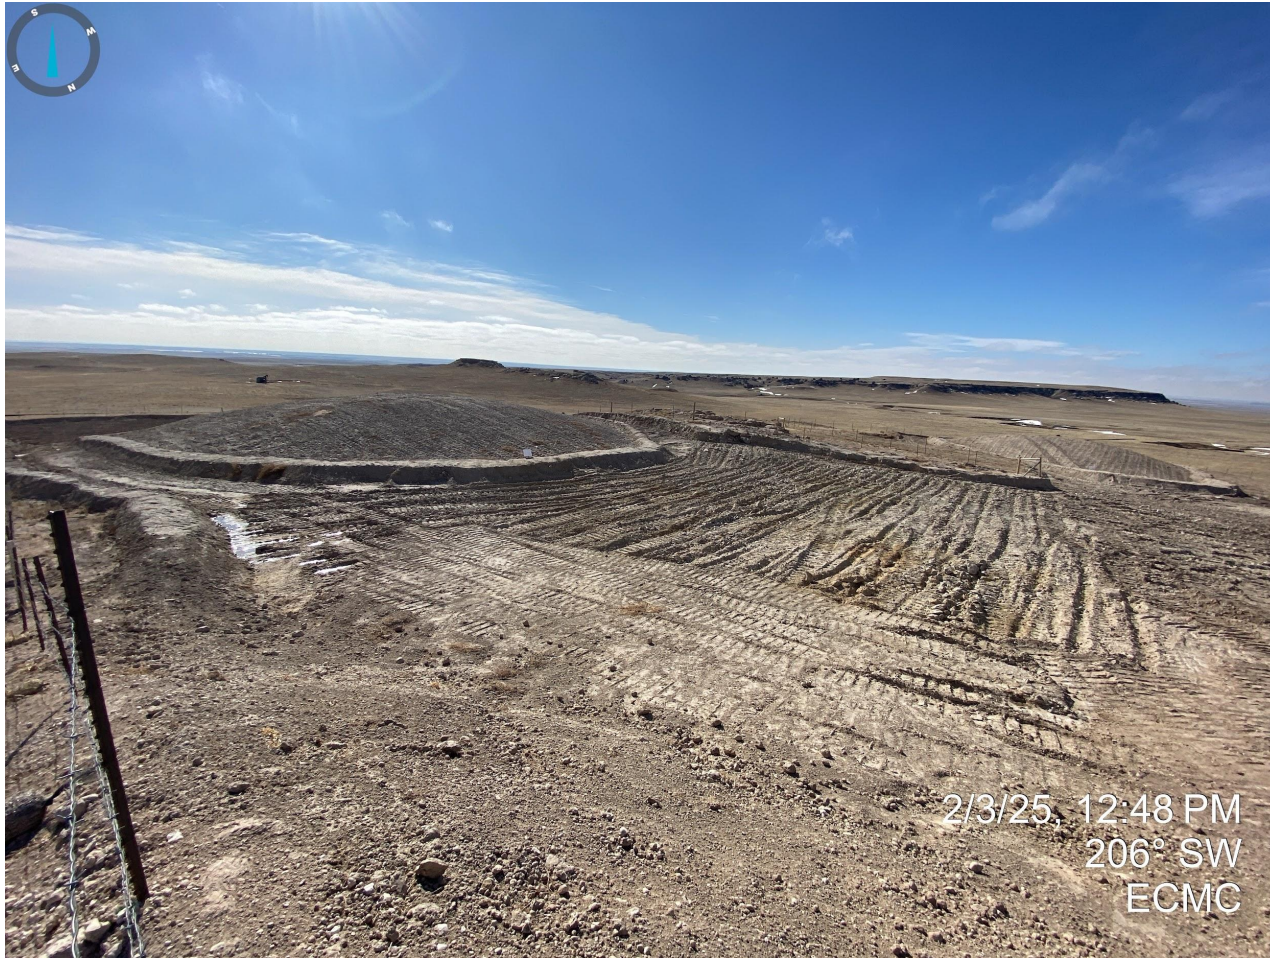
Photo 16. Overview of pit and salt kill excavation. Undesirable vegetation previously documented appears to have been removed.

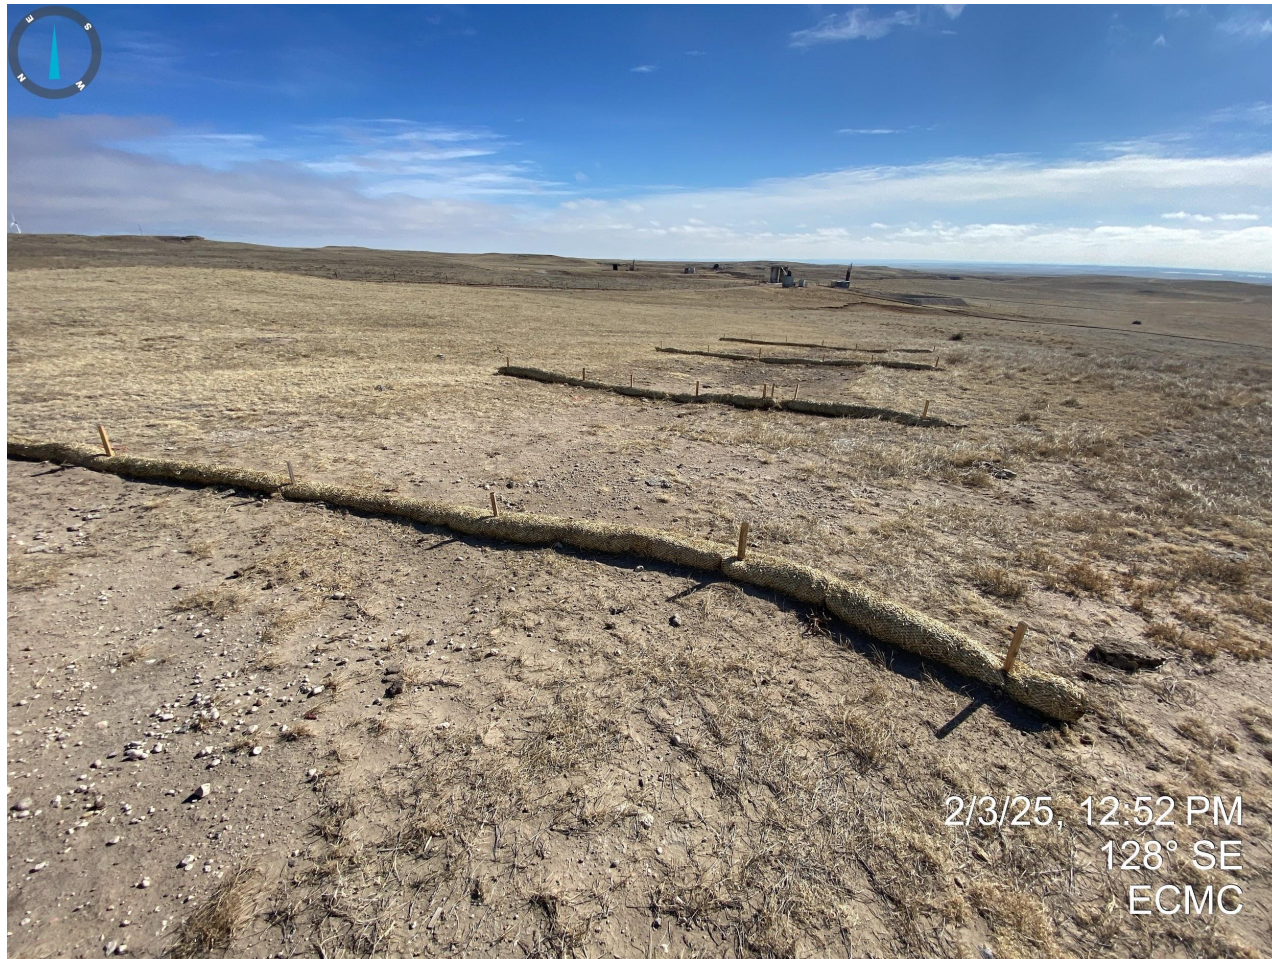
Photo 17. South of former heater treater. It appears that stormwater control measures have been installed per good engineering practices. Additional reclamation activities are required to stabilize areas experiencing bare soil and/or non-uniform vegetation cover.
