Interim Reclamation and Stormwater Inspection

Date: 02/03/2025

Operator: WESTERN OPERATING COMPANY - 95620

Location ID: 312291

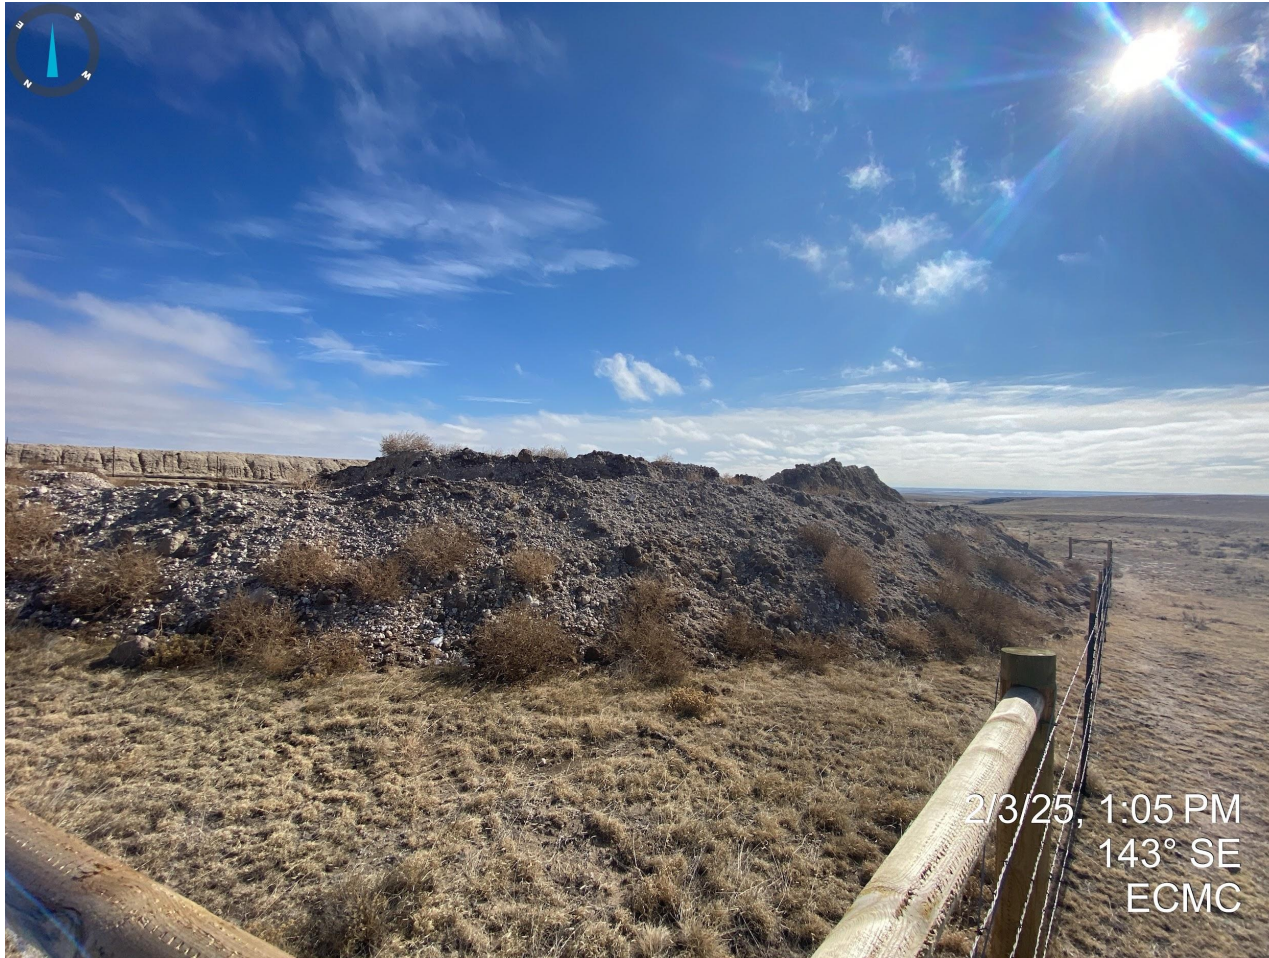
Photo 1. Taken from the north side of the stockpiled soils. No perimeter stormwater control measures/BMPs, or impermeable liners underneath the stockpile were observed. Impacted soils appear to have been placed directly on top of undisturbed lands. Additionally, it does not appear that topsoil has been salvaged Per Rule 1002.b prior to stockpiling the soil on undisturbed portions of land. Undesirable vegetation observed throughout stockpiled areas.

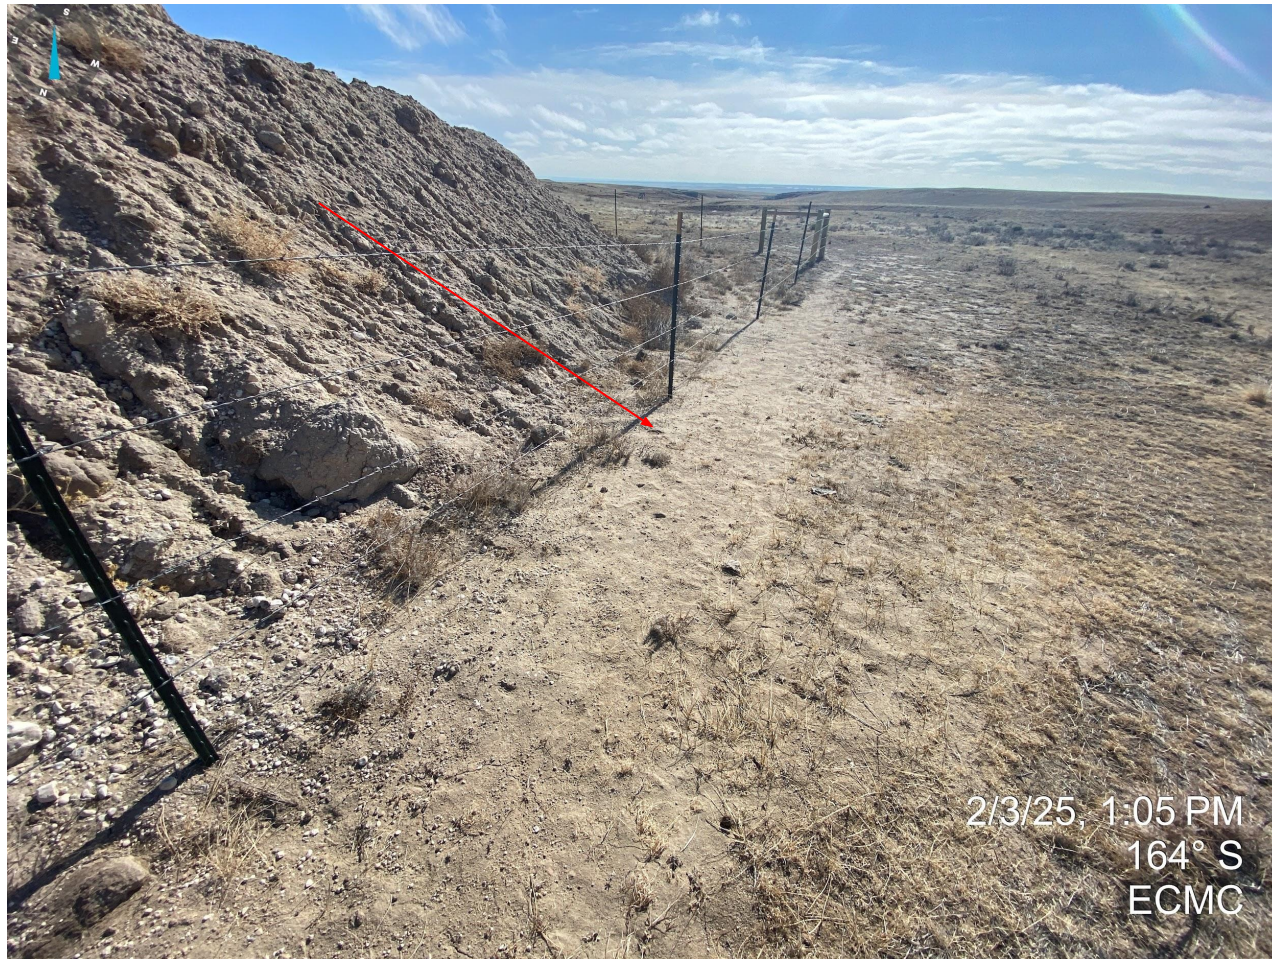
Photo 2. Continued from Photo 1; evidence of unstabilized soils (rill erosion) and sediment migration outside of the fenced portions. Undesirable vegetation (russian thistle) also observed.

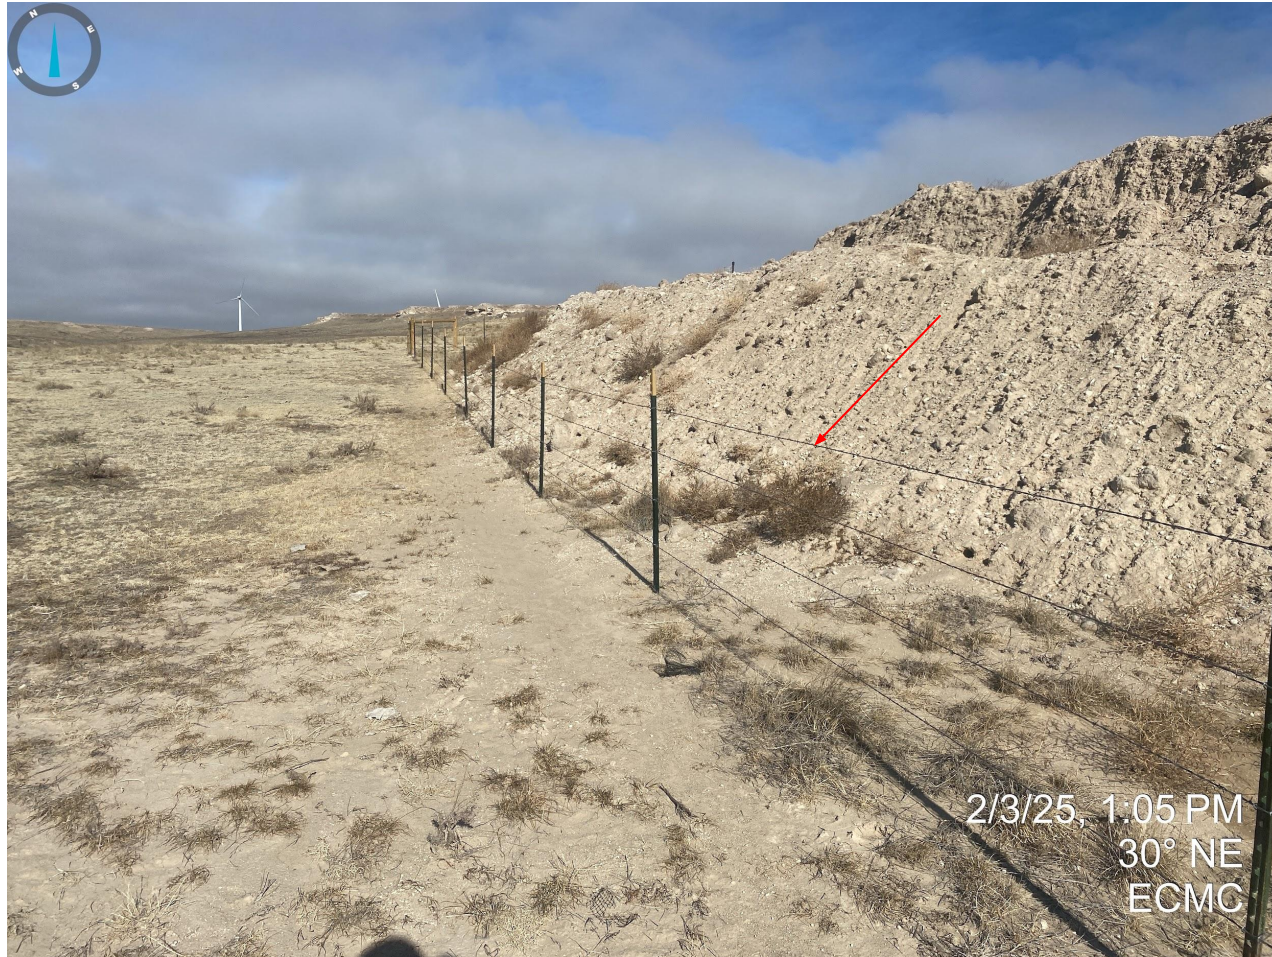
Photo 3. Continued from Photo 2; facing northeast. Evidence of unstabilized soils (rill erosion) and sediment migration outside of the fenced portions. Undesirable vegetation (russian thistle) also observed.

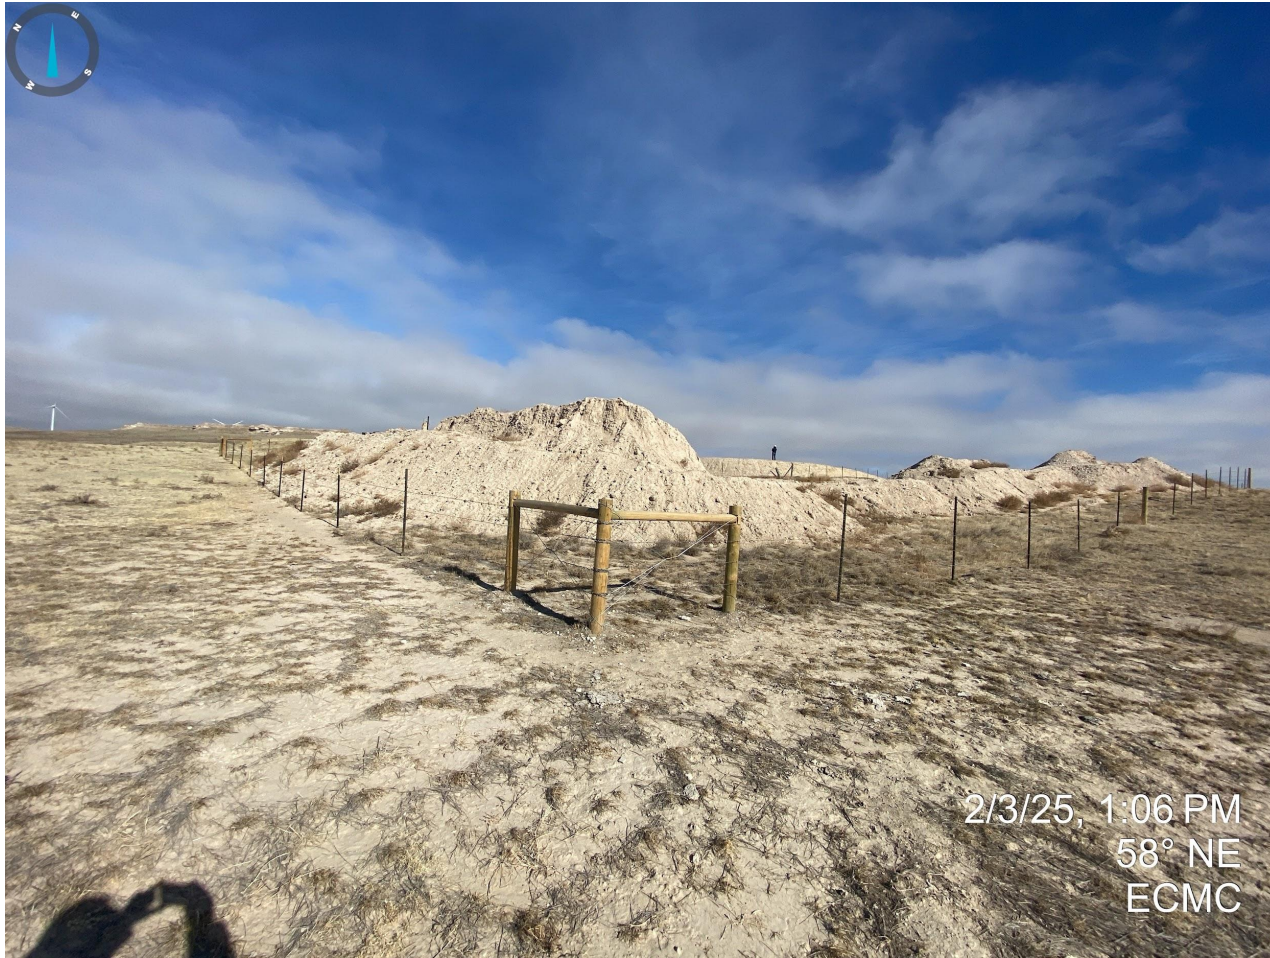
Photo 4. Sediment deposition resulting from unstabilized stockpiles, southwest corner of the pit.

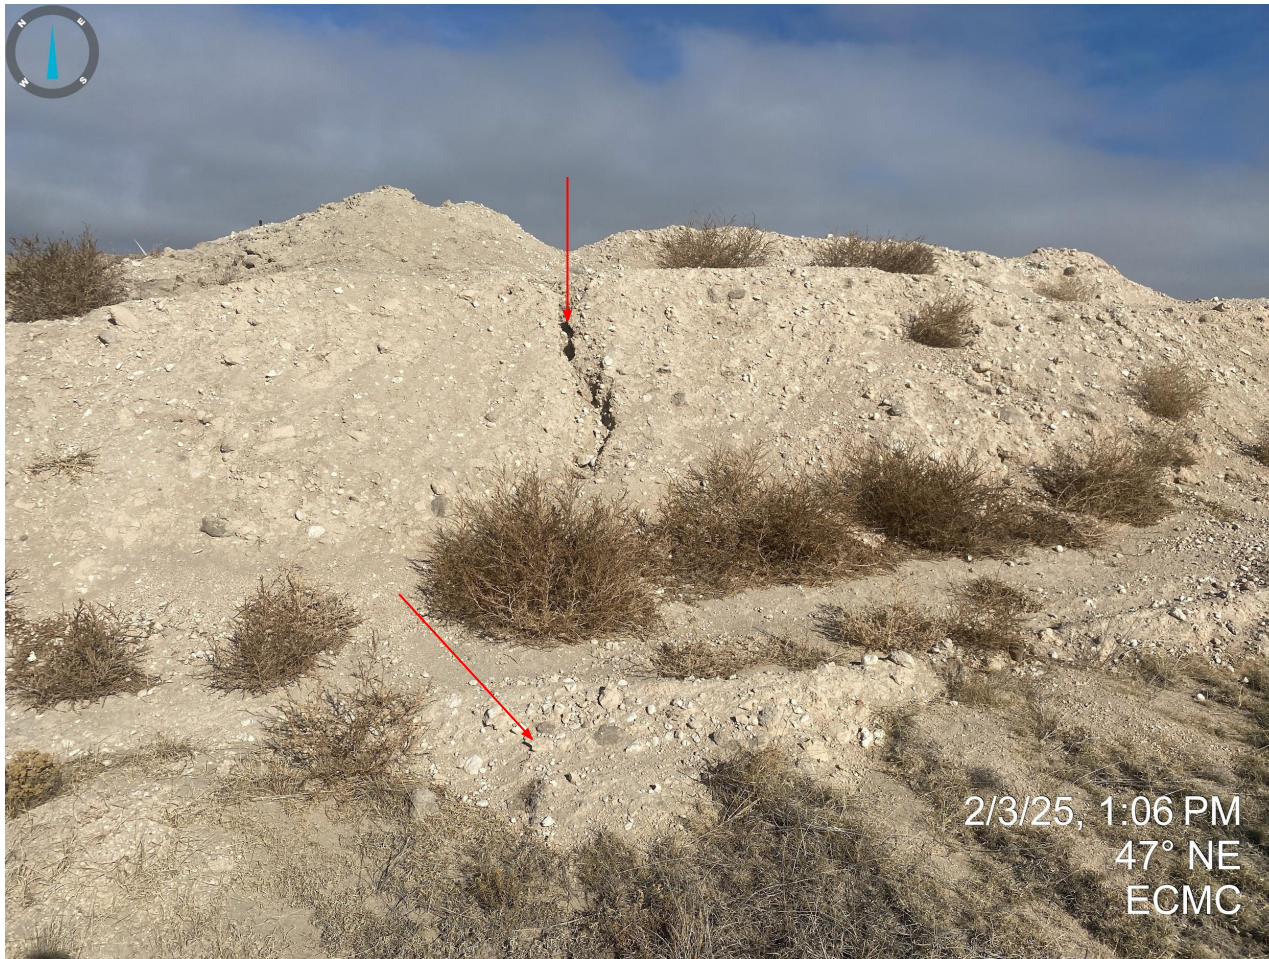
Photo 5. Evidence of erosion degradation and sediment migration from the unstabilized stockpiles. Also pictured, russian thistle/tumbleweed debris. South side of stockpiles.

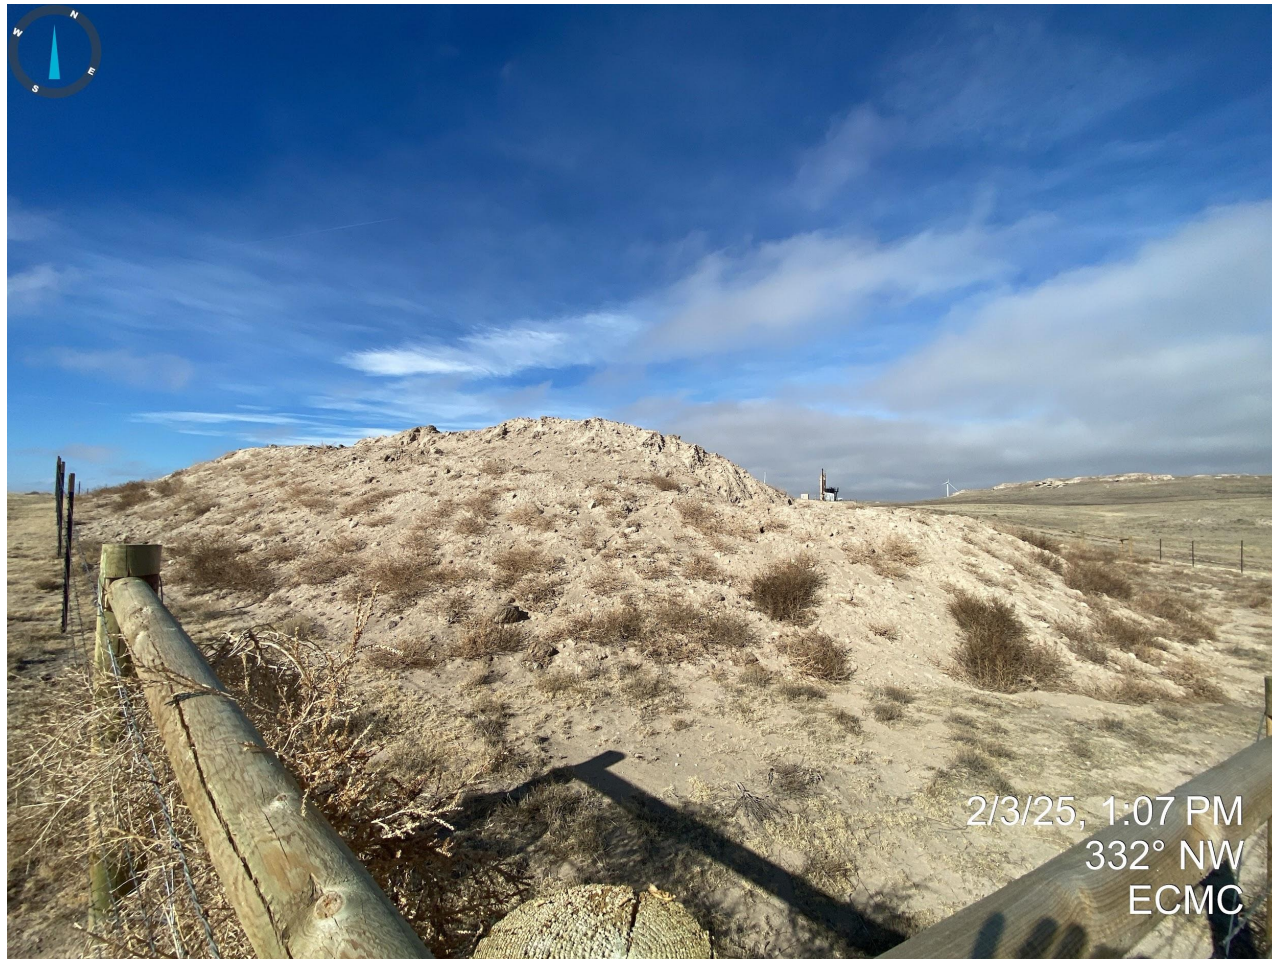
Photo 6. Taken from the southeast corner of the stockpiled material; see comments in Photo 1.

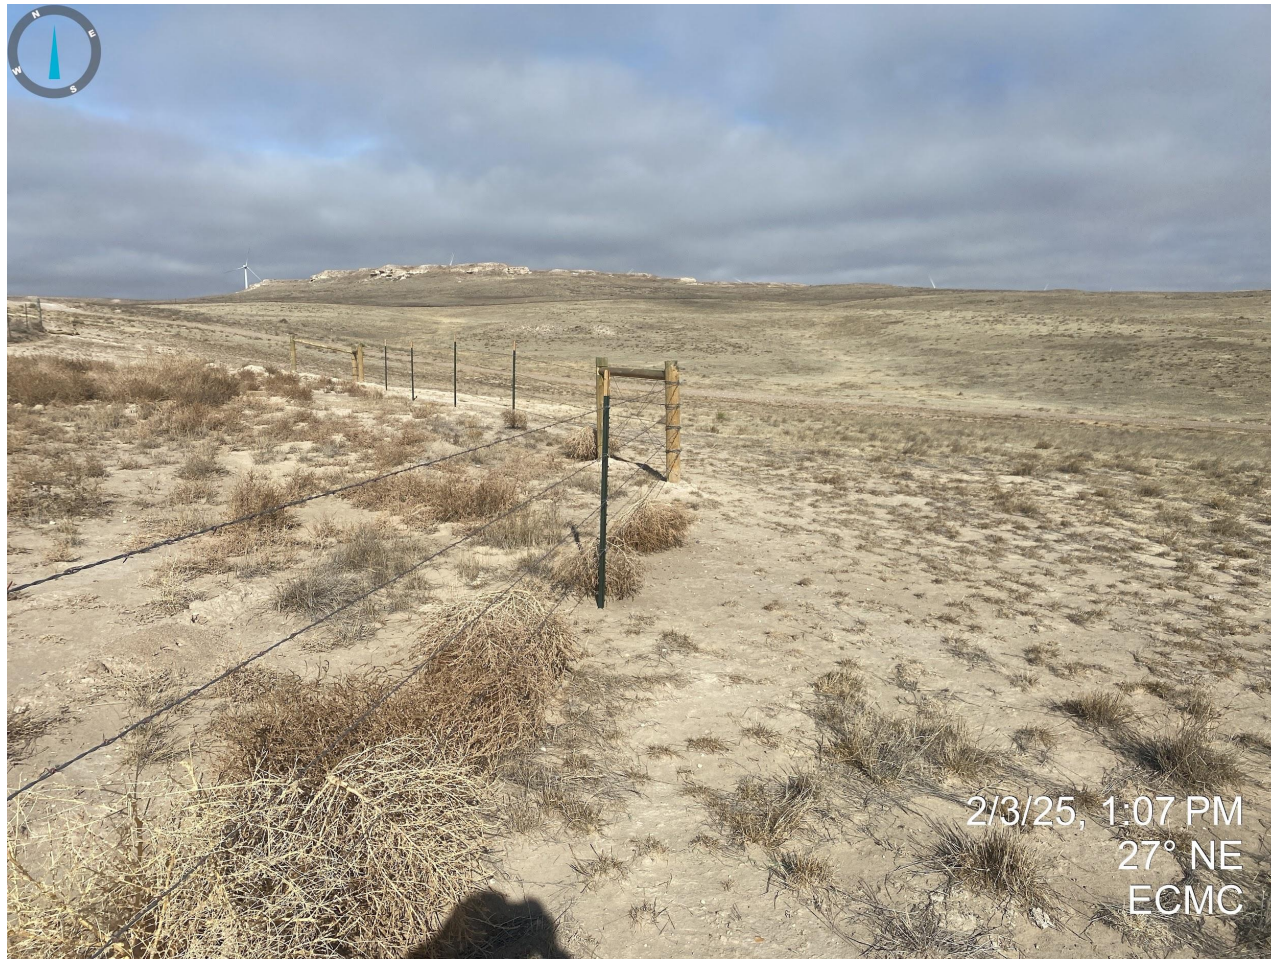
Photo 7. Taken southeast of the excavated area and stockpiled material; no apparent perimeter stormwater control measures and sediment deposition observed. Tumbleweed debris also pictured.

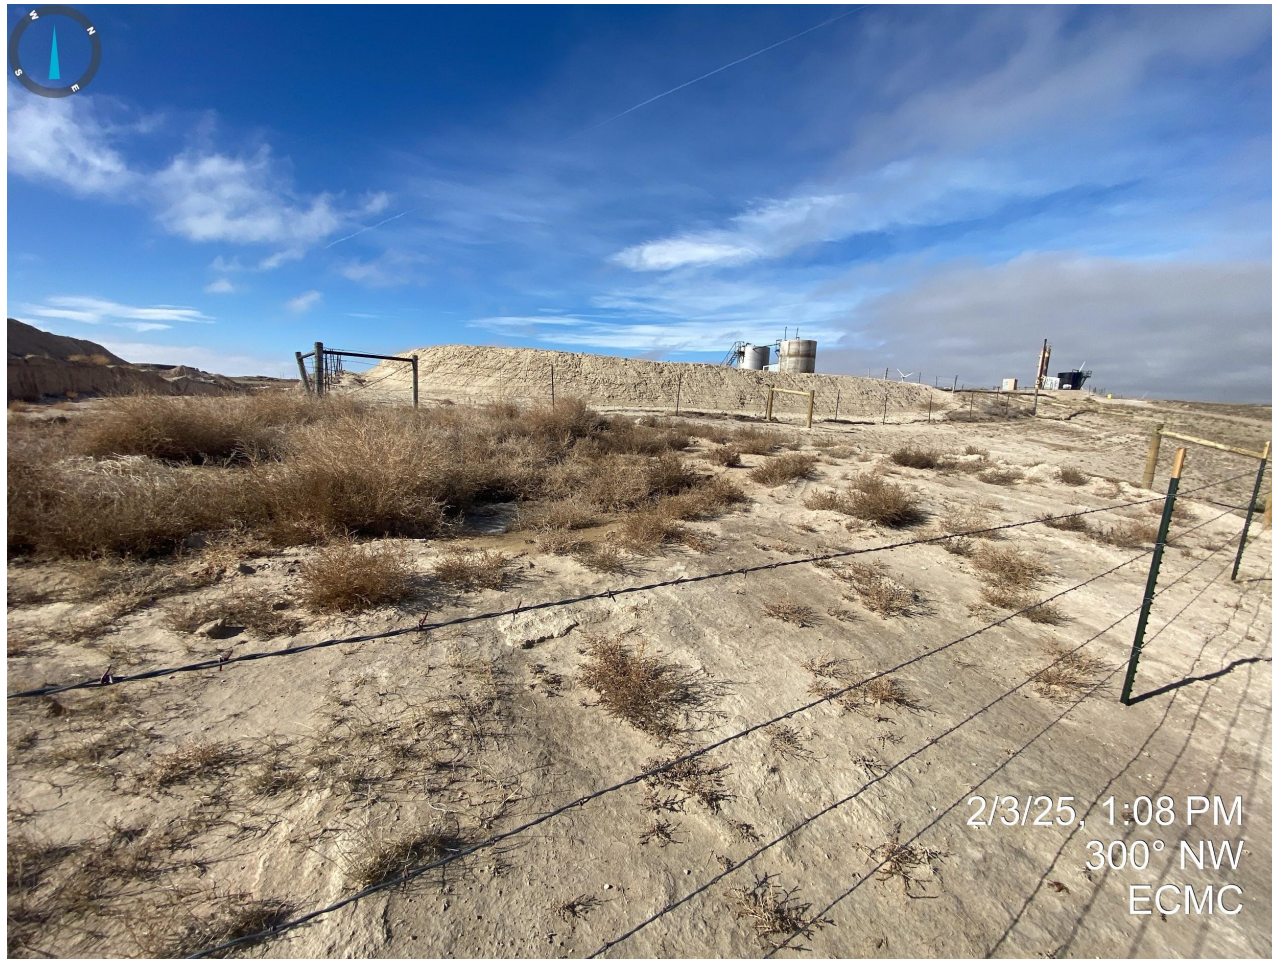
Photo 8. Continued from Photo 7, facing northwest.

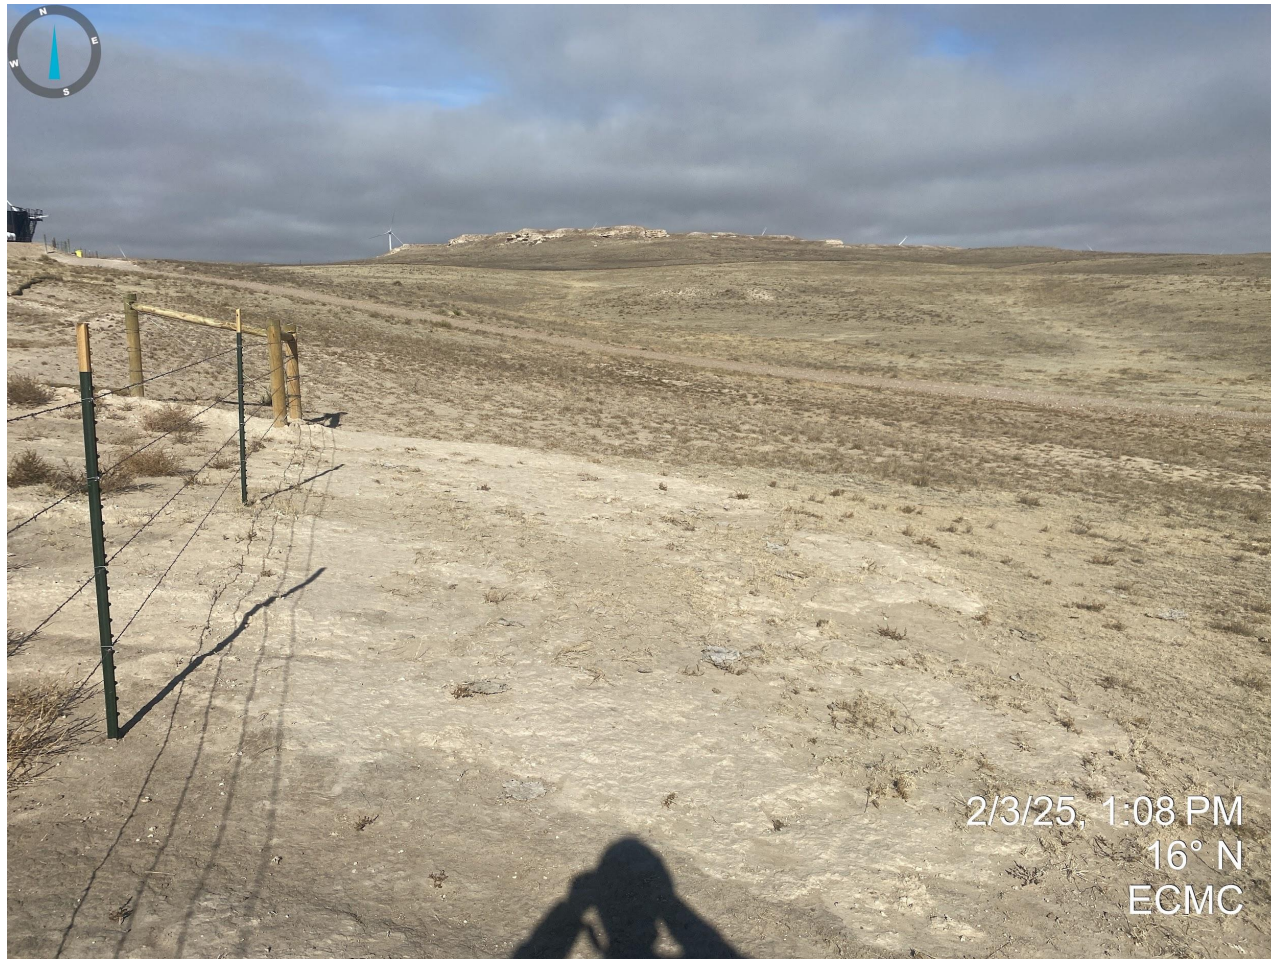
Photo 9. Sediment deposition resulting from unstabilized soils, southeast corner of the pit. No apparent stormwater controls measures/BMPs observed.

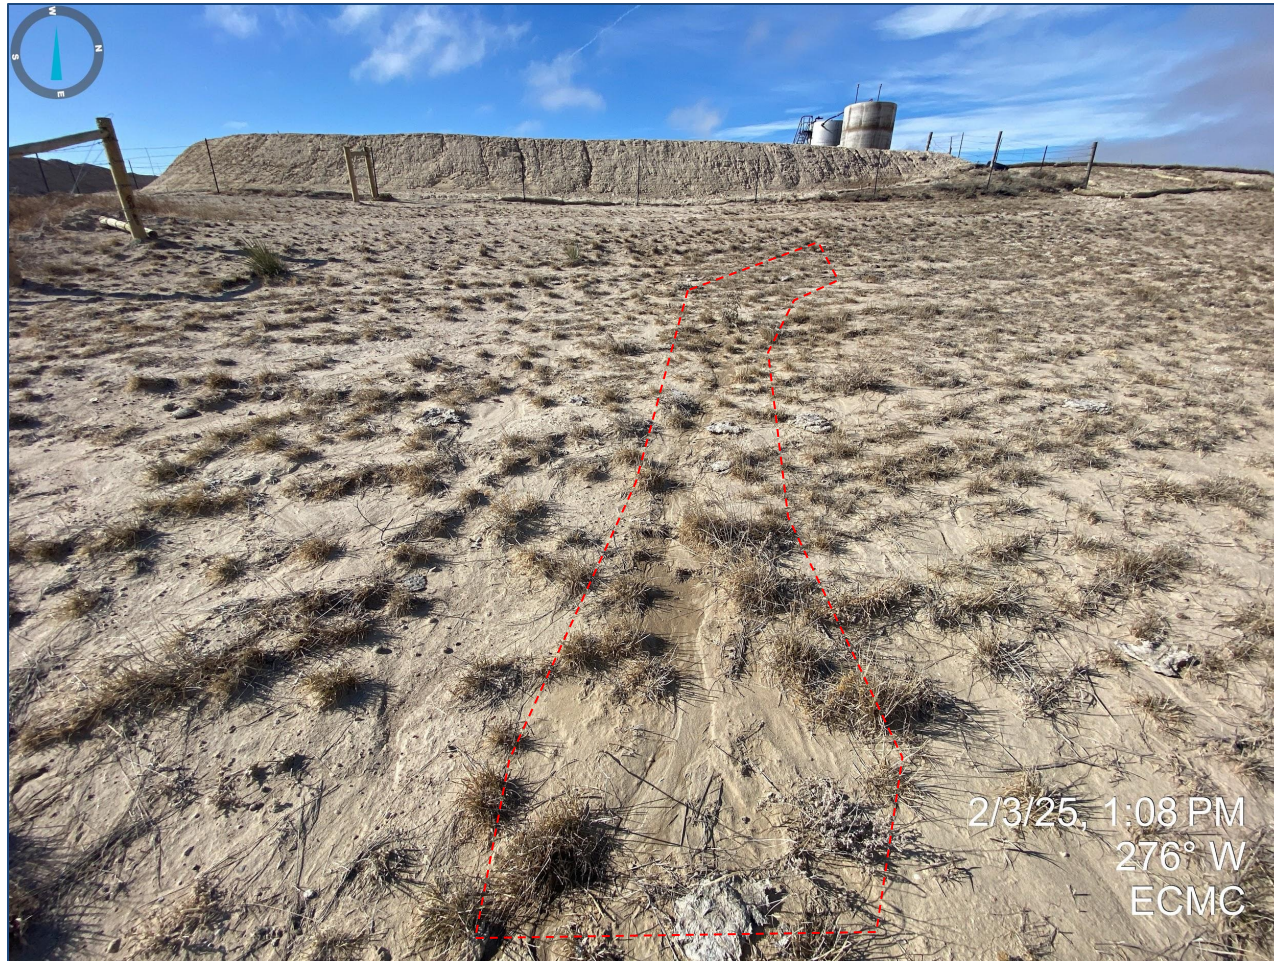
Photo 10. New stormwater erosion degradation observed east of the pit. Stormwater control measures remain inadequate.

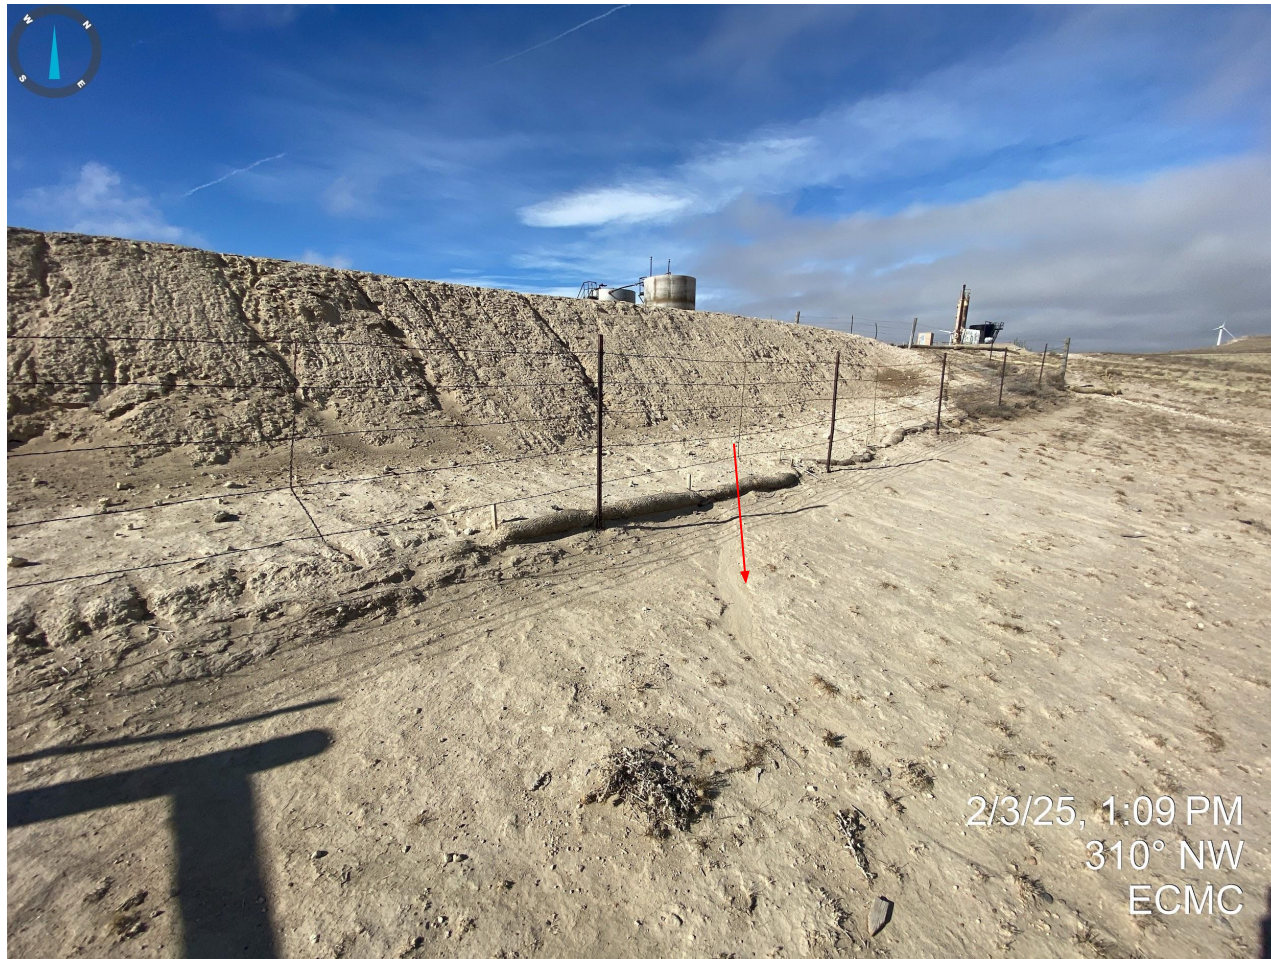
Photo 11. Continued from Photo 10. New stormwater erosion degradation observed east of the pit. Stormwater control measures remain inadequate.

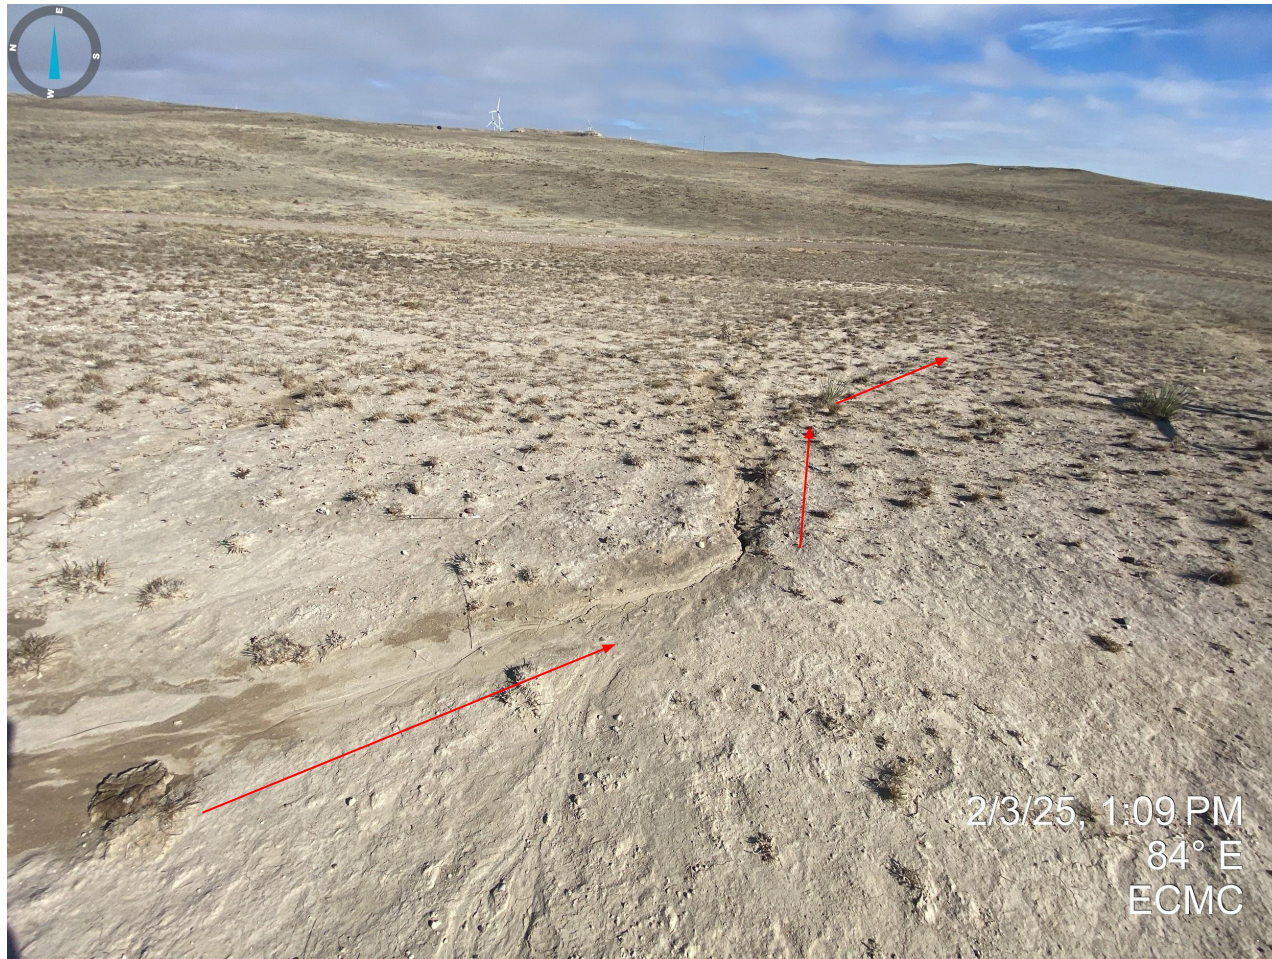
Photo 12. Continue from Photo 11, facing east. New stormwater erosion degradation observed east of the pit. Stormwater control measures remain inadequate.

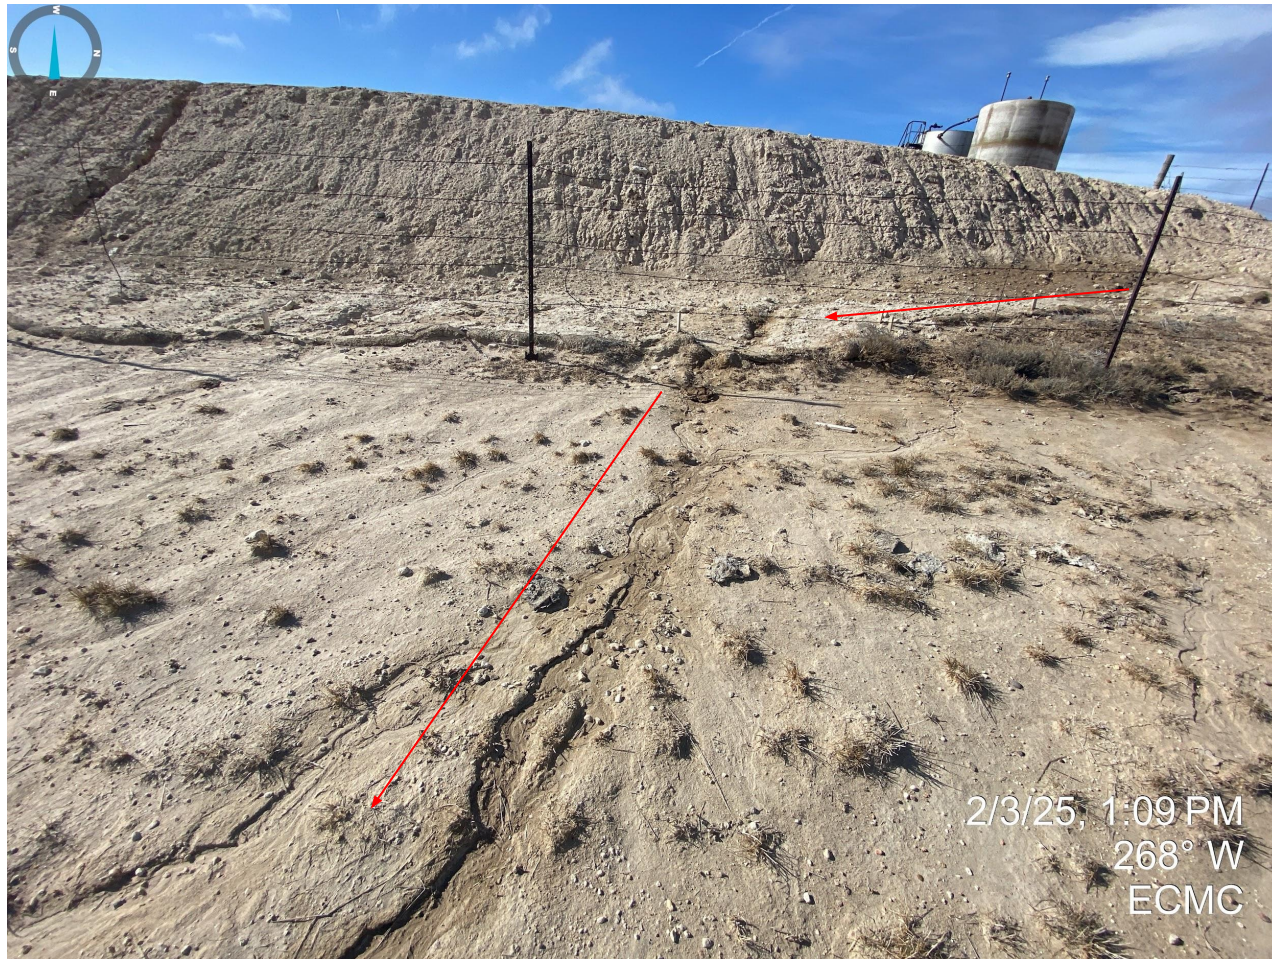
Photo 13. Near the northeast corner of the pit. New stormwater erosion degradation observed east of the pit. Stormwater control measures remain inadequate.

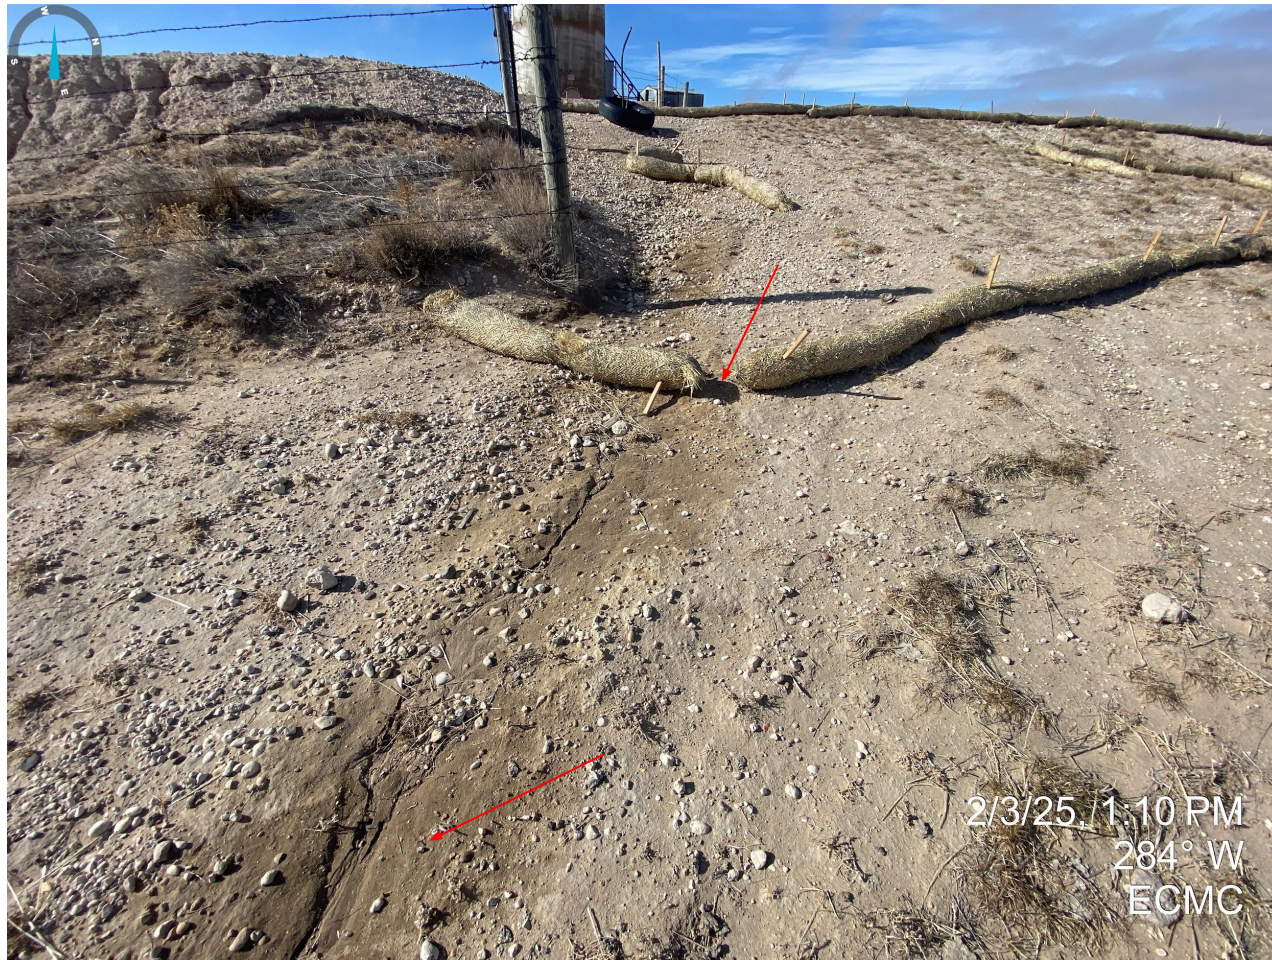
Photo 14. Erosion degradation occurring on the northern/eastern portion of the production areas, near the pit. Stormwater control measures appear to be degraded/damaged and not properly functioning with erosion degradation evidence.

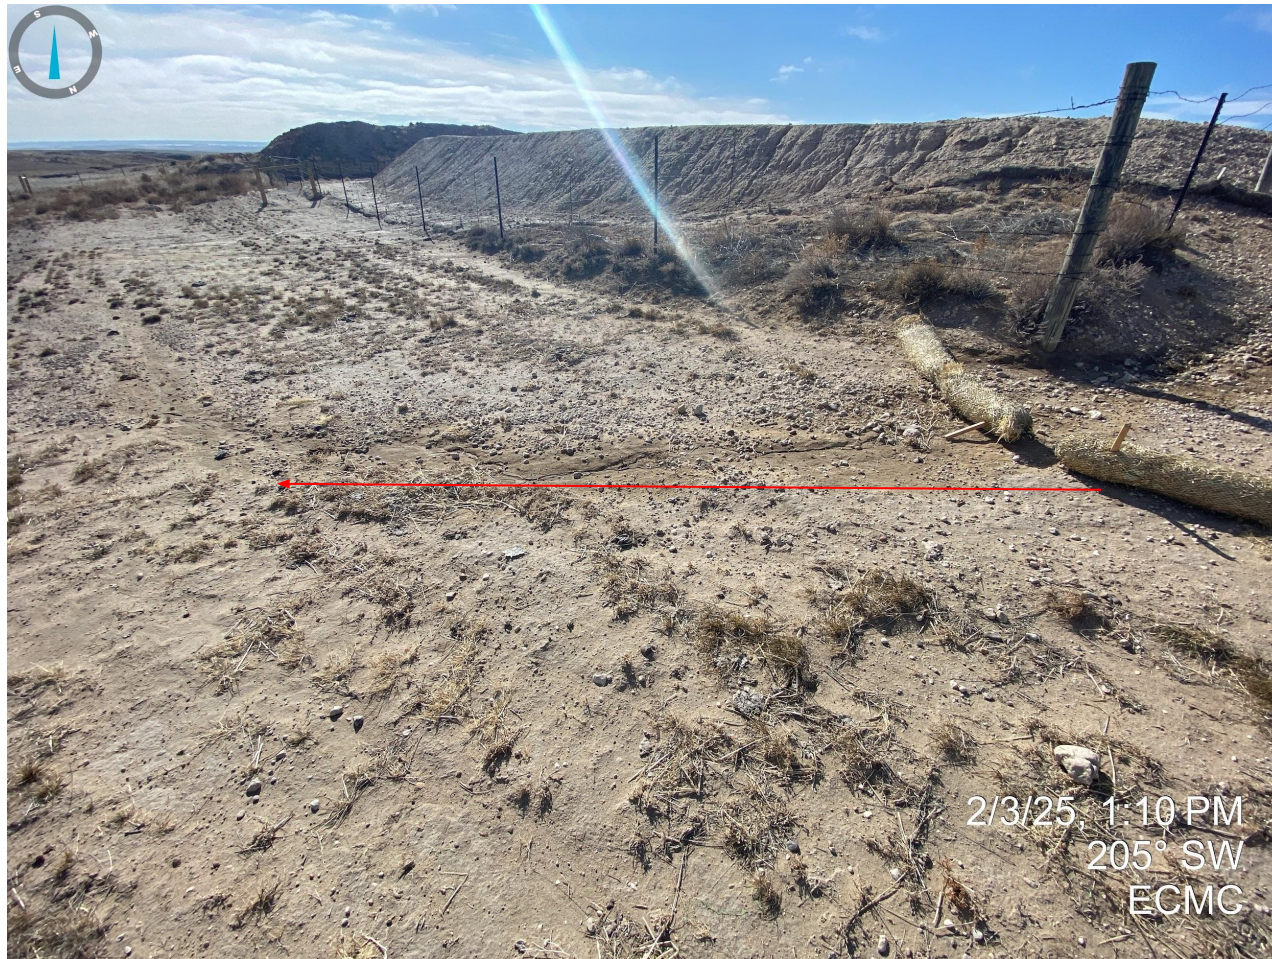
Photo 15. Continued from Photo 14, facing southwest.

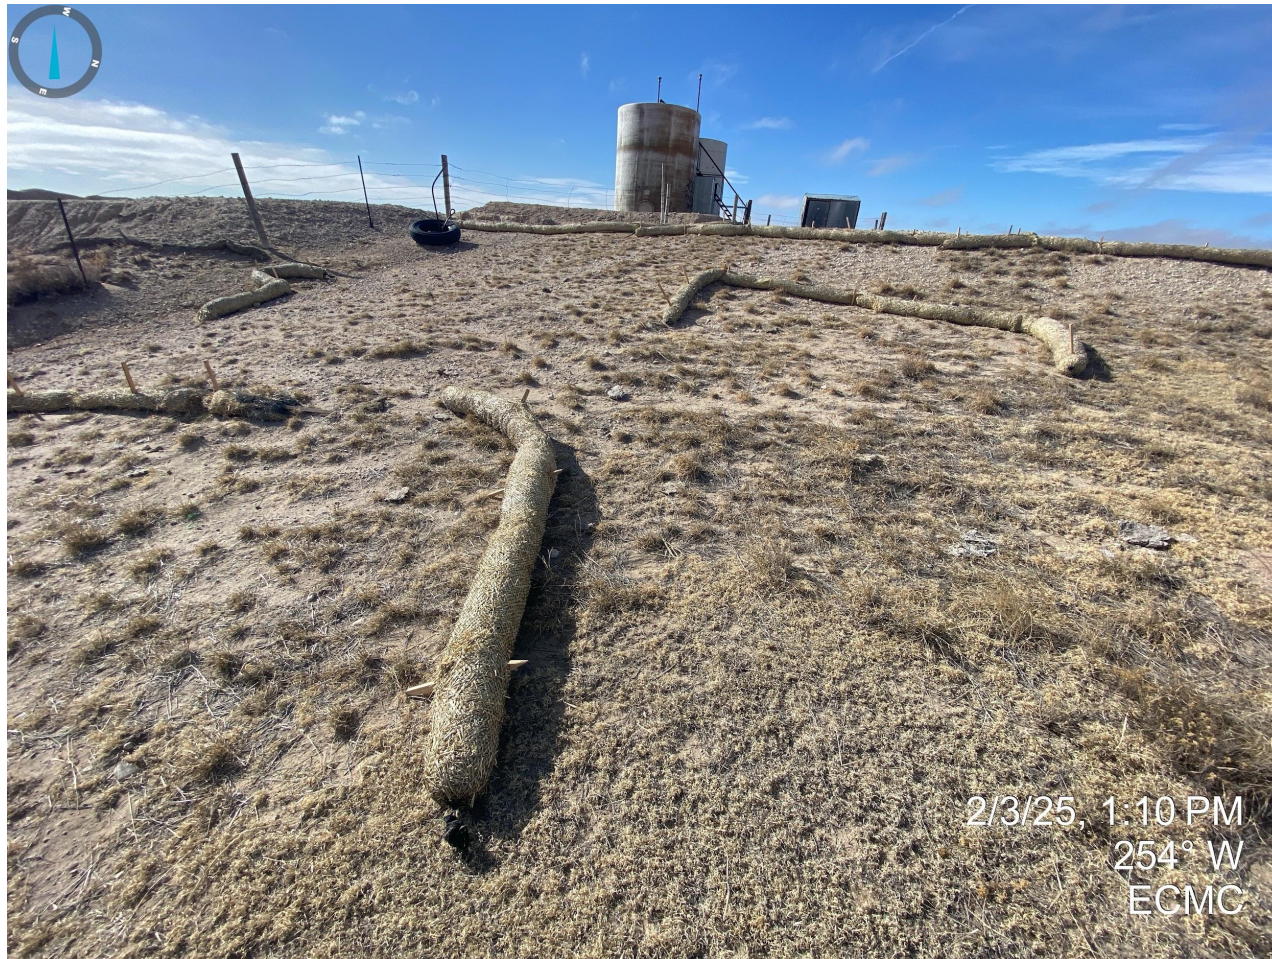
Photo 16. Northern/eastern portion of the production areas, near the pit. Stormwater control measures do not appear to be installed per good engineering practices.

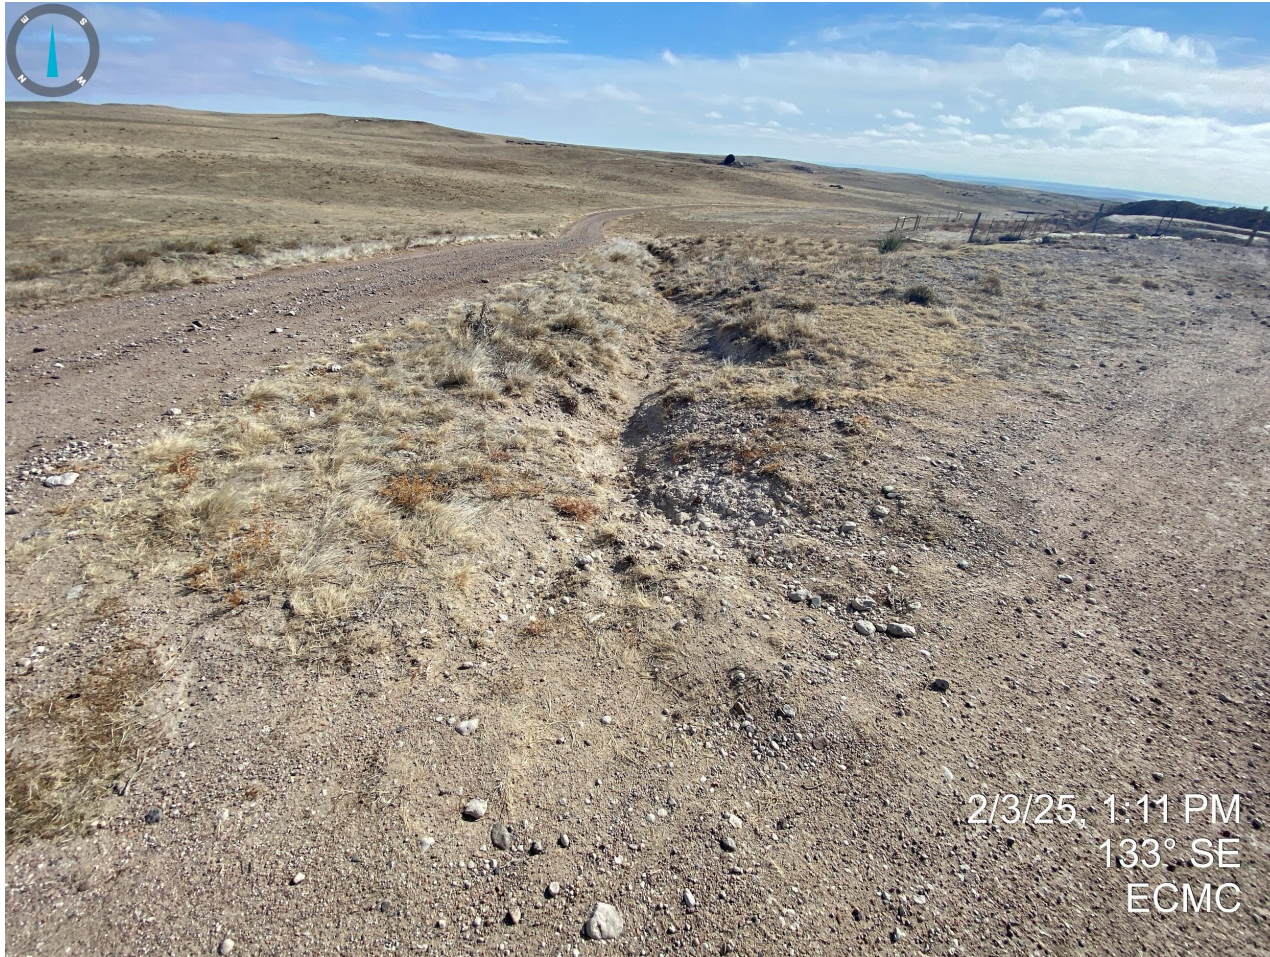
Photo 17. Taken north of pit. Evidence of erosion degradation, previously documented, does not appear to have been repaired/stabilized with no evidence of control measures/BMPs observed that would prevent further erosion of the production areas and access roads.

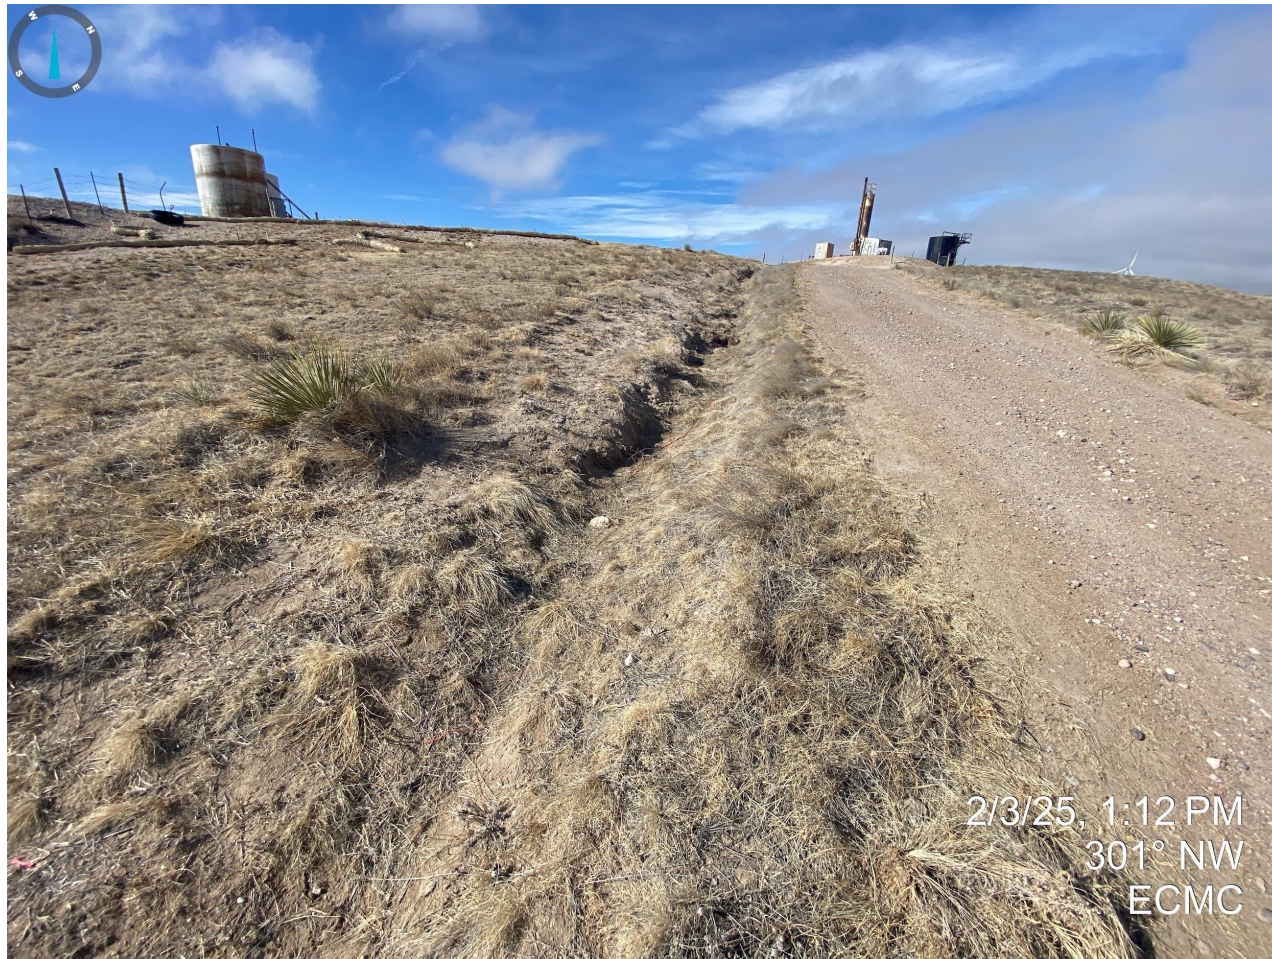
Photo 18. Continued from Photo 17, facing northwest.
