Interim Reclamation and Stormwater Inspection

Date: 02/03/2025

Operator: WESTERN OPERATING COMPANY - 95620

Location ID: 312291

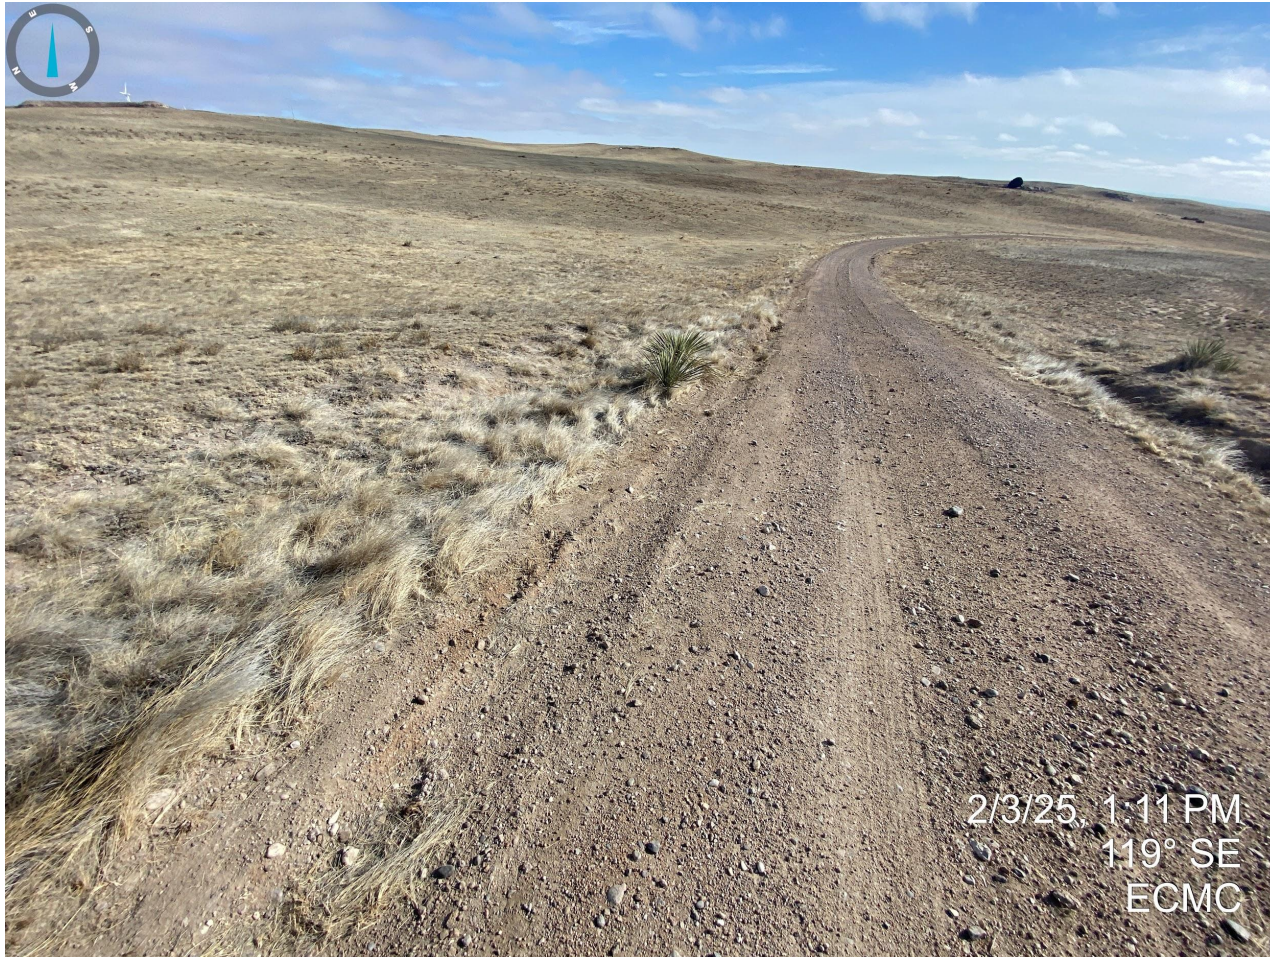
Photo 19. It appears that erosion degradation along the north side of the access road has been repaired. See proceeding photo for additional information.

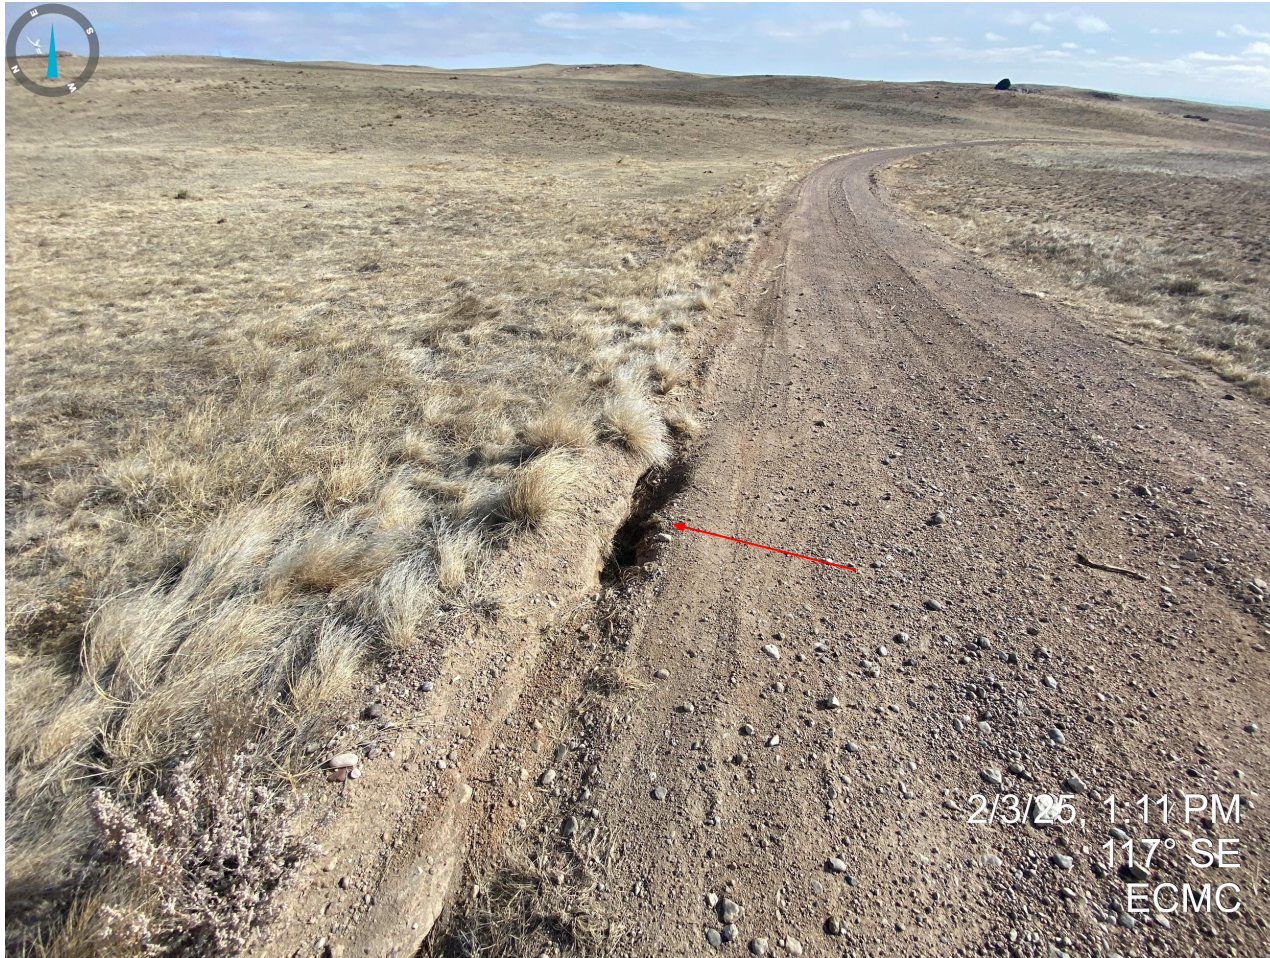
Photo 20. Continued from Photo 19. While some work appears to have been completed to repair erosion degradation along the northern portion of the access road, there is still evidence of erosion degradation that requires maintenance.
