Inspection Photos

API: 011-05055

Loc: 321208

Operator: RENEGADE OIL & GAS COMPANY LLC

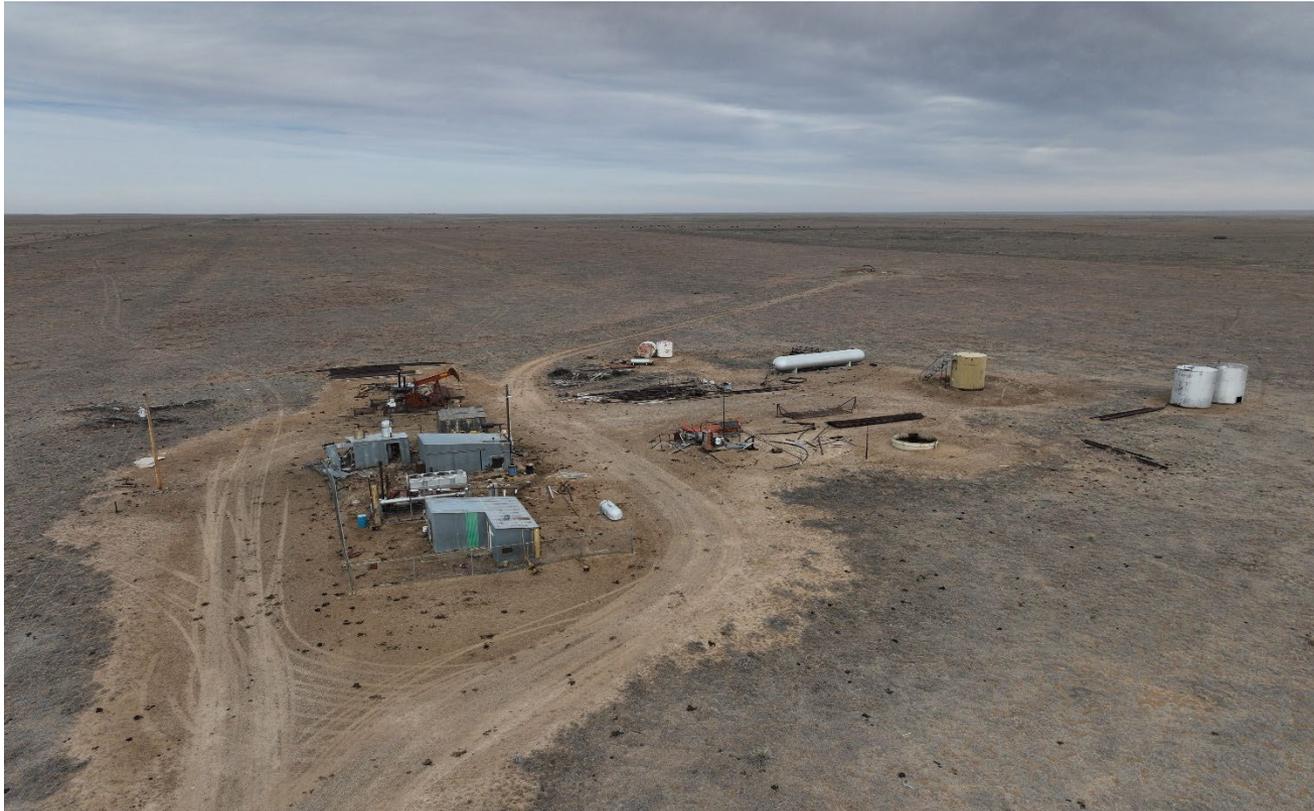
Photo 1. Drone aerial photo facing northeast toward the GAS PROCESSING PLANT and Wellsite.

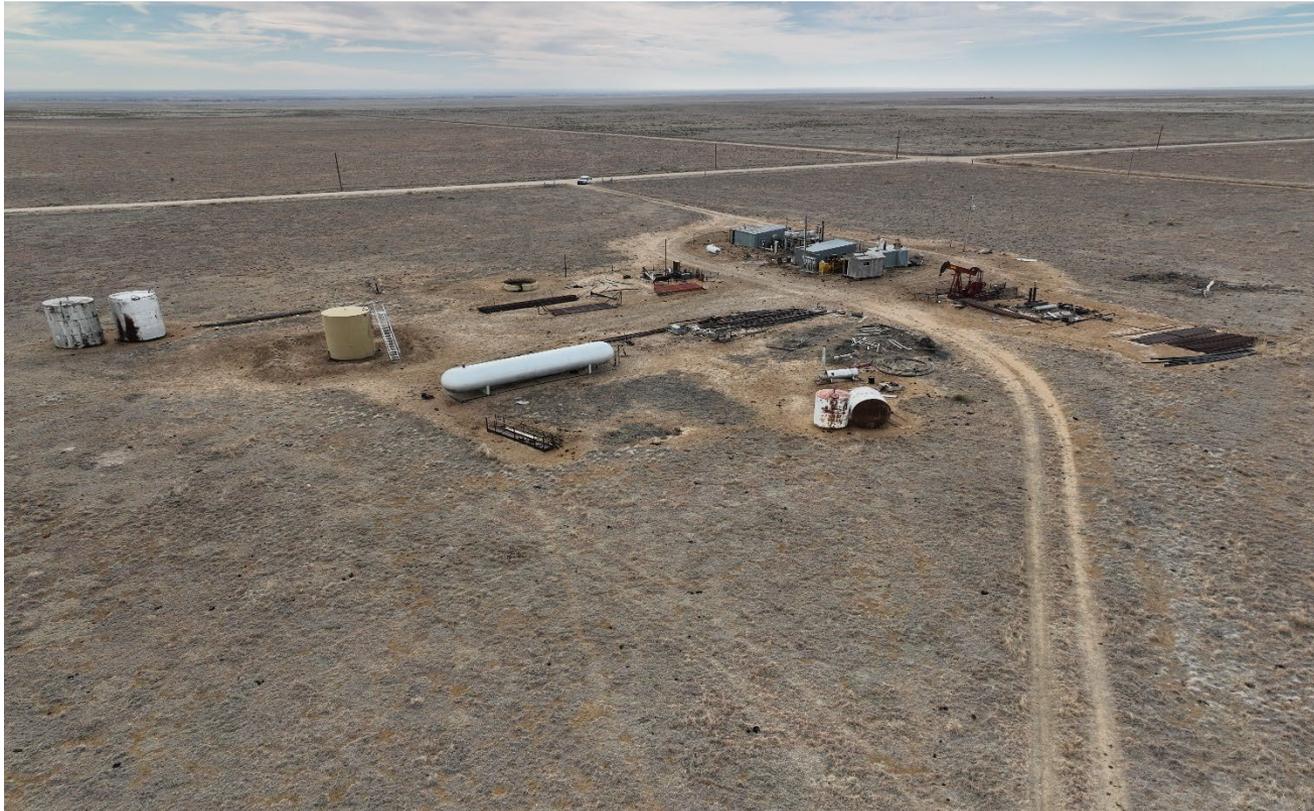
Photo 2. Drone aerial photo facing southwest toward the GAS PROCESSING PLANT and Wellsite.

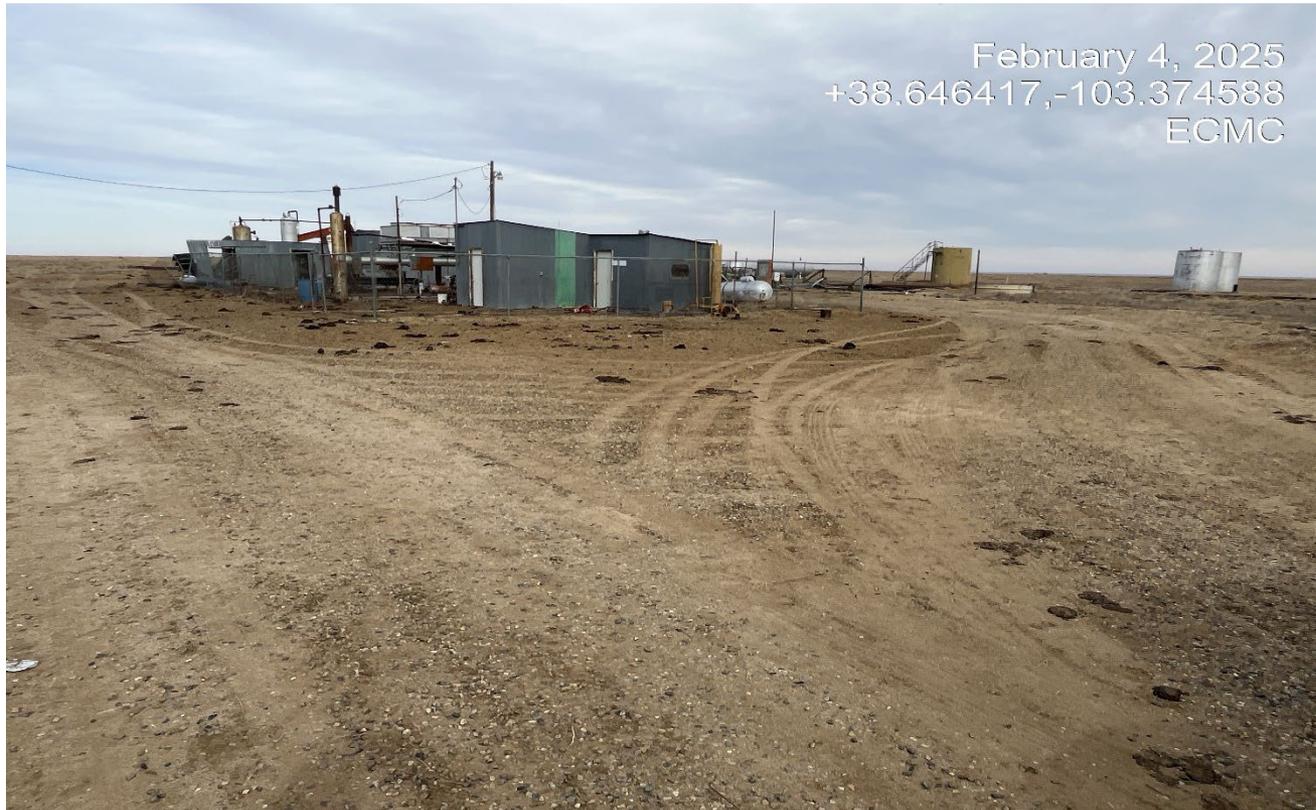
Photo 3. Facing northeast toward the GAS PROCESSING PLANT and Wellsite.

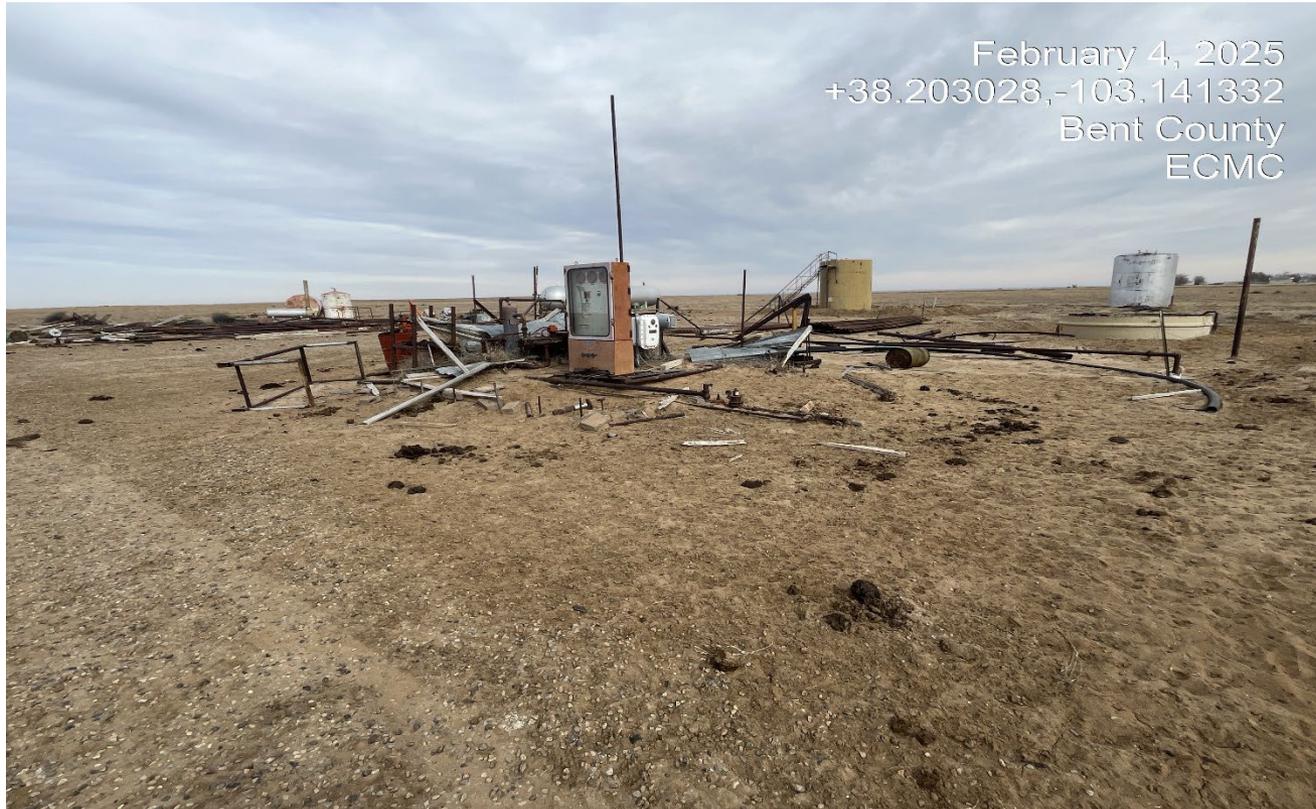
Photo 4. Facing northeast at the location. There is various unused equipment, supplies and tanks stored at the location that will need to be removed. Previous CA has not been completed.

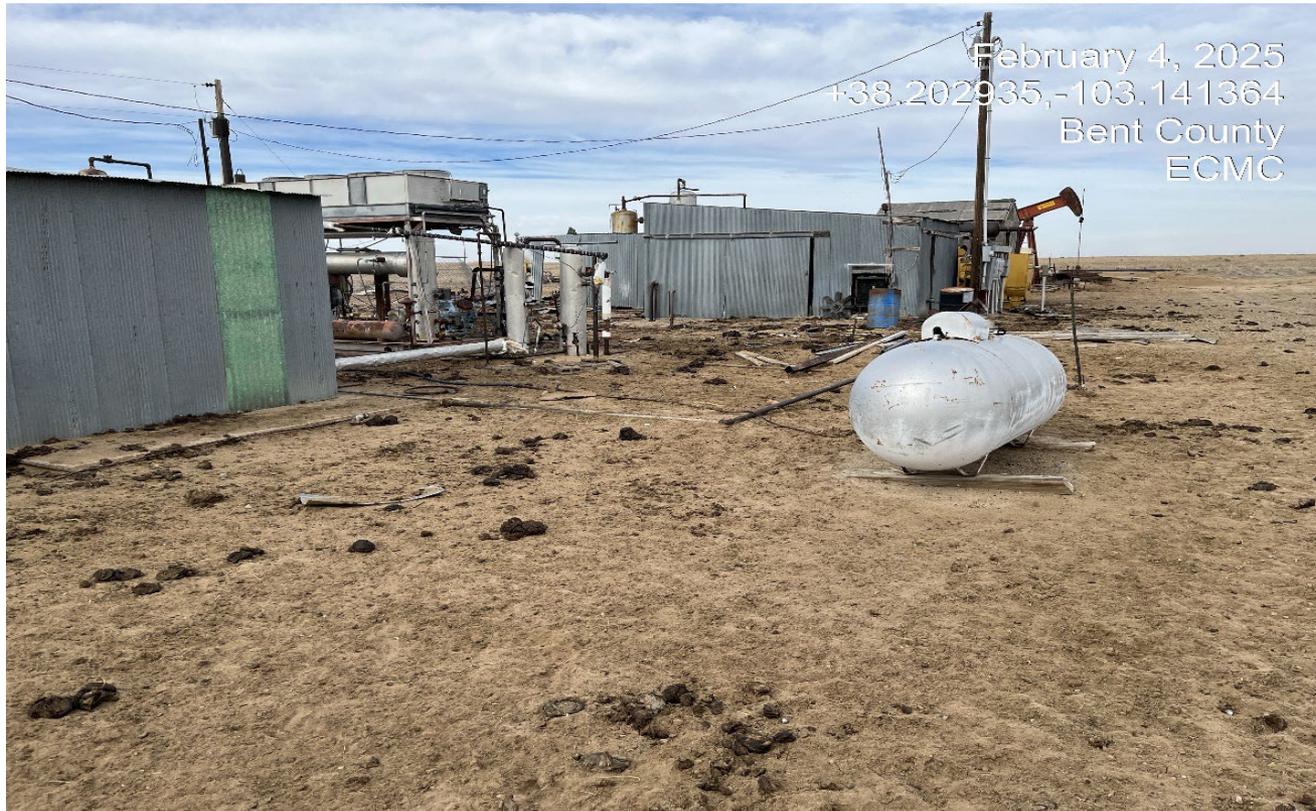
Photo 5. Facing northwest toward the GAS PROCESSING PLANT and Wellsite. There is various supplies and debris scattered throughout the location.

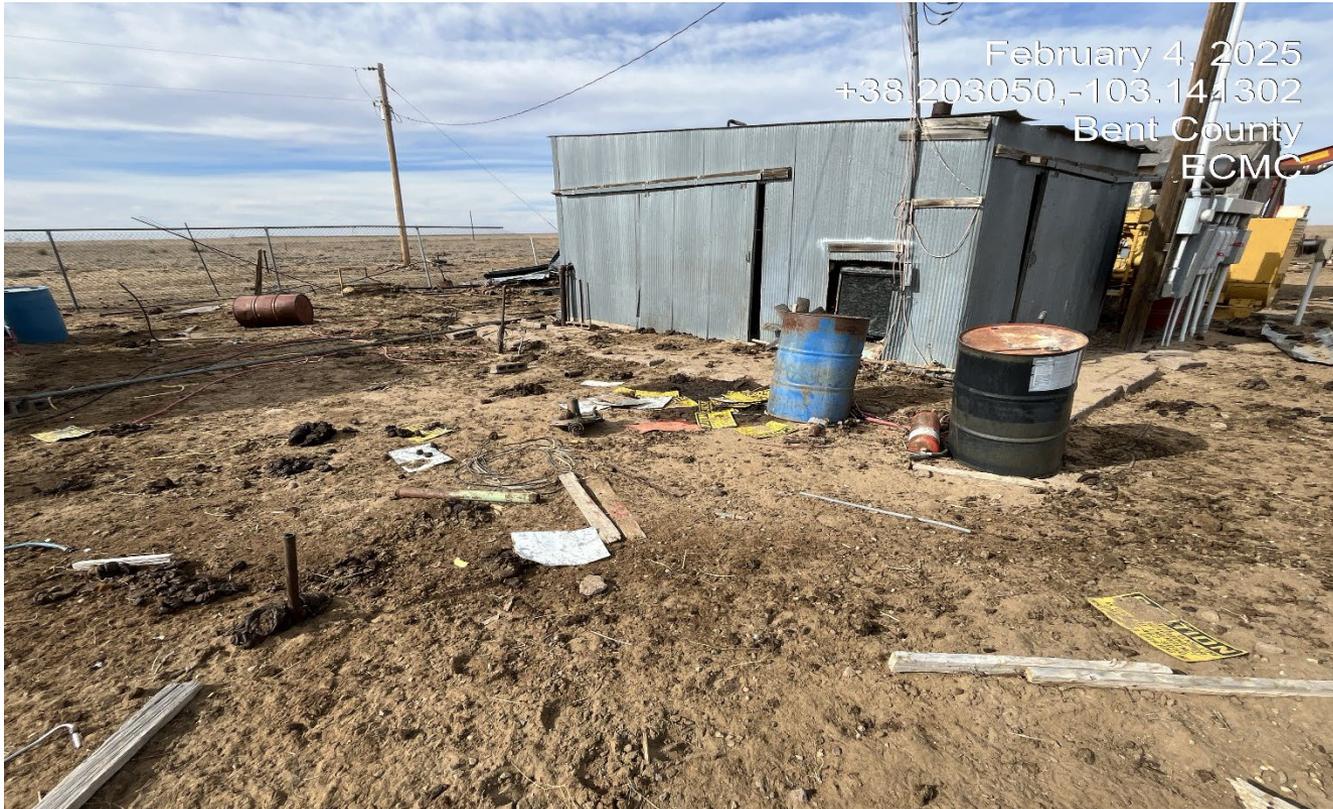
Photo 6. Facing northwest at the sheds and various equipment which are in disrepair. There is chemical barrels with no containment and various debris laying on the ground.

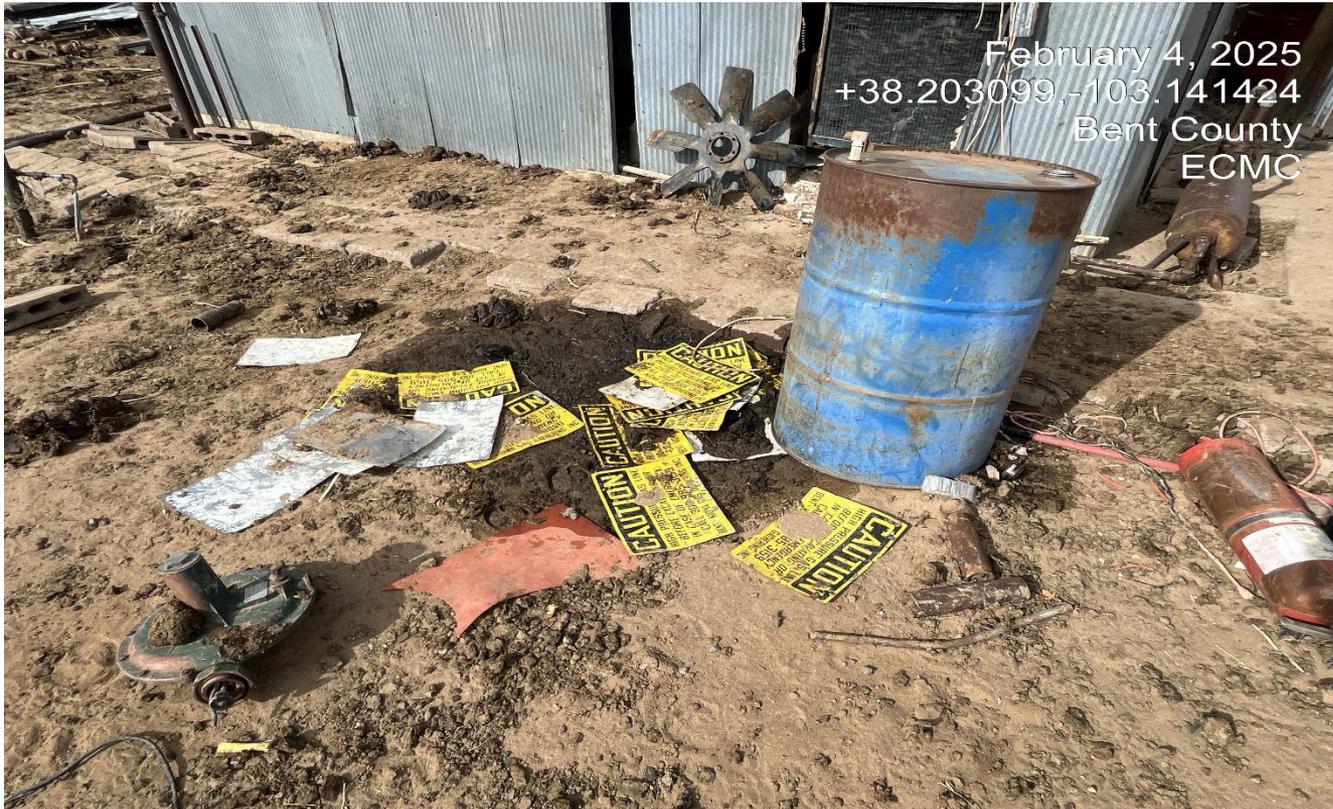
Photo 7. This blue barrel has leaked out oil onto the ground.

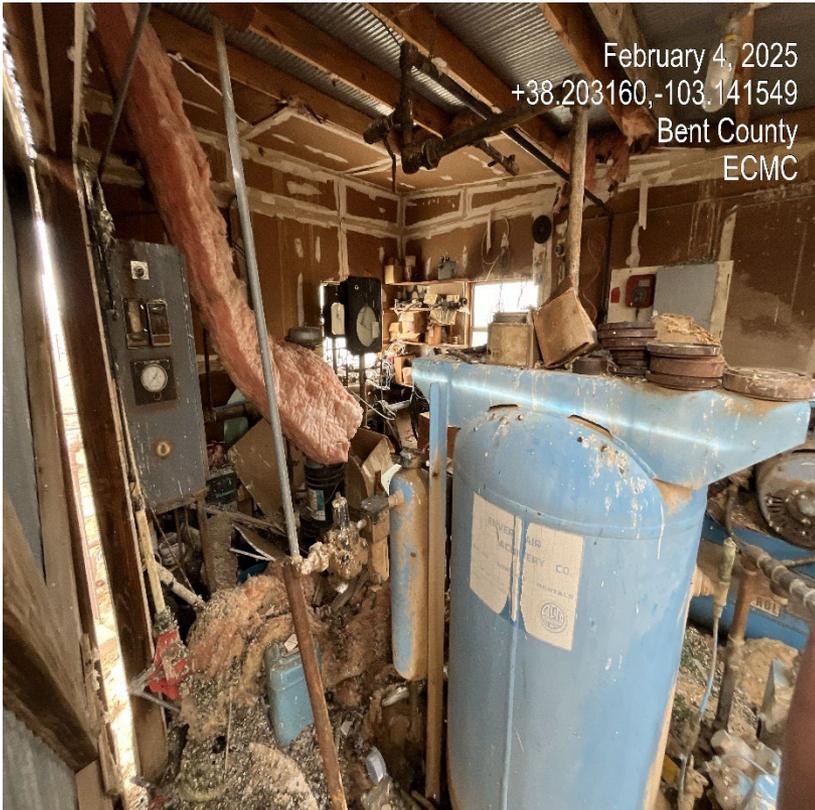
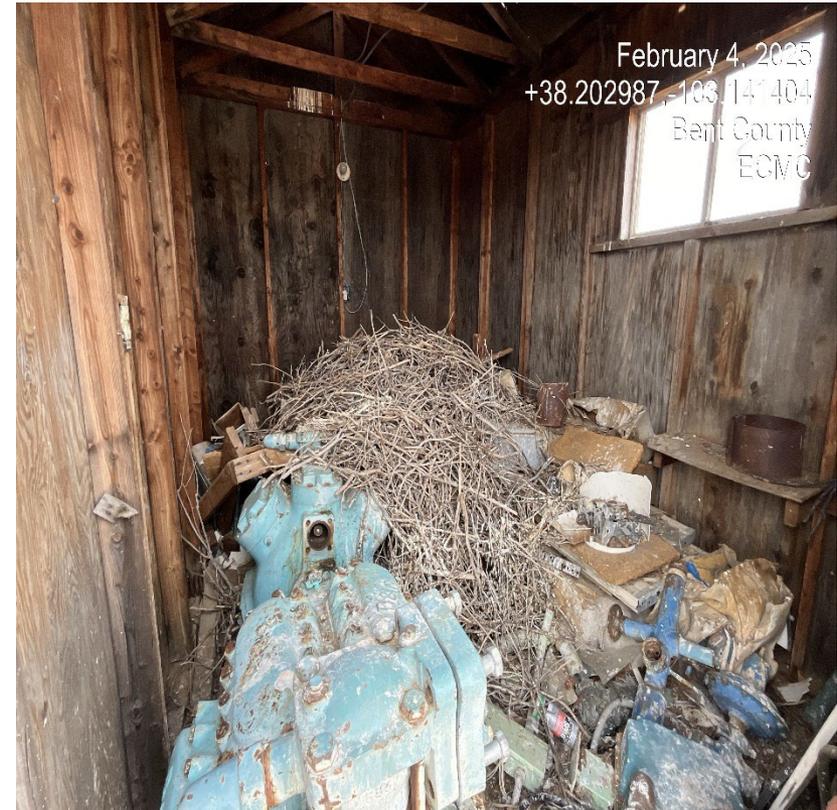
Photo 8&9. There are sheds in disrepair with large bird nests. Operator will need to consult with USFS and CPW regarding time restrictions and relocation of any migratory bird nests.

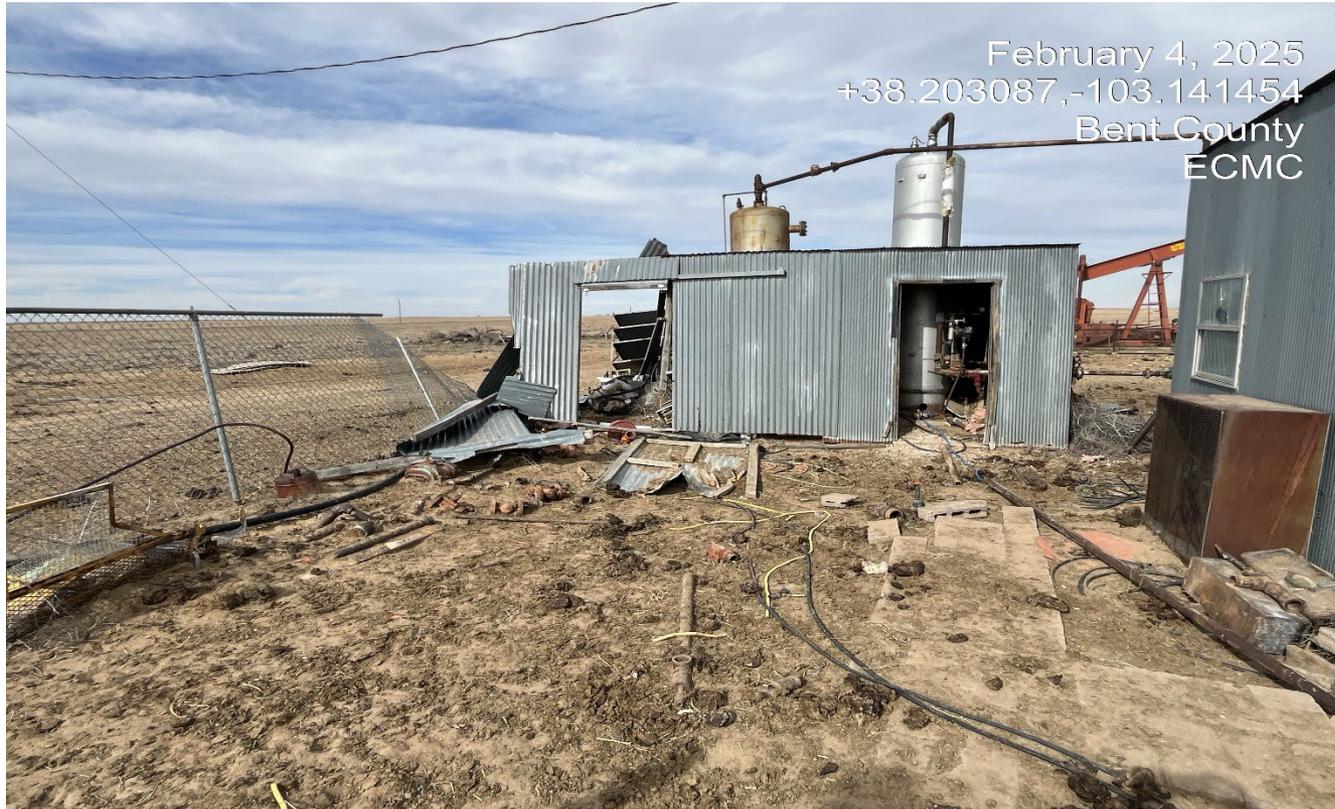
Photo 10. Facing northwest at the sheds and equipment which are in disrepair.

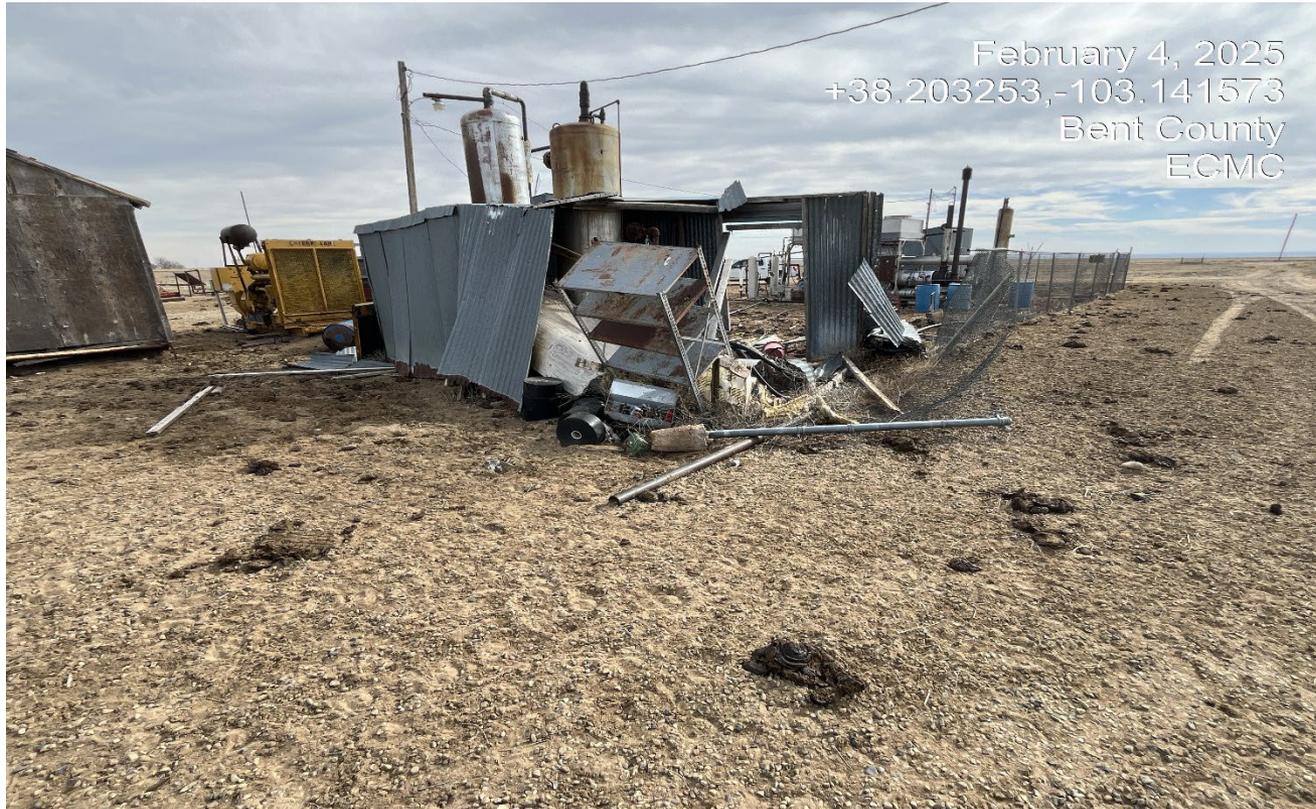
Photo 11. Facing southeast at the west side of the location. This shed and fence are in disrepair with supplies have fallen out of the dilapidated shed.

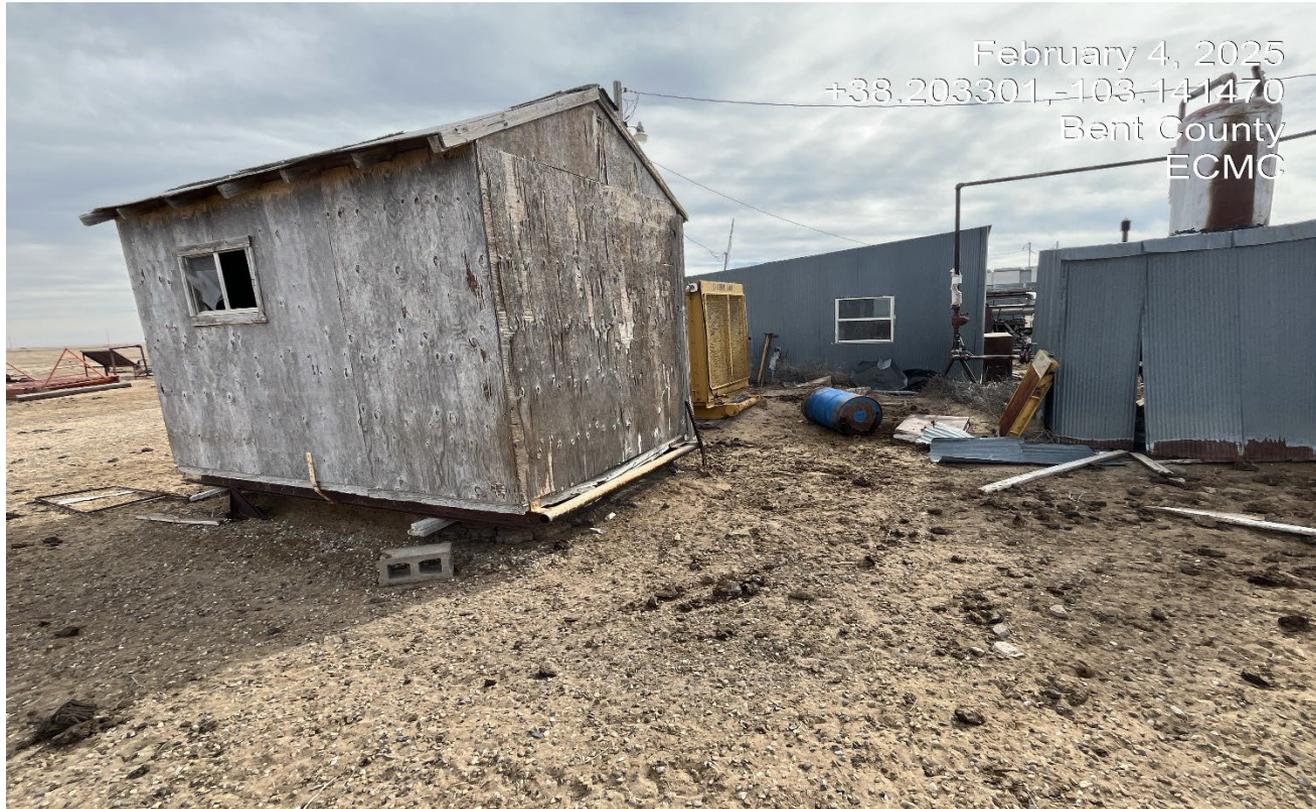
Photo 12. There is panels, boards, and a blue barrel laying on the ground which has leaked out fluids onto the ground..

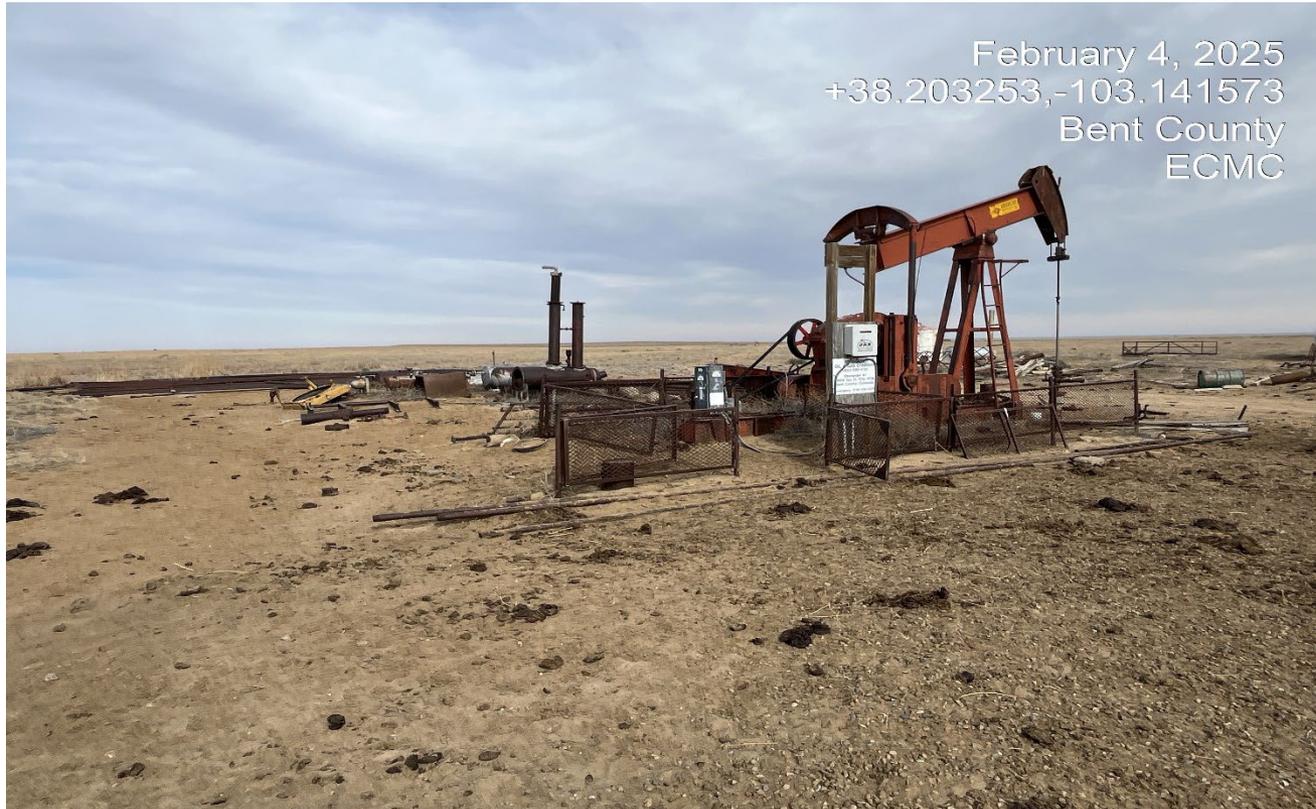
Photo 13. Facing northeast toward the well. The fence around the pumpjack is in disrepair and there is unused equipment stored near the well.

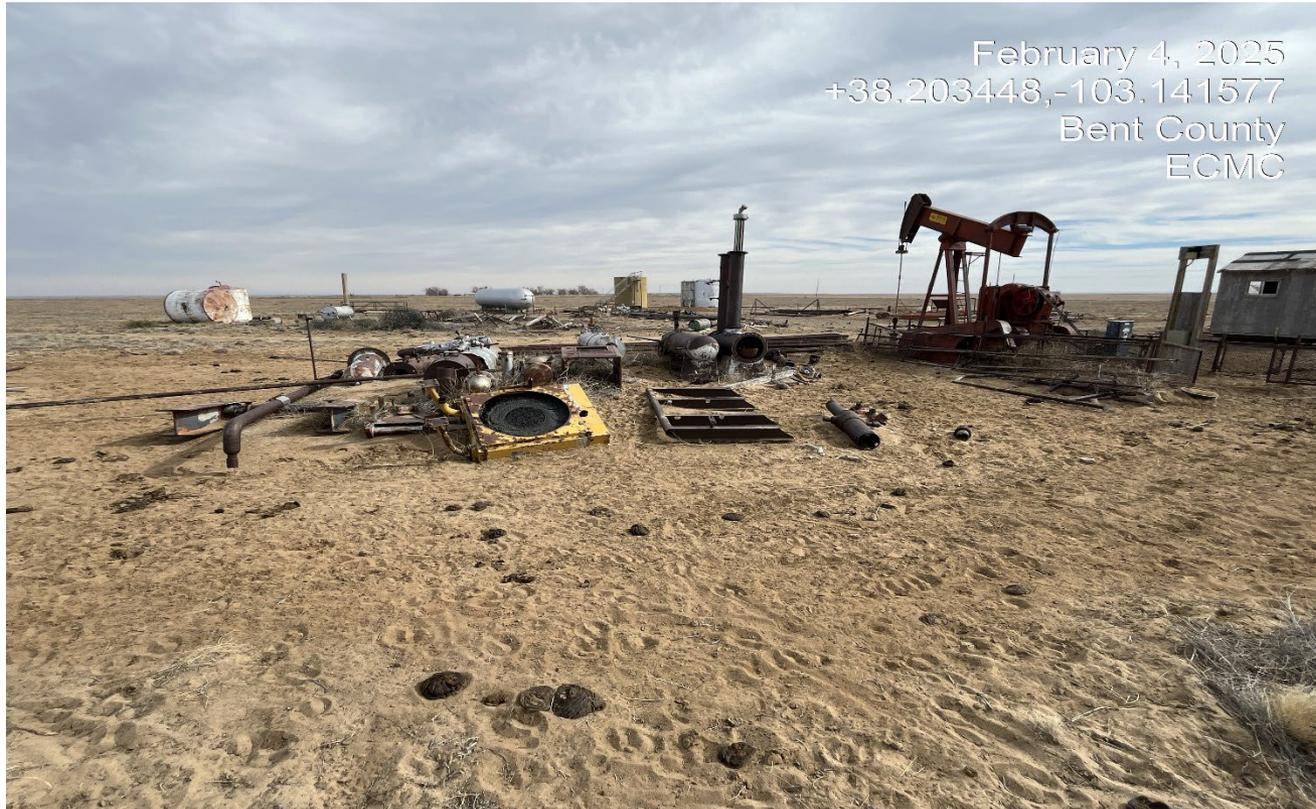
Photo 14. North side of the location facing east. There is various unused equipment stored on location that needs to be removed.

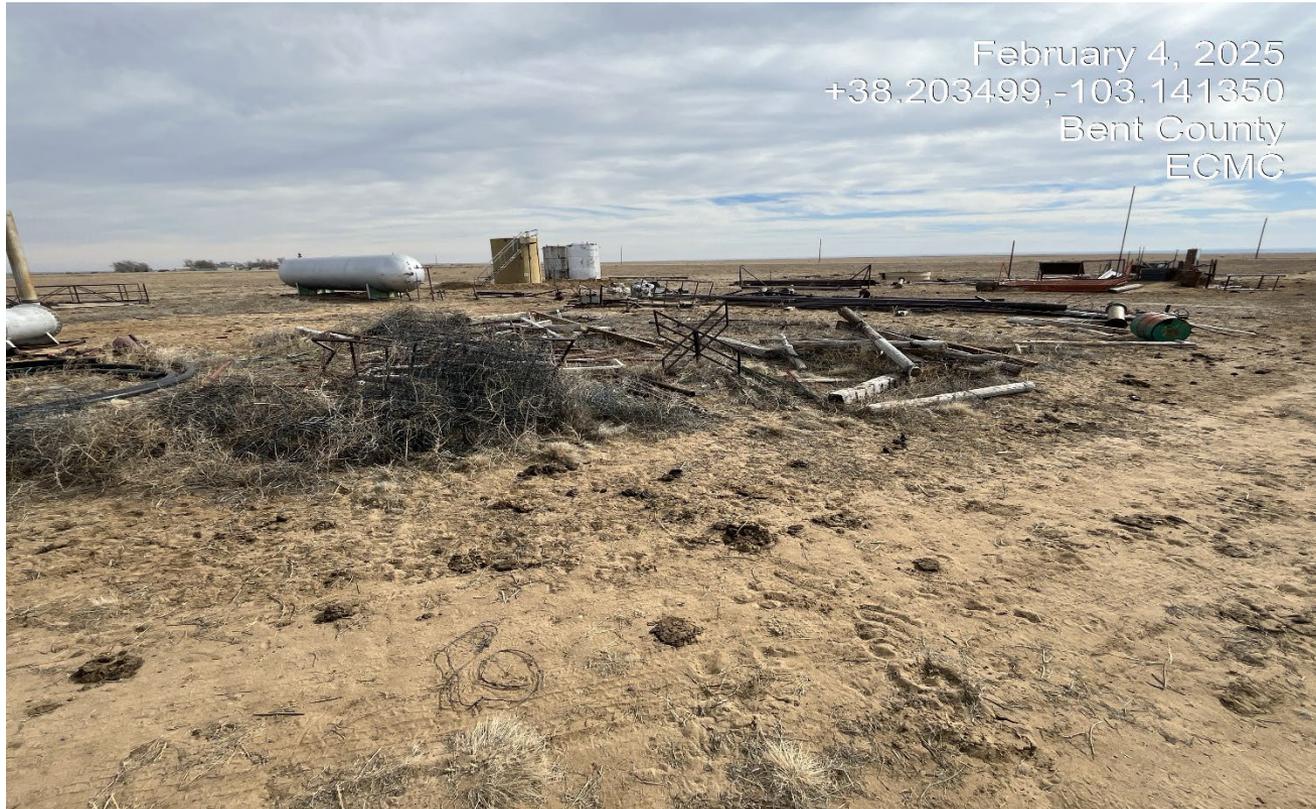
Photo 15. Facing southeast at the location. There are various unused equipment, wire, and debris stored on location that needs to be removed. Previous CA was not completed.

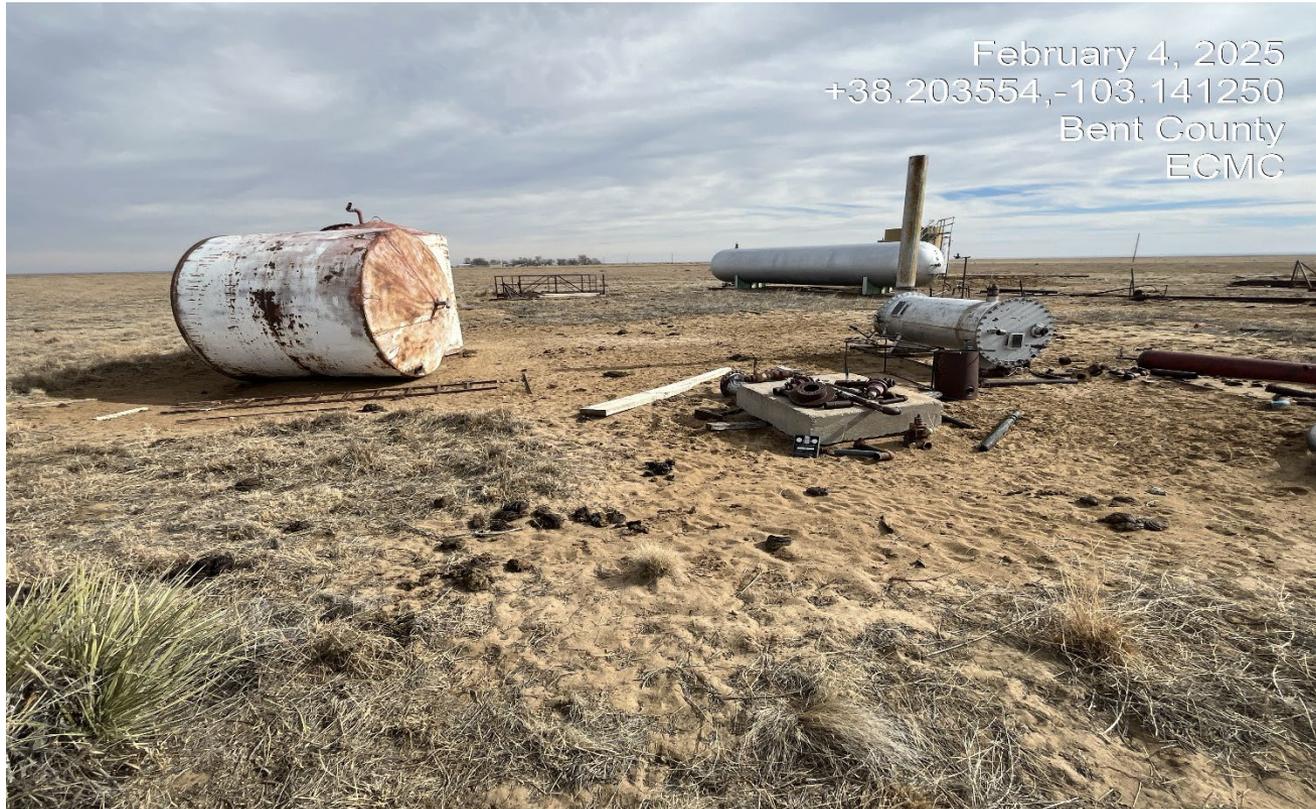
Photo 16. North side of the location facing east. There are unused tanks stored and various supplies scattered throughout the location.

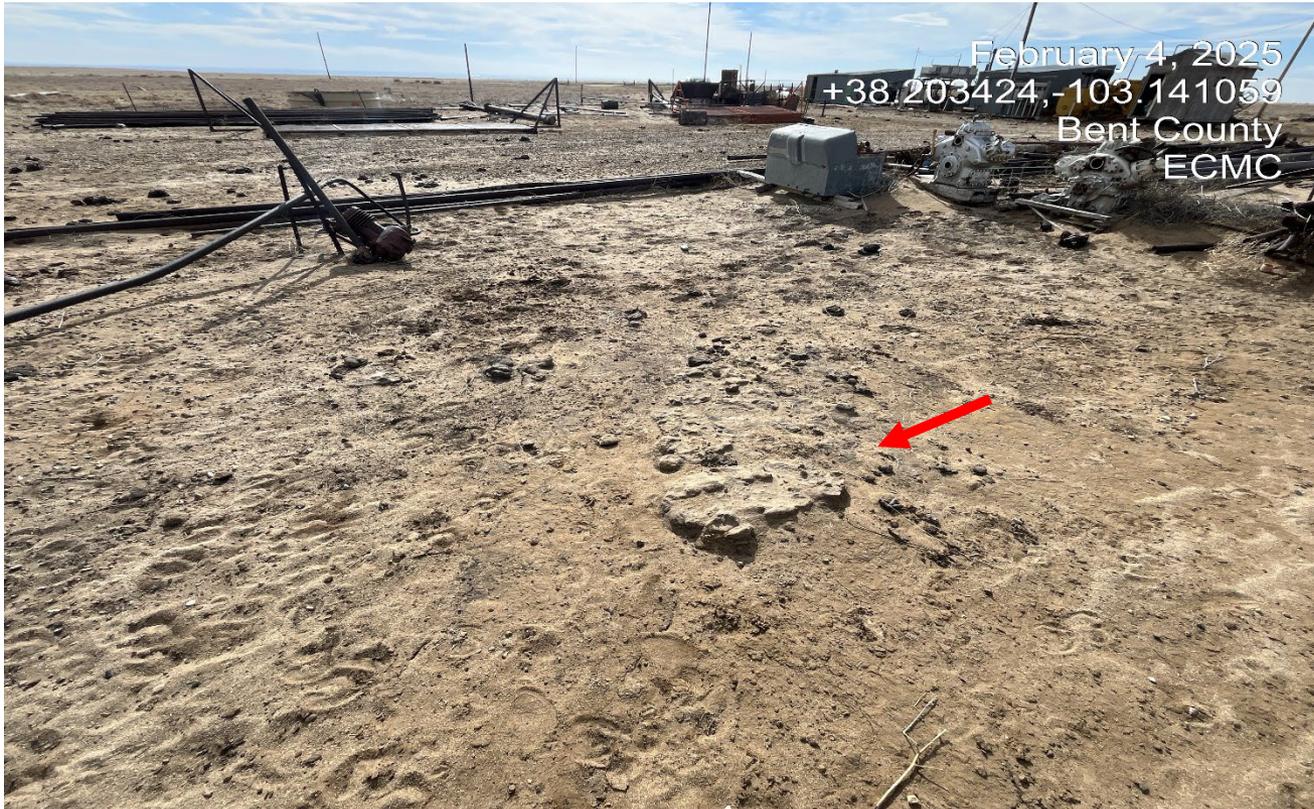
Photo 17. Facing southwest at the location. There are hardened hydrocarbon impacts shown at red arrow.

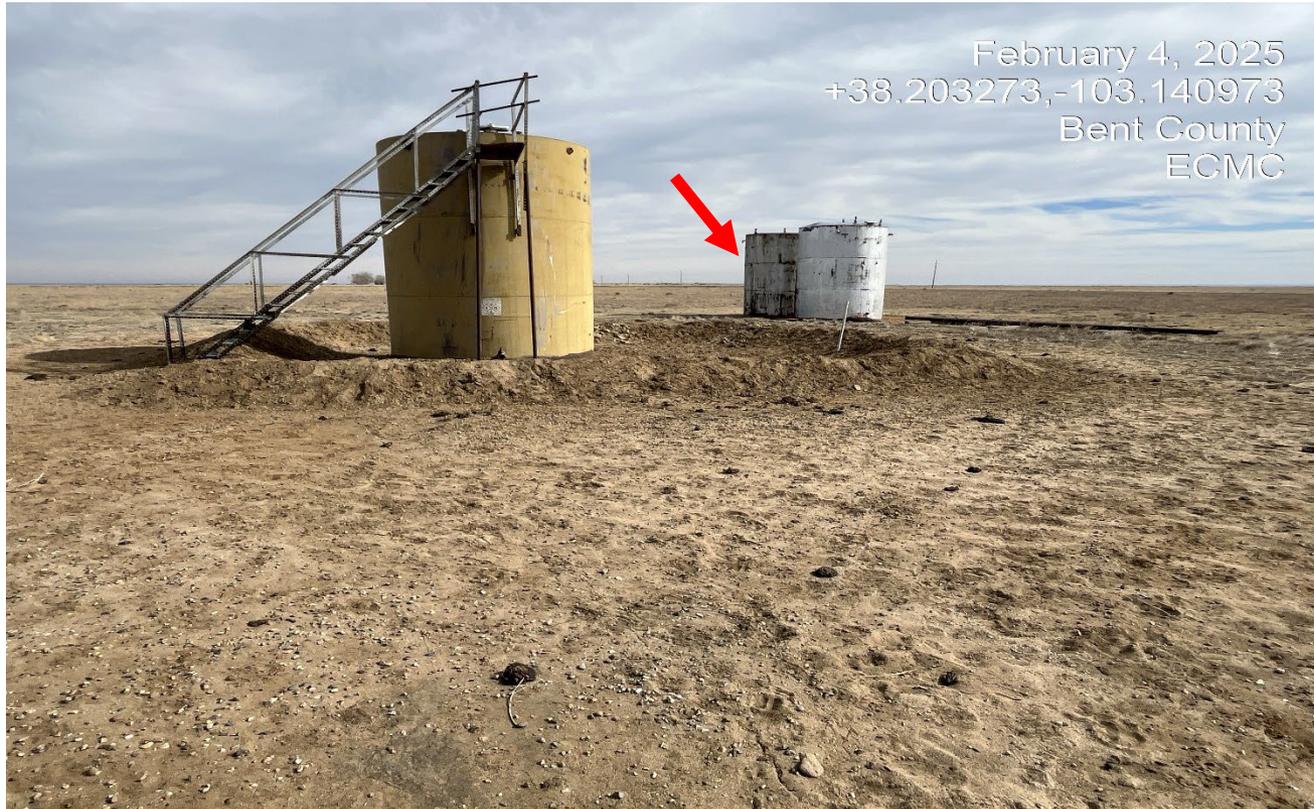
Photo 18. Facing southwest at the location. The old tank was removed and anew one has been installed. It is unknown if impacts around the tank were cleaned up. There are two unused tanks stored on location at red arrow.

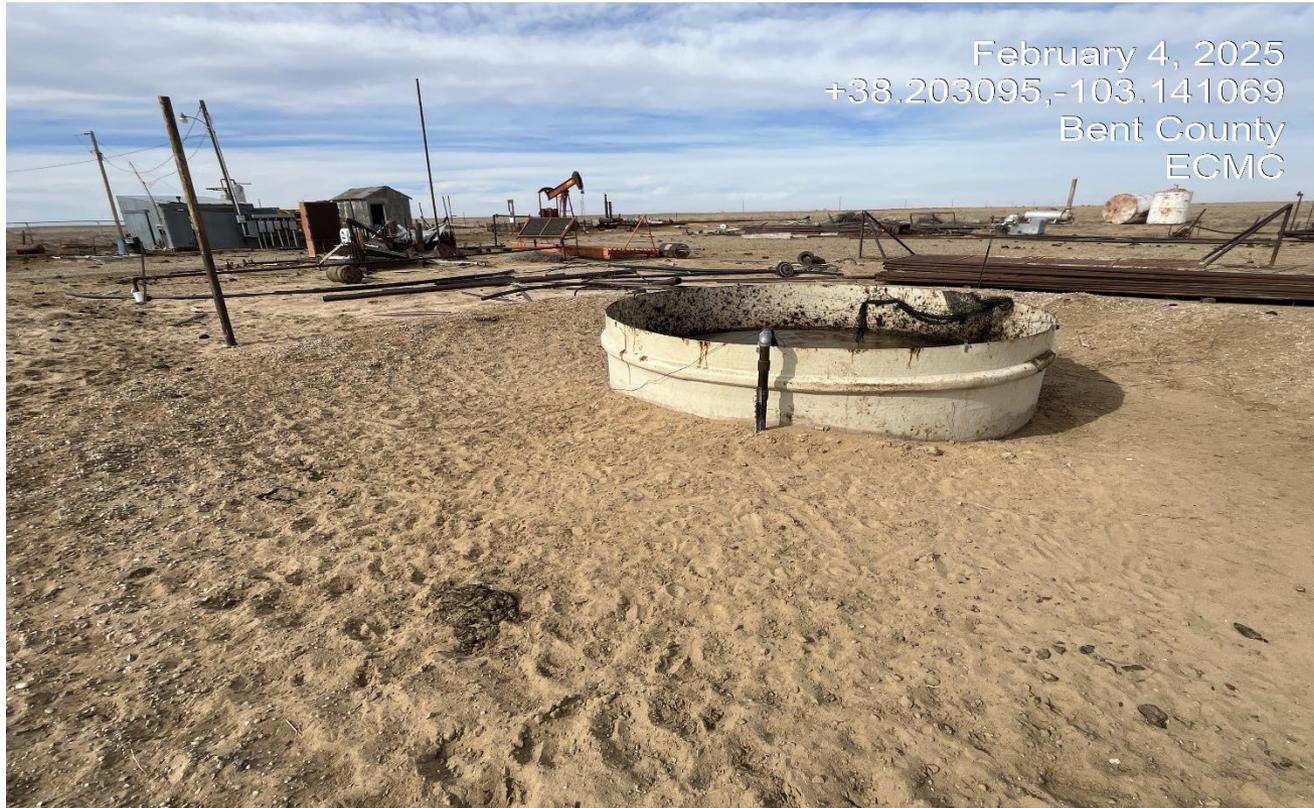
Photo 19. Facing northwest at the south side of the location. There is an open top fiberglass condensate tank with no wildlife or livestock protections. There are cattle tracks all around the tank indicating that cattle could be drinking out of this tank.

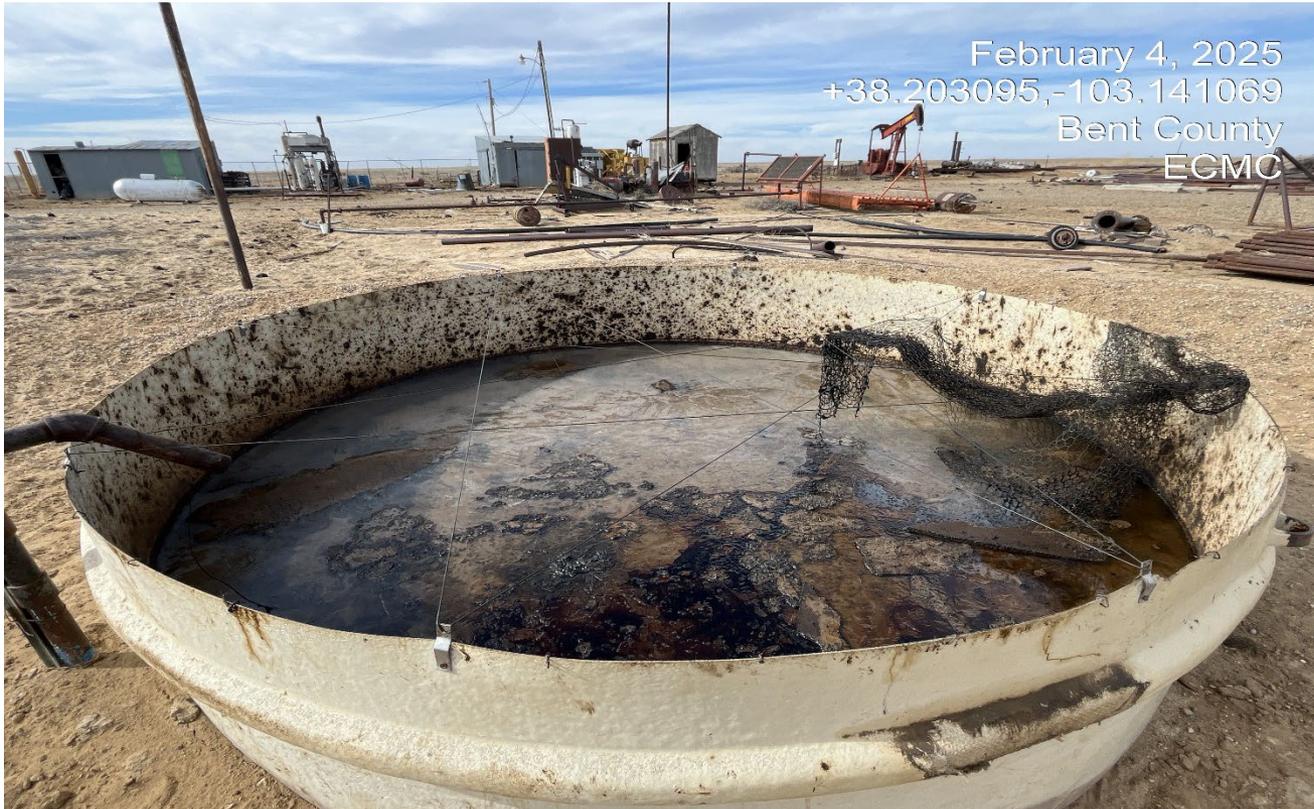
Photo 20. Facing toward the open top tank which has oil condensate inside the tank with no wildlife or livestock protection.

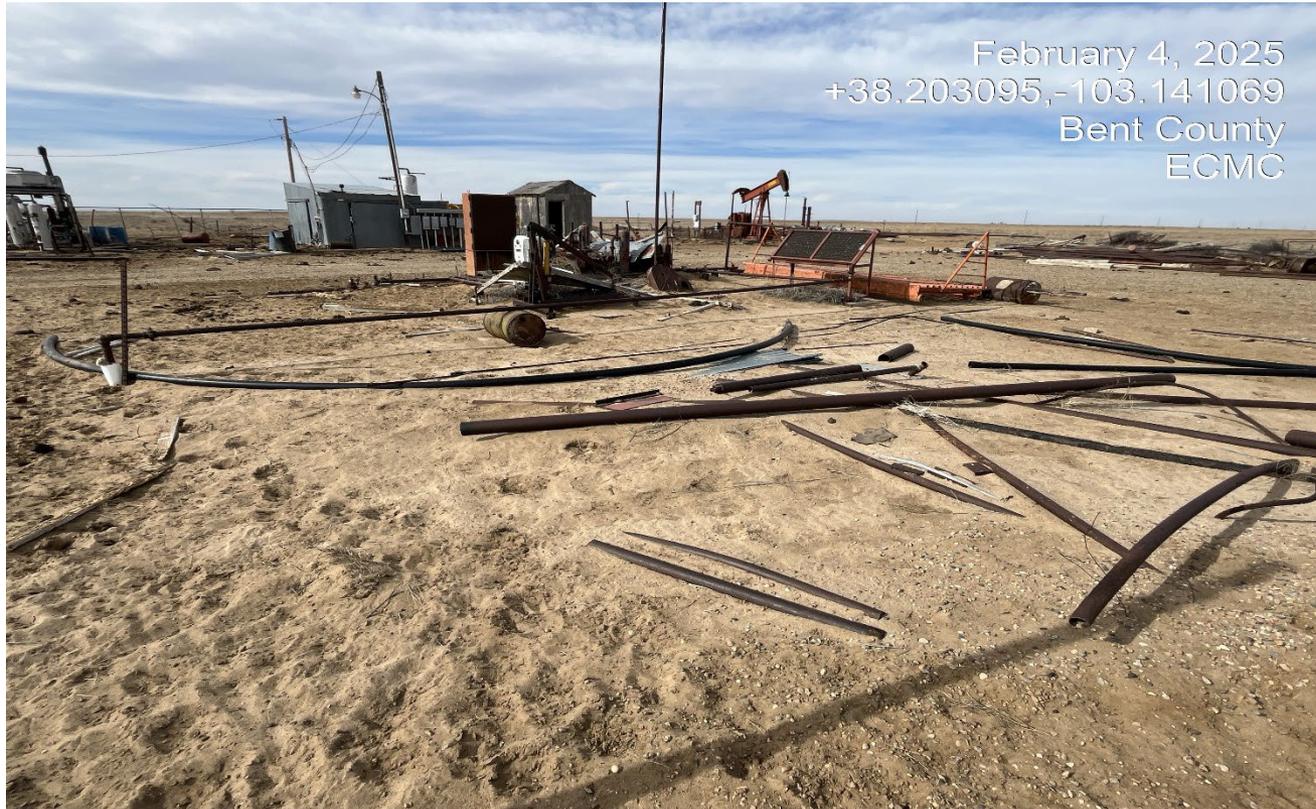
Photo 21. Facing northwest at the location. There is various pipe, supplies, and debris scattered throughout the location.
