Inspection Photos

Loc: 437659

Operator: PIONEER NATURAL RESOURCES USA INC

Inspection Date: 2/4/2025

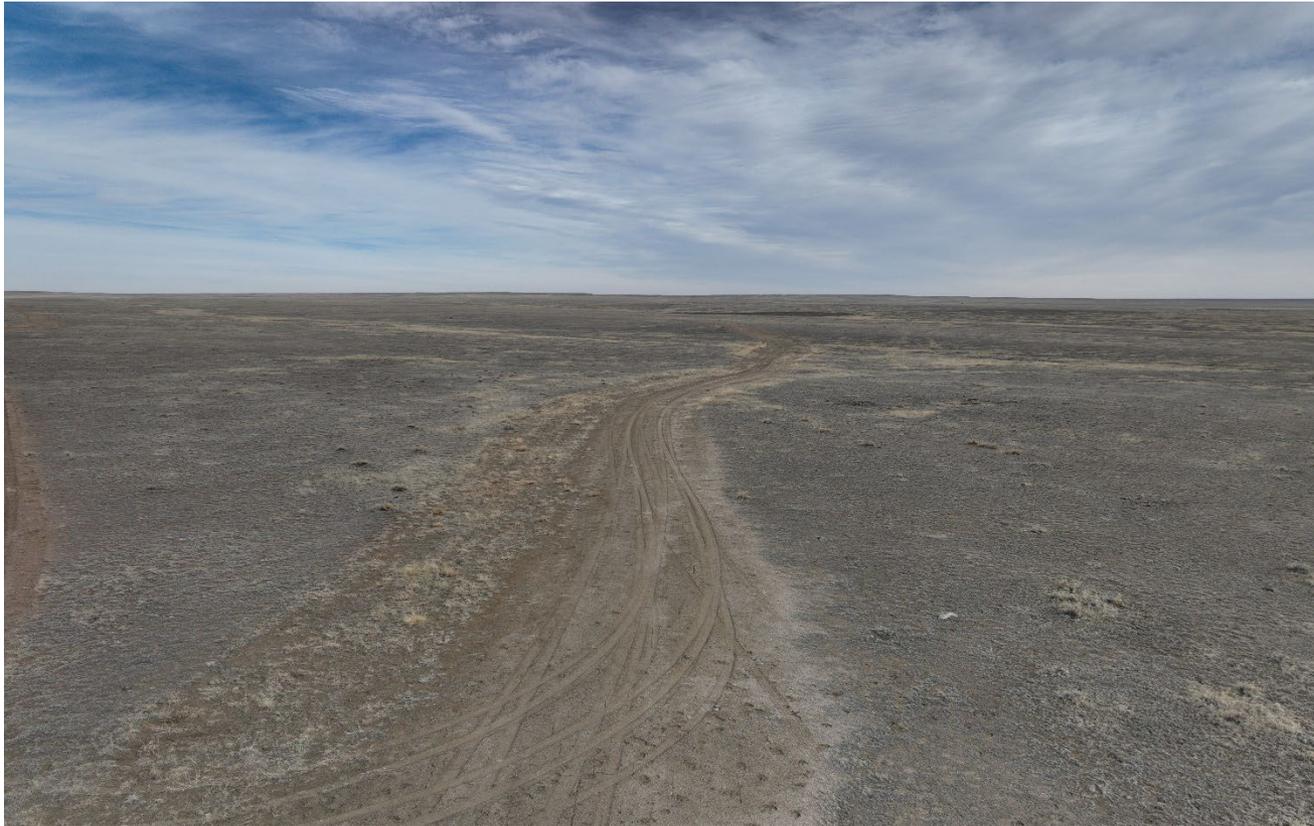
Photo 1. Drone aerial photo facing northeast along the access road. The former access road has not established perennial vegetation and needs to be reseeded.

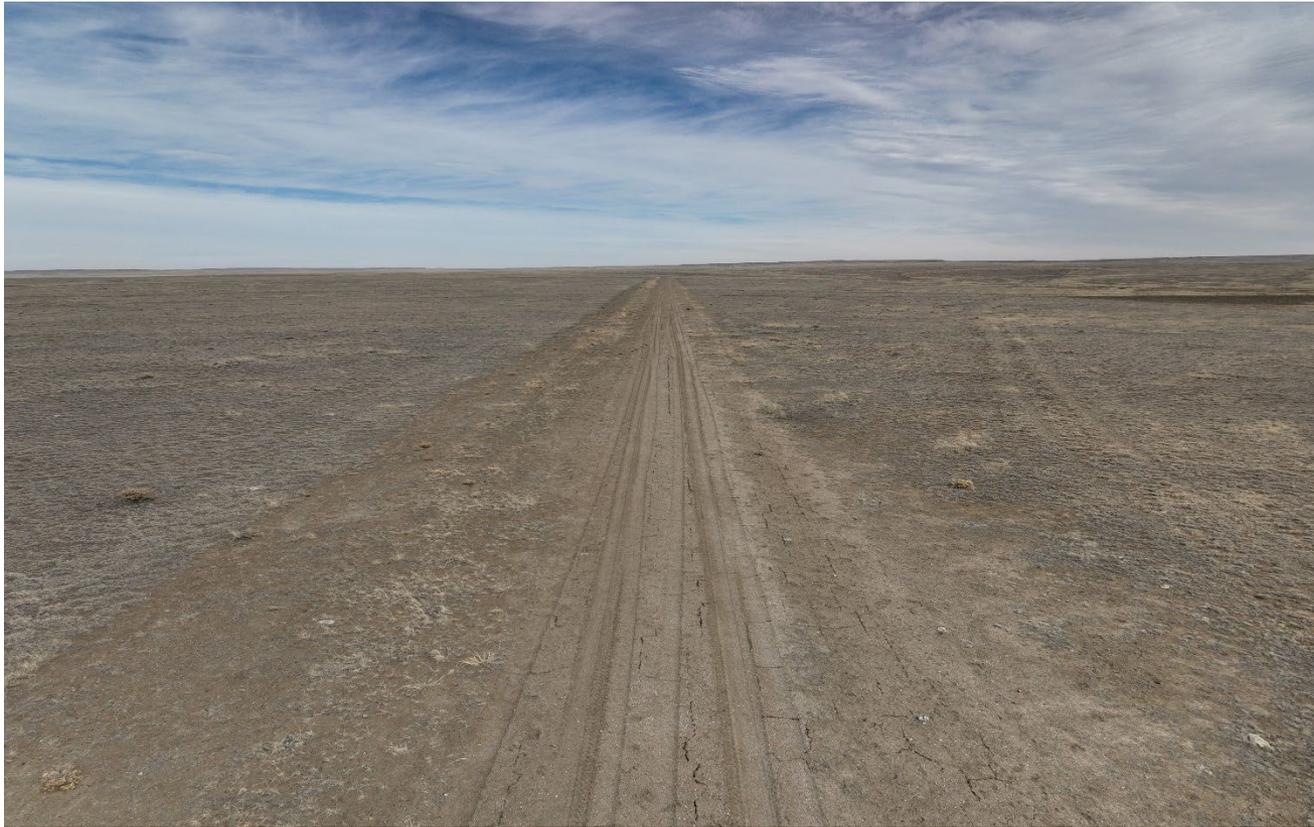
Photo 2. Drone aerial photo facing north along the access road. The former access road has not established perennial vegetation and needs to be reseeded.

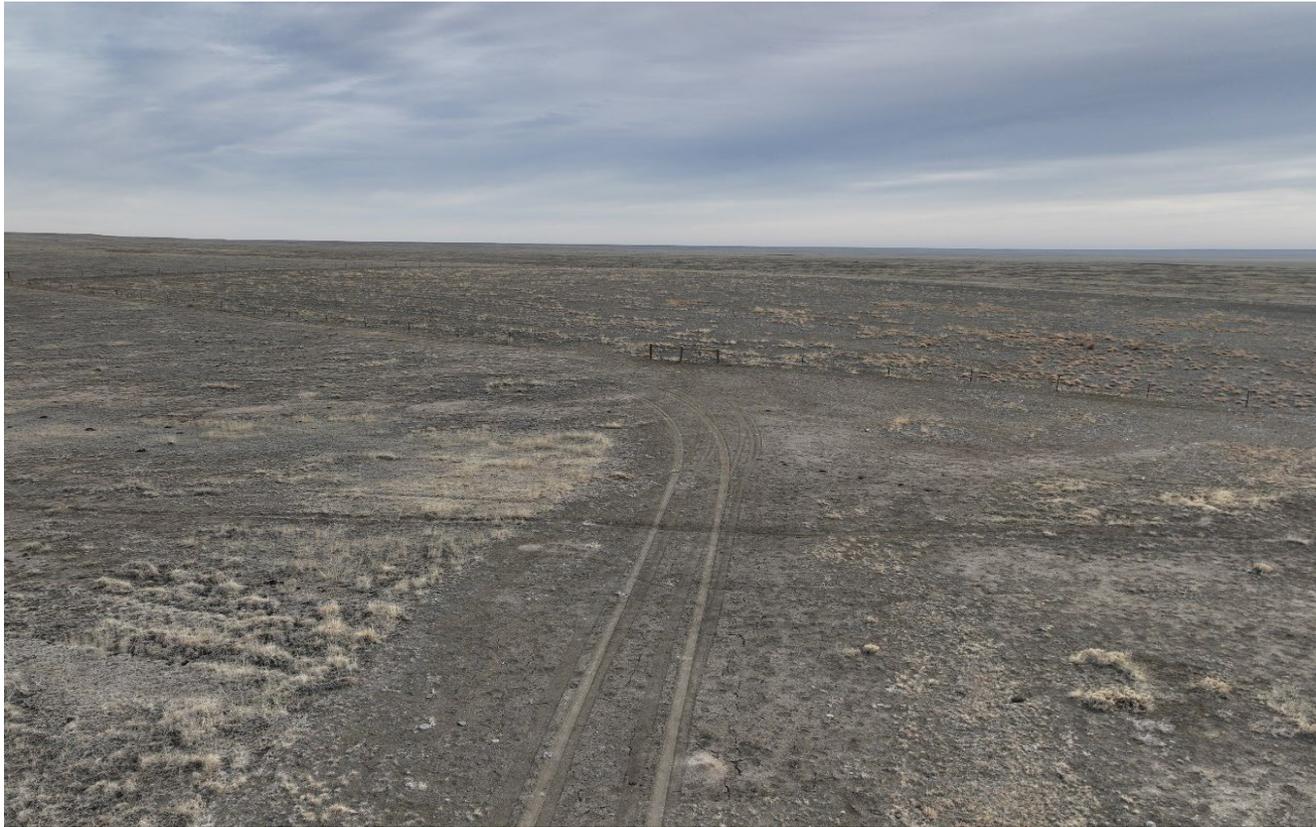
Photo 3. Facing east along the road toward the fenced location.

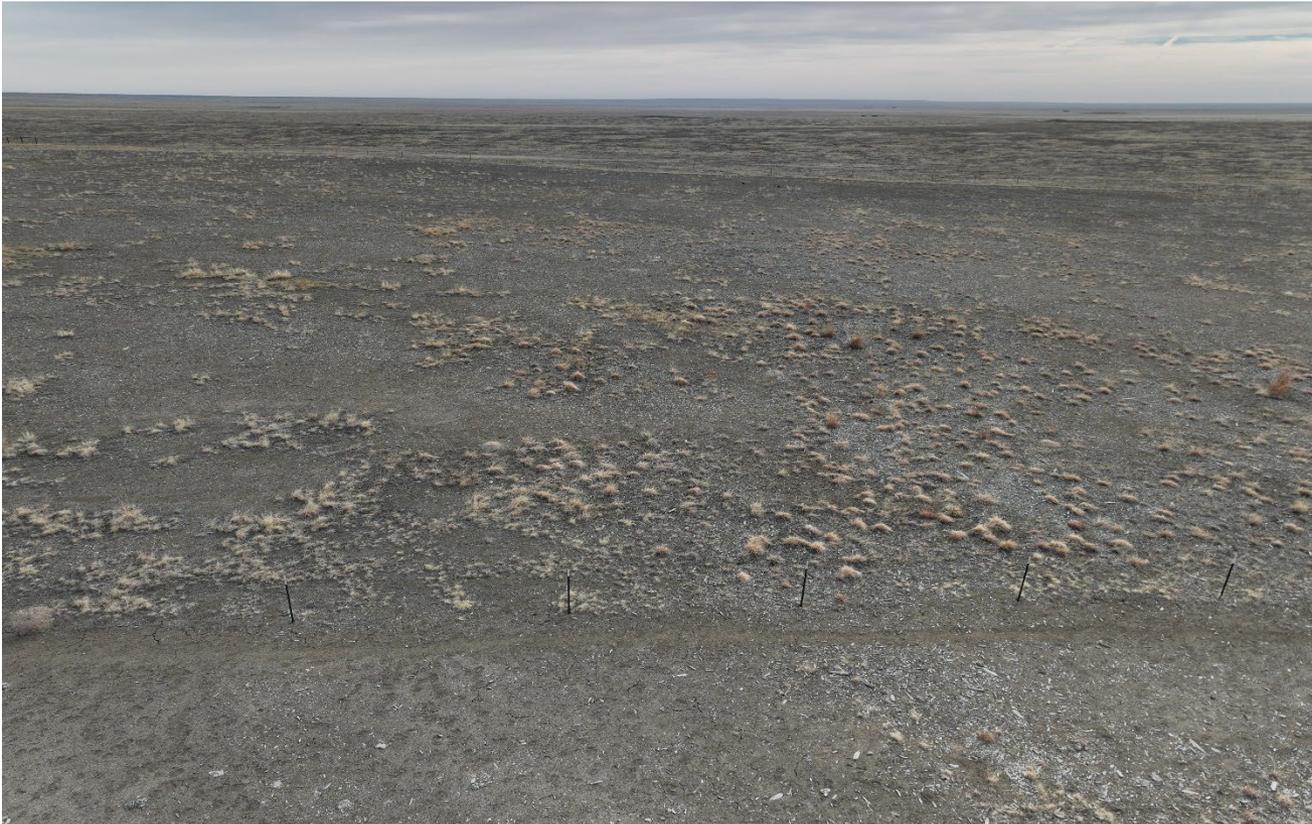
Photo 4. Facing east toward the location. There are areas of perennial vegetation but additional seeding needs to be performed to help promote more growth.

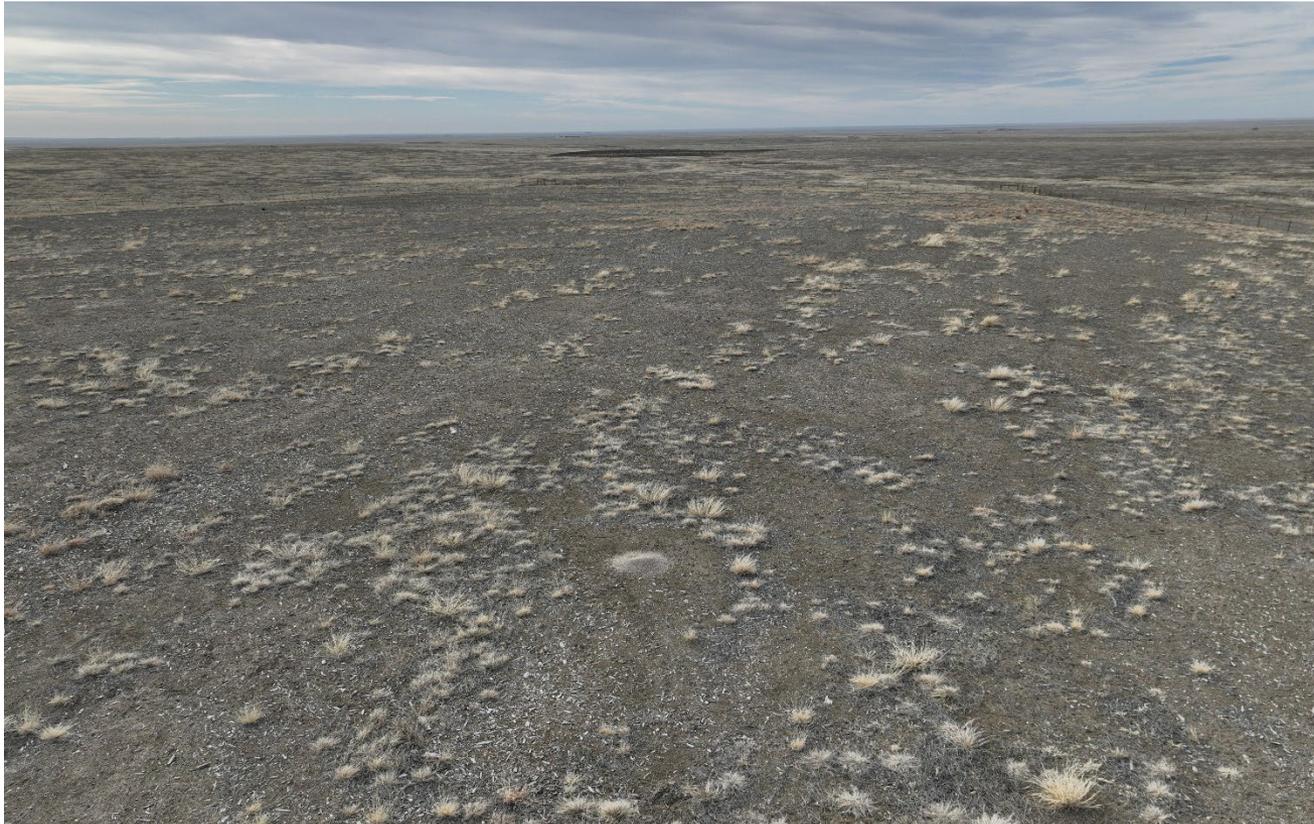
Photo 5. Facing south toward the location. There are areas of perennial vegetation but additional seeding needs to be performed to help promote more growth.

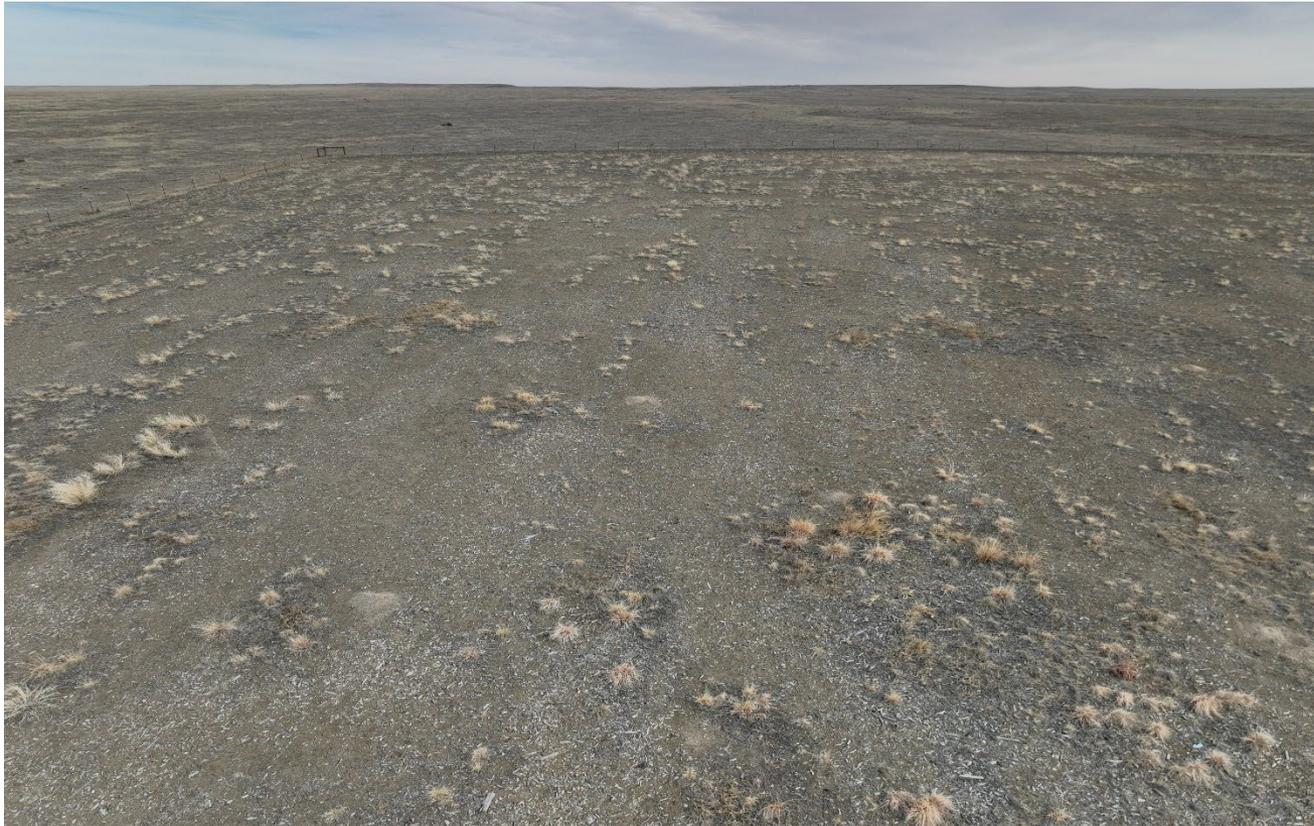
Photo 6. Center of the location facing north. There are areas of perennial vegetation but additional seeding needs to be performed to help promote more growth.

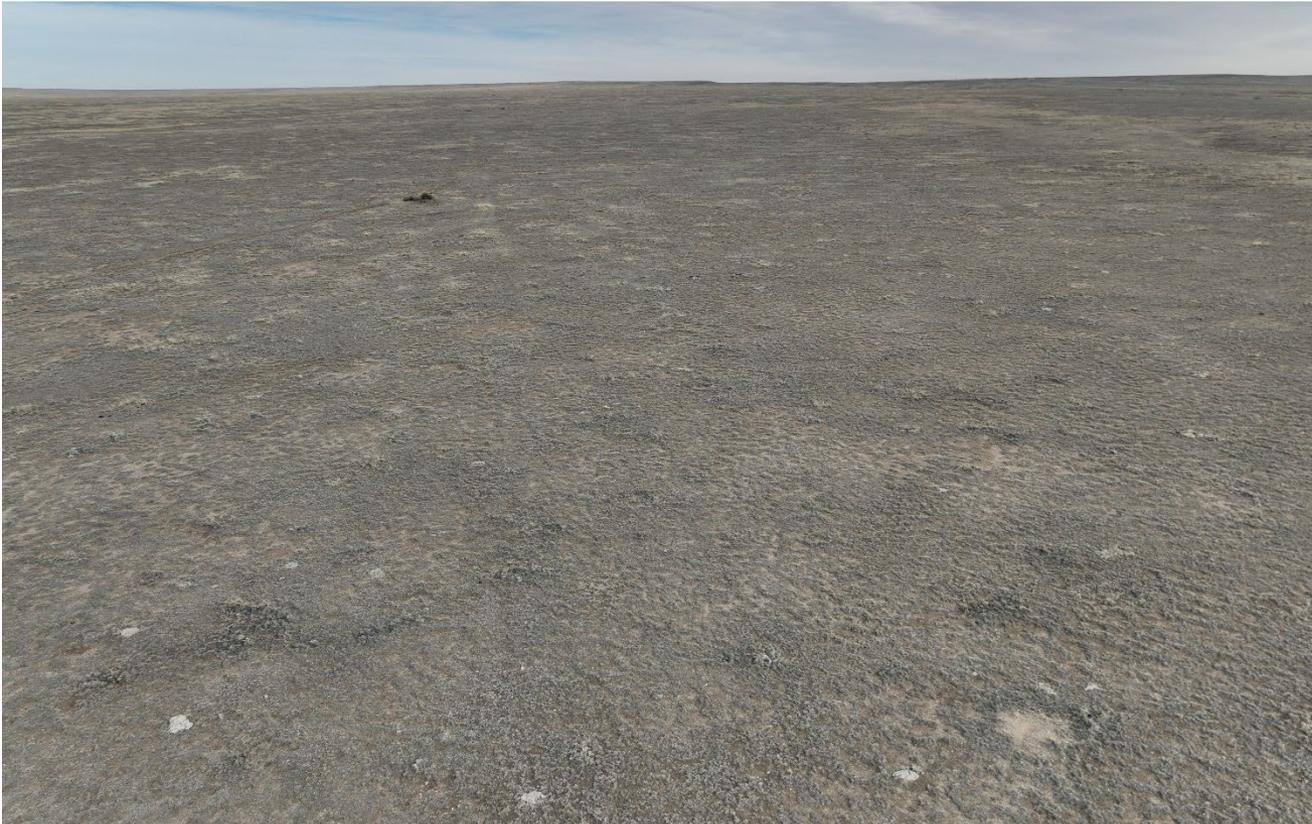
Photo 7. Facing north toward the reference area which consists of native Blue grama dominate grassland.
